GEOTECHNICAL RECONNAISSANCE OF THE 2010 DARFIELD (NEW ZEALAND) EARTHQUAKE

Version 1: 14 November 2010

EDITORS

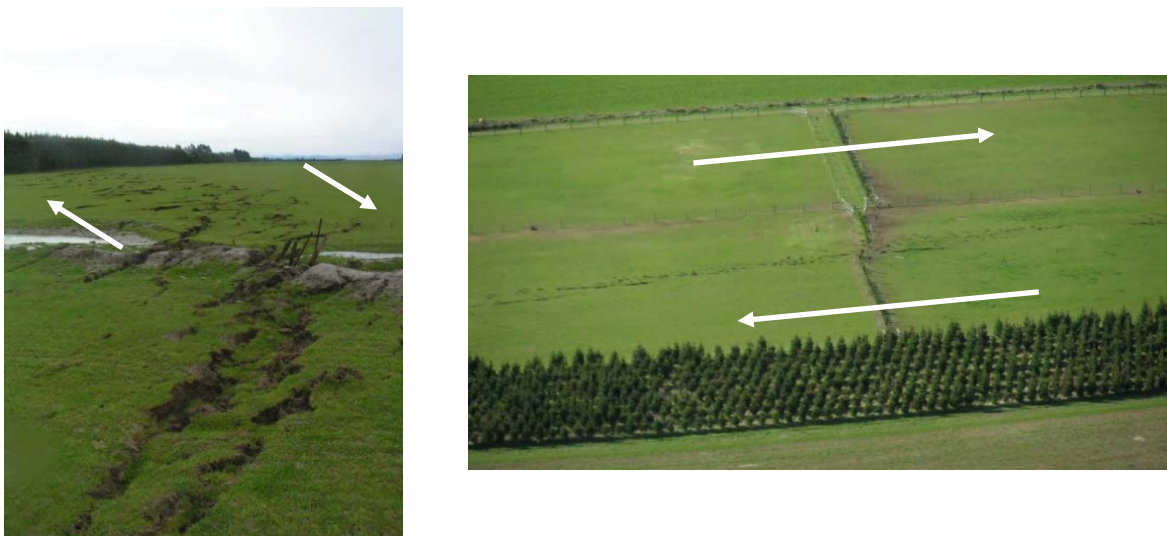
Figure 2.4 Photographs of surface fault rupture on the Greendale fault (left photo: <http://daveslandslideblog.blogspot.com/2010/09/images-of-darfield-canterbury.html>).

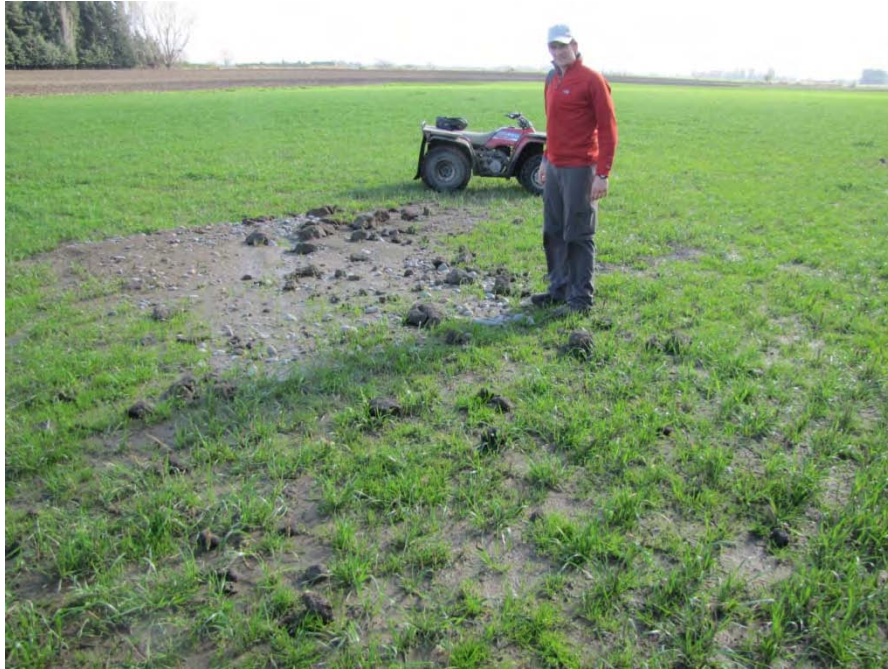
Figure 4.40 Ejected material on another paddock of the Selwyn Forks farm (Sheepyard paddock). As well as sand and gravel the ejecta contain clods of topsoil. (Position marked as Photo 4 in Fig. 4.36.)

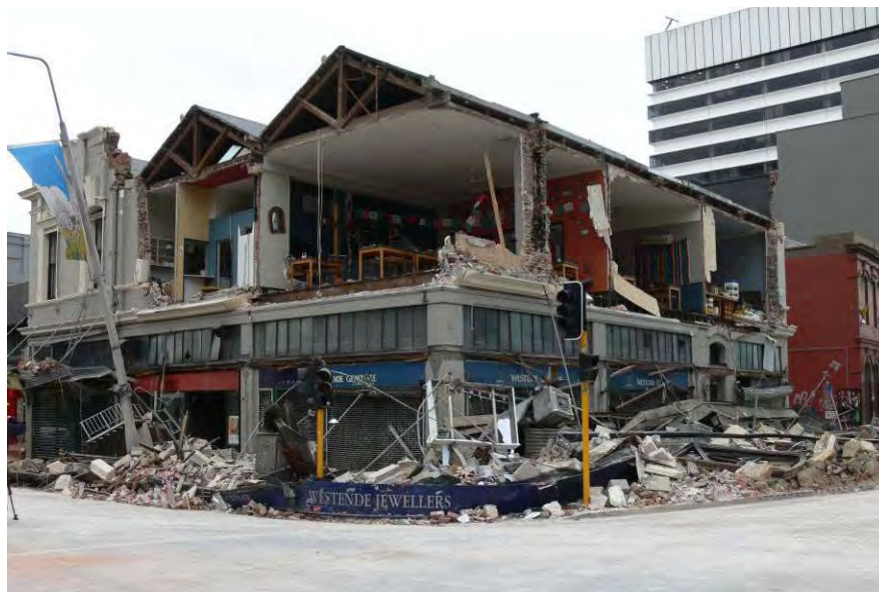
Figure 5.1 Structural collapse of a URM in the Christchurch Business District, 184 Manchester St. (Photograph courtesy of Prof Jason Ingham)

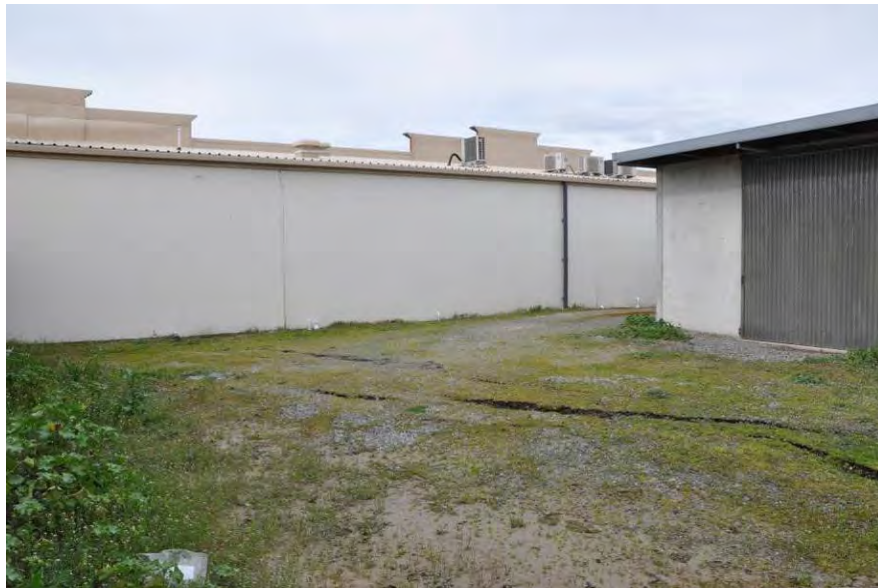
Figure 5.9 Surrounding ground failure patterns directly adjacent to the Property and Family Law Offices in Kaiapoi business district. View looking southeast (43.3819° S, 172.6593° E; 1100 hrs on 11 September 2010)

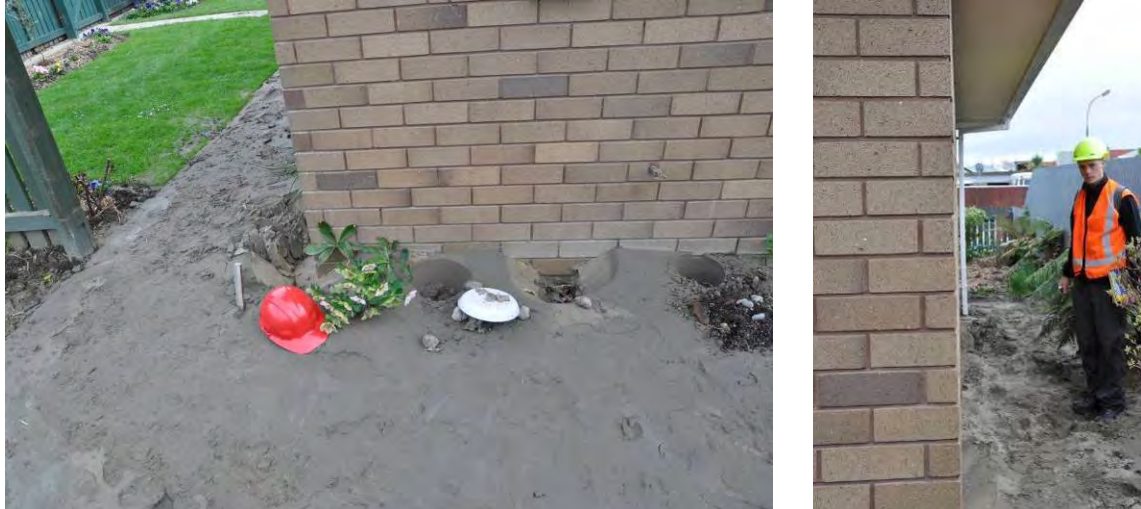
Figure 5.18 Red tagged residence on Charles St. Extensive surrounding ejecta at perimeter of house (43.3838°S, 172.6607°E; 1130 hrs on 11 September 2010)

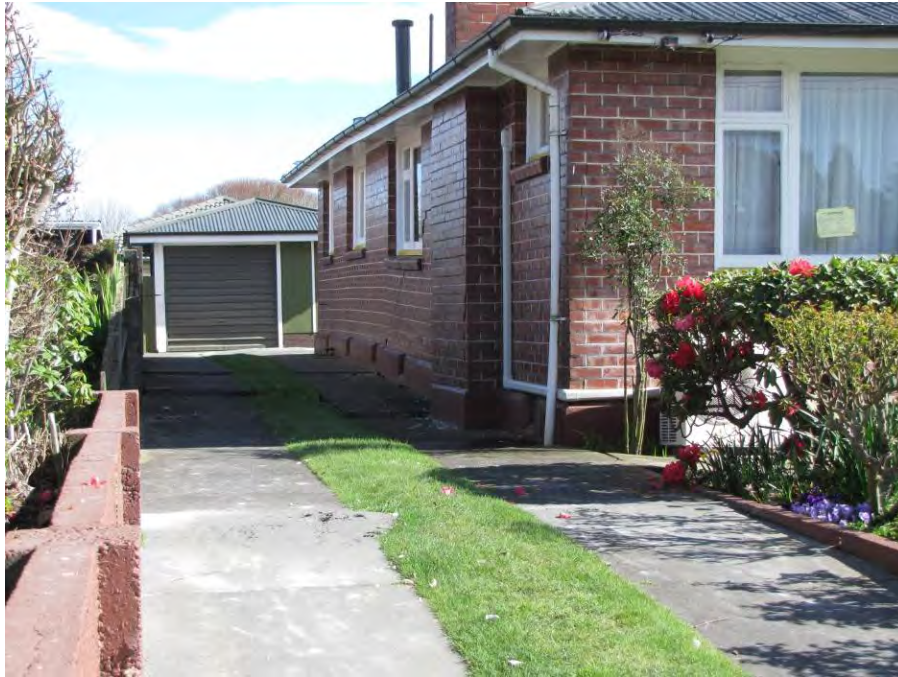
Figure 5.26 Residence affected by lateral spreading along the driveway, which has induced differential settlement between the front and rear of the house. (Note that this is not a slab-on-ground house, and older style of construction with a concrete perimeter beam and the timber floor being supported on shallow foundations; Locksley Ave; -43.5194° , 172.6754° ; 1130 hrs on 14 September 2010)

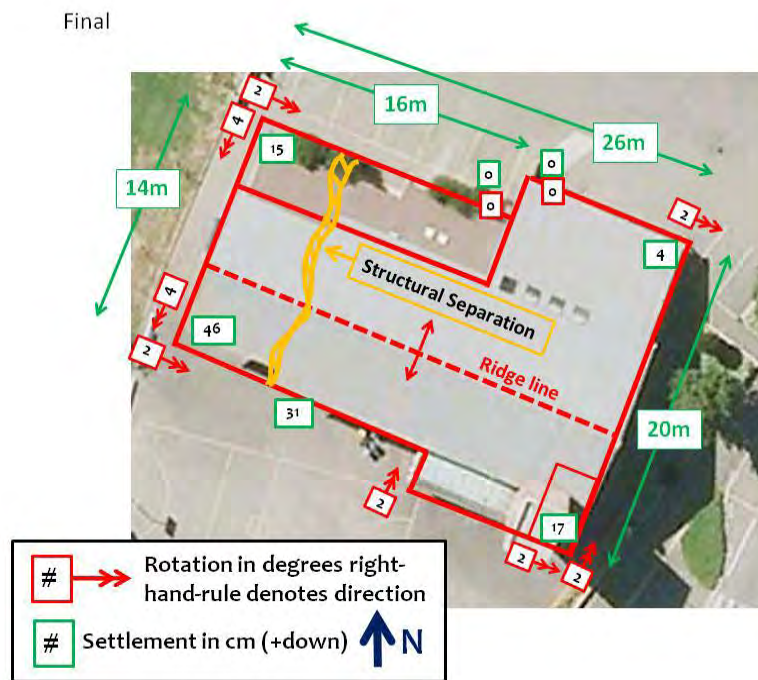
Figure 5.29 St Paul's church damage map – survey conducted 12 September 2010; Global dimensions approximate (extracted from GoogleEarth image), deformation obtained directly in the field.

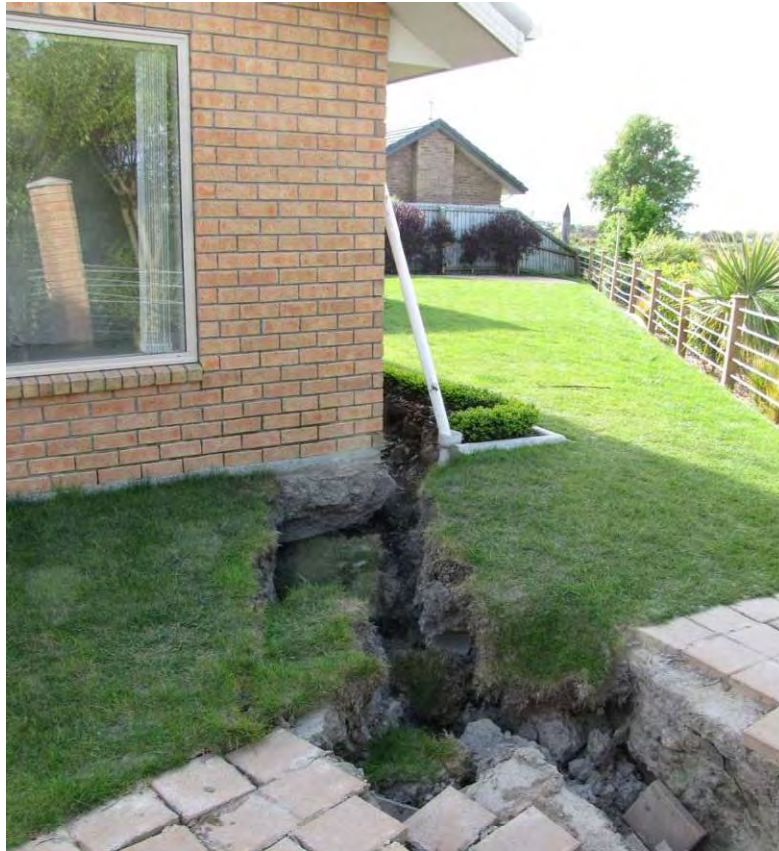
Figure 5.38. Lateral spreading compromising ground support beneath the concrete slab-on-grade house foundation. (Kokopu St; -43.5183°, 172.7220°; 1030hrs on 12 September 2010)

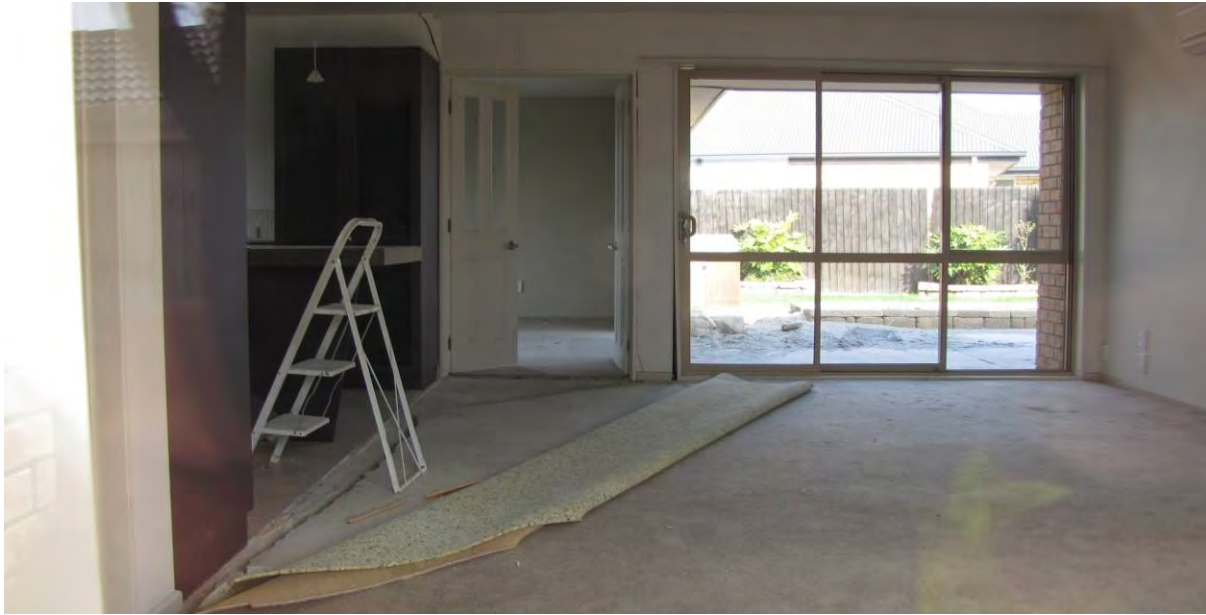
Figure 5.39. Fissure in concrete floor slab (to the left hand side passing beneath the ladder). (Same house as in Figure 5.38.) (Kokopu St; -43.5183°, 172.7220°; 1030hrs on 12 September 2010)

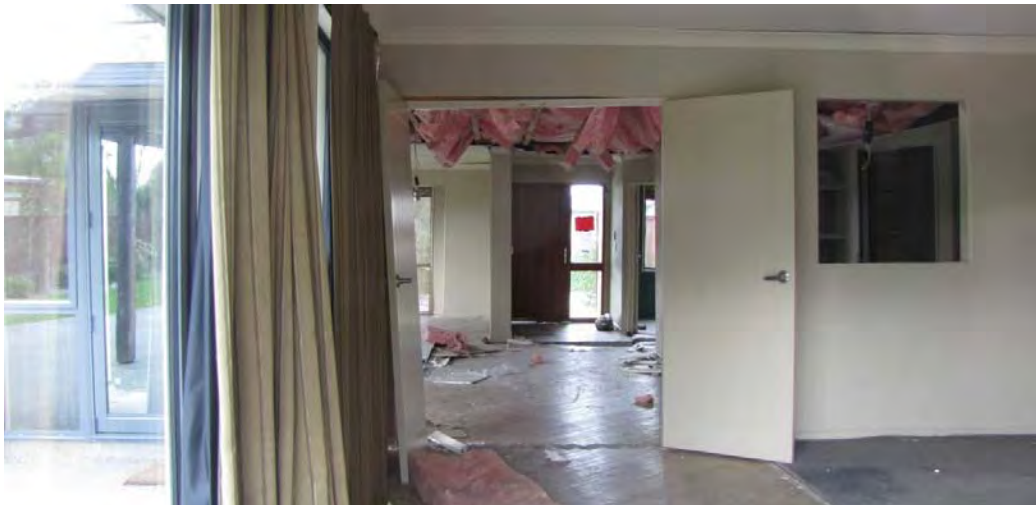
Figure 5.45 Interior view of residence at Riverside Ln. Note the two floor breaks visible in the photograph. (-43.4310° , 172.69319° ; 1500hrs on 28 September 2010)

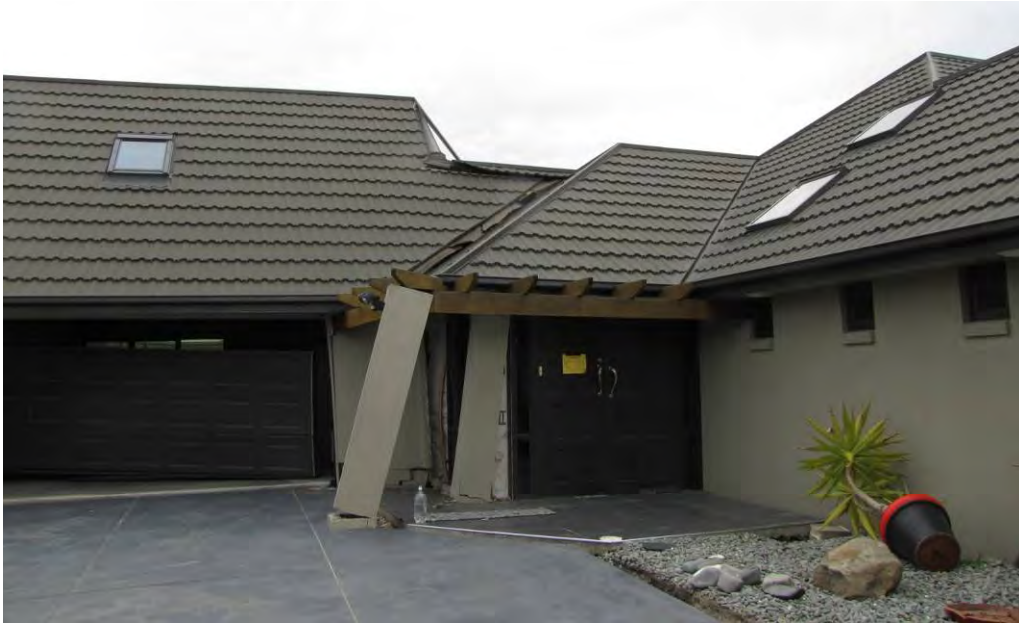
Figure 5.47. House with fissured floor slab with damage carried through to the roof line, which is no longer weather proof. (Riverside Ln, Spencerville). (-43.4311° , 172.6935° ; 1600hrs on 28 September 2010)

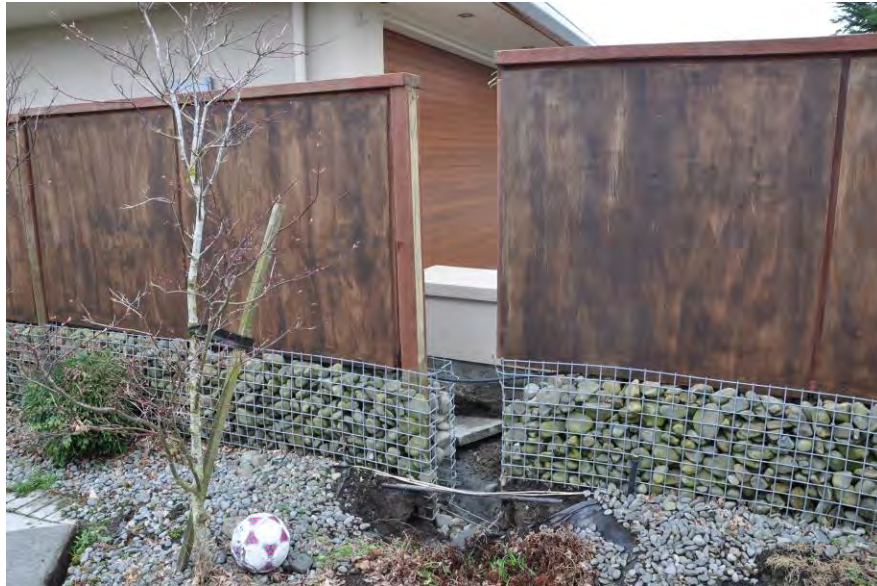
Figure 5.48 Separated fence line due to propagating ground fissure meandering between houses along Riverside Ln. (-43.43096°, 172.6931°; 1230hrs on 13 September 2010)

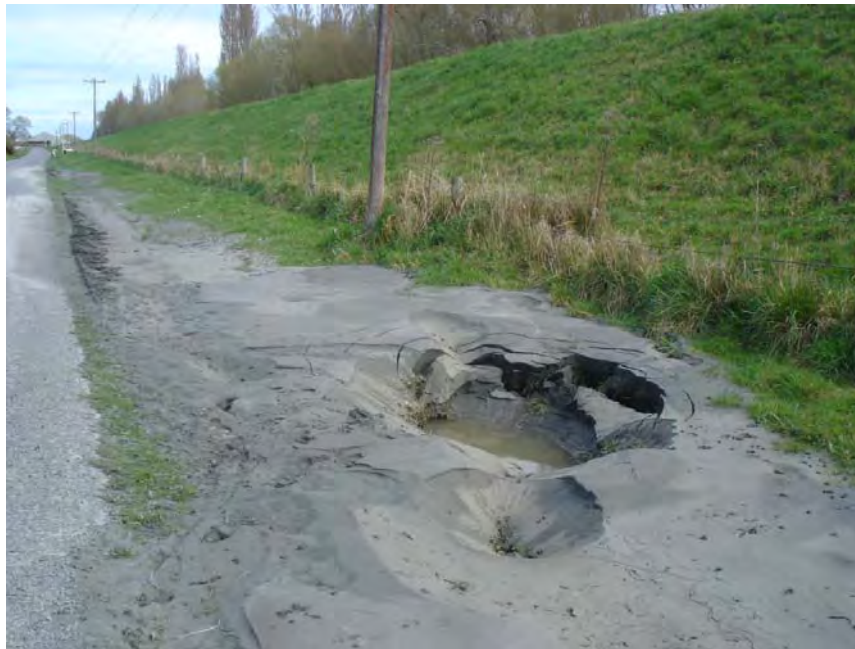
Figure 6.6 Photo 1: Large sand boil at the base of the landside of the levee on Coutts Island Rd. The location of this photograph is denoted in Figure 6.4. (-43.425018°, 172.628442°)

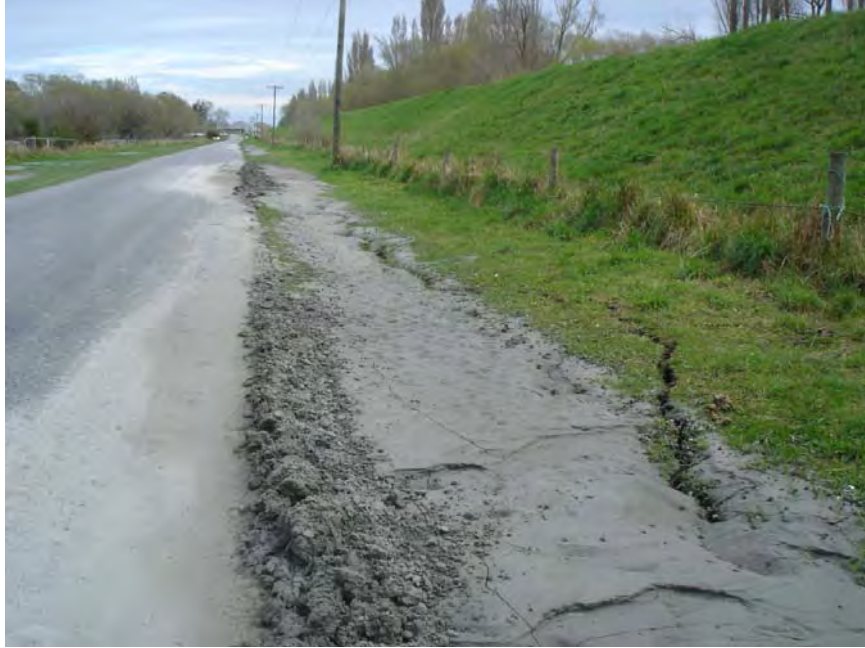
Figure 6.7 Photo 2: Crack running along base of levee on Coutts Island Rd (landside) and liquefaction ejecta. The location of this photograph is denoted in Figure 6.4. (-43.424466° , 172.629907°)

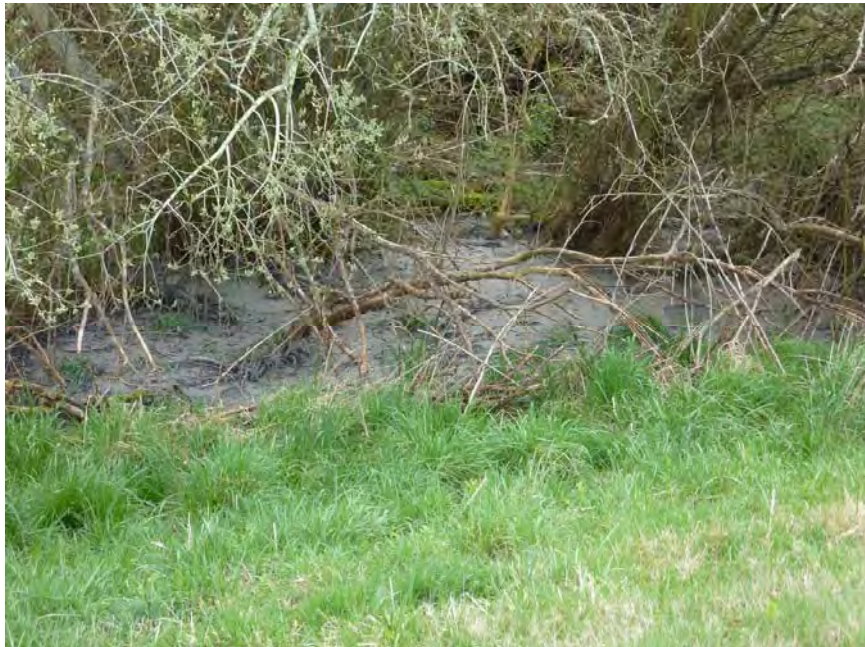
Figure 6.8 Photo 3: Liquefaction ejecta (center of photo) along the base of the levee on Coutts Island Rd (riverside). The location of this photograph is denoted in Figure 6.4. (-43.424093° , 172.630468°)

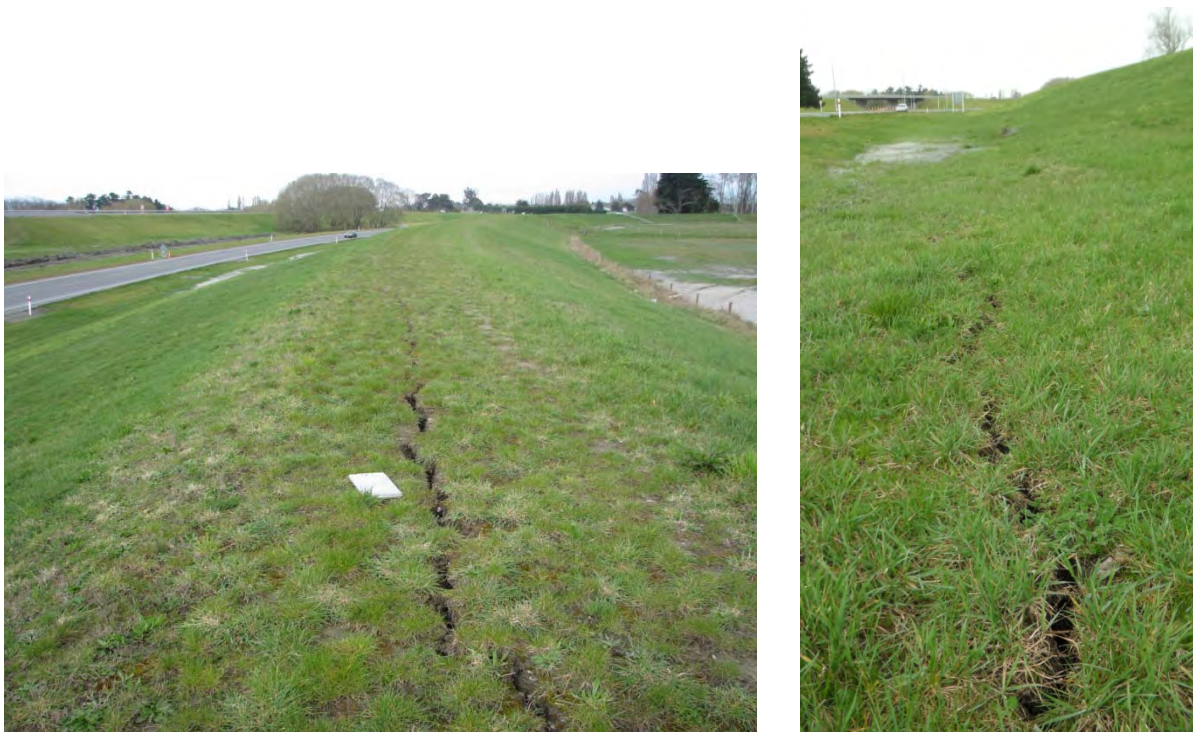
Figure 6.17 Photos 9 and 10: ~5-cm wide longitudinal cracks running along the crest (left) and base (right) of a secondary levee for the Waimakariri River. Photo taken looking southwest; SH1 on left of levee. The locations of these photographs are denoted in Figure 6.4. (-43.430108°, 172.643434°)

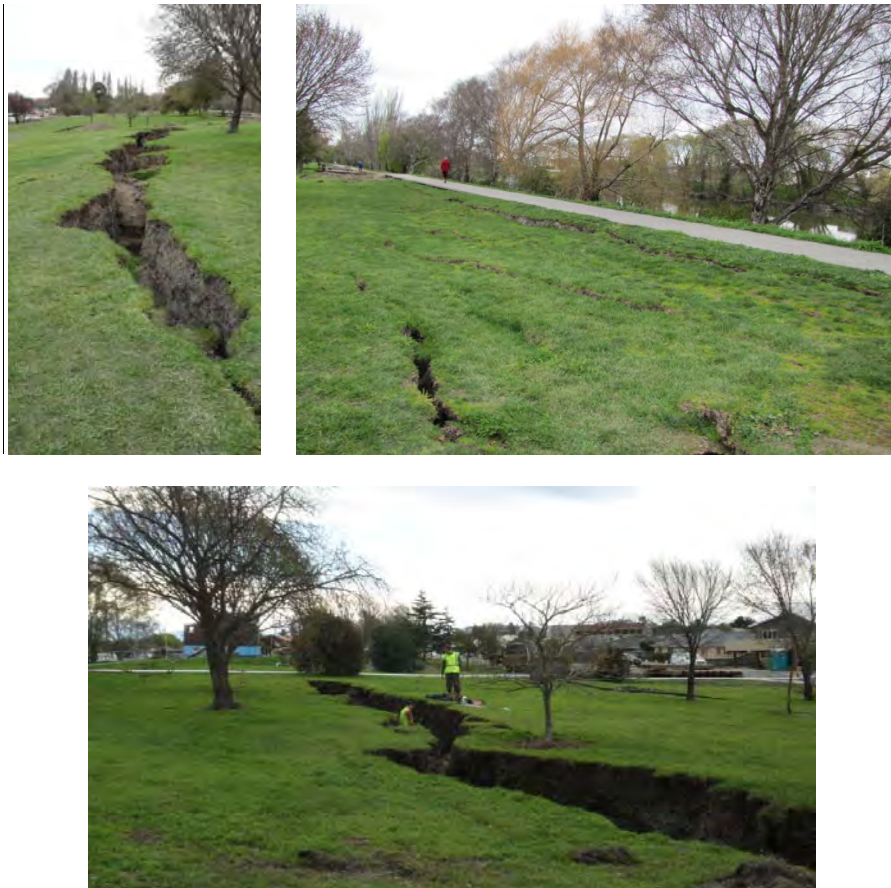
Figure 6.20 Photos 16-18: Lateral spread cracks along landside of the levee on the north side of the Kaiapoi River. The locations of these photographs are denoted in Figure 6.4. (-43.384484° , 172.660653°)

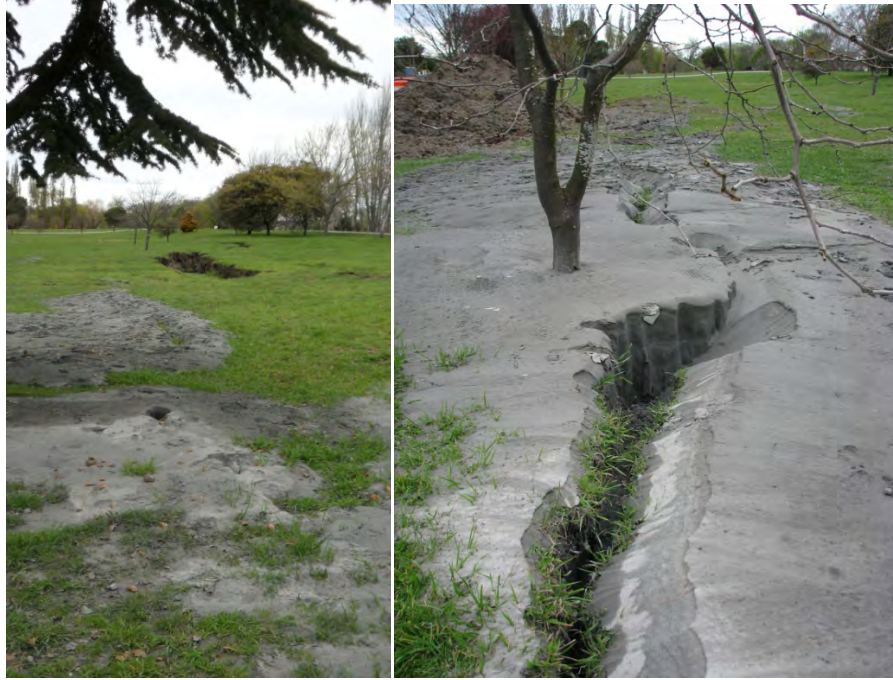
Figure 6.21 Photo 19 and 20: Lateral spread cracks along landside of the levee on the north side of the Kaiapoi River. The locations of these photographs are denoted in Figure 6.4. (-43.384633° , 172.661231°)

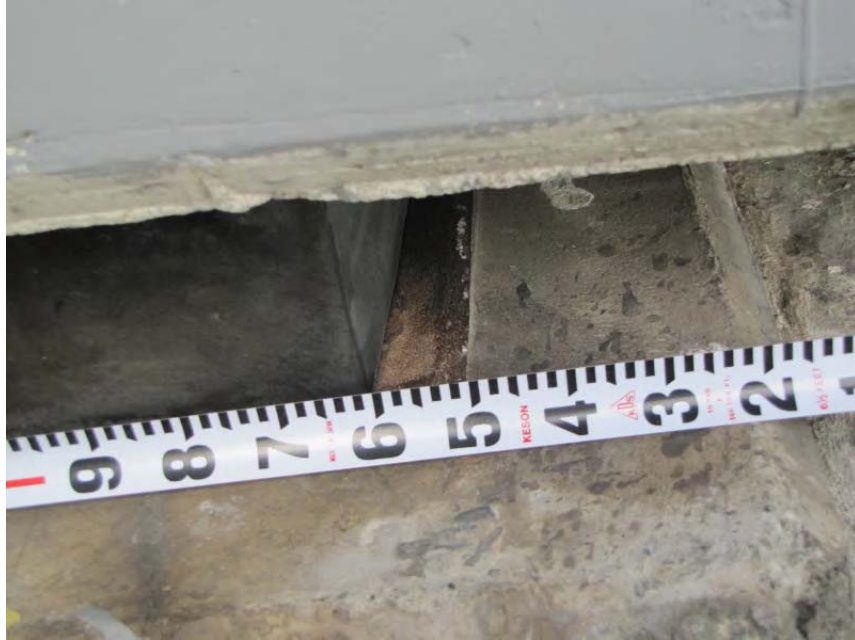
Figure 7.5 West abutment bearing pad displacement, Bridge Street Bridge (scale in Inches). (-43.5253°, 172.7242°)

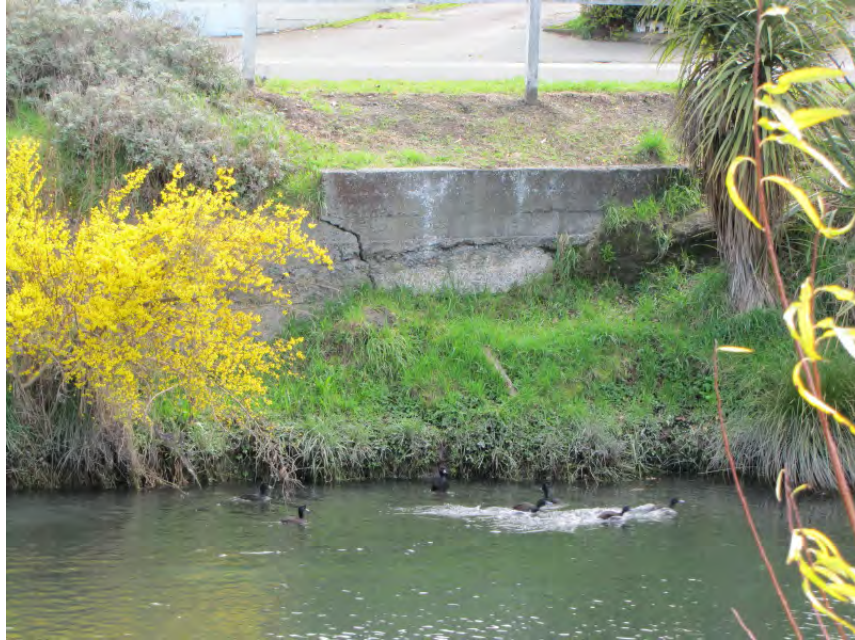
Figure 7.15 Cracking of retaining wall, north bank of the Avon River.

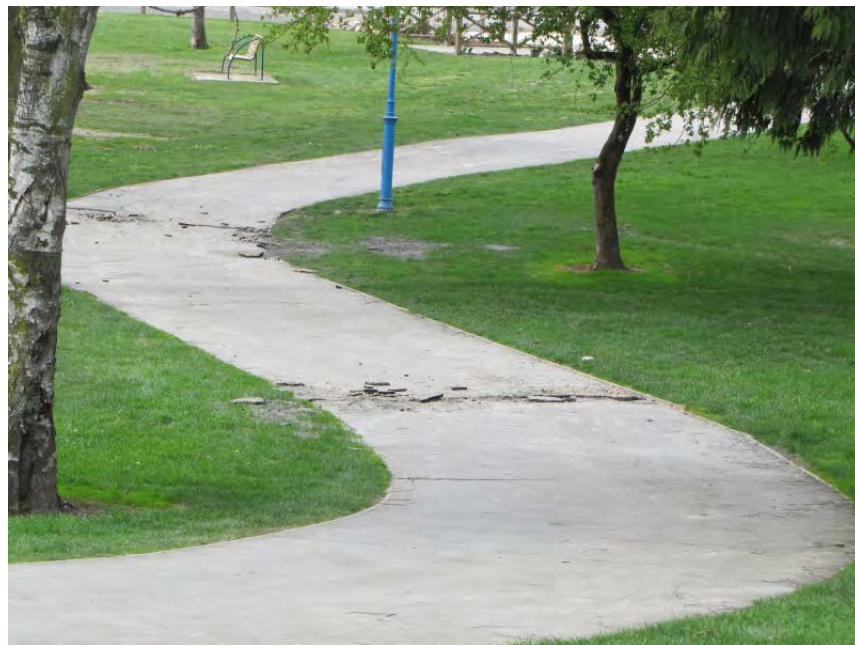
Figure 7.20 Cracking of sidewalk and evidence of liquefaction in Trousselot Park. (-43.3811° , 172.6558°)

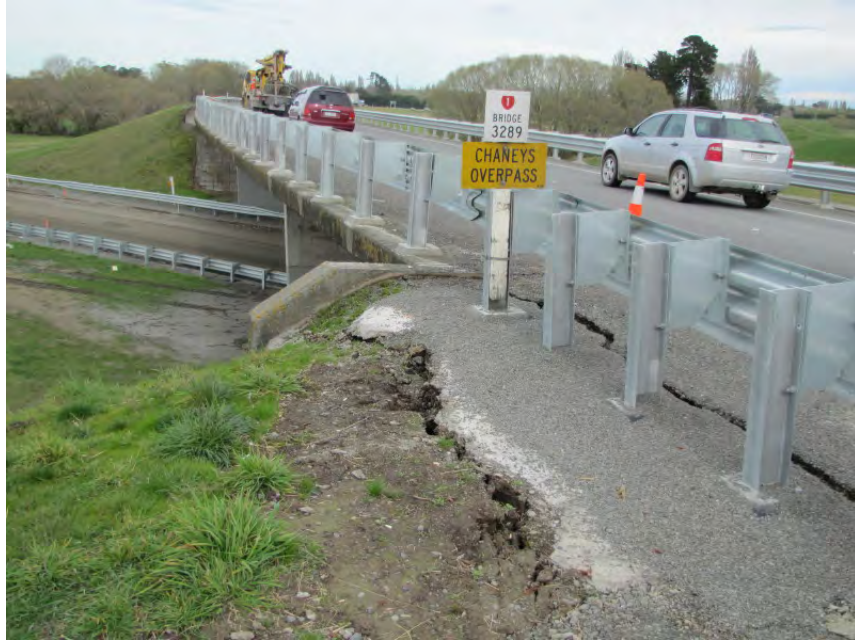
Figure 7.21 Incipient lateral spreading at Chaney's Overpass north abutment. (-43.4300°, 172.6464°)

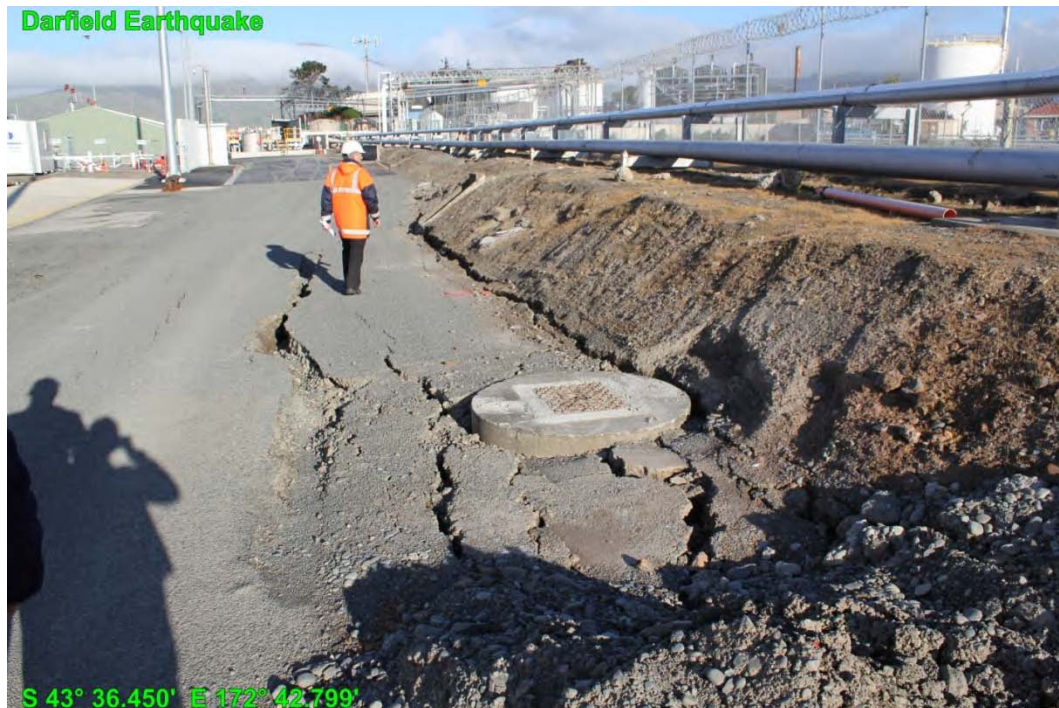
Figure 7.37 Settlement and lateral deformation at fuel transfer facility (-43.60750°, 172.71332°).

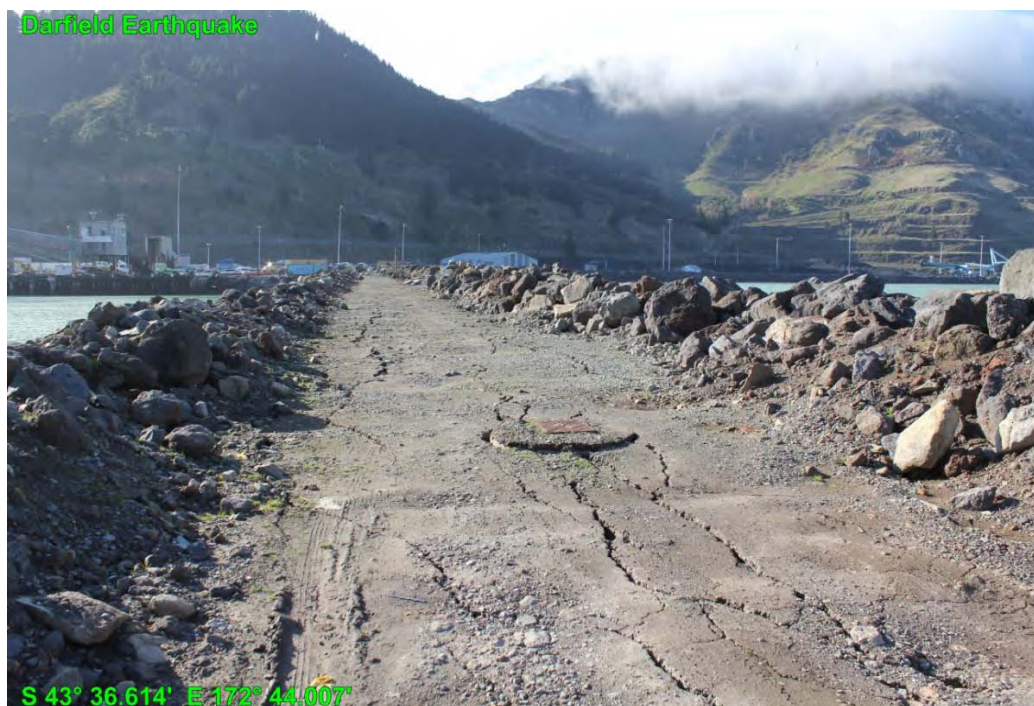
Figure 7.39 Cracking along jetty at eastern end of port (-43.61023°, 172.73345°).
