Surface rupture displacement on the Greendale Fault during the M_w 7.1 Darfield (Canterbury) earthquake, New Zealand, and its impact on man-made structures

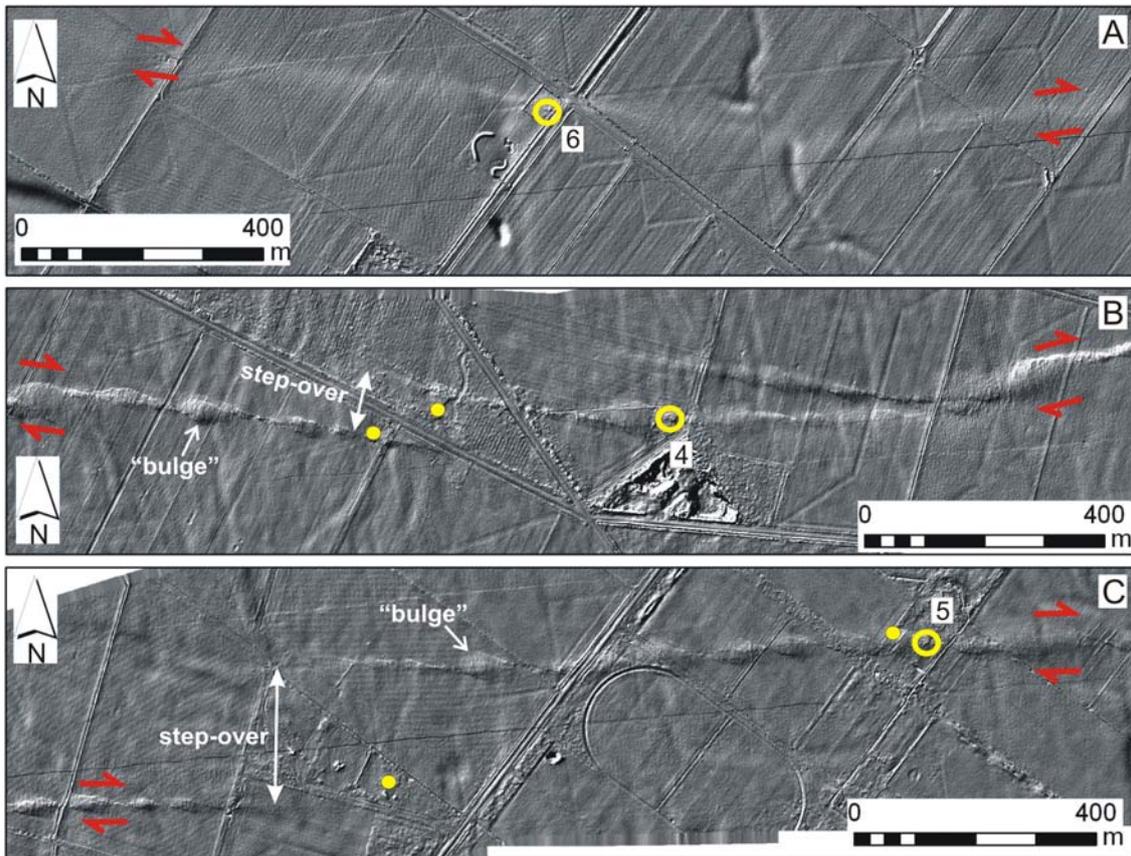
The zone of identified surface rupture extends for about 30 km from ~4 km west of the hamlet of Greendale (from which the fault gets its name) to an eastern tip ~2 km north of the town of Rolleston (Fig. 1). The gross morphology of the surface rupture is that of an en echelon series of east-west striking, left-stepping surface traces (Figs 1 & 2). The largest step-over is ~1 km wide, and there is a multitude of smaller ones. Push-up “bulges” formed at most of these restraining left-steps, with amplitudes up to ~1 m, but typically less than 0.5 m (Figs 2B & 2C).

Figure 2. LiDAR hillshade DEMs (illuminated from the NW) of three ~1.8 km long sections of the Greendale Fault (see Figure 1 for locations), showing characteristic left-stepping in echelon rupture pattern (especially evident in B & C), and dextral offset of roads, fences, irrigation channels, hedges and crop rows. Red arrows straddle the surface fault rupture and show the sense of lateral displacement. Representative examples of fault step-overs and push-up “bulges” are identified in B & C. Open yellow circles show the locations of buildings damaged by surface fault rupture that are depicted and discussed in Figures 4-6. Small yellow dots show the locations of other buildings damaged by surface rupture deformation that are not discussed in this paper. The general amount of net surface rupture displacement in A, B, and C is, respectively, 1.5 to 2.5 m (horizontal to vertical ratio ~3:1, south side up), 4 to 5 m (predominantly dextral), and 4 to 2.5 m (predominantly dextral).

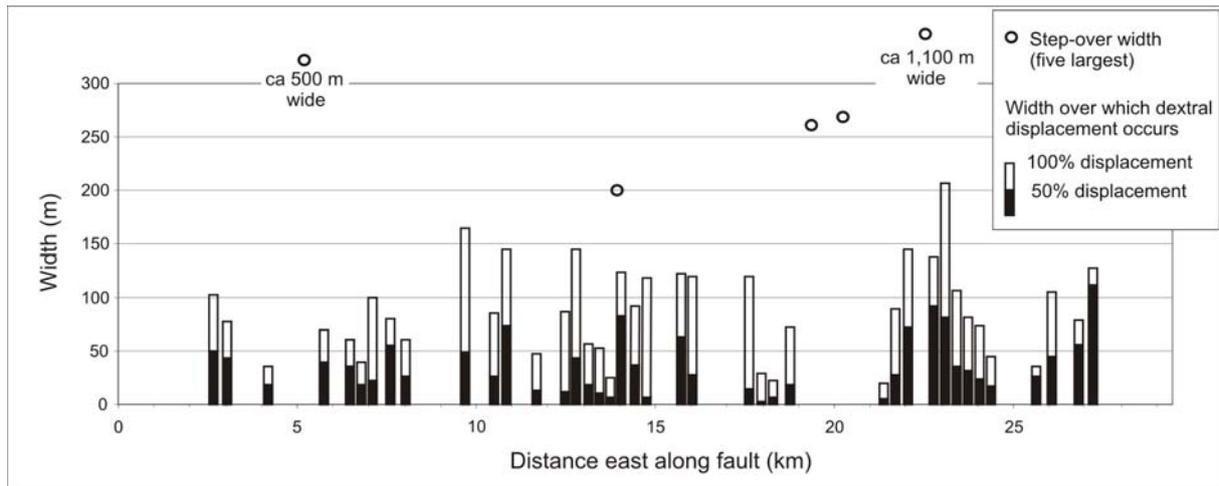
Perpendicular to the strike of the Greendale Fault, surface rupture displacement is distributed across a ~30 to 300 m wide deformation zone (Fig. 3), largely as horizontal flexure. The width of the surface rupture deformation zone is greatest at step-overs, and damaging ground strains developed within these. On average, 50% of the horizontal displacement occurs over 40% of the total width of the deformation zone with offset on discrete shears, where present, typically accounting for less than 25% of the total displacement. Across the paddocks deformed by fault rupture, there is a threshold of surface rupture displacement of ~1.5 m, or greater, where discrete ground cracks and shears occur and form part of the surface rupture deformation zone, and less than this where they are rarely present. The distributed nature of Greendale Fault surface rupture displacement undoubtedly reflects a considerable thickness of poorly consolidated alluvial gravel deposits underlying the plains.

Figure 3. Width (horizontal distance) measured perpendicular to fault strike over which it takes to accumulate 50% and 100% of the total dextral surface rupture displacement at 40 sites along the Greendale Fault. 50% widths are centred over the portion of the deformation zone that exhibits the greatest amount of displacement. The average width of the surface rupture deformation zone is about 80 to 90 m, excluding the largest step-overs. It is relevant to note that the true width of deformation, as documented in the field through detailed surveys of deformed fences and the like, is usually several tens of metres wider than the width of deformation evident in hillshade LiDAR images as processed and depicted in Figure 2, and can be over 100 m wider. For example, the eastern ~7 km of surface rupture, across which there is as much as ~1.5 m of dextral and ~0.5 m of vertical distributed deformation, is not visible in hillshade LiDAR images similar to those depicted in Figure 2.

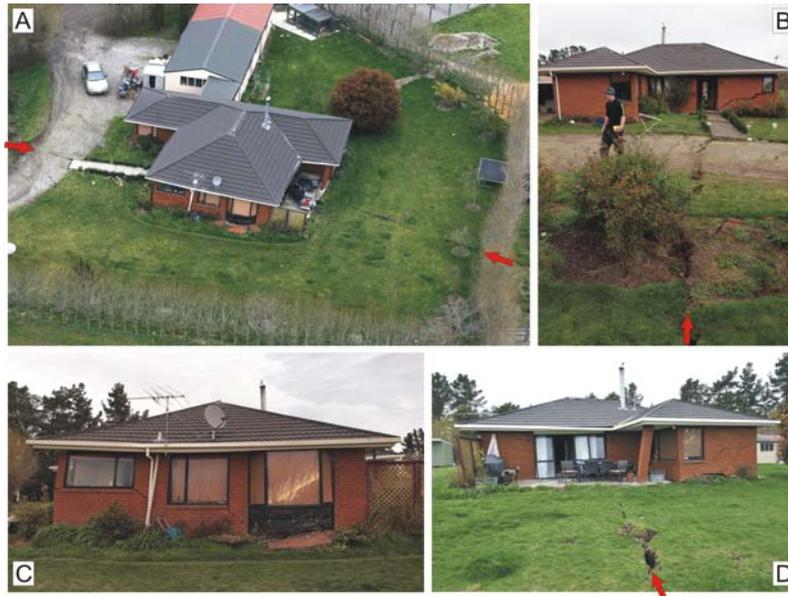
shear extending through/under them (Figs 4 & 5), but all were more damaged than comparable structures immediately outside the zone of surface rupture deformation. Some of the buildings most damaged by fault rupture are scheduled for demolition. From a life-safety standpoint, all these buildings performed satisfactorily, but with regard to post-event functionality, there are notable differences. The houses with lightly-reinforced concrete slab foundations (often also brick-clad) suffered moderate to severe structural and non-structural damage. Three other buildings exhibited more favourable performance and will be potentially more straightforward to reinstate. One had a reportedly well-reinforced concrete slab foundation (Fig. 6). Another had a shallow-seated pile foundation that fortuitously isolated a significant amount of ground deformation from the timber-framed, metal-clad superstructure (Fig. 5). The third, despite having steel piles set in concrete, had a steel and plywood structural system that was exceptionally robust and allowed the house to tilt and rotate as a rigid body (Fig. 7).

Figure 4. Timber-framed, brick-clad house with concrete slab foundation (at most only lightly-reinforced) and light-weight roof that is located within a ~150 m wide deformation zone accommodating 4 to 5 m of dextral displacement. The house is badly damaged by distributed deformation, and ~0.5 m of discrete strike-slip rupture (red arrows) that enters the house through the front door (B), passes through the house's foundation (including living room), and exits through the back door (D). Photos: A by Richard Cosgrove looking S; B by Hayden Mackenzie looking WNW; C by Hayden Mackenzie looking SSW; D by Dougal Townsend looking ESE.

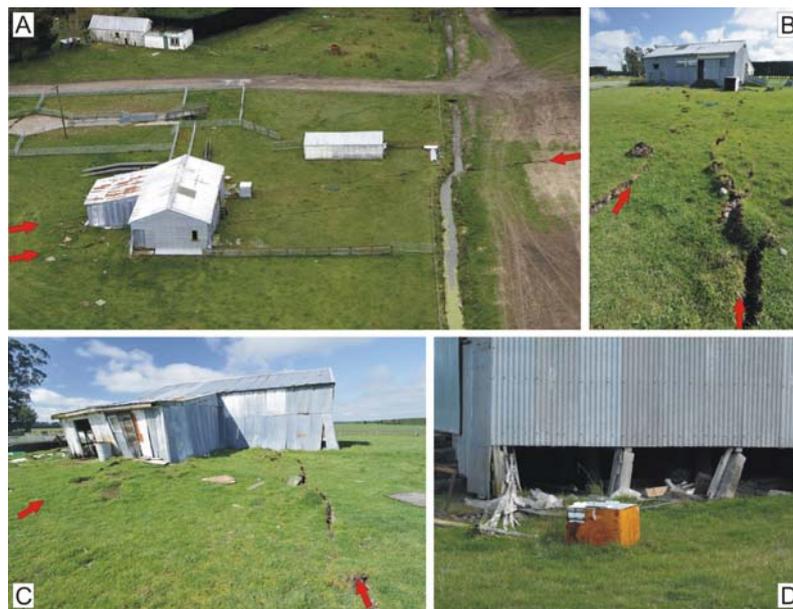
Figure 5. Timber-framed farm shed that is located within a 25 to 50 m wide deformation zone comprising both discrete shears (red arrows) and distributed deformation, and accommodating ~2.7 m of net slip (predominantly strike-slip - note dextral offset of irrigation channel in right-hand side of A). The farm shed is made up of two parts, a larger metal-clad structure with a timber floor that is founded on shallow seated ~700 mm high concrete piles (D), and a smaller lean-to structure attached to the side (A & C). The lean-to is a pole building (part metal-clad and part wood-clad) with an unreinforced concrete floor. The response of the two different construction styles to surface fault rupture was noticeably different. The support poles of the lean-to are set into the ground. Dextral fault rupture under the lean-to led to lateral displacement of the support poles on either side of the rupture, and significant distortion of the walls and roof (C). In contrast, surface rupture deformation under the larger piled structure was, in large measure, isolated from the superstructure by rotation of the shallow seated piles. The timber flooring and framing, and metal cladding proved a resilient structural system that limited internal distortion. It would be a relatively straightforward process to re-level and reinstate this portion of the building. Photos: A by Richard Cosgrove looking NE; B by Dougal Townsend looking W; C by Dougal Townsend looking E; D by Russ Van Dissen looking SW.

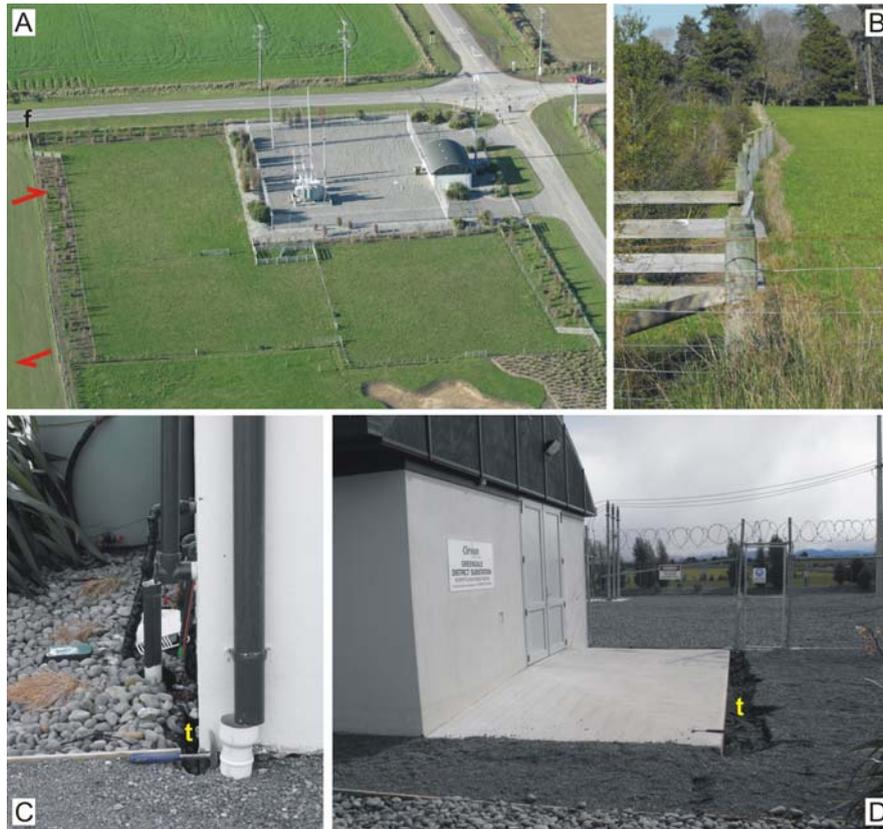
Figure 6. A) Light-industrial building with a reportedly well-reinforced concrete slab foundation is tilted and rotated, but relatively undamaged, by ~ 1.7 m dextral and < 1 m vertical (south side up) displacement distributed across a ~ 100 m wide deformation zone. Red arrows denote location, strike and sense of lateral displacement of the surface rupture deformation zone. Photo by Richard Jongens looking NE. B) Fence line adjacent to site crosses the surface rupture deformation zone and records the amount, width, and distributed style of fault displacement here (camera location for B is shown by black “f” in A). Photo by Russ Van Dissen looking SW. C & D) Long axis of building is oriented $\sim 55^\circ$ counter-clockwise to the general strike of the fault rupture. Distributed displacement imposed tensile ground strains across the site with an orientation roughly sub-parallel to the building’s long axis. The foundation of the building was robust enough to resist these strains (i.e. no cracking of the foundation was evident) and, instead, the soil pulled away from either end of the building’s foundation (yellow “t” in C & D). Photos C & D by Russ Van Dissen looking NW.
