SURFACE RUPTURE OF THE GREENDALE FAULT DURING THE M_w 7.1 DARFIELD (CANTERBURY) EARTHQUAKE, NEW ZEALAND: INITIAL FINDINGS

M. Quigley¹, R. Van Dissen², P. Villamor², N. Litchfield², D. Barrell², K. Furlong³, T. Stahl¹, B. Duffy¹, E. Bilderback¹, D. Noble¹, D. Townsend², J. Begg², R. Jongens², W. Ries², J. Claridge¹, A. Klahn¹, H. Mackenzie¹, A. Smith¹, S. Hornblow¹, R. Nicol¹, S. Cox², R. Langridge², K. Pedley¹

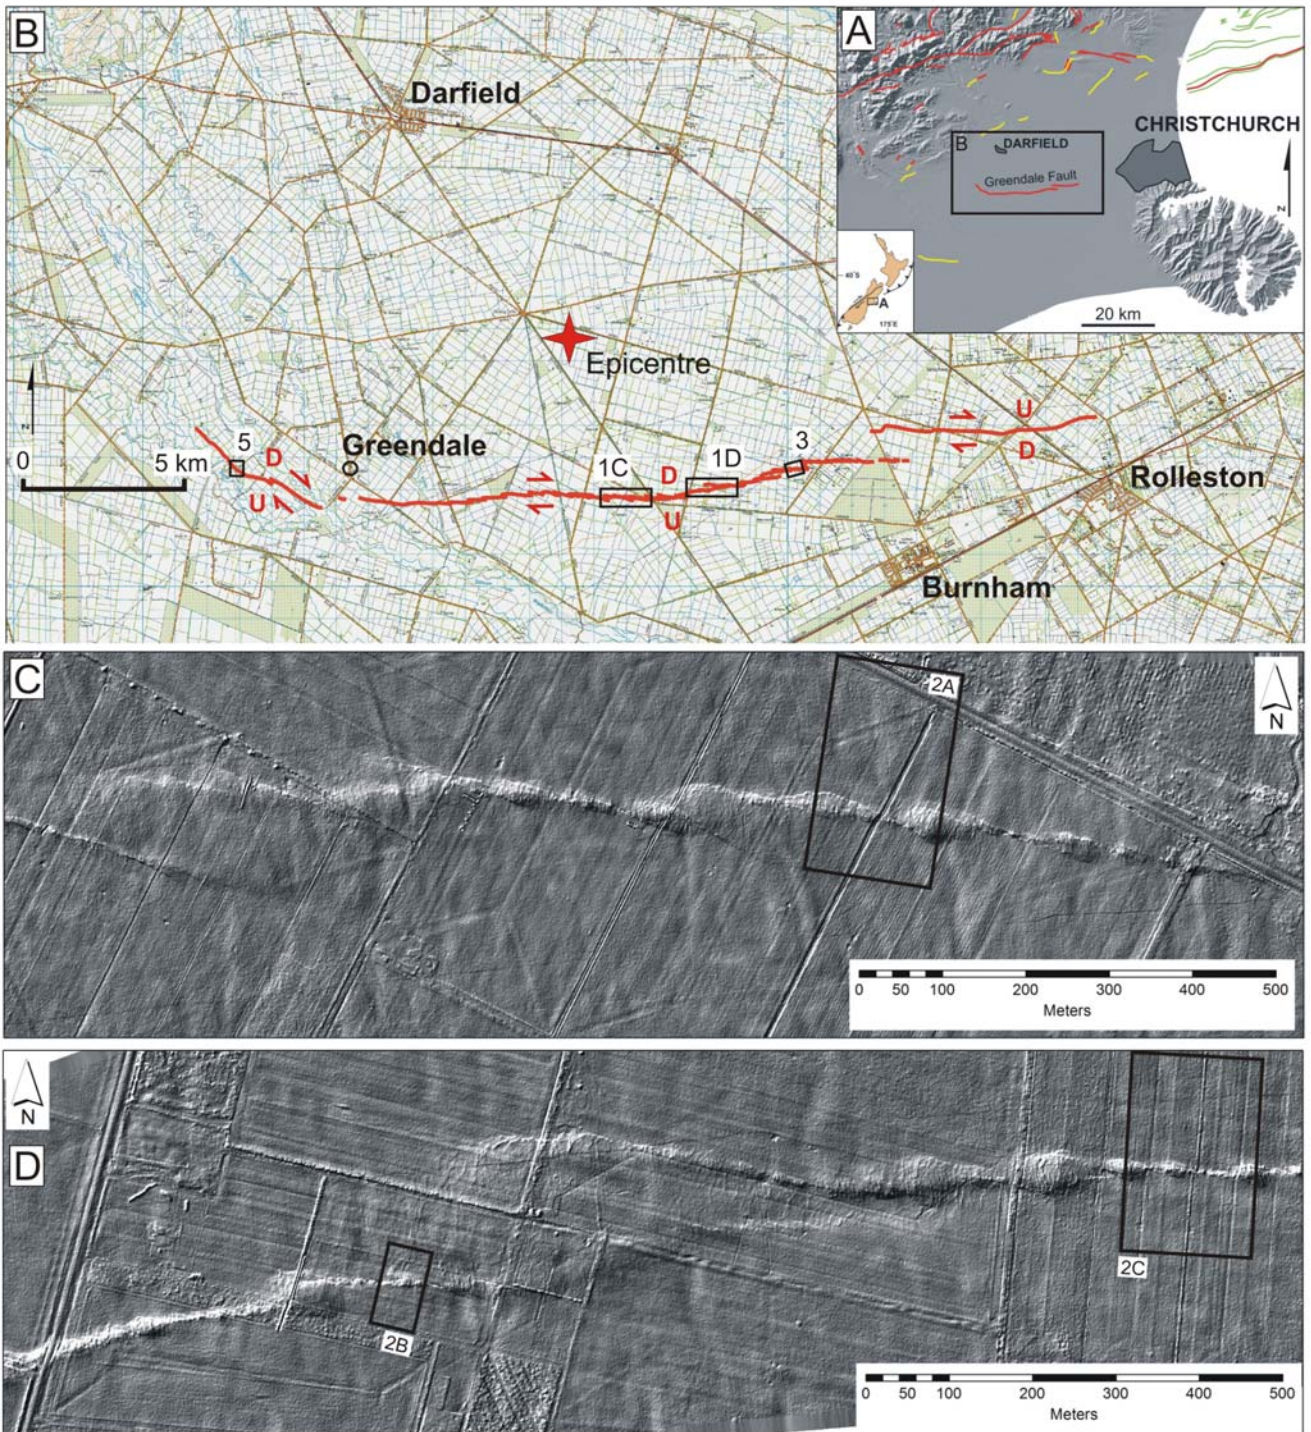
Figure 1: A) DEM of the Christchurch area of the Canterbury region showing location of the Greendale Fault and other tectonically active structures. Red lines are active faults, and yellow and green lines are, respectively, on-land and off-shore active folds (combined data from Forsyth *et al.* (2008) and GNS Active Faults Database). B) Mapped surface trace of the Greendale Fault. Red arrows indicate relative sense of lateral displacement, while vertical displacement is denoted by red U = up and D = down. Also shown are locations of Figures 1C, 1D, 3 & 5, and Darfield earthquake epicentre (red four-pointed star). C & D) LiDAR hillshade DEMs (illuminated from the NW) of two ~1.5 km long sections of the Greendale Fault, showing characteristic left-stepping en echelon rupture pattern, and dextral offset of roads, fences, hedges and crop rows. Also shown are locations of Figures 2A, 2B & 2C.

The zone of identified surface rupture extends from ~4 km west of the hamlet of Greendale for about 29.5 km to an eastern tip ~2 km north of the town of Rolleston (Figure 1). The fault was named the Greendale Fault by the fault rupture reconnaissance and response team. The gross morphology of the surface rupture is that of an en echelon series of east-west striking, left-stepping surface traces (Figure 1). The largest step-over is ~1 km wide, located ~7 km from the eastern end of surface rupture, with another ~20 step-overs between 300 and 75 m wide, and a multitude of smaller ones. Push-up structures have formed at most of these restraining left-steps, with amplitudes up to ~1 m, but typically < 0.5 m (Figures 1C & 1D).

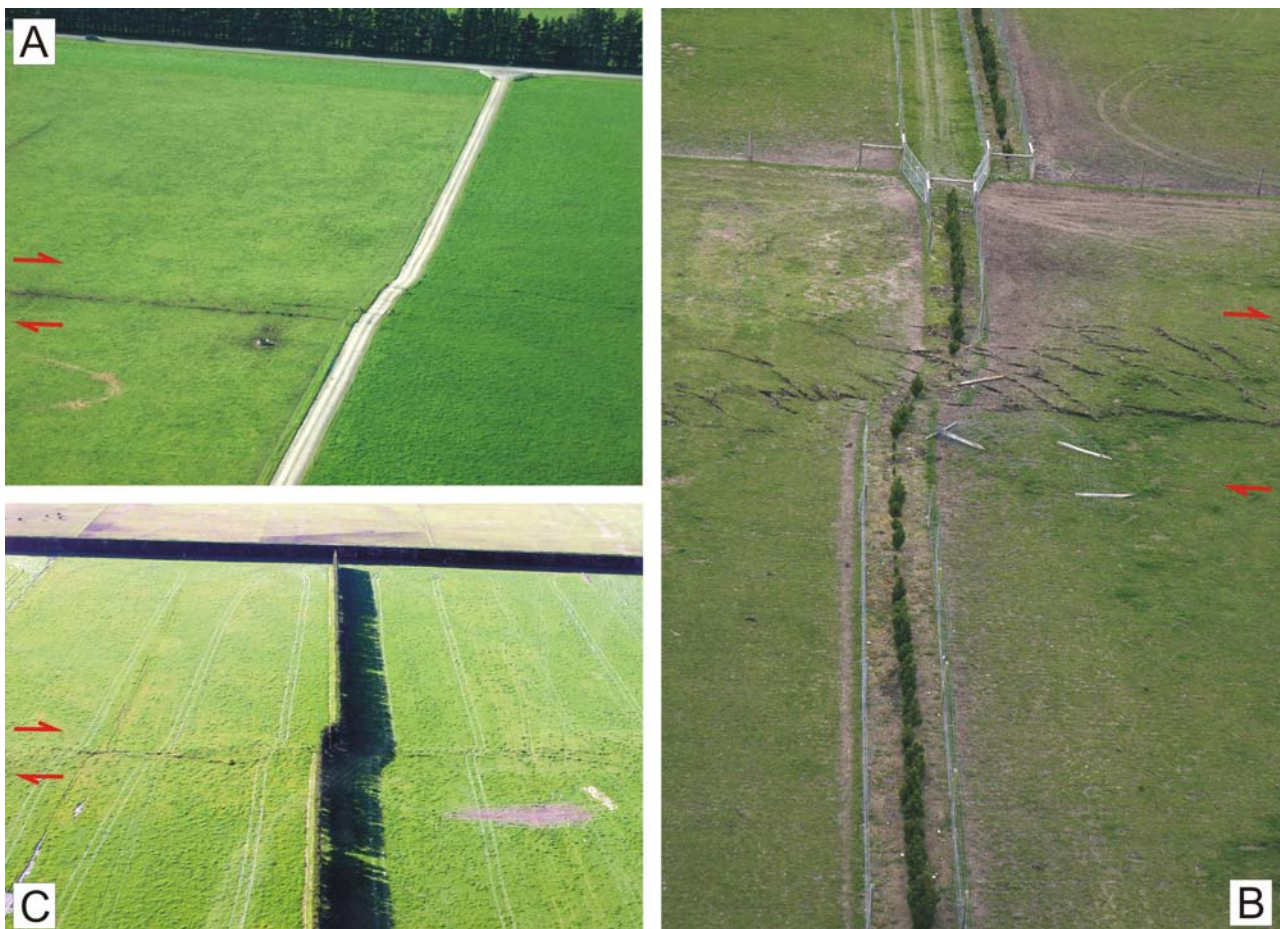
Many well-defined straight features were offset by the fault (Figure 2), allowing the amounts and styles of displacement to be measured with high precision at more than 100 localities along the entire length of surface rupture. Average displacement over the full length of surface rupture is ~2.5 m (predominantly dextral), and is distributed across a ~30 to 300 m wide deformation zone, largely as horizontal flexure. On average, 50% of the dextral displacement occurs over 40% of

Figure 2: *Oblique aerial photographs of Greendale Fault surface rupture (see Figures 1C & 1D for locations). Lateral displacement is distributed across a deformation zone of several tens of metres width; red arrows indicate relative sense of lateral displacement. A) 4.5 to 5 m of dextral displacement of a single-lane gravel road. Photo taken by Simon Cox about 11 hours after the earthquake looking north. B) ~3.5 m of dextral displacement of two wire fences and a row of small pine trees. Photo taken by Richard Cosgrove several days after the earthquake looking north. C) 4.5 to 5 m of dextral displacement of a hedge-row (wind break) of pine trees and tractor tyre tracks. Photo taken by David Barrell about 11 hours after the earthquake looking north.*

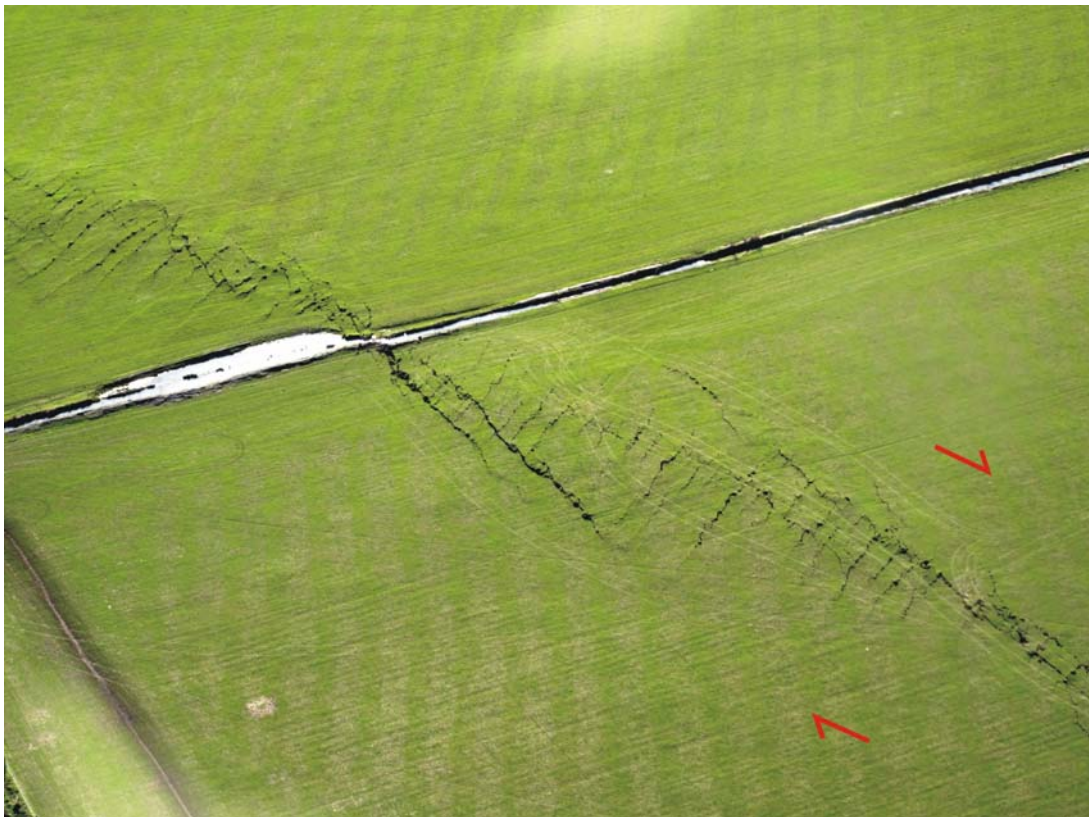
The distribution of surface rupture displacement is approximately symmetrical along the fault, with ~6 km at either end of the fault where overall displacement is less than ~1.5 m, and an ~8 km long central section where net displacement is > 4 m, with maxima of ~5 m (Table 1). Over the reach of the fault where displacement exceeds the average, the deformation zone comprises east-southeast striking Riedel fractures with right-lateral displacements, southeast striking extensional fractures, south-southeast to south striking Riedel fractures with left-lateral displacements, northeast striking thrusts, horizontal dextral flexure, and decimetre-amplitude vertical flexure and bulging (Figure 3).

Figure 3: *Oblique aerial photograph of Greendale Fault surface rupture (see Figure 1B for location). Red arrows indicate relative sense and width of lateral displacement. Here, ~3.5 m of dextral displacement is distributed across a deformation zone up to 40 m wide comprising Riedel shears, conjugate Riedel shears, horizontal dextral flexure, and decimetre-amplitude vertical flexure and bulging. Photo taken by Richard Jongens about 11 hours after the earthquake looking northwest.*

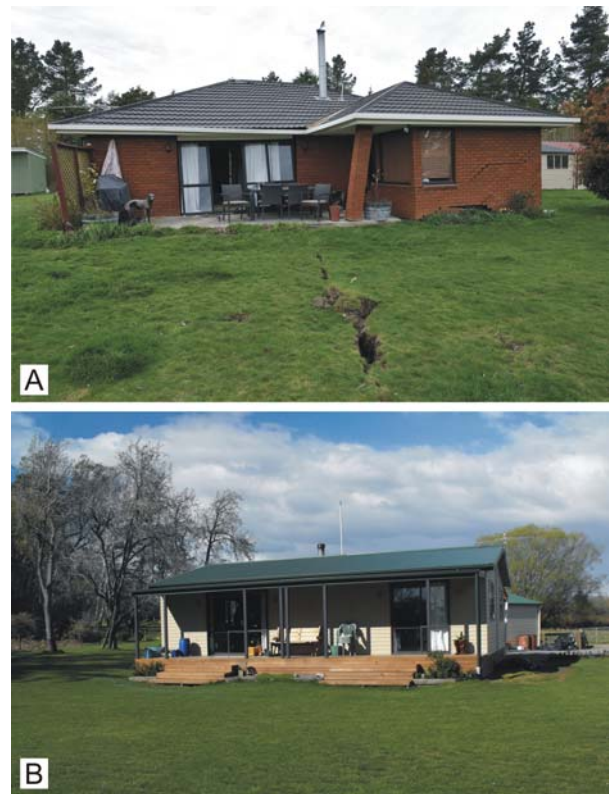
Over a dozen buildings, typically timber-framed houses and farm sheds with light-weight roofs, lay either wholly, or partially, within the Greendale Fault surface rupture deformation zone. None of these buildings collapsed, even the two with 0.5 to 1 m of discrete shear extending through/under them (Figure 4A), but all were more damaged than comparable structures immediately outside the zone of surface rupture deformation. Some of the properties worst damaged by fault rupture have been condemned. From a life safety standpoint, all these buildings performed satisfactorily, but with regard to post-event functionality, there are notable differences. The houses with concrete slab foundations (typically brick-clad) suffered moderate to severe structural and non-structural damage, while a light industrial building with a more robust concrete slab, and the two piled structures (Figure 4B) were less damaged and will be more straightforward to reinstate.

Figure 4. *Examples of houses affected by Greendale Fault surface rupture. A) Timber-framed, brick-clad house with concrete slab foundation and light-weight roof that is located within a ~150 m wide deformation zone accommodating 4 to 5 m of dextral displacement. House is badly damaged by ~0.5 m of discrete strike-slip rupture that passes through the foundation of the house as well as distributed shear within the broad deformation zone. Photo by Dougal Townsend. B) Light-gauge steel framed, plywood- and weatherboard-clad house with steel pile foundation and steel I-beam bearers that is tilted, and rotated, but only slightly damaged, by ~1 m of distributed vertical and dextral fault rupture spread over several tens of metres width. Photo by Russ Van Dissen.*

Fault was typically distributed across a relatively wide zone of deformation. Buildings located within this distributed zone of deformation were subjected to only a portion of the fault's total surface rupture displacement, and no structure within this zone collapsed. This provides a clear example of the appropriateness of the MfE's *Distributed Fault Complexity* parameter, at least for Building Importance Category 2a structures (i.e. residential structures).

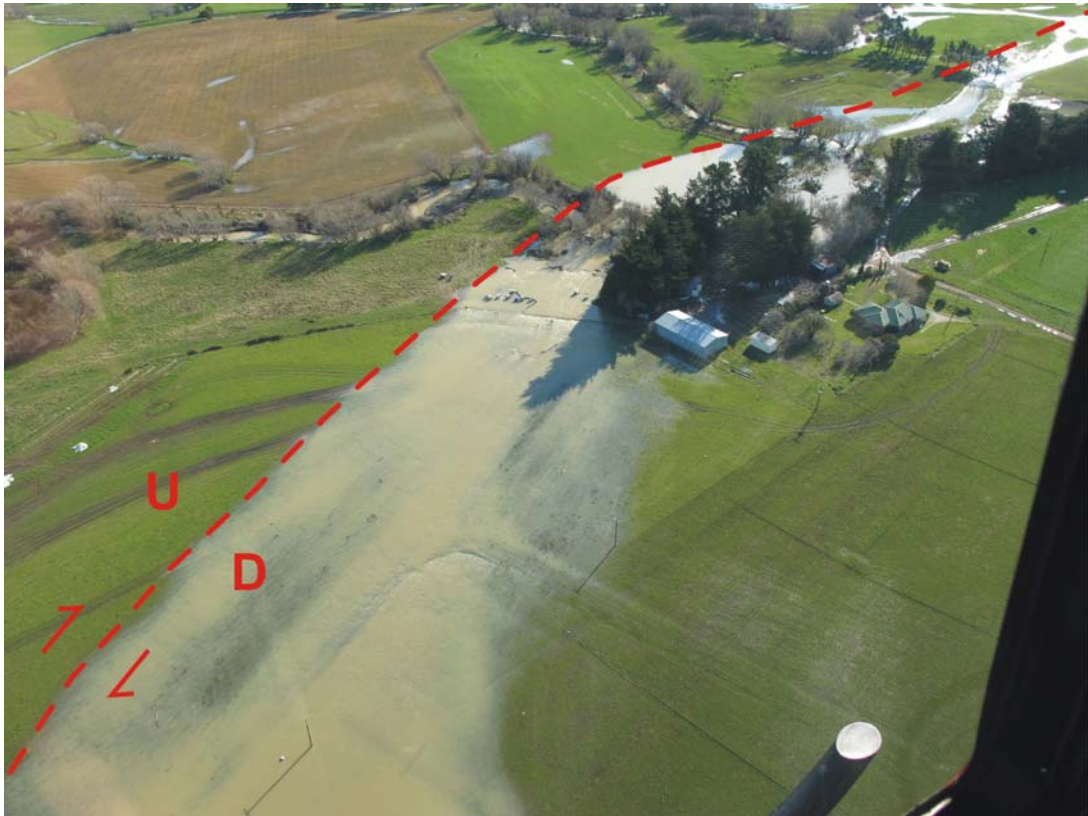
Some irrigation channels flooded due to the fault displacements, other ground disturbance and/or changes in groundwater tables. The most spectacular and extensive flooding caused by fault rupture occurred at the Hororata River, near the western end of the fault (Figures 1B & 5), where ~1 to 1.5 m of both dextral and vertical (southwest-side up) rupture extended across the river, partially blocking its channel, and resulting in partial avulsion. Deepening of the channel downstream of the fault rupture, via two backhoes, was required in order to return the full river flow to its original channel position.

Figure 5: *Oblique aerial photograph of Greendale Fault surface rupture and partial avulsion of the Hororata River (see Figure 1B for location). Hororata River flows right to left (i.e. southeast), location of Greendale Fault is denoted by dashed red line with relative sense of lateral displacement shown by red arrows, and relative vertical displacement indicated by red U = up and D = down. Here, ~1.5 m of oblique dextral southwest-side up rupture of the Greendale Fault extended across the Hororata River, partially blocking the river's channel, and leading to partial avulsion and significant flooding of dairy farmland. Photo taken by David Barrell about 11 hours after the earthquake looking west.*
