# Strike-slip ground-surface rupture (Greendale Fault) associated with the 4 September 2010 Darfield earthquake, Canterbury, New Zealand

Quarterly Journal of Engineering Geology and Hydrogeology, 44, 283-291 DOI 10.1144/1470-9236/11-034

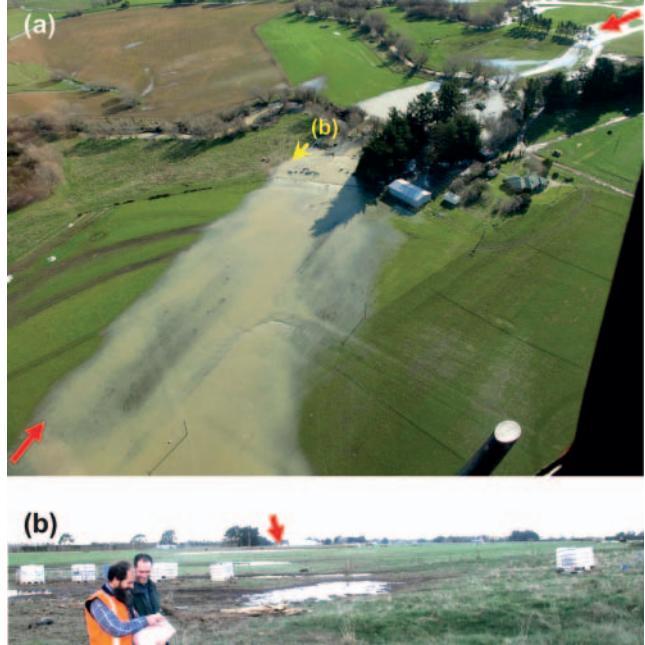
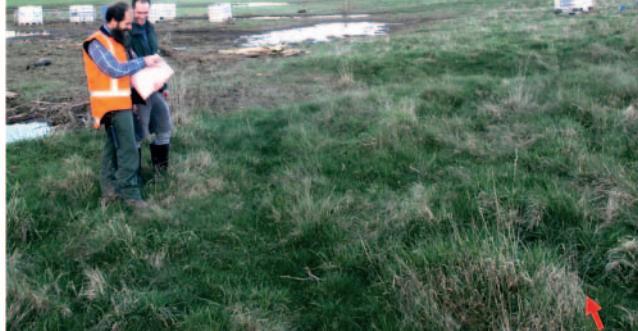
Fig. 2. (a) The sinuous course of the Hororata River, flowing from upper right to upper left, is crossed by the fault in this westward view, taken 4 September. A significant portion of the river's flow is diverted towards the lower left, along the downthrown side of the fault. (b) In this view SE from location shown in (a), taken 15 September, the broad rise up to the right is the fault, which here has bent rather than broken the ground. Excavation of the river channel has stemmed the overflow across farmland.

The westernmost c.6 km of the surface trace has a NW–SE strike and displays oblique dextral and southside-up vertical displacement (net) of as much as 1.5 m (Figs 2 and 3). Movement was accommodated by ground flexure, with few, if any, surface shears. Net upthrow to the south caused partial avulsion of the Hororata River (Fig. 2a), although this was rectified within a few days by deepening of the natural channel using excavators.

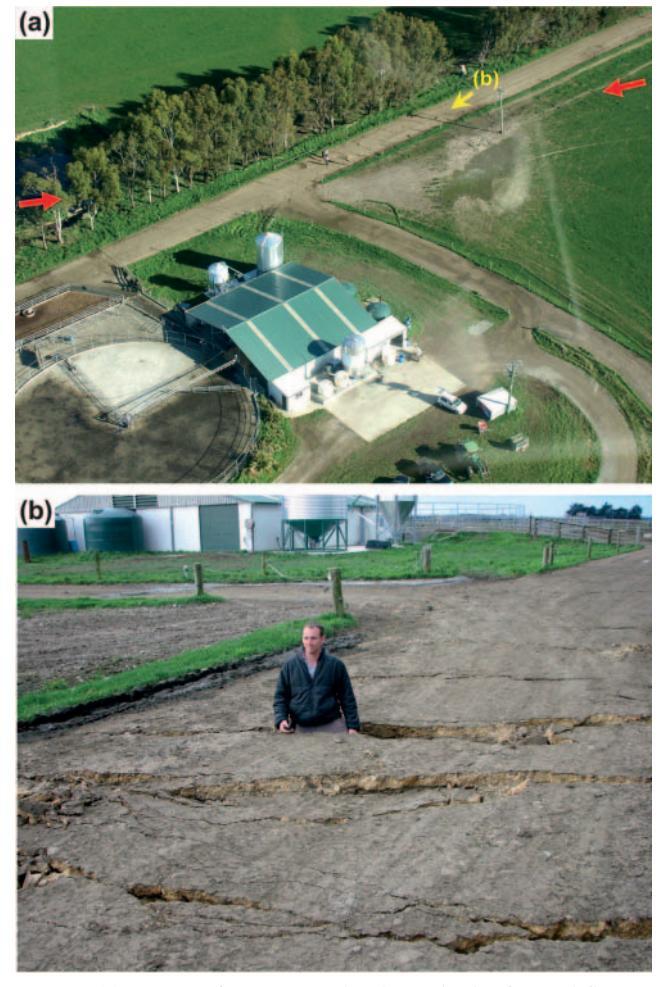
Fig. 4. (a) Progressing eastward, where the horizontal flexure exceeds 2 m, ground cracking became increasingly evident, as seen across the farm lane in this view to the south. (b) Detail of the form and depths of tension cracks seen in (a), looking NE, on 5 September.

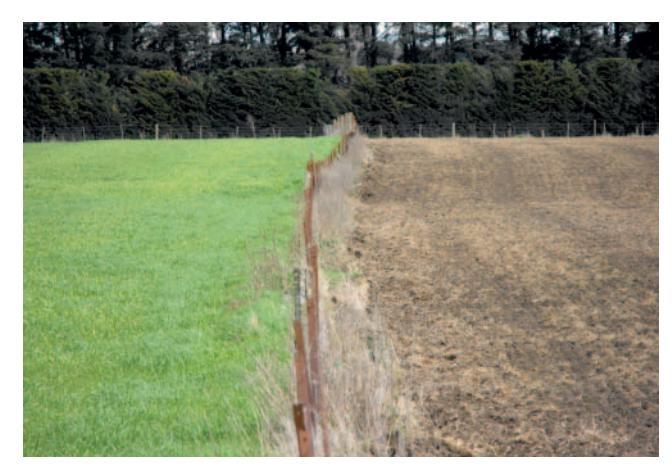
**Fig. 3.** This view south along an originally straight fence in a formerly flat field illustrates the oblique right-lateral (c. 1 m) and up-to-south (c. 1 m) ground flexure that characterizes the western end of the Greendale Fault.

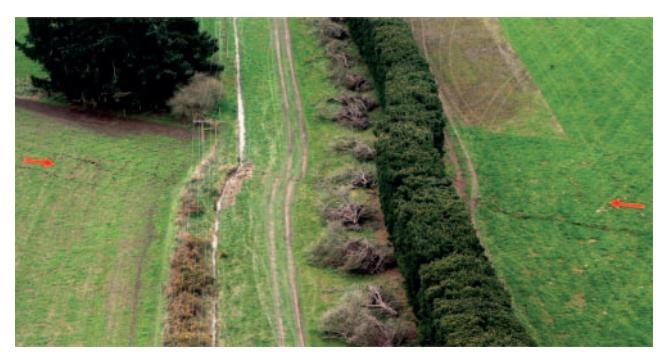
Fig. 5. This northward aerial view at Stranges Road highlights Reidel shears, at a low angle to the strike of the fault, each with as much as 1 m lateral offset, as seen across the vehicle ruts. However, most of the c. 4.5 m right-lateral displacement is by horizontal flexure, as shown by the hedgerow and irrigation ditch. Flow in the ditch was impeded by slight upthrow to the south, but the ditch had been deepened prior to this photograph on 9 September.

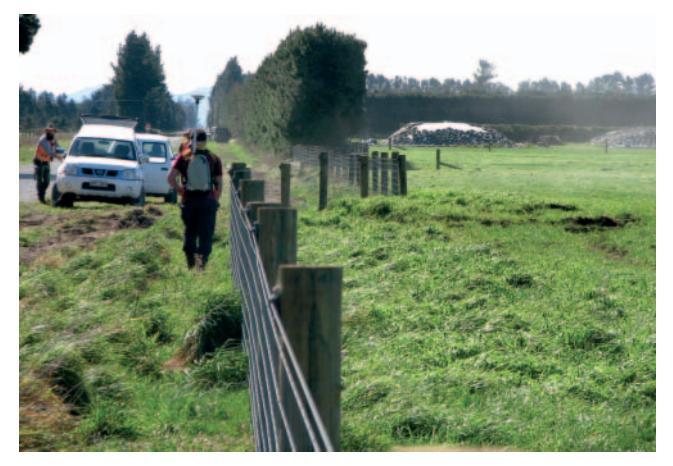
**Fig. 6.** At Courtenay Road, this northward view shows team members carrying out a precise real-time kinematic global positioning system (GPS) survey of a right-lateral offset (c. 4.3 m) of the formerly straight fenceline. The deformation occurred over a c. 35 m wide zone, and the ground is broken by discrete shears right of centre.

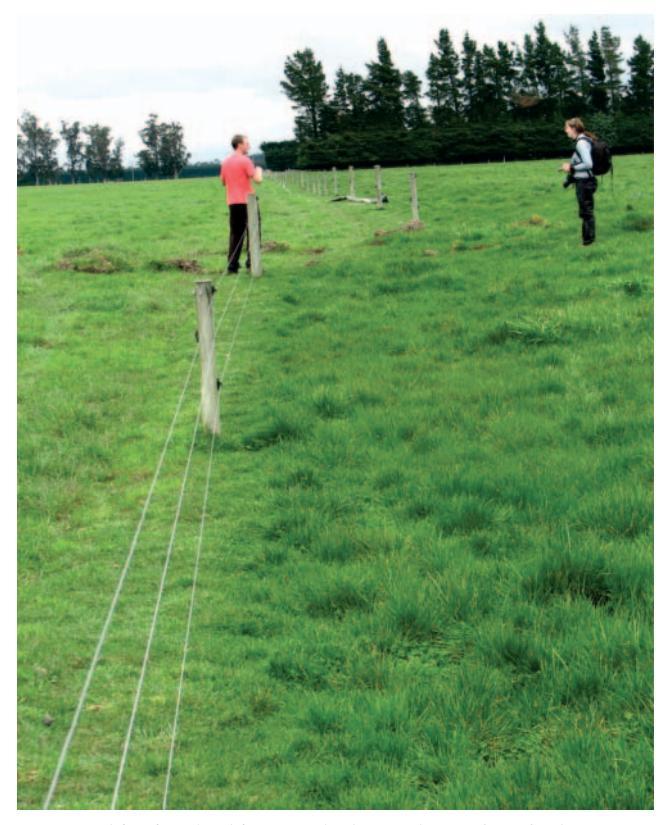
Fig. 7. This view looking south shows the surface fault rupture where most of the lateral displacement (c. 4.6 m) is concentrated within a narrow zone, with 'mole tracks' (displaced turf) evident along shears that displace the fenceline.

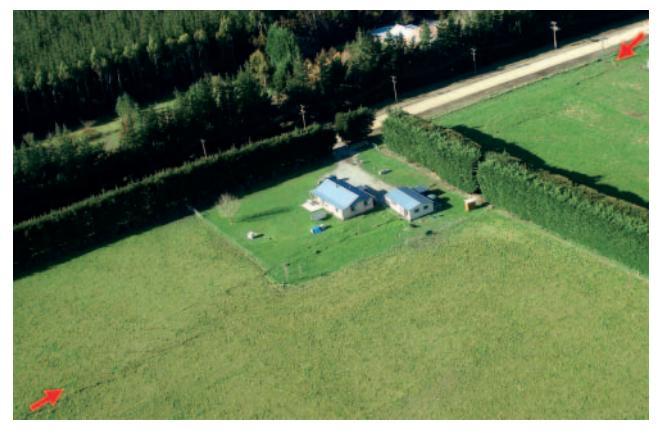
Fig. 8. An aerial view looking NE showing en echelon Reidel shears that narrowly miss a house, but pass through its garage.

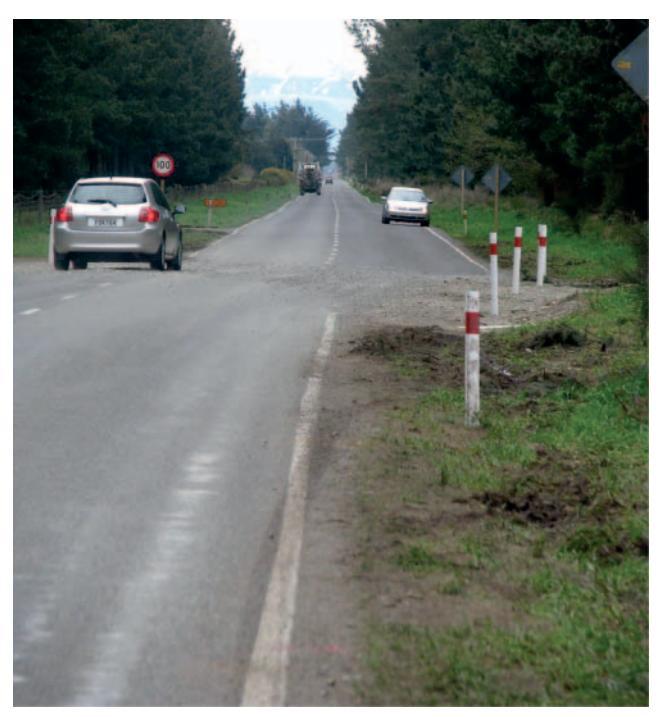
**Fig. 9.** In this telephoto view north along Telegraph Road, the busiest road to have been crossed by the fault rupture, the Greendale Fault has displaced the road right-laterally by approximately a lane width. Being a major rural thoroughfare, initial repairs were undertaken on the day of the earthquake.

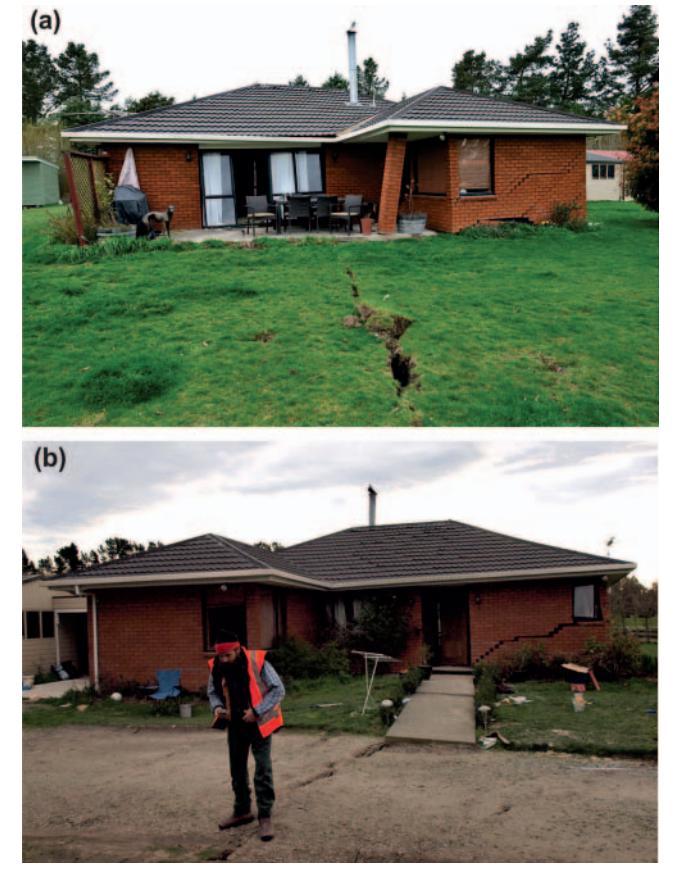
Fig. 10. (a) A shear with about 0.5-1 m of right-lateral displacement passed through this modern, timber-framed, brick-clad farmhouse. Despite undergoing severe structural damage, the house remained standing and its occupants were unharmed. (b) A view looking west at the opposite side of the house shown in (a).

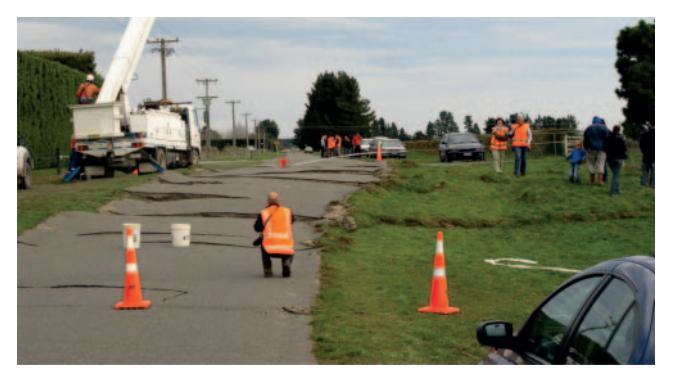
**Fig. 11.** A view south down Highfield Road, the second of only two tarsealed roads to have been crossed at a high angle by the fault in its high-displacement central section. Being a minor road, several days passed before repairs were made to the spectacular array of shears and cracks across the tarseal. In the mean time, the site became a local tourist attraction because it was one of the few fault rupture locations that was both undisturbed and publicly accessible. Here, localized bulg-ing resulted in an upthrow of more than 1 m, creating a visual phenomenon in concert with the *c*. 4.5 m right-lateral offset of the carriageway, roadside fences and hedgerows.

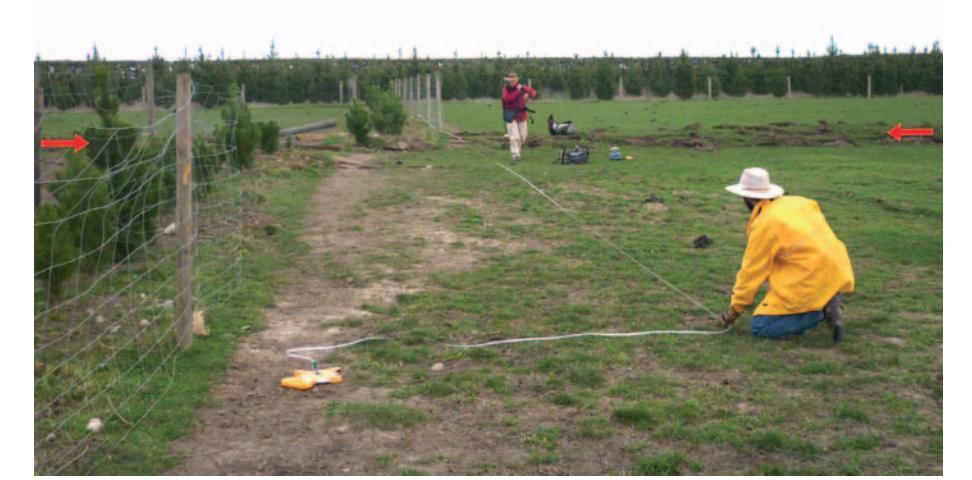
Fig. 12. Members of the fault rupture reconnaissance team measure offsets (c. 3.6 m) of a fenceline a few hundred metres east of Highfield Road, view looking south.

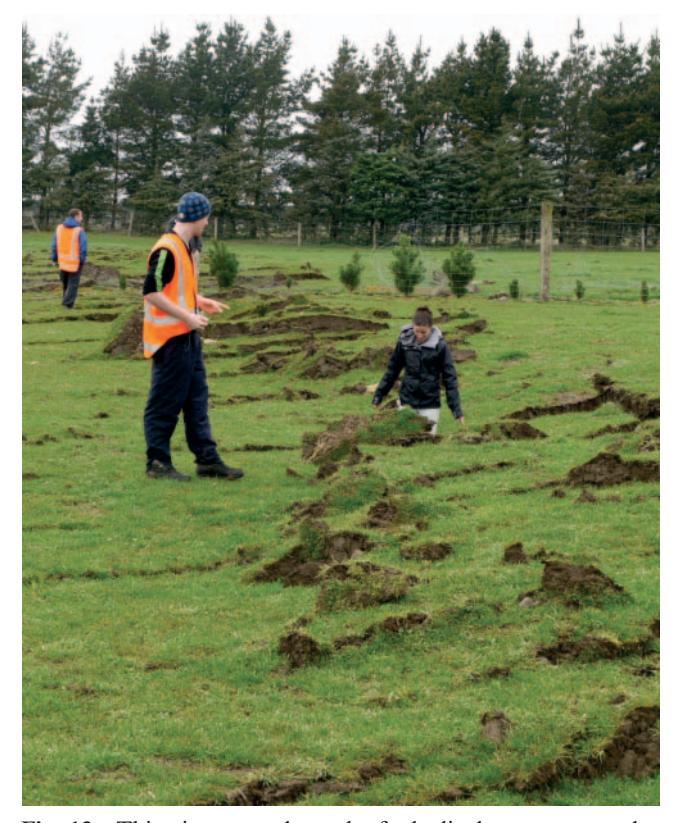
**Fig. 13.** This view east along the fault displays a spectacular pattern of conjugate Reidel shears at a high angle to the strike of the fault, which curves off towards the upper left. The fence in the mid-ground is the same one as shown in Figure 12.

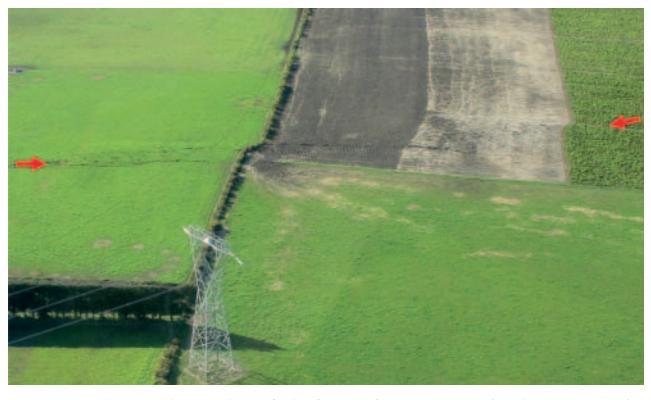
**Fig. 14.** A northward aerial view of a narrow fault zone (left) diffusing into a broad flexure across the ploughed fields, then narrowing into a shear near the crops to the right. Total right-lateral displacement of these features is c. 4.5 m.

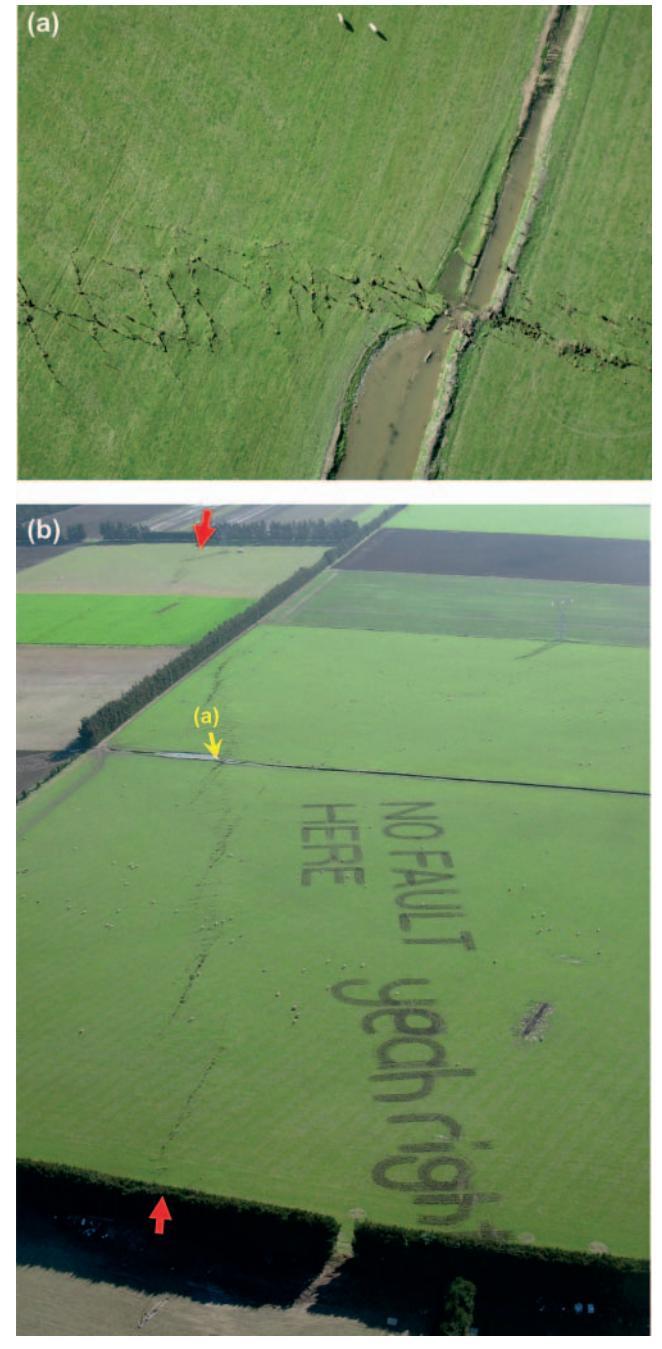
Fig. 15. (a) Arrays of shears and localized bulges are seen in this aerial view looking north. The irrigation ditch is displaced laterally by c. 3.5 m. (b) Following initial science reports to the media, stating that there was no prior knowledge of a fault in this area, a landowner ploughed these words into this field. The words reference a nationwide billboard advertising campaign for a brand of beer, in which a bold statement is made, alongside which are the words 'yeah, right', indicating that a sensible person would not believe the statement. The view is SW, and the features shown in (a) are upper left from centre.

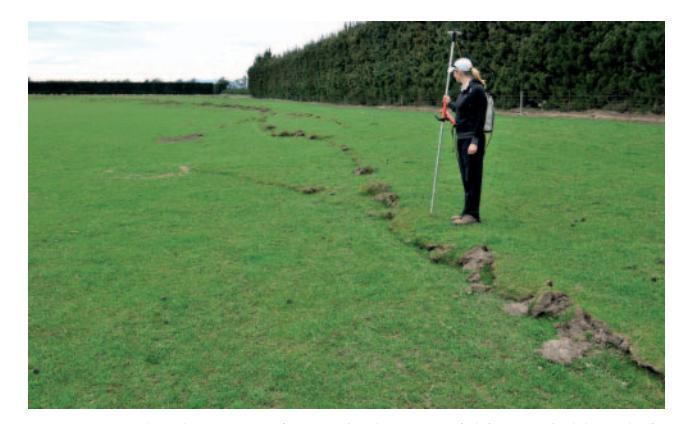
Fig. 16. A close-up view of shears within a field. Their expressions are particularly clear on account of the very short grass. The total right-lateral displacement at this site is c. 3.5–4 m.

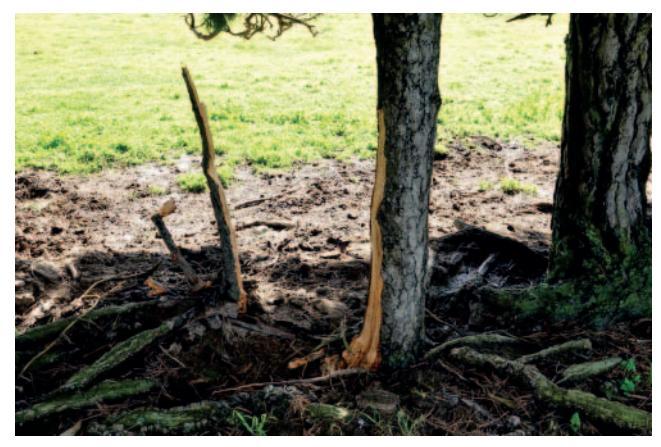
Fig. 17. Where shears crossed belts of trees, commonly the trees were loosened from the soil, or uprooted. This was one rare instance where a shear split a tree in two, in this case a juvenile *Pinus radiata* with trunk diameter of c. 0.15 m.

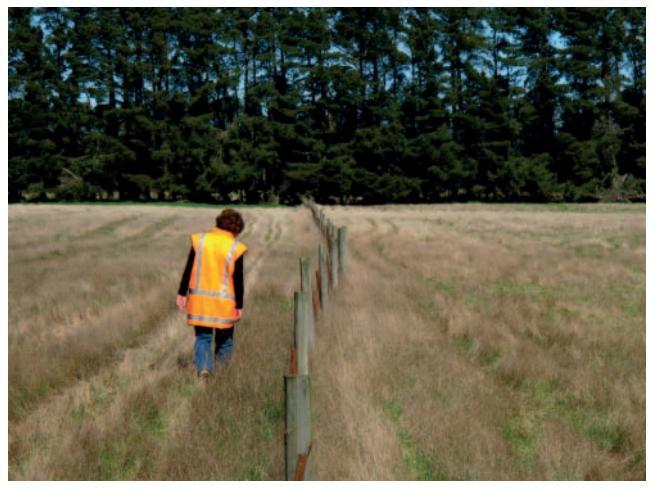
**Fig. 19.** On the eastern strand of the fault, deformation comprised horizontal flexure, with very little cracking of the ground. For the most part, cracks were evident only where the fault crossed a relatively brittle feature such as a tarsealed road. In this view southward, the fence reveals a right-lateral flexure of about 1.3 m.

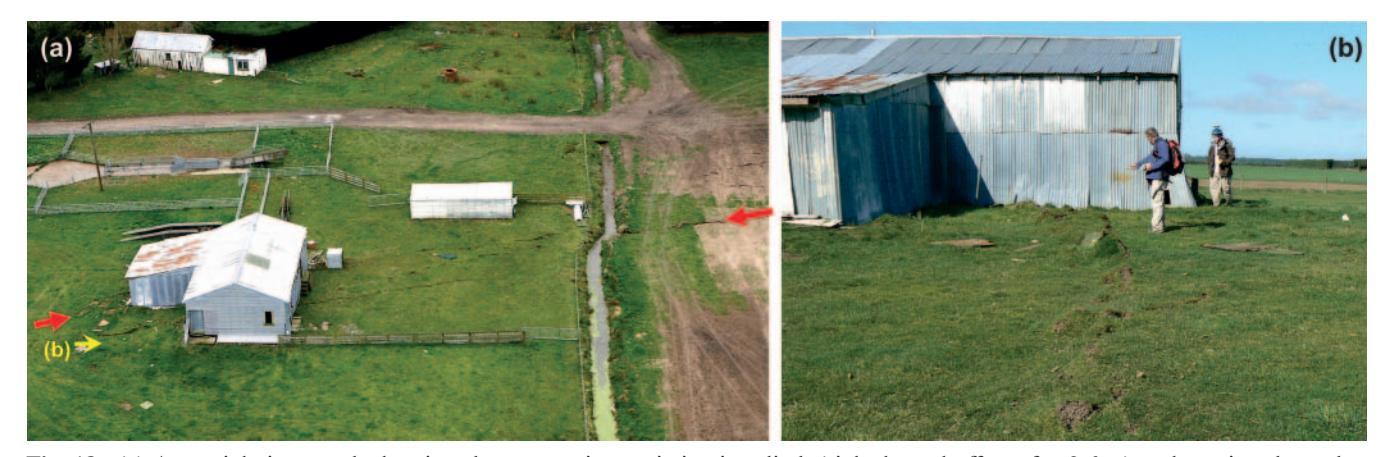
**Fig. 18.** (a) An aerial view north showing shears crossing an irrigation ditch (right-lateral offset of c. 2.6 m) and passing through a farm shed. The left-hand side of this building is shown in (b). (b) Members of the fault rupture reconnaissance team measure the effects of a shear, its mole track evident in the foreground, on the farm shed.

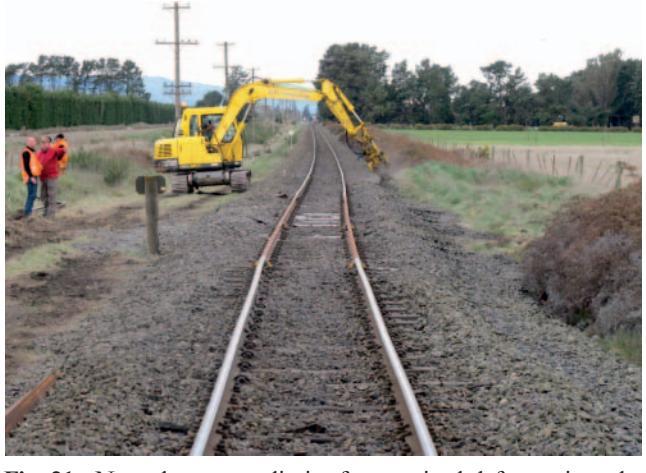
**Fig. 21.** Near the eastern limit of recognized deformation, the fault crossed the South Island Midland Railway. This view southward illustrates a broad right-lateral flexure of c. 1 m of the line of the rails. As the rail embankment tends to smooth over the minor natural fluvial irregularities of the plains, the rails were an excellent datum for estimating the vertical component of offset. Precise GPS surveying indicated c. 0.4 m of upthrow to the north at this location. During the earth-quake, one section of the rails was kinked sideways to the left (east). This photograph was taken on 5 September, immediately after replacement of the kinked rail section. The new rails are rusty as they have yet to be polished by train movement.
