GEOTECHNICAL & FLOODING RECONNAISSANCE OF THE 2014 MARCH FLOOD EVENT POST 2010-2011 CANTERBURY EARTHQUAKE SEQUENCE, NEW ZEALAND

Version 1: 19 June 2014

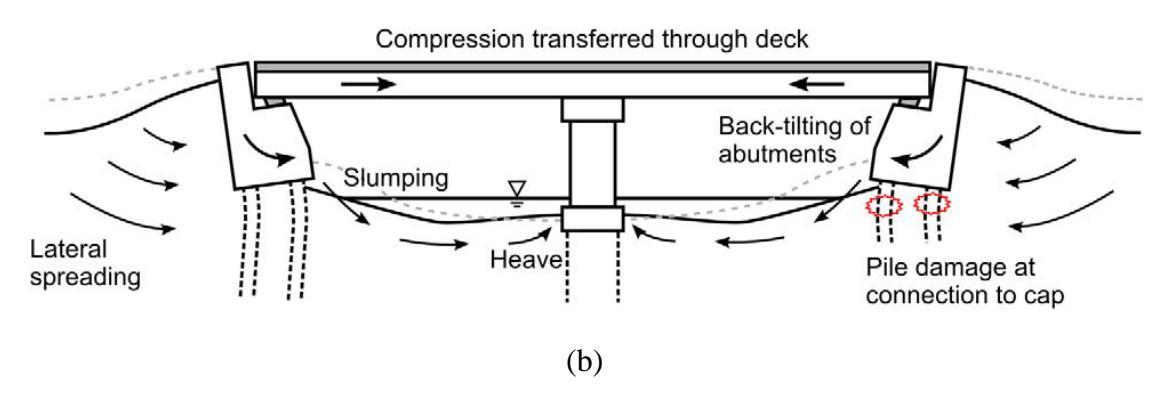
Figure 3-8 (a) Displacement of the river bank towards the center of the river at the Anzac Bridge and (b) example of lateral spread and slumping of bridge abutments creating loss of channel capacity from Cubrinovski et al. (2014)

Cubrinovski et al. (2014) show the collapse of the river banks in Figure 3-8a due to lateral spreading around the bridge foundations along the Avon River. The result is shown in Figure 3-8b as a narrowing of the channel from slumping of the sides and heave at the center as the two slumping sides come together.

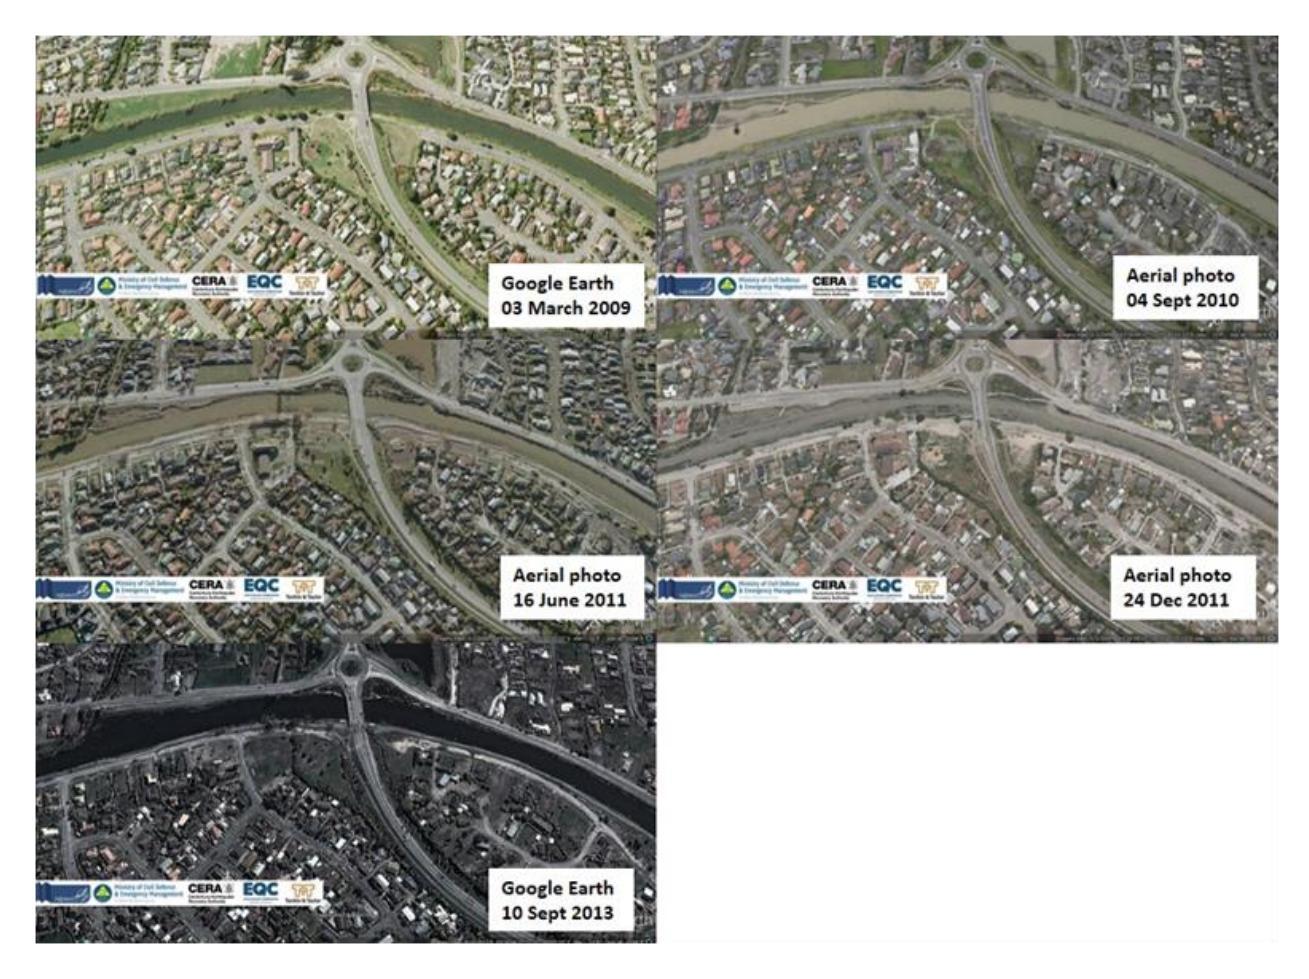
The review of a time series of Google Earth images and aerial photos in Figure 3-9 gives a first insight into changes in river morphology. Regarding a short section of the Avon River in the vicinity of the Anzac Bridge, which suffered noticeable damages during the earthquake (NZ-GEER 2011), the river banks can be described as well-defined and distinguishable in the Google Earth image from March 2009. In the aerial photo (Canterbury Geotechnical Database, 2012) from September 2010 the northern banks of this section, in particular, are washed out and the river appeared to be widened. In 2011, this process appears to have increased slightly, while a shoal at the southern side of the river seems to be present.

Figure 3-9 Time series of Google Earth images and aerial photos (Canterbury Geotechnical Database 2012) from March 2009 to September 2013 showing a short section of the Avon River in the vicinity of the Anzac Bridge (Anzac Drive: -43.500924°, 172.701084°).

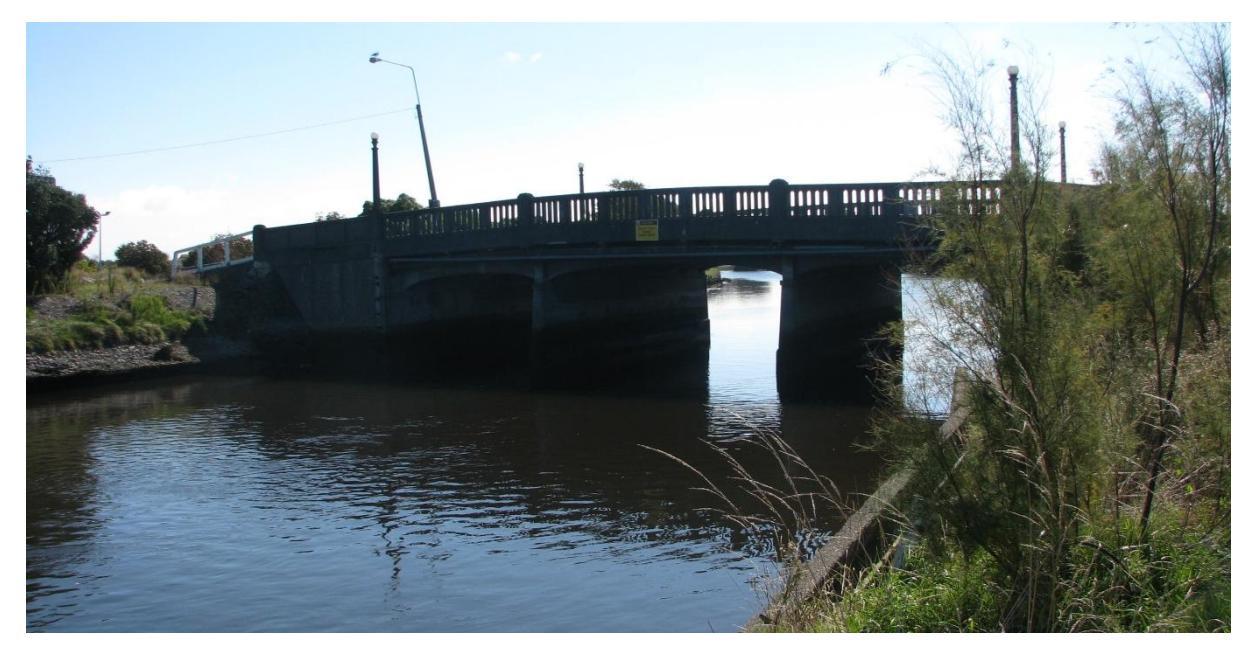
Figure 6-11 Pages Road Bridge on 19 March 2014.

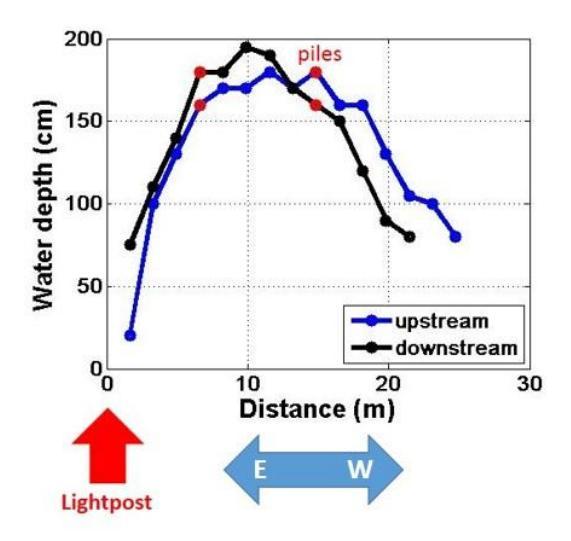
Figure 6-12 Soundings at Pages Road Bridge. Measurements level with the piles are indicated as red circles. Zero corresponds to the eastern lightpost.

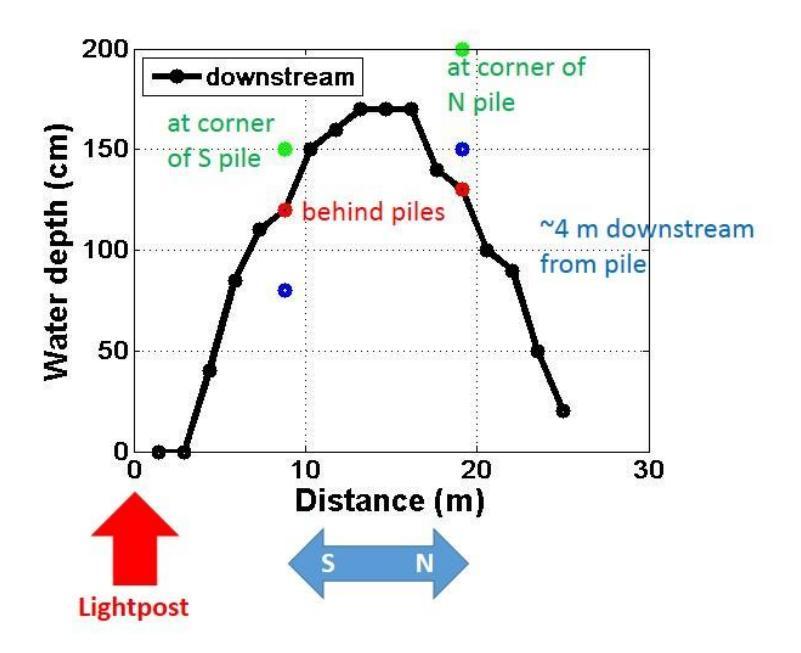
Figure 6-13 Soundings at Bowers Bridge. No measurements were conducted on the upstream side of the bridge due to traffic. Regarding measurements at the pier pile foundations, red circles indicate sounding behind the square piles, green circles at the corner and blue circles ~ 4 m downstream.

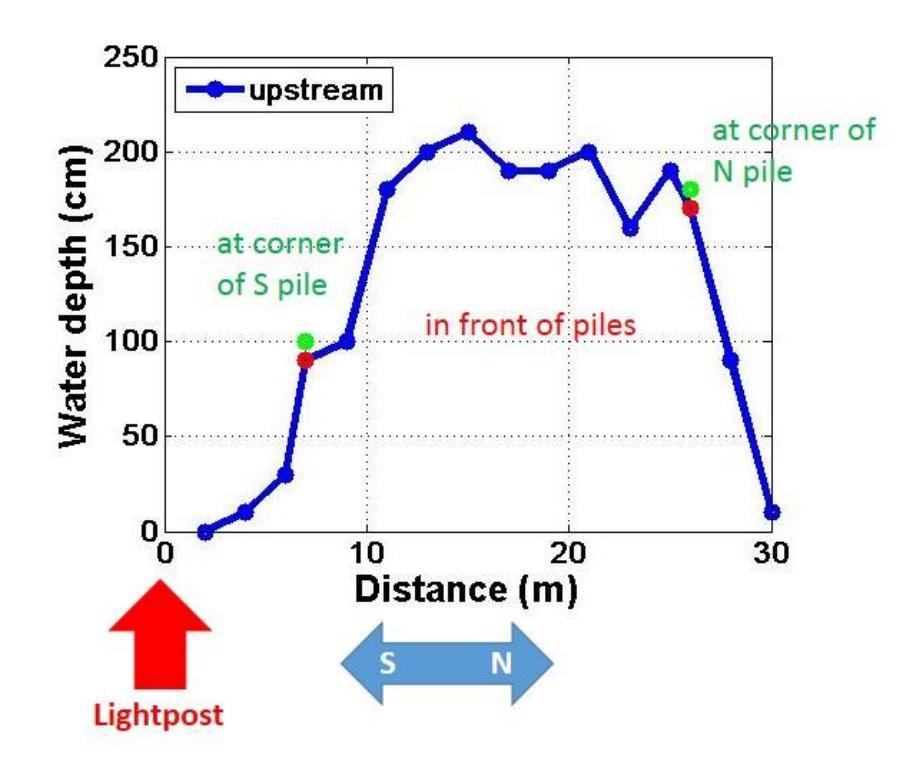
Figure 6-17 Soundings at Anzac Drive Bridge. Only upstream measurements were possible due to traffic.

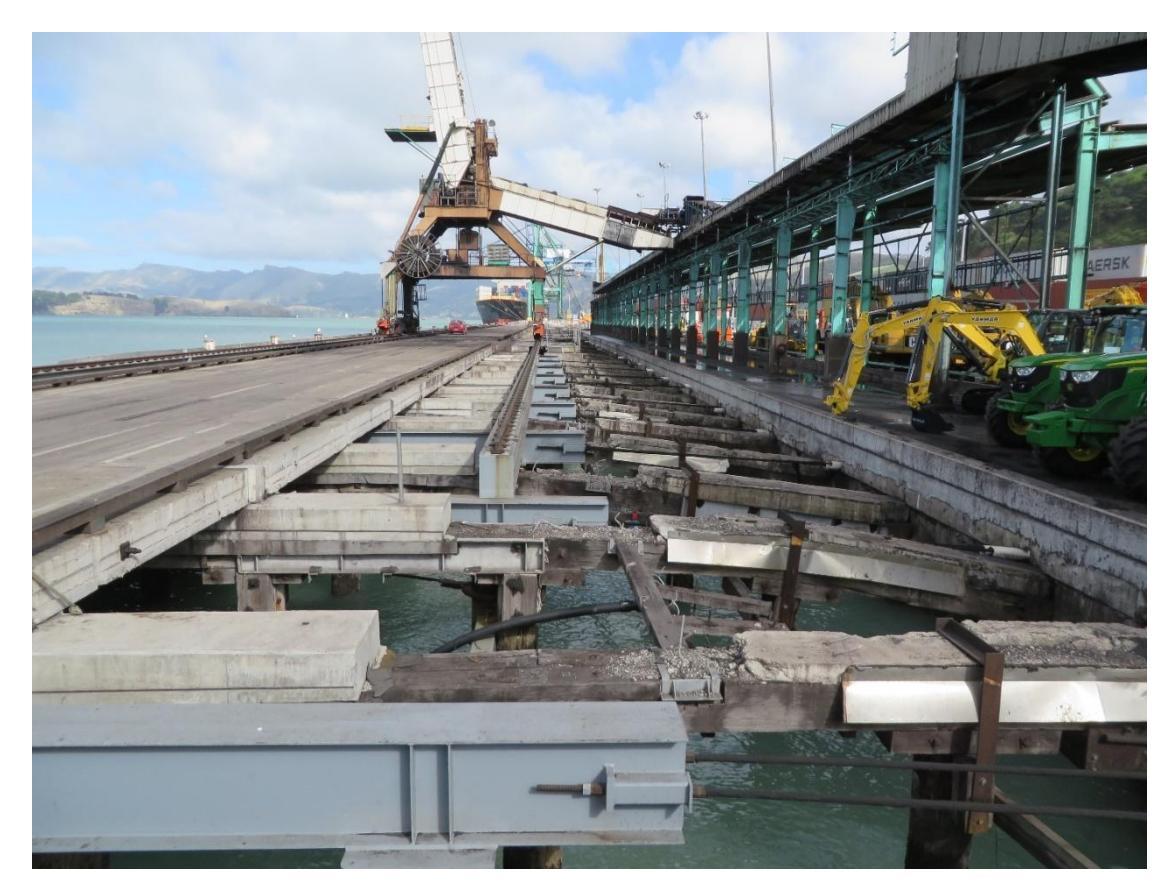
Figure 6-24 Example of visible earthquake induced damage to Cashin Quay in March 2014.

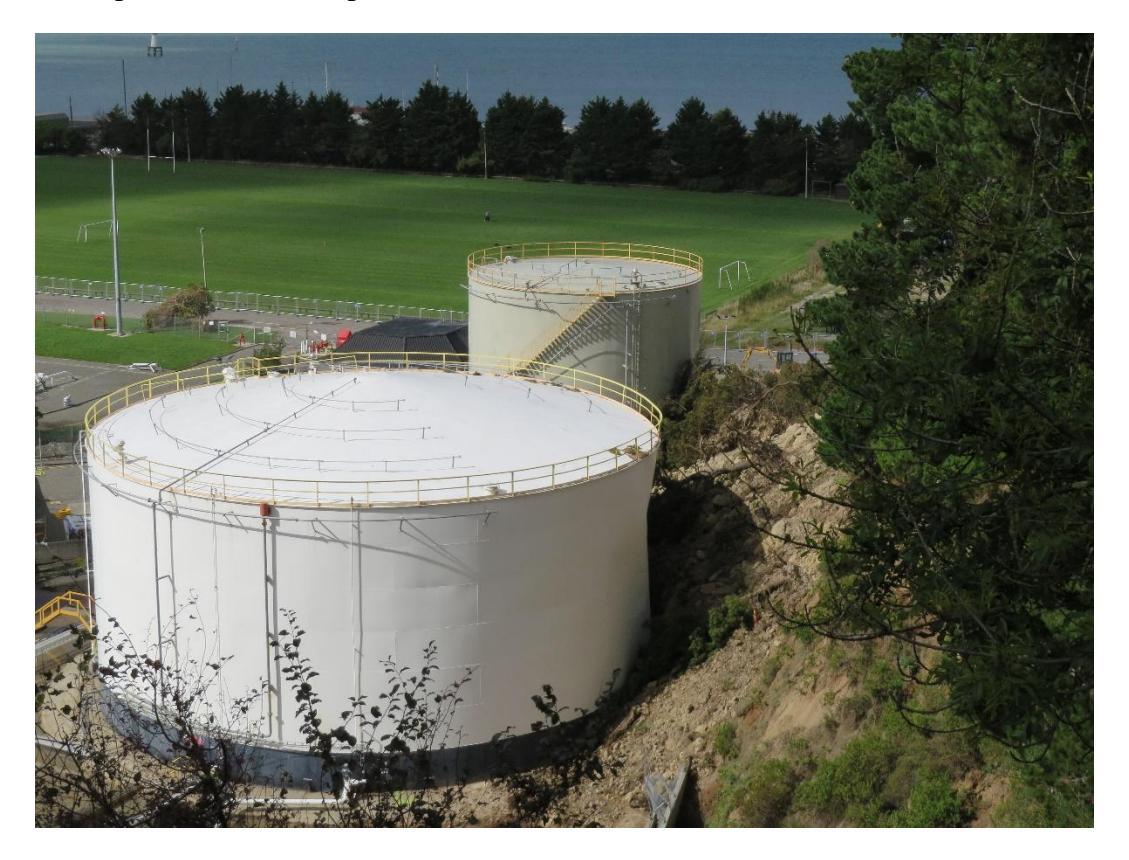
Figure 6-27 Tank impacted by landslide that initiated during periods of heavy rainfall.

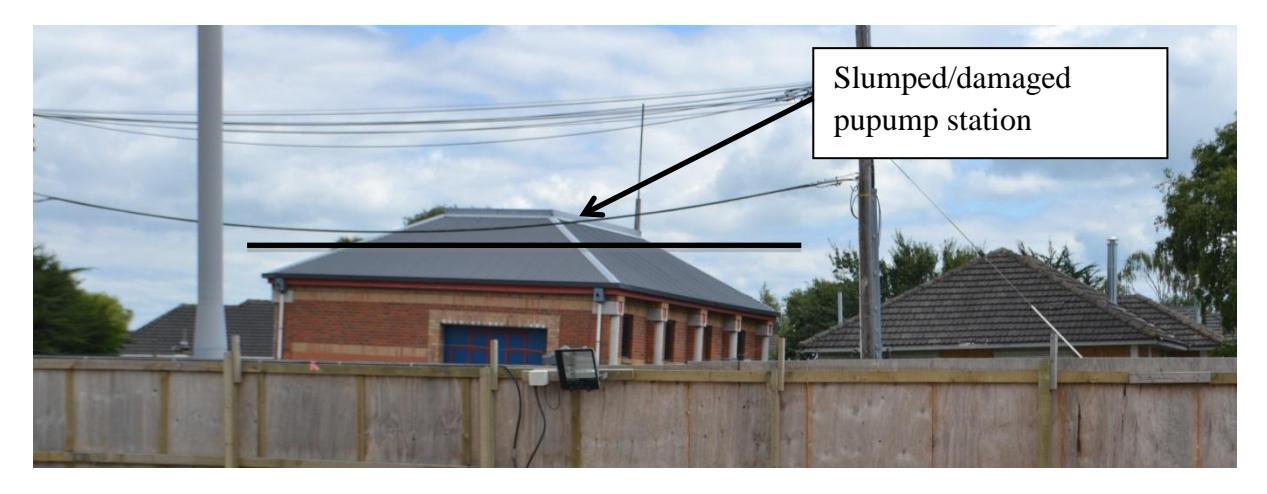
Figure 7-3 Currently damaged Pages Road gravity pump station (-43.513658°, 172.709793°). View from new gravity pump station construction site opposite. Photo courtesy of Dave Holland.

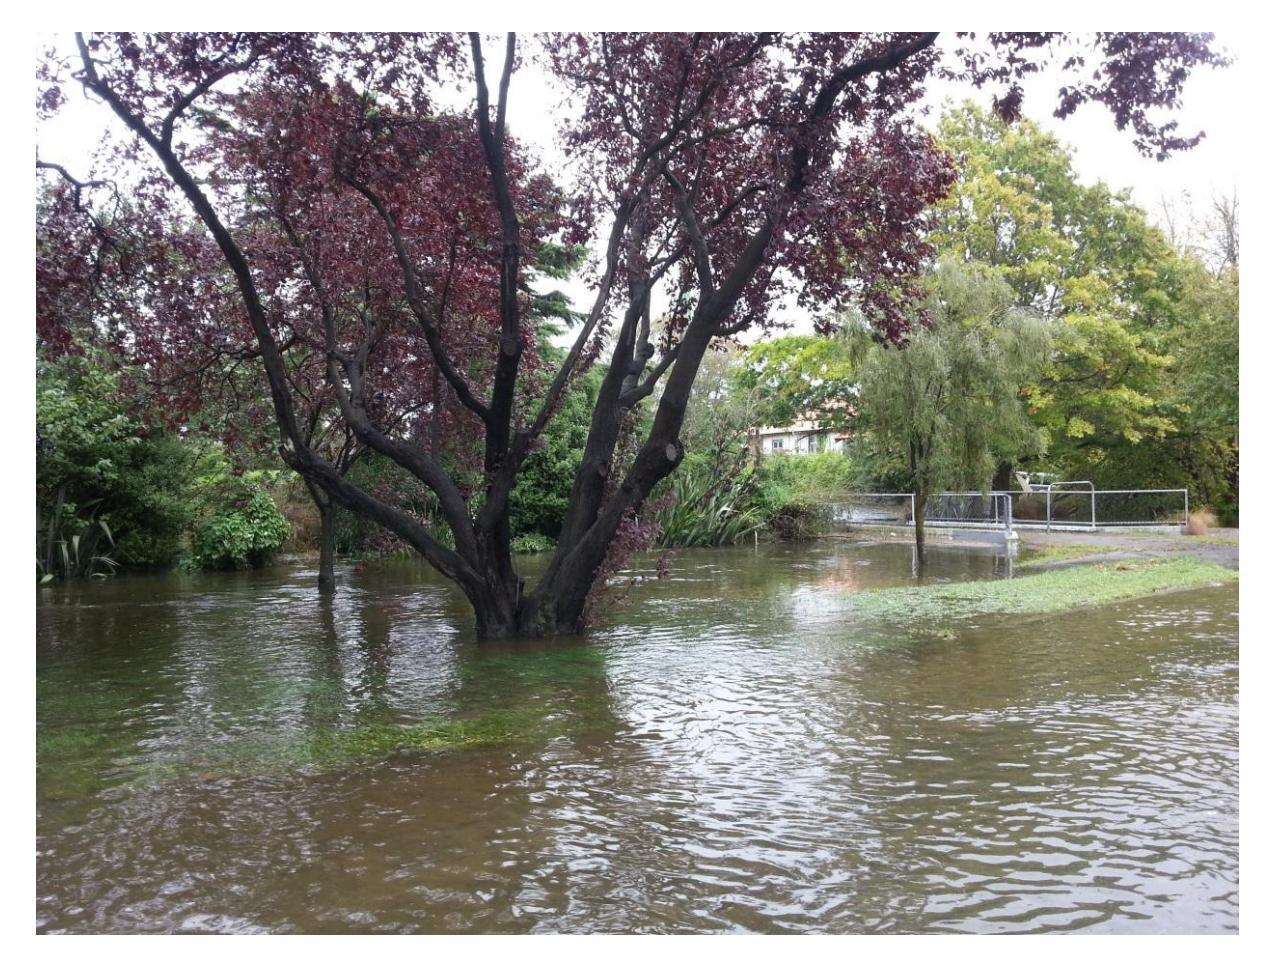
Figure 7-4 Dudley Creek overflowing on to Stapletons Road (-43.509433°, 172.655949°) and footbridge in Richmond, Christchurch. Photo courtesy of Su Young Ko.

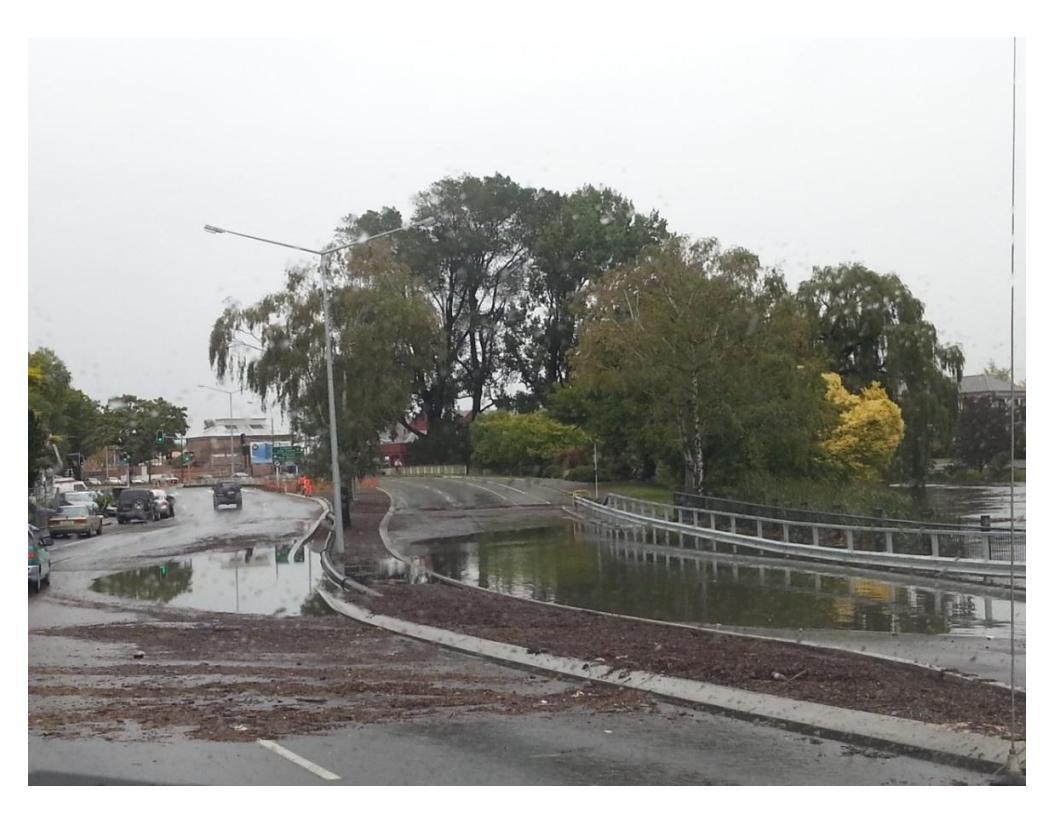
Figure 7-5 Avon River overflow causing surface flooding on Fitzgerald Avenue (-43.524078°, 172.650935°), Central City, Christchurch. This road demonstrates a postearthquake reconstruction design error. The road should have been built at a higher elevation to avoid flooding. Photo courtesy of Su Young Ko.

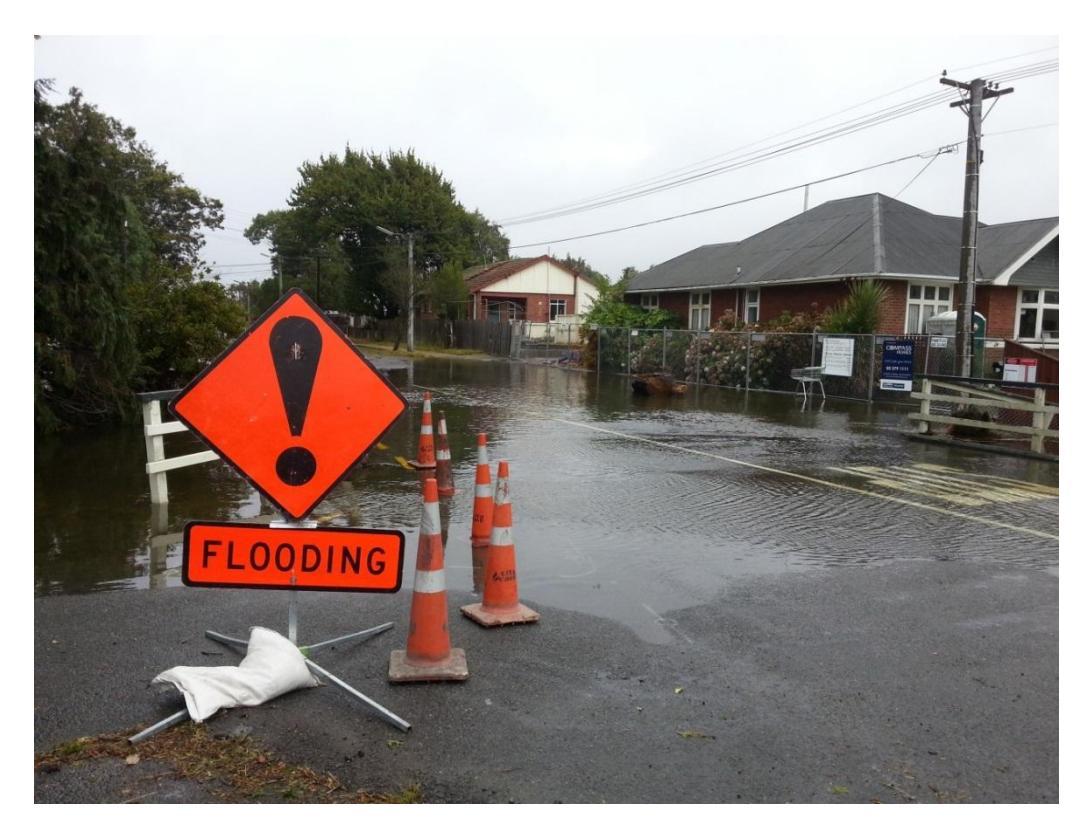
Figure 7-7 Warning sign for flooded streets – Warden Street (-43.510297°, 172.655095°), Richmond, Christchurch. Photo courtesy of Su Young Ko.
