GEOLOGIC, GEOMORPHIC, GEOTECHNICAL, AND DISPLACEMENT MAPS OF LAND AND BUILDINGS AT SELECTED SITES OF CHRISTCHURCH CITY COUNCIL OWNED REINFORCED CONCRETE STRUCTURES DAMAGED DURING THE 2010-2011 CANTERBURY EARTHQUAKES

MANCHESTER ST CARPARK STUDY

University of Canterbury Consultancy Report CN4600001360

November 2015

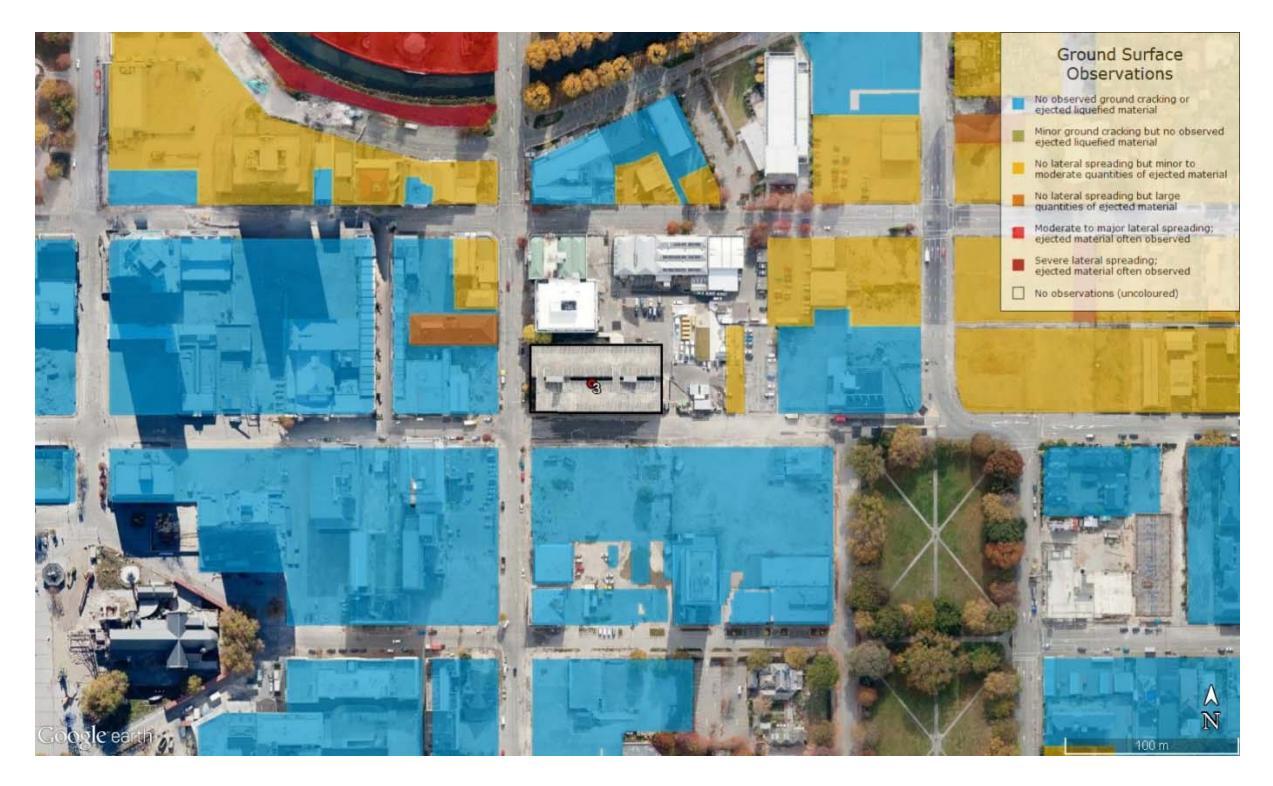
Figure 2: Area reconnaissance mapping of liquefaction and lateral spreading in the vicinity of Manchester St Carpark following the 22 Feb 2011 Christchurch Mw 6.2 earthquake (mapping by Tonkin and Taylor Ltd). More detailed mapping (this report) is presented in Fig. 11

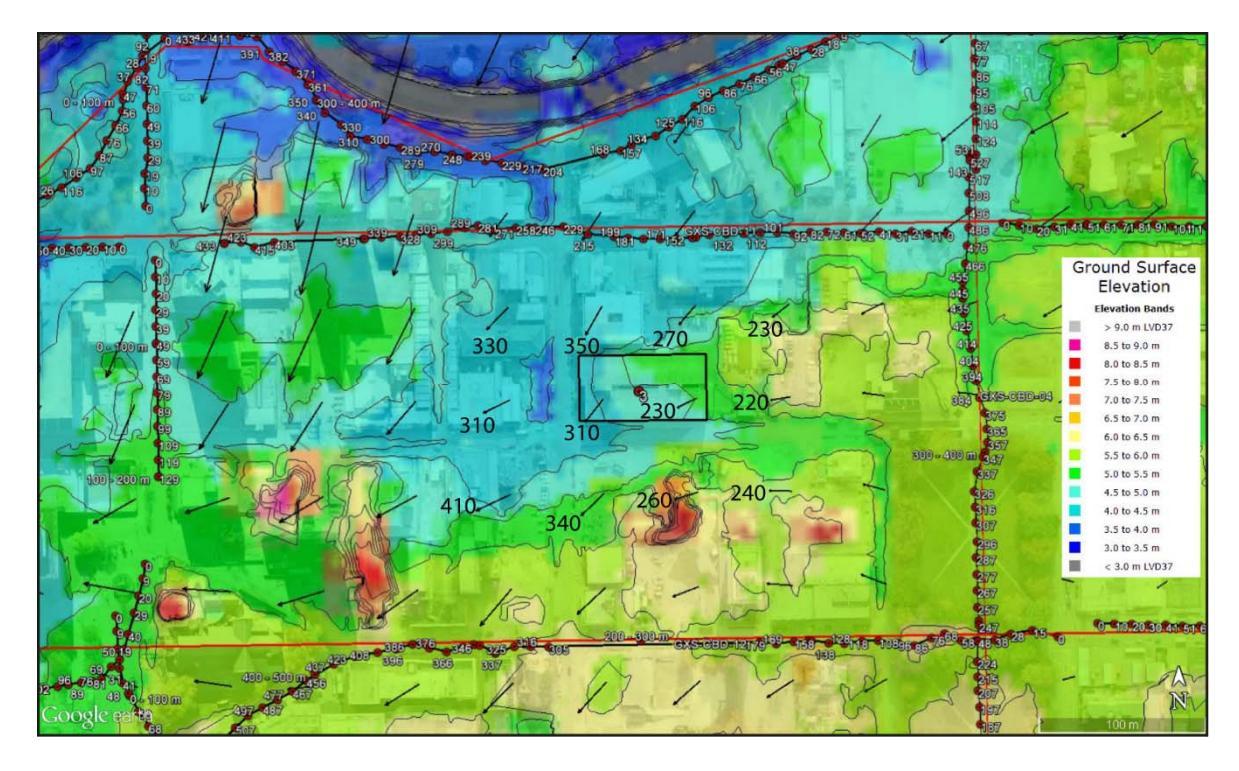
Figure 4: Cumulative horizontal permanent land displacements in mm with tectonic component removed for the Manchester St Carpark area, superimposed on DEM underlay. Location of MASW surveys and geologic cross-sections shown.

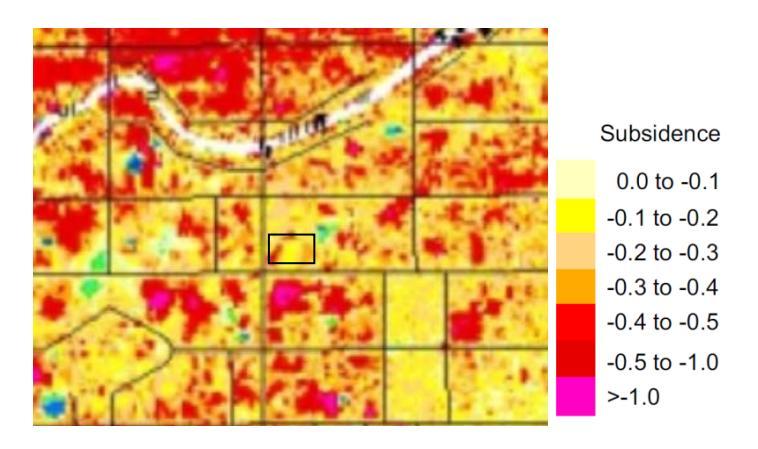
Figure 5: Permanent vertical land displacements from 2003 to December 2011 in metres for the Manchester St Carpark area. Image from Hughes et al. (2015)

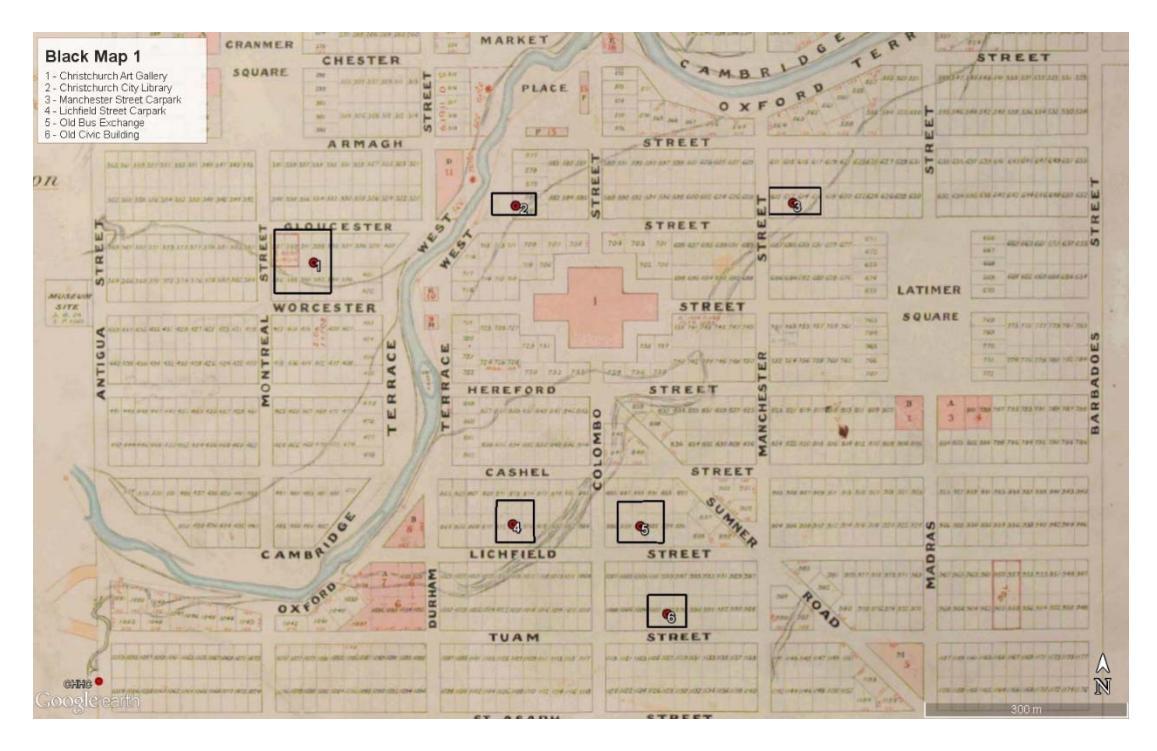
Figure 6: Historic drainage in Christchurch, showing location of historic channel beneath present-day southeast corner of Manchester St Carpark (3).

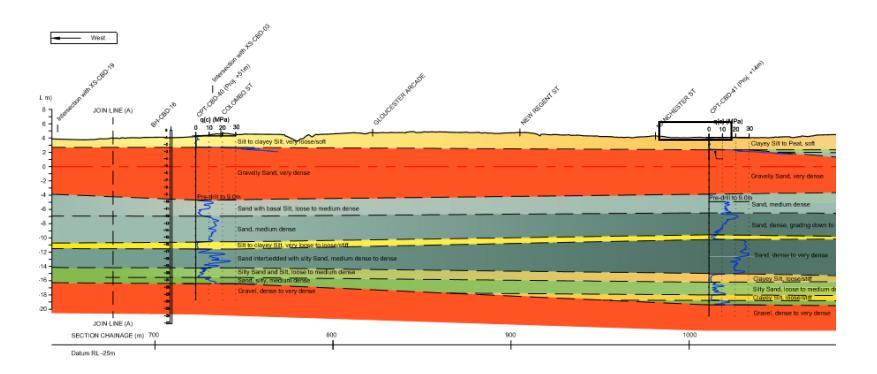
Figure 11: Geologic cross-section GXS-CBD-11 (Armagh St) showing projected position of Manchester Cark Park. Note westward slope and thickening of deep (~10-12m bsl), thin, very loose, highly liquefiable yellow unit, through to perhaps provide an explanation for west-directed lateral displacements in the absence of surface ejecta (further hypothesis testing required).

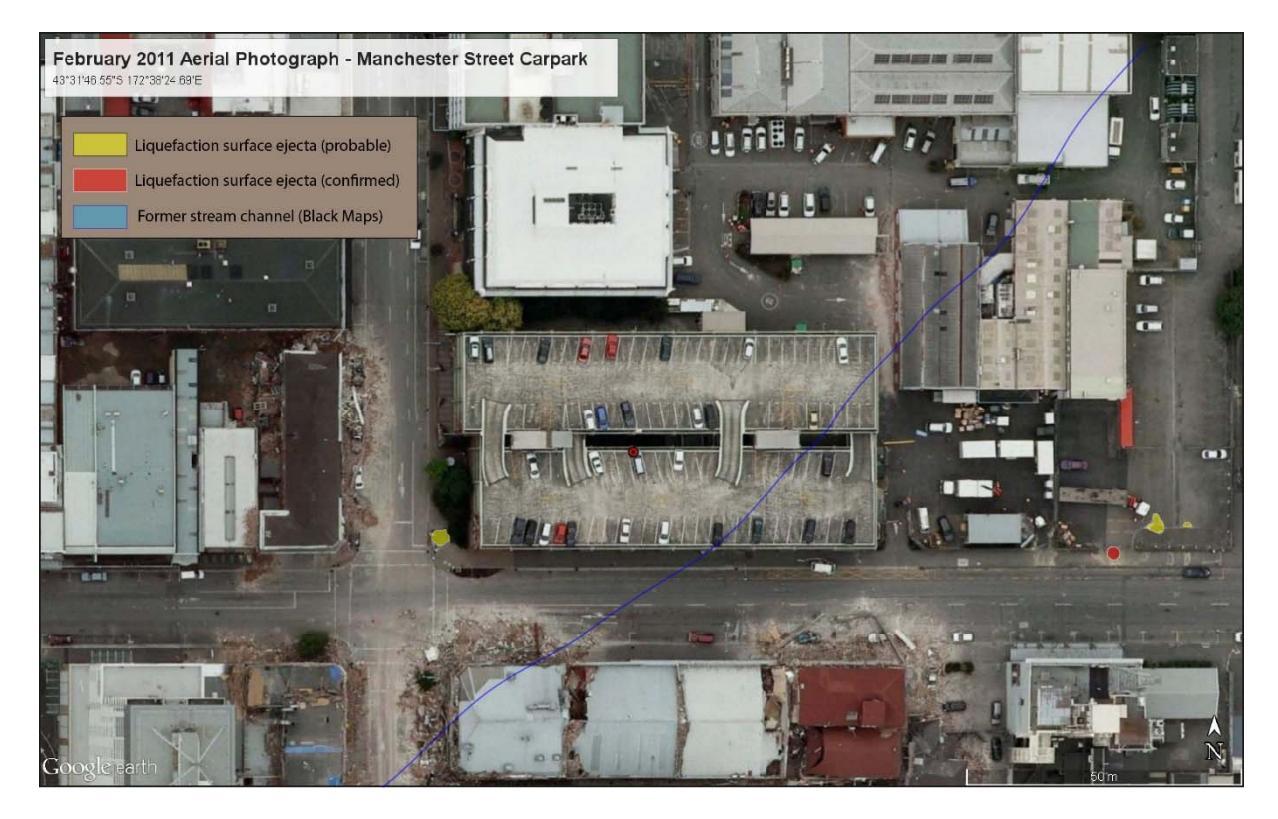
The first part of our analysis was to produce detailed maps of liquefaction surface ejecta (Fig. 11) using airphotos obtained immediately following the 22 February earthquake in order to better quantify the extent of liquefaction surface ejecta. Distributions of liquefaction were characterised as definite or inferred. Former (historic) stream channels were added to maps where present. Liquefaction ejecta were rare in the vicinity of the Manchester St Carpark. The small, circular shape of possible or confirmed ejecta suggest anthropogenic control; it is possible that shallow infrastructure provide conduits for localized pockets of liquefiable material to reach the surface. Fig.

12 highlights the abundance of building damage in the area surrounding the Manchester St Carpark in the absence of abundant surface ejecta and scarcity of liquefiable material at depth; strong transient ground shaking during the 22 Feb Christchurch earthquake is suggested to be the primary cause of observed damage surrounding this site, rather than ground failure.

Figure 12: Map of liquefaction surface ejecta in the Manchester St Carkpark site following the 22 February 2011 Mw 6.2 Christchurch earthquake.

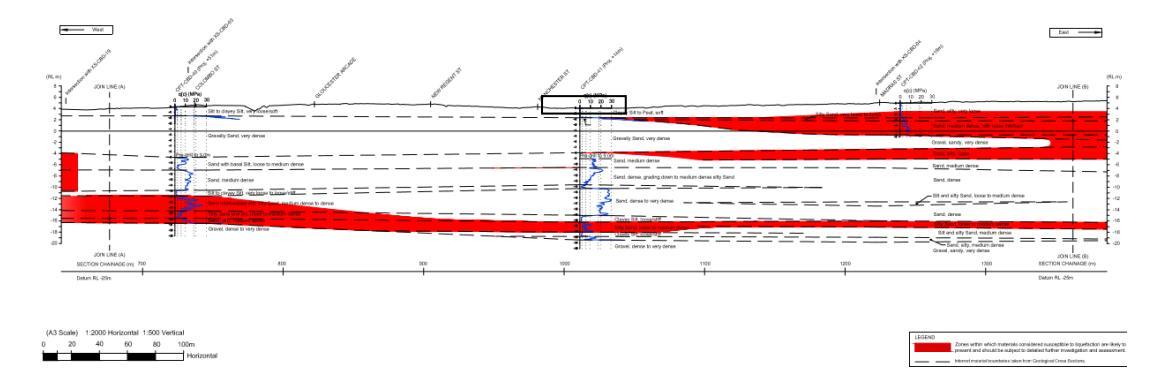
Figure 13: Projected footprint of Manchester Carkpark on to LHXS-CBD-11 (Armagh St). Cross-section showing zones susceptible to liquefaction (RED) from T&T Ref # 51845. Note eastward thickening of liquefaction-susceptible zones in shallow levels (1-10 m below surface) and westward thickening of liquefaction-susceptible deep zones (15-20 m below surface). It is possible that the regional westward-directed lateral displacements reflect translational slip of the capping units above a deep liquefiable layer.
