Geologic and geomorphic impacts of the 2010-2012 Canterbury earthquake sequence and local evidence for large prehistoric earthquakes

M.C. Quigley

University of Canterbury

2013 Hochstetter Lecture

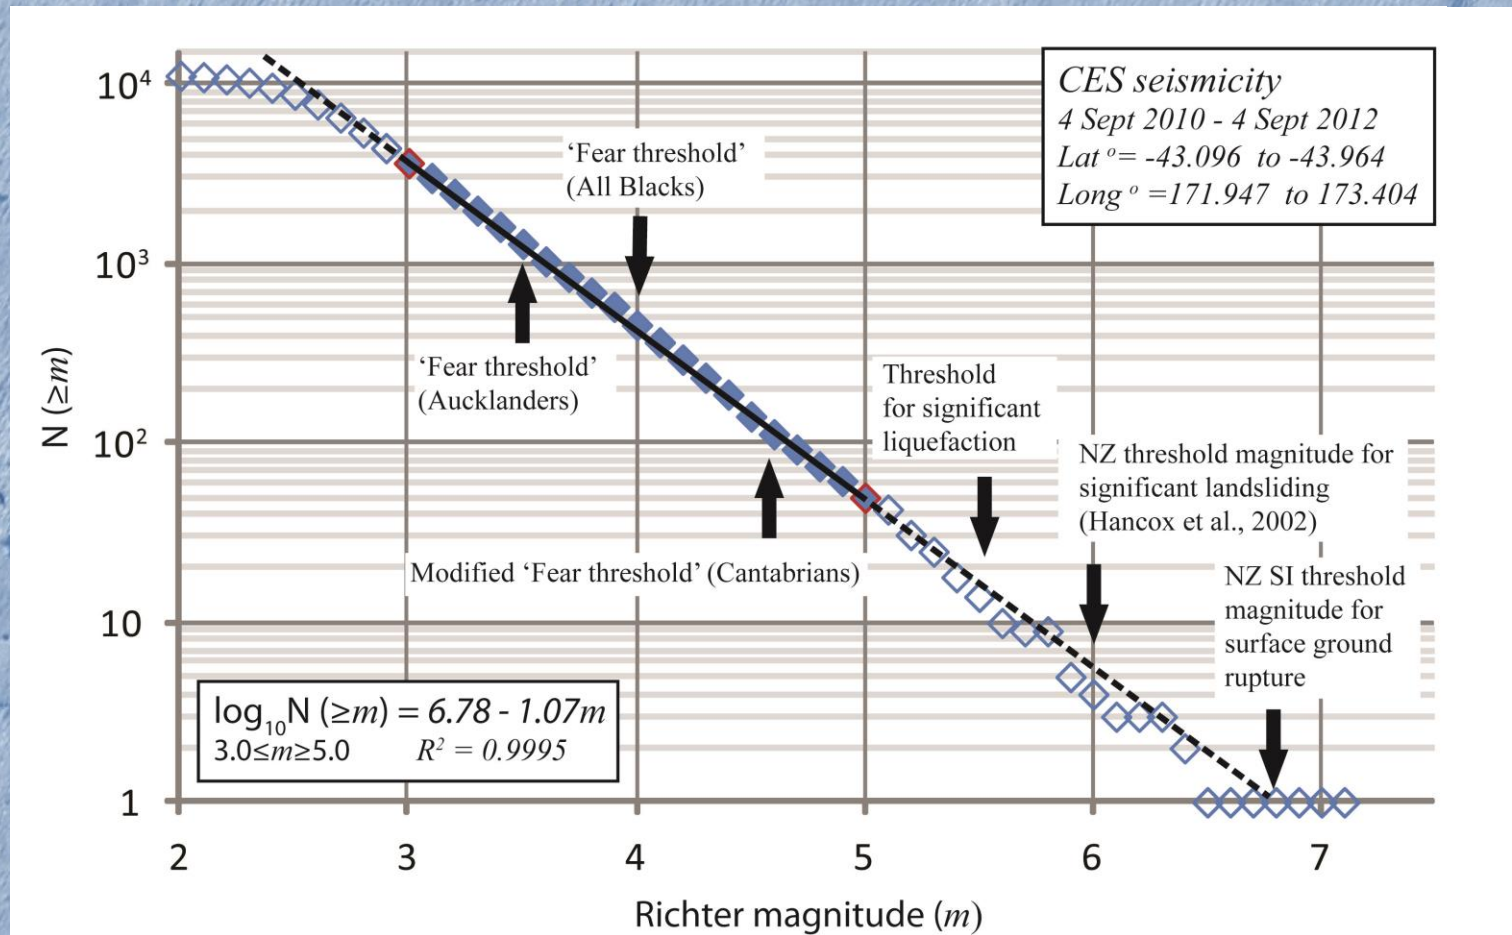
Truth and beauty of earthquakes: The Gutenberg-Richter relationship

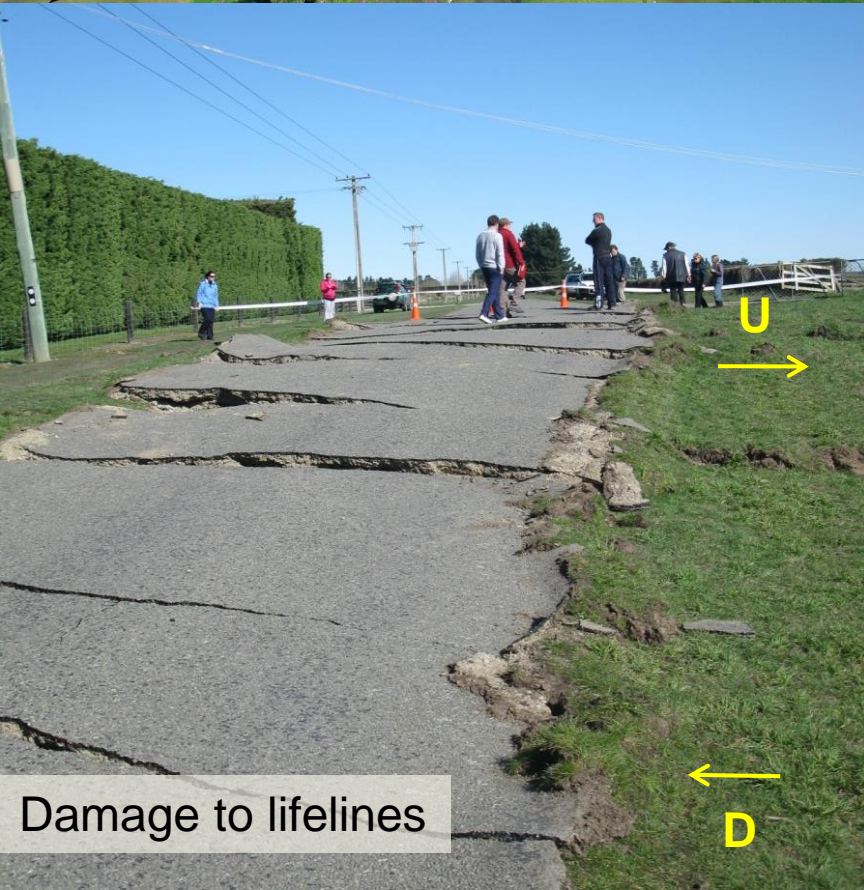
Rupture-induced river avulsion

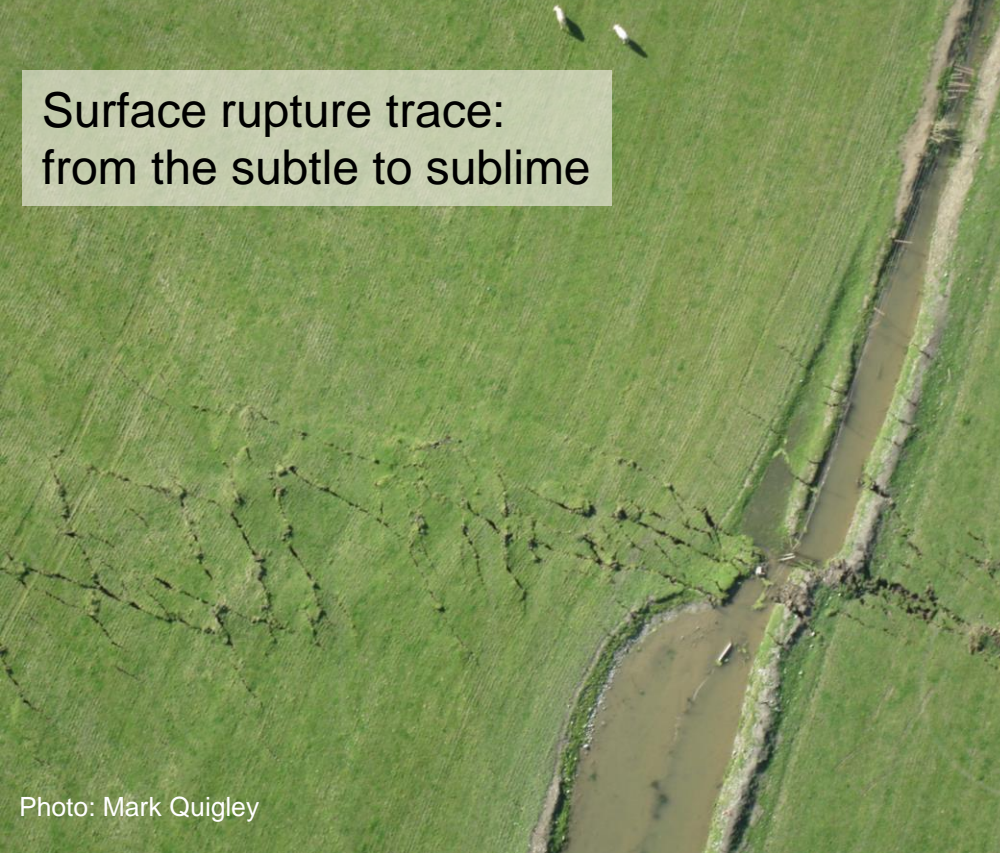
Photo: Mark Quigley

Surface rupture trace:
from the subtle to sublime

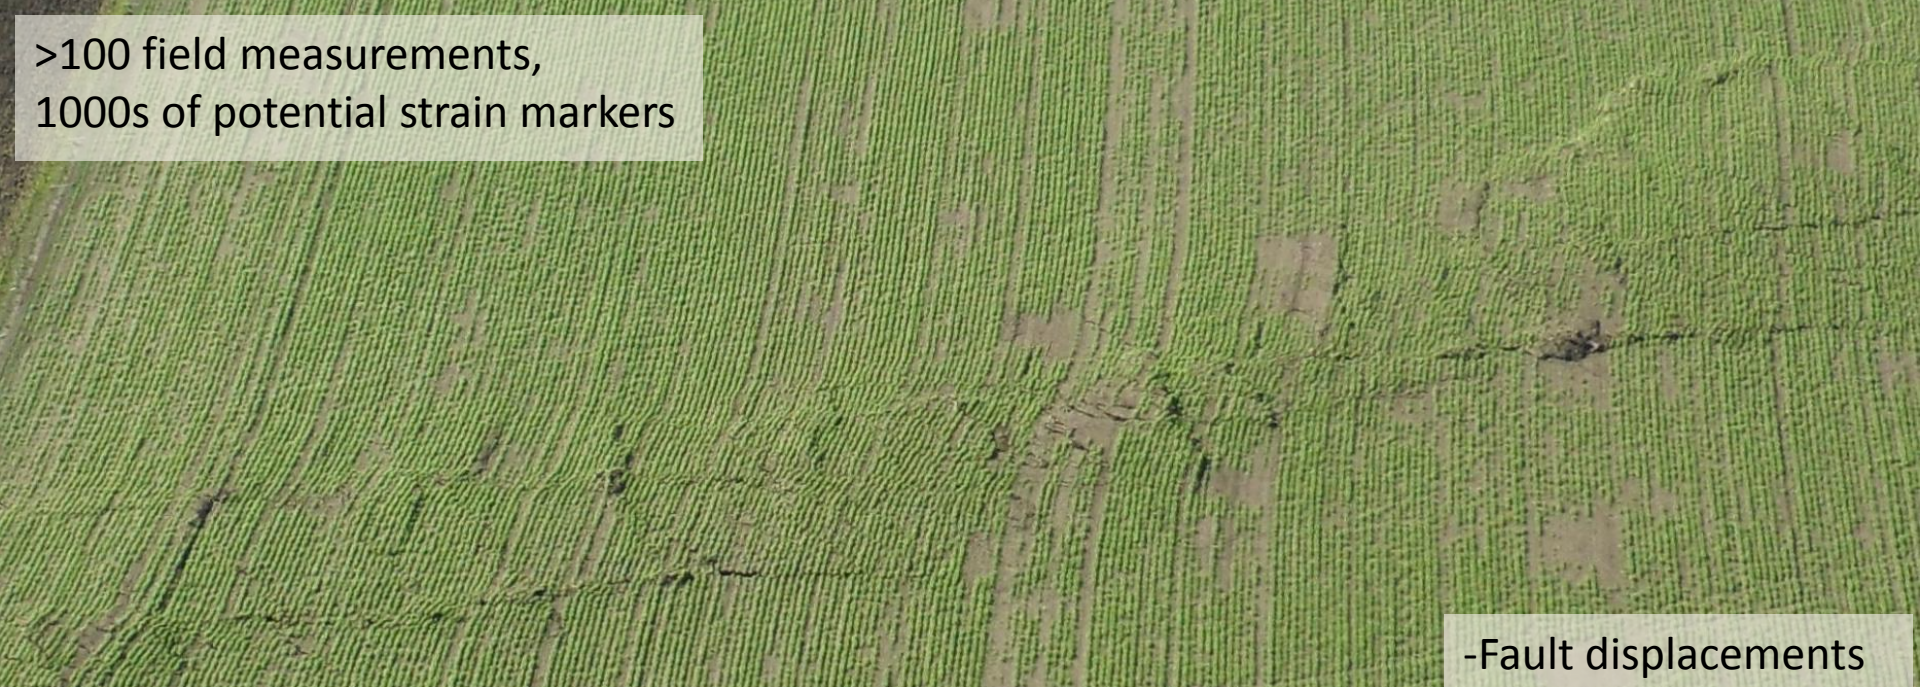
>100 field measurements,
1000s of potential strain markers

-Fault displacements
-Thresholds between
bending and breaking

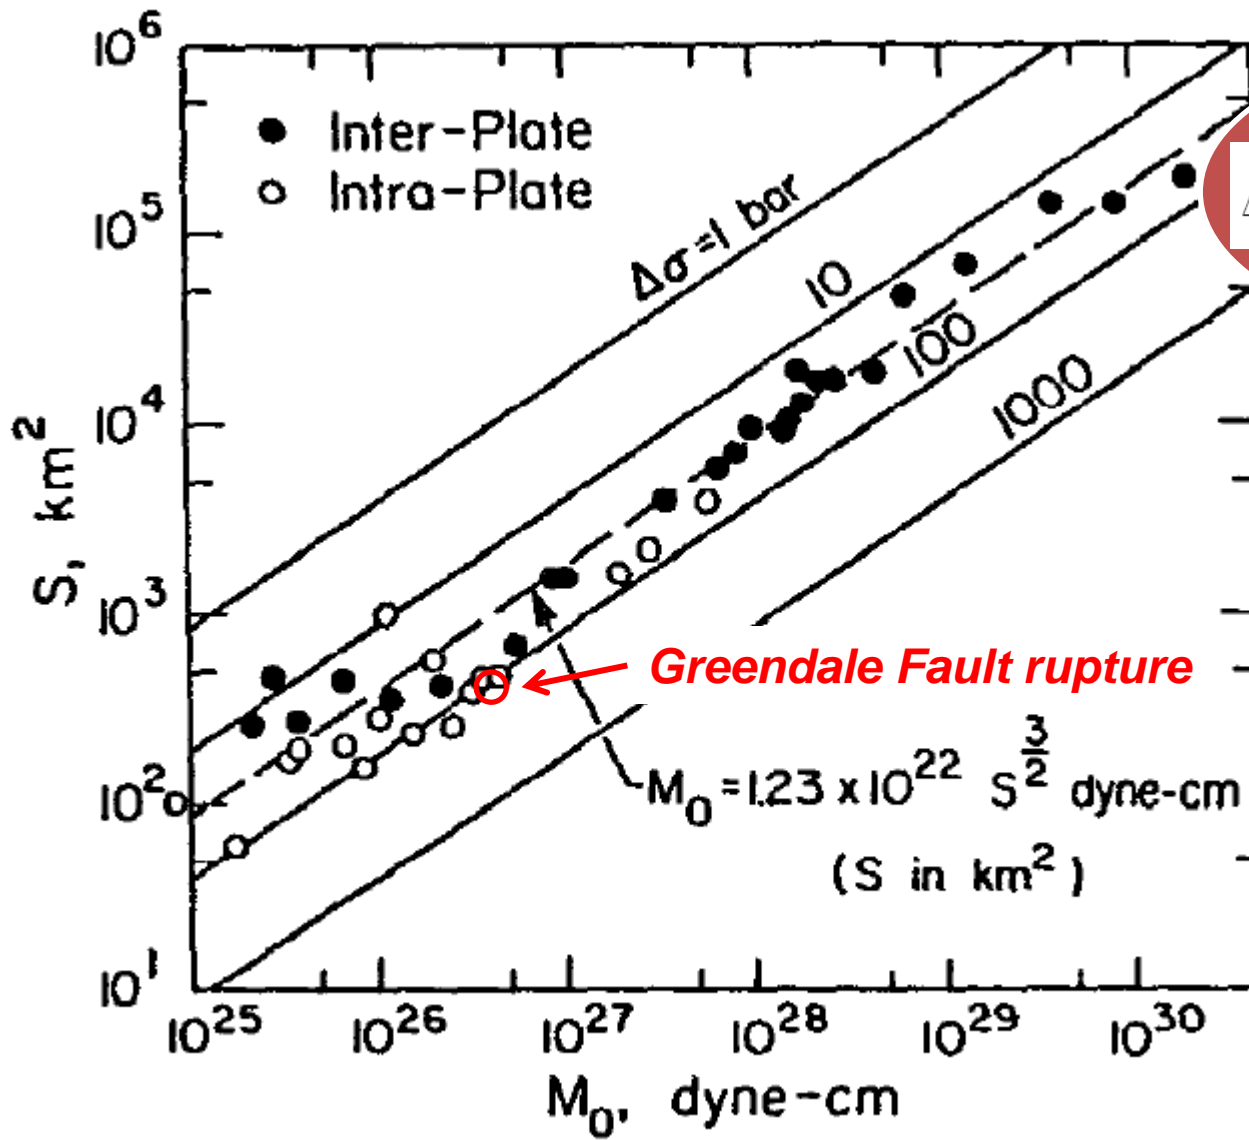
$$\Delta\sigma^G = (\mu/C) \times (D/W) = 13.9 \pm 3.7 \text{ MPa}$$

At the high end of stress drop estimates but not surprising for tectonic setting

Higher than 'analogous' earthquakes ($8 \pm 1 \text{ MPa}$ for 1992 Mw 7.3 Landers; $10 \pm 2 \text{ MPa}$ for 1999 Mw 7.1 Hector Mine; Price and Bürgmann, 2002) = higher fault friction due to long recurrence intervals?

Relation between fault area and seismic moment for large and great earthquakes (Kanamori & Anderson 1975)

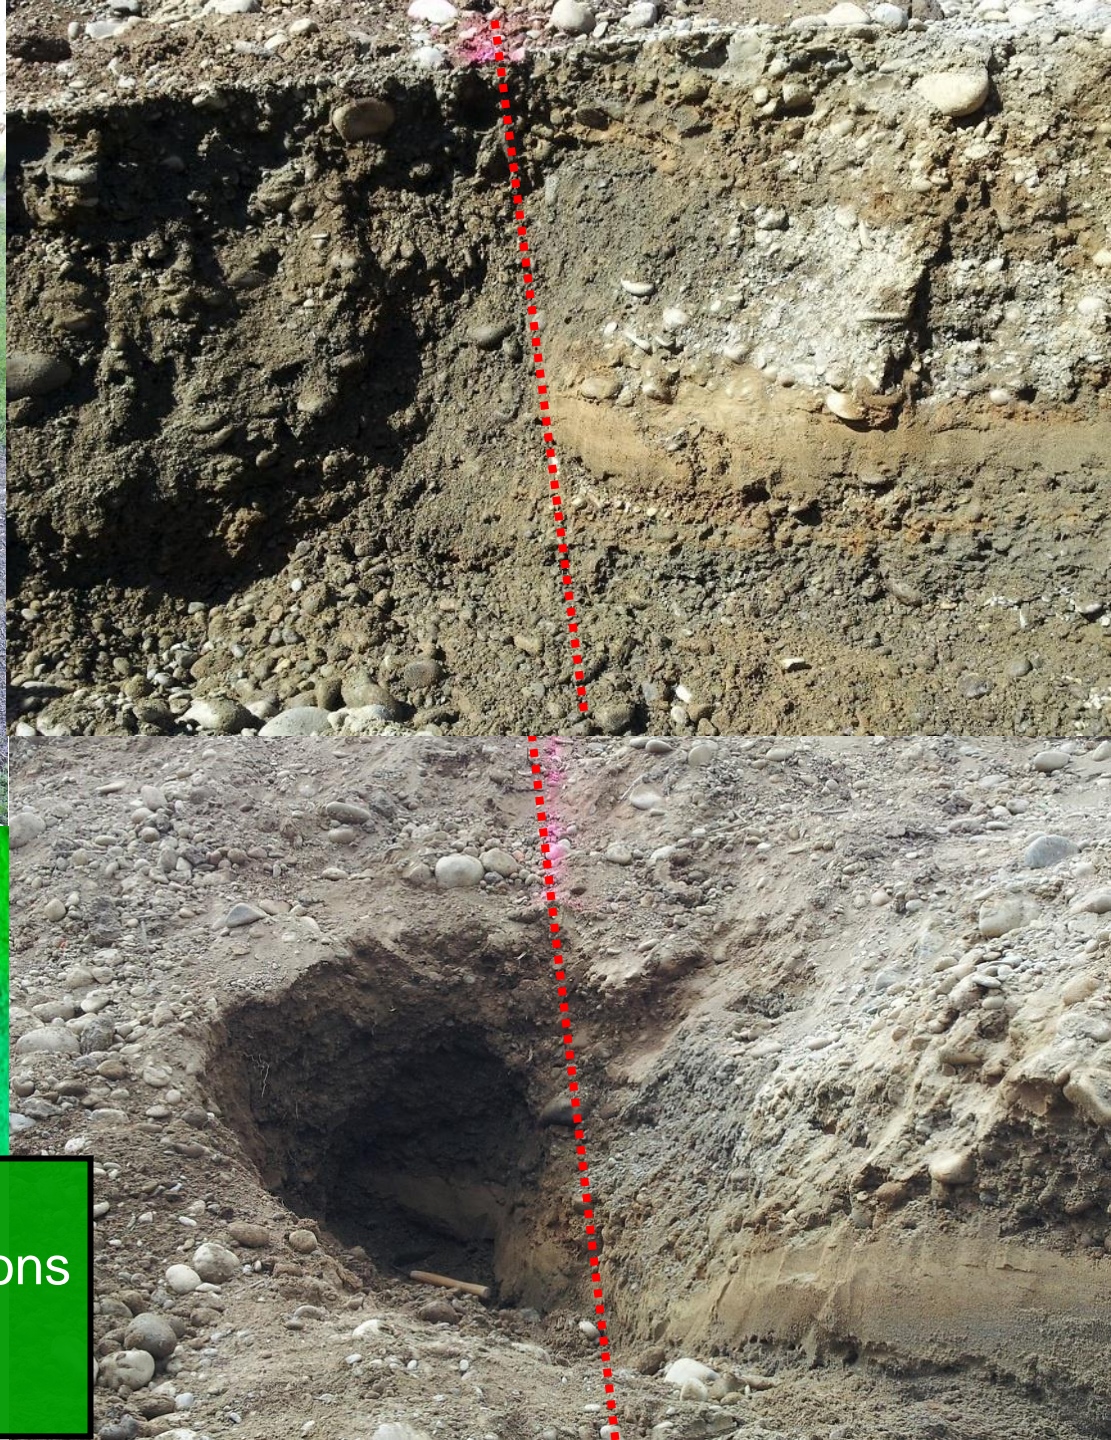
Digging laterally along fault to expose paleochannel cross-sections and measure piercing points (channel facies and margins)

**The penultimate earthquake:
Between ~22 and ~28 ka
Consistent slip-at-a-point**

- We see geologic evidence for penultimate earthquake rupture on the Greendale Fault ca. 25 ± 3 kyr ago, we infer from stress modelling that the complexity of this earthquake is the norm rather than the exception, we think it is unlikely that GF rupture could have propagated coseismically on to the Feb and June faults, but the fractures between these faults are effective ‘waveguides’

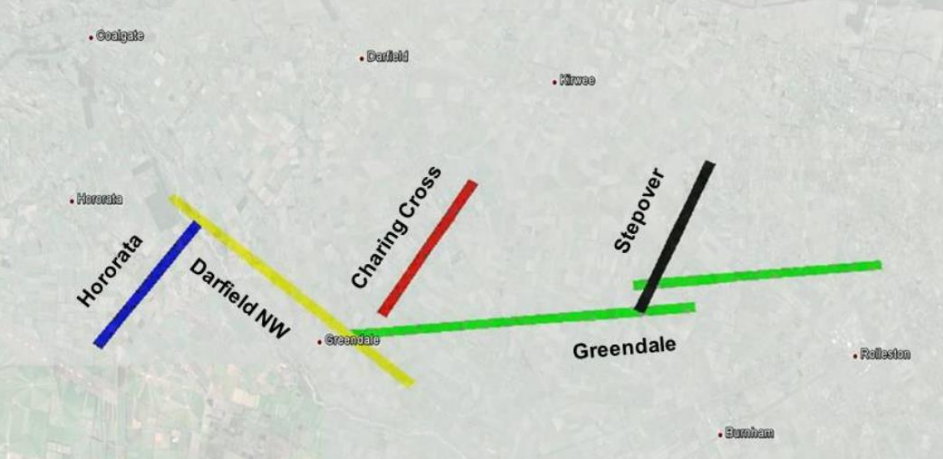
From point measurements to complex rupture scenarios

*What happens if the dominoes
topple the other way?*

Coulomb 'static' stress evolution for rupture initiating on CCF

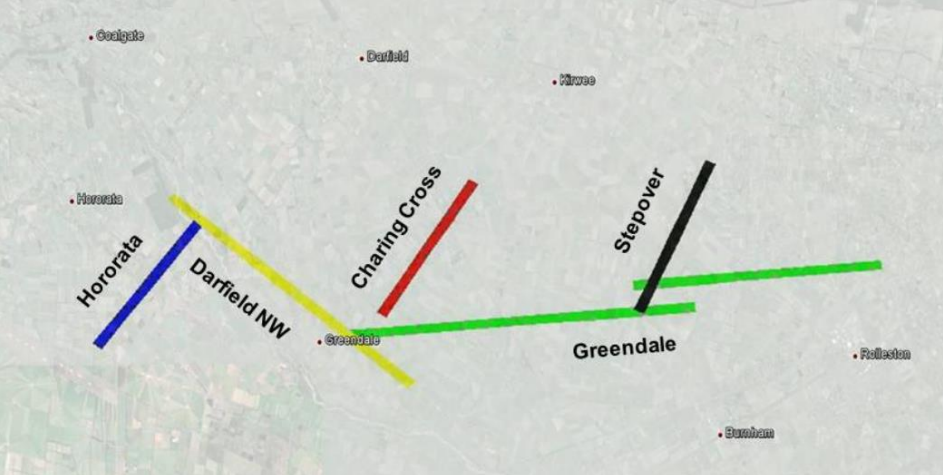
Coulomb 'static' stress evolution for rupture initiating on Darf NW

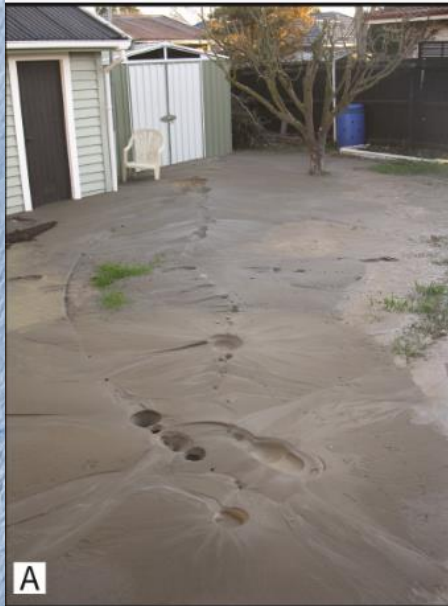
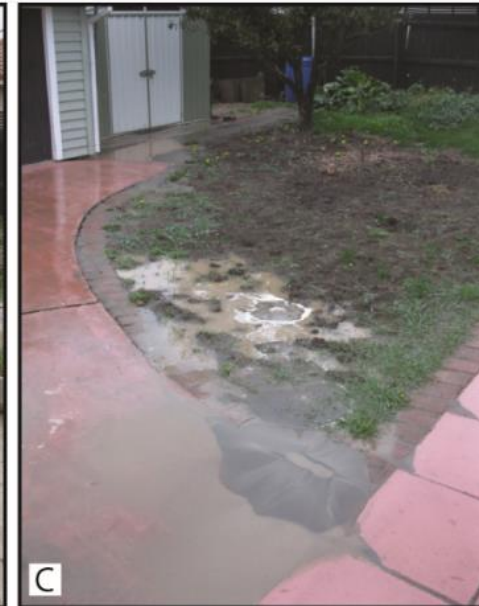
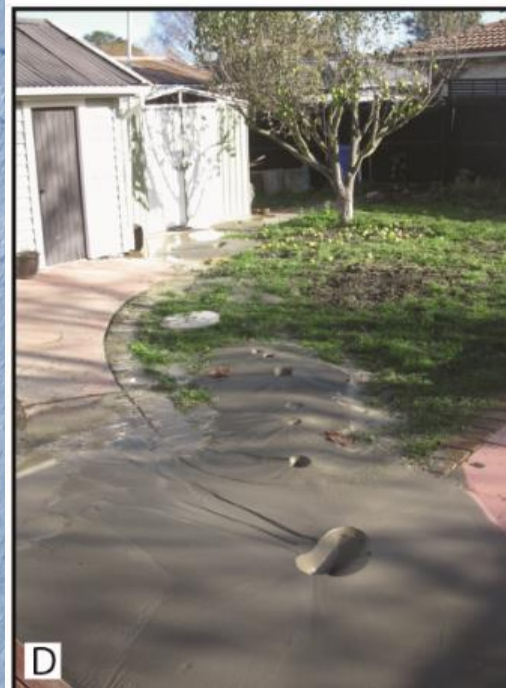
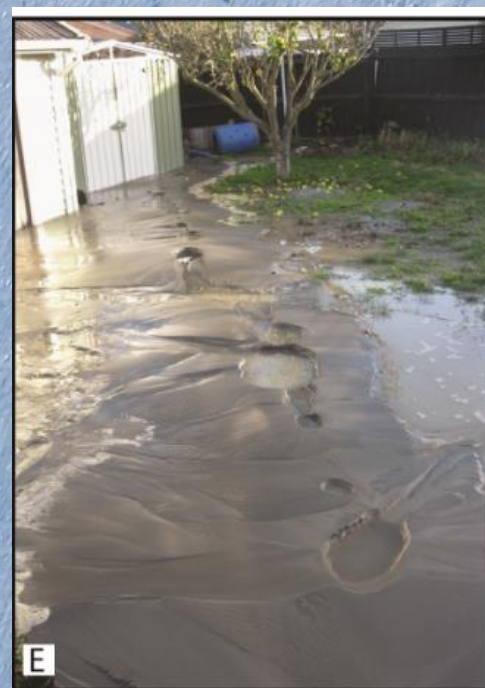
Recurrent liquefaction in Christchurch during the Canterbury earthquake sequence

At least 10 liquefaction episodes, some of which occurred at surprisingly low PGAs

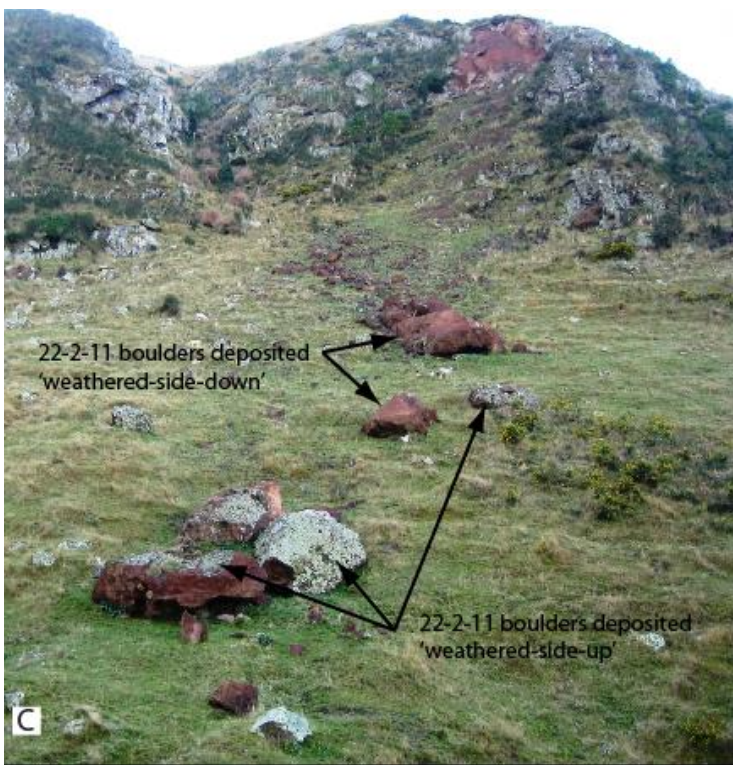
Rockfall / Boulder Roll Hazard

boulder deposited
by paleo-rockfall

loess and colluvium
accumulation
upslope of boulder
