Characterisation of modern and paleoliquefaction features in eastern Christchurch, NZ following the 2010-2011 Canterbury earthquake sequence

Proc. 19th NZGS Geotechnical Symposium. Ed. CY Chin, Queenstown

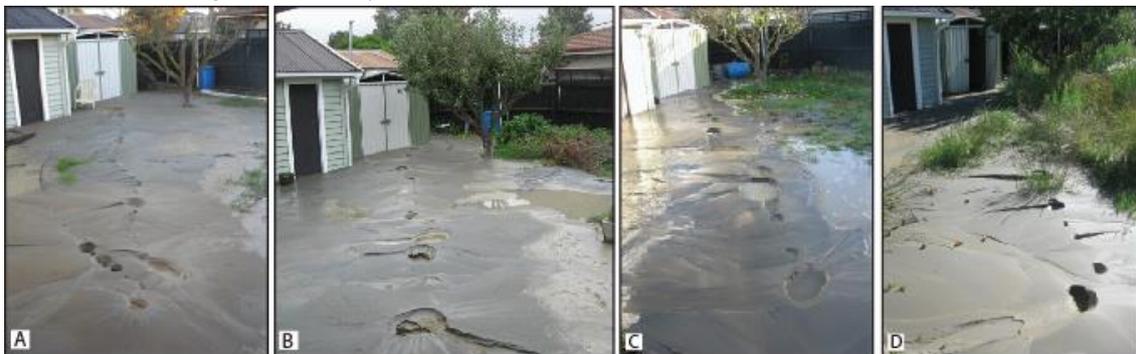
Figure 2: Photographs taken in the backyard of the Bracken St site following the September 2010 Mw7.1 event (a), and the February 2011 Mw 6.2 (b), June 2011 Mw 6.0 (c), and December Mw 5.9 (d) events, with the alignment and re-activation of the sand blow vents evident.

The study area of Avonside, eastern Christchurch is located within an inside meander bend of the Avon River (Figure 1), which undergoes tidal current reversals. Near-surface deposits beneath the top soil and anthropogenic material consist of alluvial silts and sands, with some gravel units in abandoned channels. Two study sites are investigated in this paper (Figure 1). The study site at 11 Bracken St experienced liquefaction and formation of sand blows (Figure 2) in at least ten CES earthquakes with local PGA $\geq 0.1g$ (Quigley et al., 2013). The Sullivan Park study site experienced significant liquefaction in the largest CES earthquakes and formed large lateral spreading cracks up to 0.5 m in width during the February 2011 Mw 6.2 event.
