GEOLOGIC, GEOTECHNICAL, AND SEISMOLOGIC CONTEXT AND DISPLACEMENTS OF LAND AND BUILDINGS AT SELECTED SITES OF CHRISTCHURCH CITY COUNCIL OWNED REINFORCED CONCRETE STRUCTURES DAMAGED DURING THE 2010-2011 CANTERBURY EARTHQUAKES

University of Canterbury Consultancy Report CN4600001360

25 November 2015

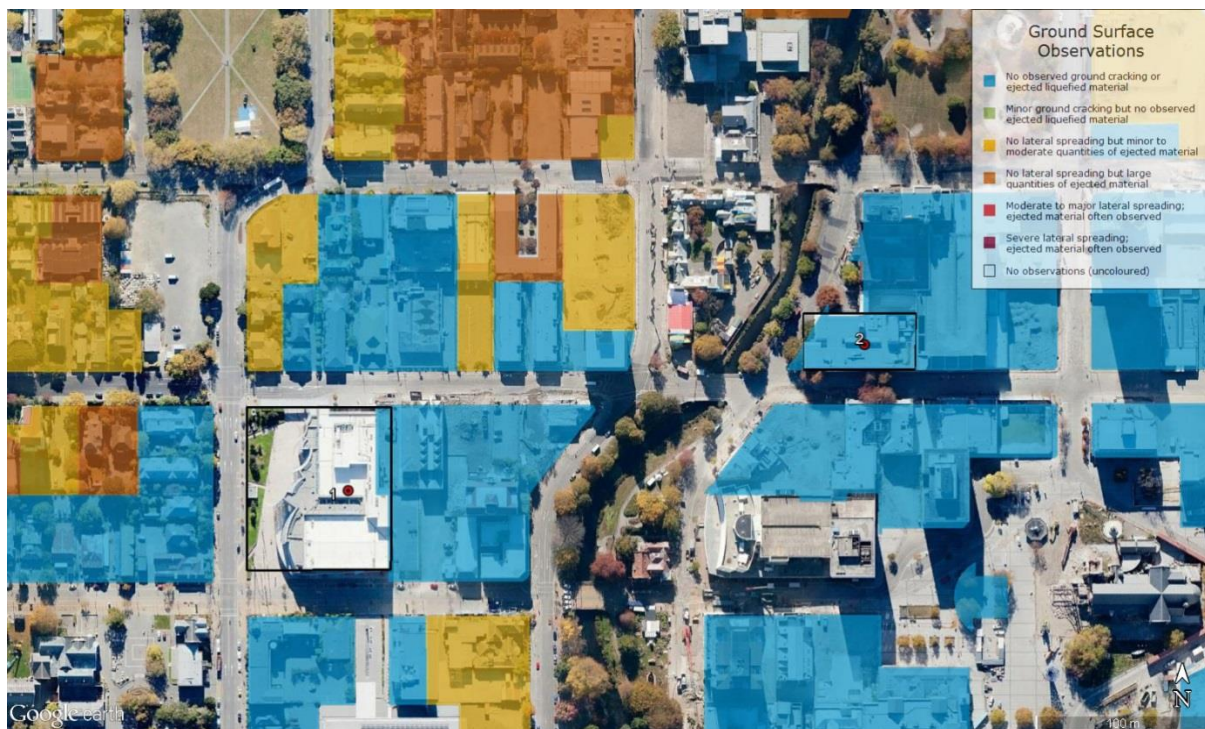
Figure 2: Area reconnaissance mapping of liquefaction and lateral spreading in the vicinity of the Christchurch Art Gallery (1) and City Library (2) following the 22 Feb 2011 Christchurch Mw 6.2

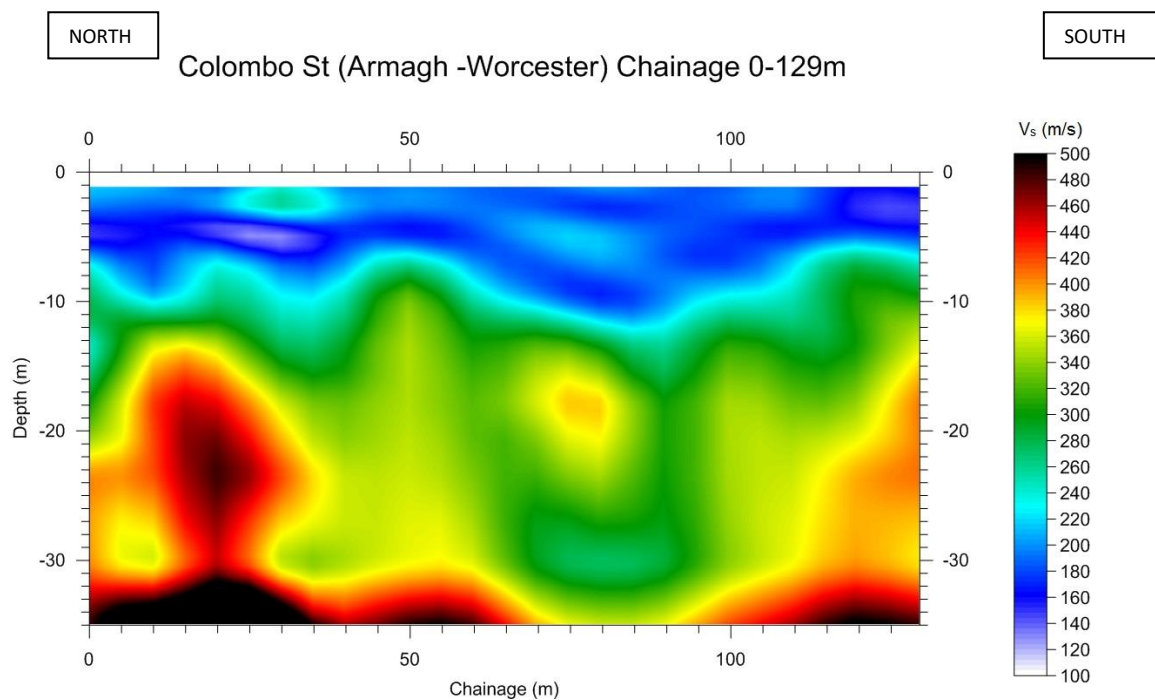
Figure 7: MASW survey for Colombo St, east of Art Gallery and City Library. See Fig. 4 for corresponding chainage.

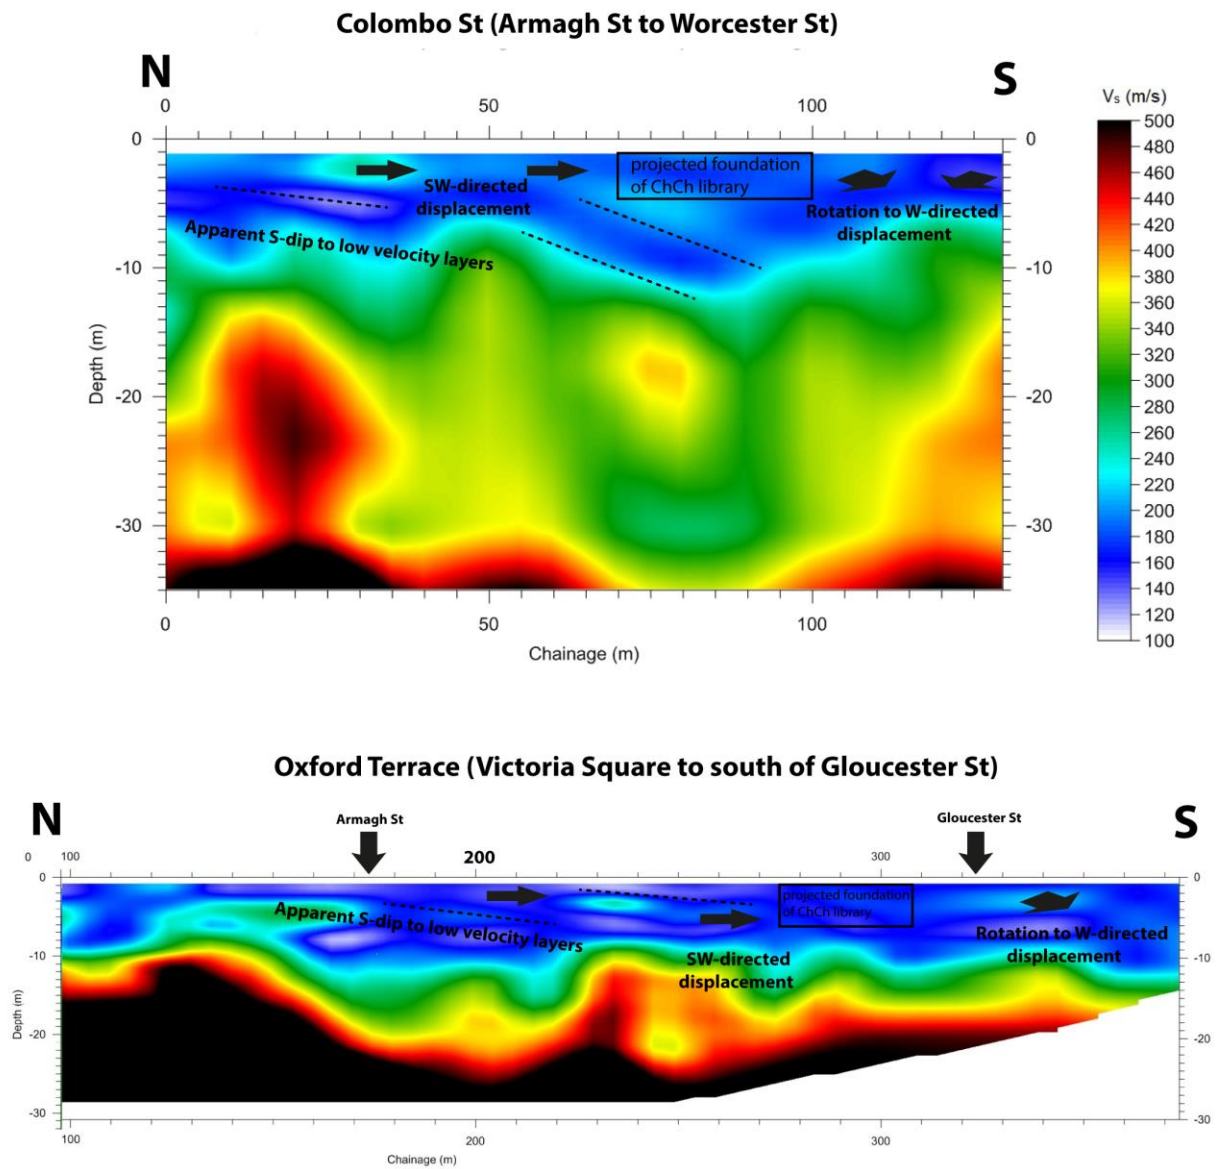
Figure 14: Interpreted MASW profiles showing apparent N-S changes in the geometry of lower velocity sediments beneath the projected locations of the Christchurch City Library.

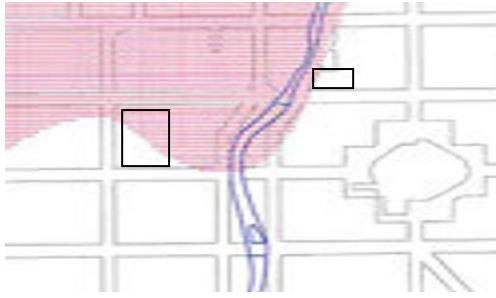
Fig. 17: Shallow liquefaction zones (~1.2 to 3m depth) beneath the Art Gallery and City Library.

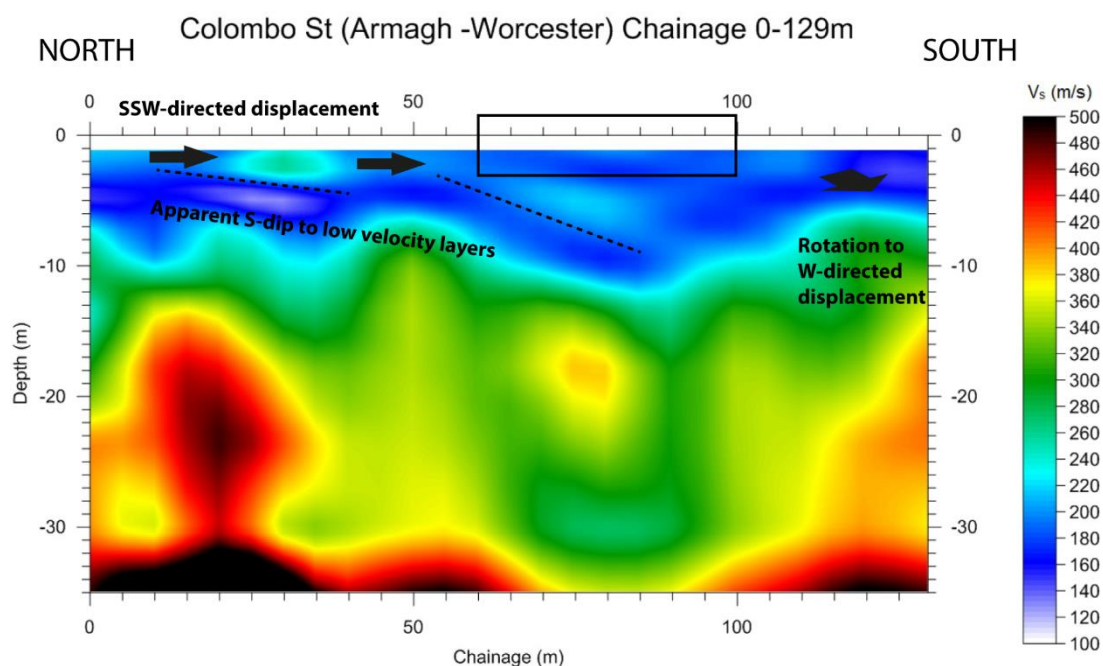
Figure 7: Interpreted MASW survey for Colombo St between Armagh St and Worcester St, immediately west of the Manchester St Carpark. See Fig. 4 for corresponding chainage.

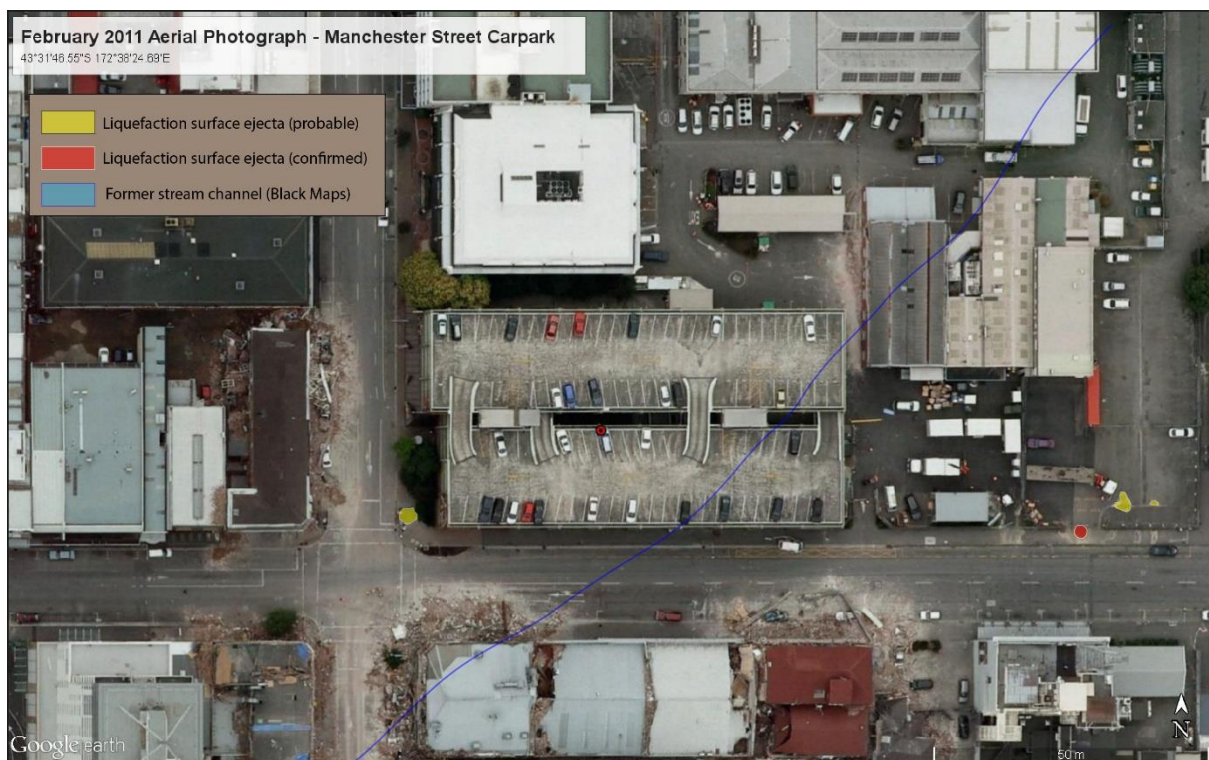
Figure 12: Map of liquefaction surface ejecta in the Manchester St Carpark site following the 22 February 2011 Mw 6.2 Christchurch earthquake.

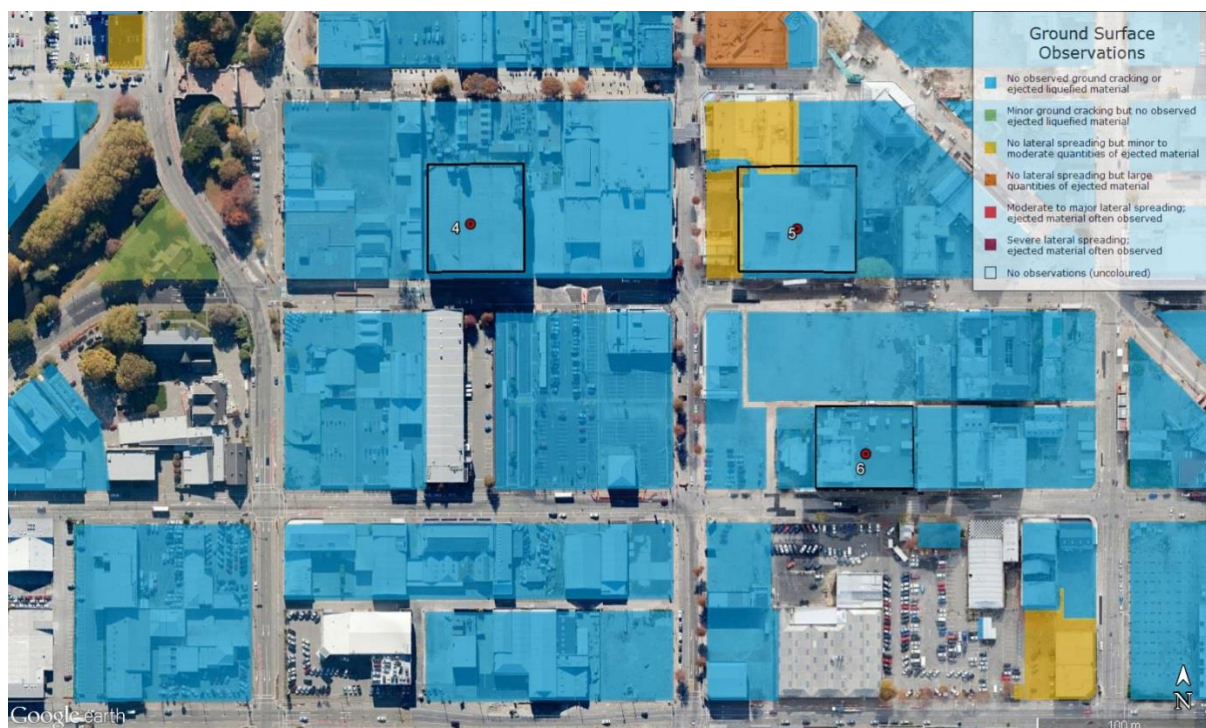
Figure 2: Area reconnaissance mapping of liquefaction and lateral spreading in the vicinity of Litchfield St carpark (4), Old Bus Exchange (5), and Old Civic Building (6) following the 22 Feb 2011

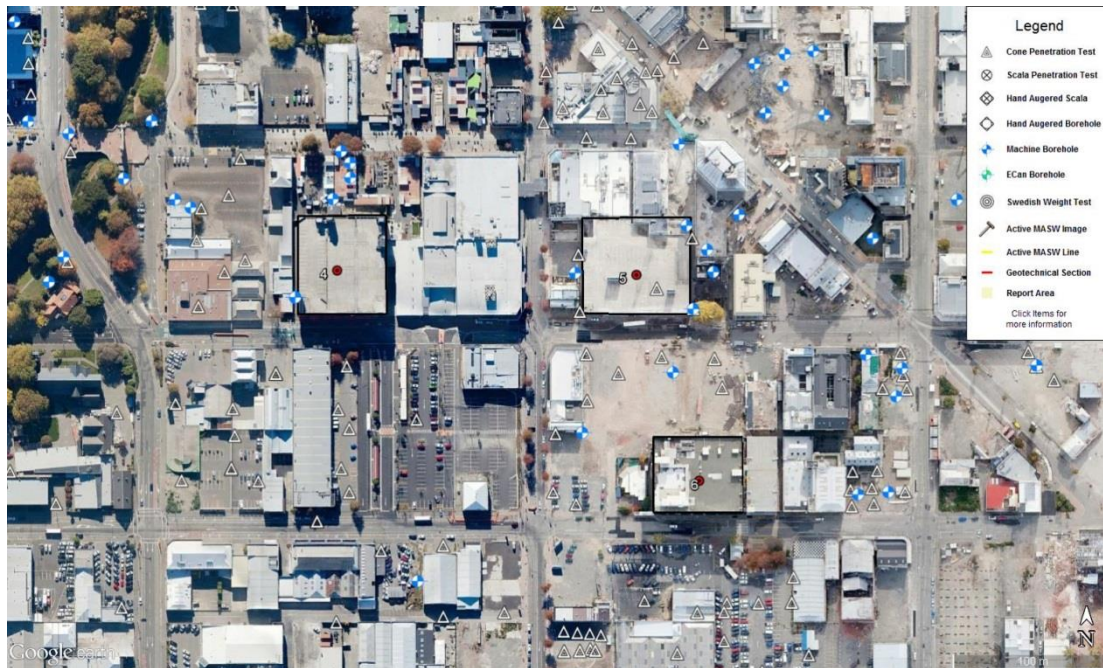
Figure 3: Location of CPT, borehole, and other geotechnical sampling sites in the vicinity of the Lichfield St carpark (4), Old Bus Exchange (5), and Old Civic Building (6). These data were variably used to construct geologic cross-sections (e.g., Fig. 10).

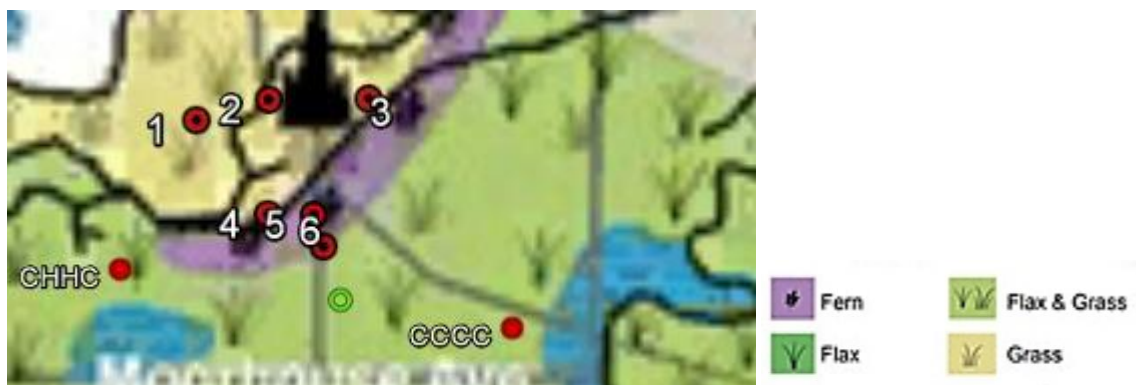
Figure 7: Paleo-ecology of the Lichfield St carpark (4), Old Bus Exchange (5), and Old Civic Building (6) sites.

Ecological maps (pre-development vegetation and waterways; Fig. 7,8) were reproduced by T&T from compilations of Christchurch Drainage Board 1856 "Black Maps" consequently reproduced by Di Lucas for Christchurch area.

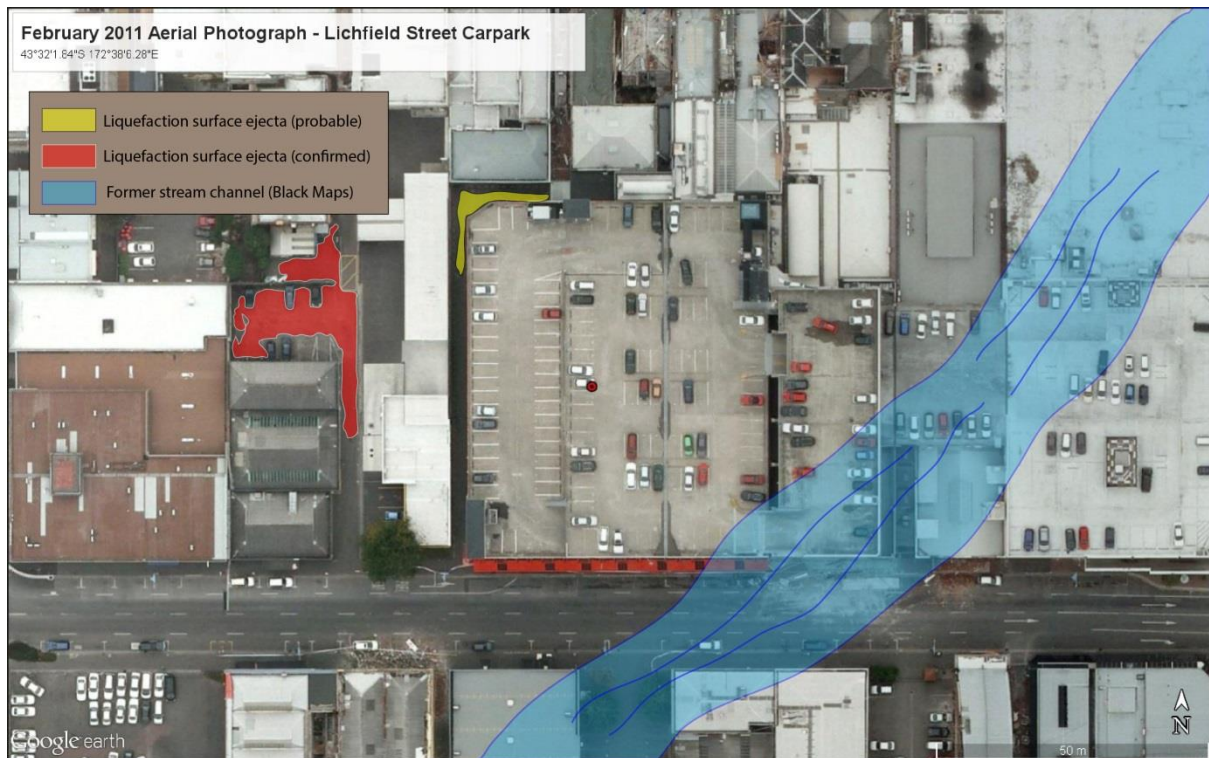
Figure 12: Map of liquefaction surface ejecta surrounding Lichfield Car Park following the 22 February 2011 Mw 6.2 Christchurch earthquake. Position of waterway identified from Black Maps as shown.

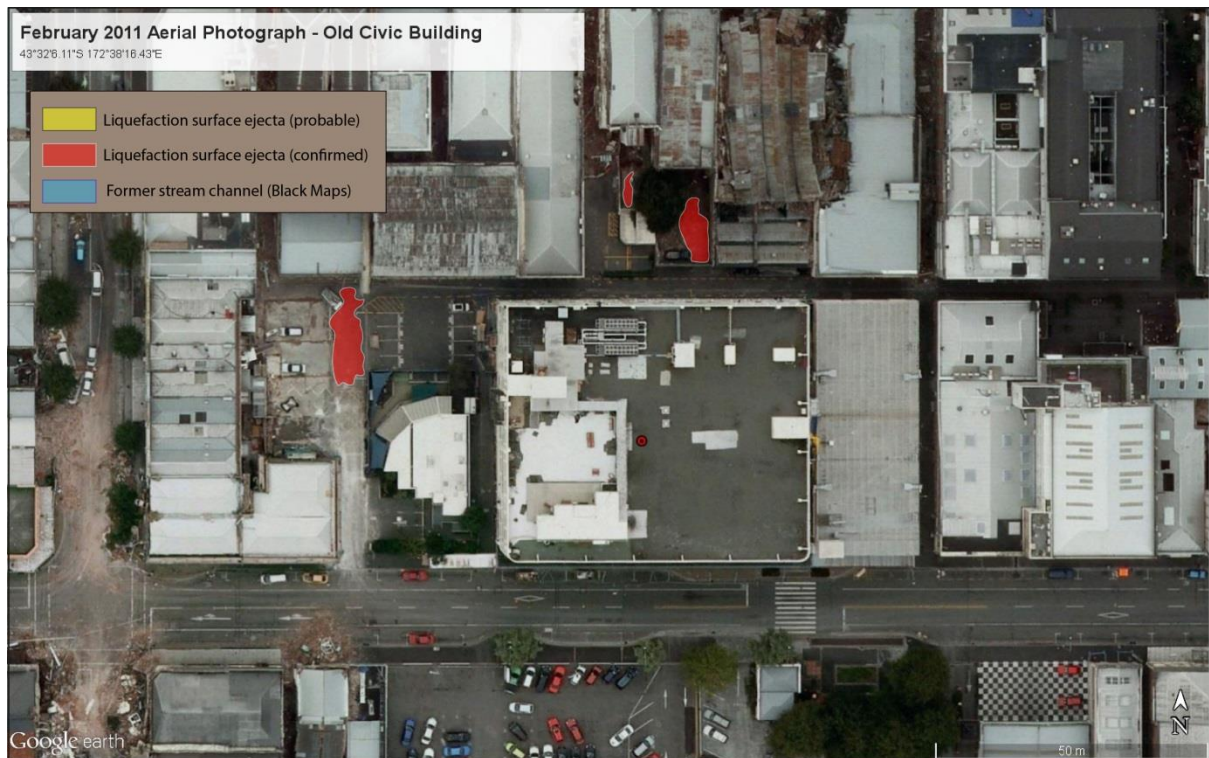
Figure 14: Map of liquefaction surface ejecta surrounding the Old Civic Building following the 22 February 2011 Mw 6.2 Christchurch earthquake

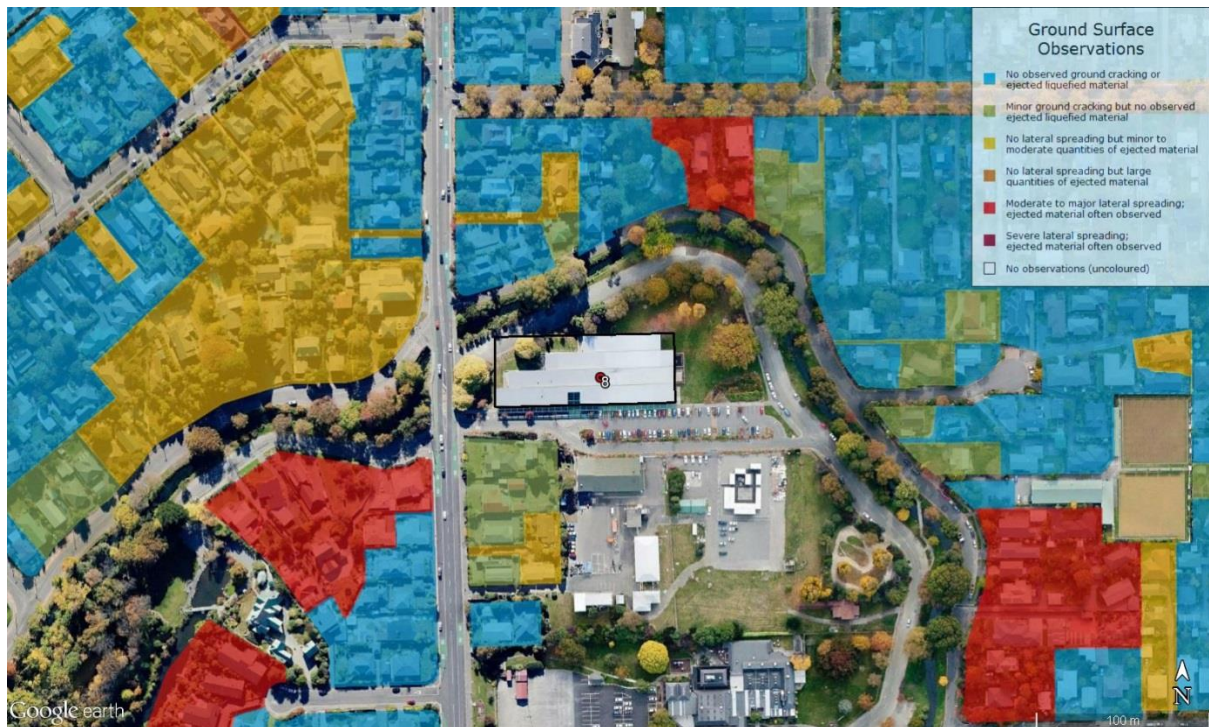
Figure 2: Area reconnaissance mapping of liquefaction and lateral spreading in the vicinity of Christchurch South Library following the 22 Feb 2011 Christchurch Mw 6.2 earthquake (mapping by Tonkin and Taylor Ltd). More detailed mapping (this report) is presented in Fig. 11

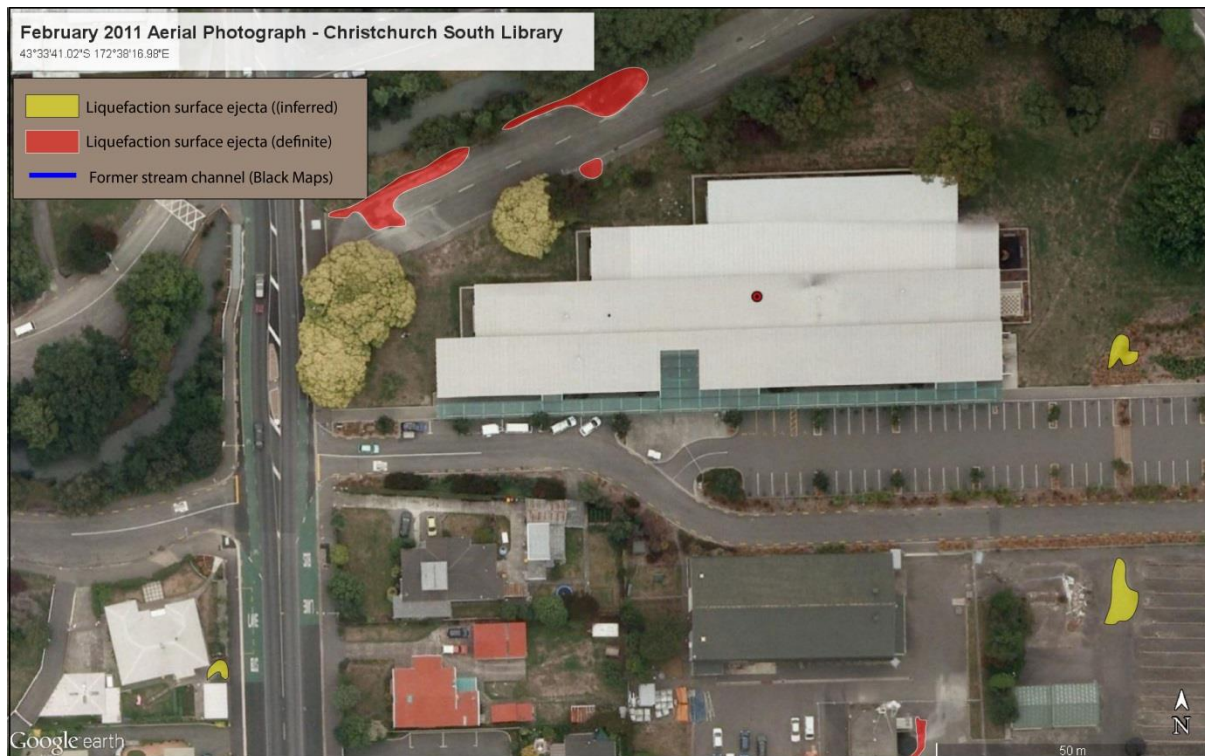
Figure 7: Map of liquefaction surface ejecta in the Christchurch South Library area following the 22 February 2011 Mw 6.2 Christchurch earthquake.
