**GEOLOGIC, GEOMORPHIC, GEOTECHNICAL, AND DISPLACEMENT MAPS OF  
LAND AND BUILDINGS AT SELECTED SITES OF CHRISTCHURCH CITY COUNCIL  
OWNED REINFORCED CONCRETE STRUCTURES DAMAGED DURING THE 2010-  
2011 CANTERBURY EARTHQUAKES**

**CHRISTCHURCH SOUTH LIBRARY STUDY**

**University of Canterbury Consultancy Report CN4600001360**

**November 2015**

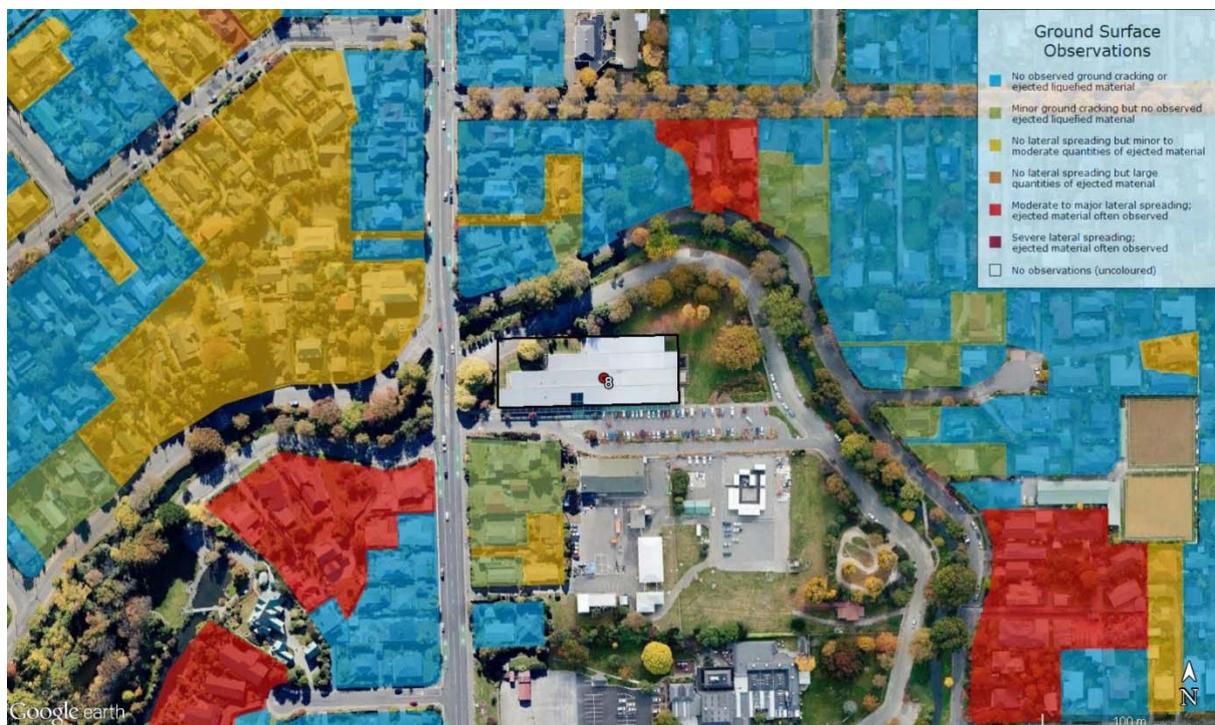
Initial mapped liquefaction distributions (Fig. 2) do not cover the site of interest in detail. However, in general, liquefaction severity appears highest in this map in areas most proximal to (i.e. within 50 m) the Heathcote River. The Christchurch South Library is proximal to the river.

*Figure 2: Area reconnaissance mapping of liquefaction and lateral spreading in the vicinity of Christchurch South Library following the 22 Feb 2011 Christchurch Mw 6.2 earthquake (mapping by Tonkin and Taylor Ltd). More detailed mapping (this report) is presented in Fig. 11*

The map presented in Fig. 7 provides higher resolution and improved accuracy compared to previously published maps (Fig. 2), which were undertaken at the suburb-scale for general land-damage and liquefaction severity purposes. The following conclusions can be drawn from the mapping.

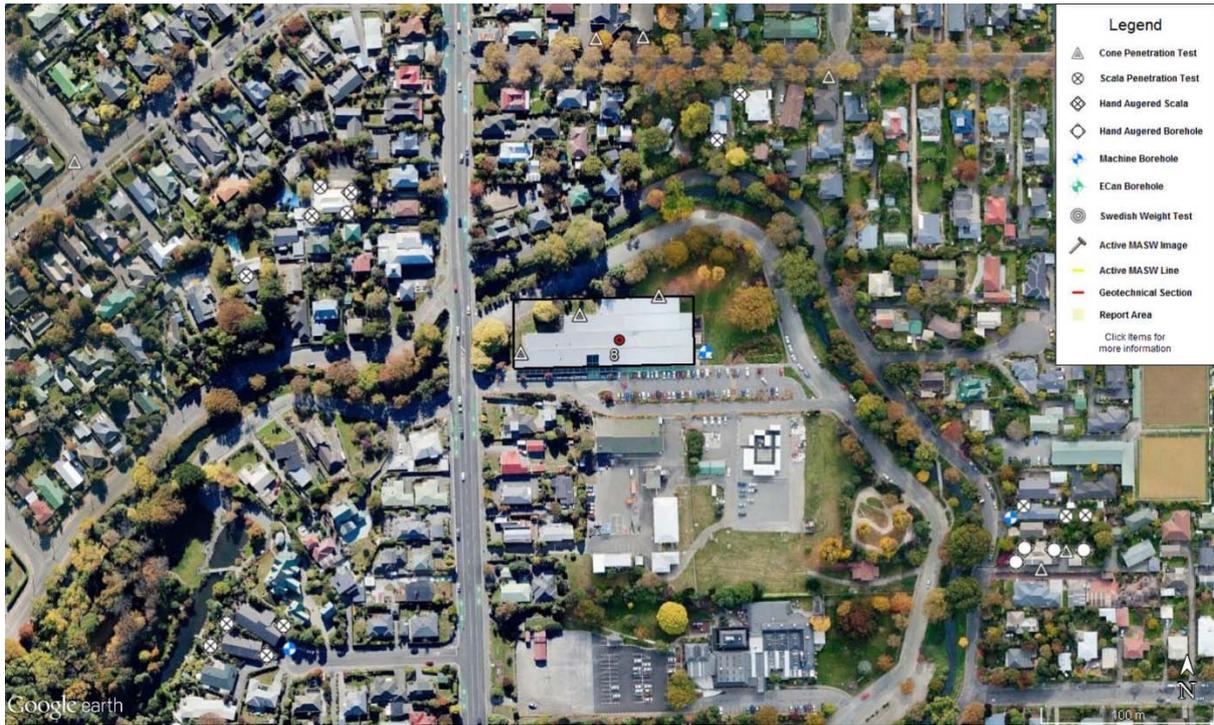
Figure 3: Location of CPT, borehole, and other geotechnical sampling sites in the vicinity of Christchurch South Library.

T&T conducted mapping (Fig. 2), and CPT investigations (Fig. 3) in close proximity to these sites.

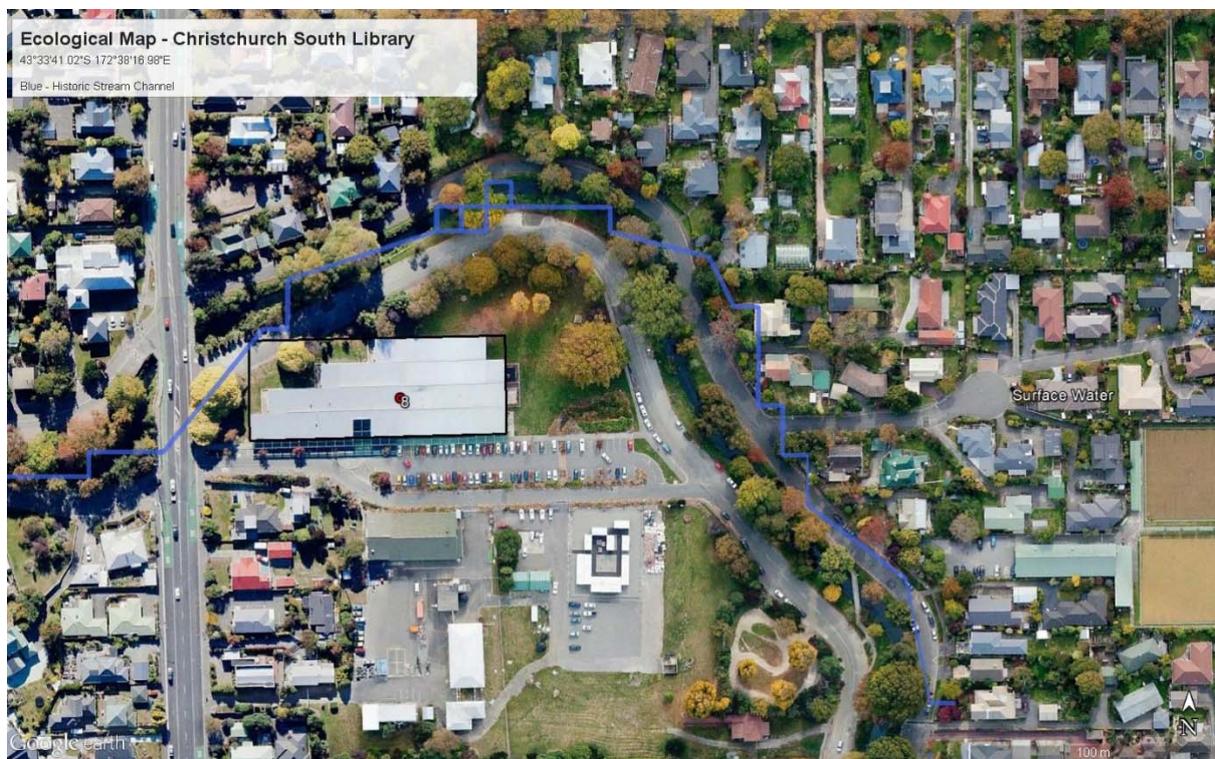
The paleo-ecology map simply shows the Heathcote River was proximal to the Christchurch South Library site in the past, as it is currently.

Figure 6: Paleo-ecology of the Christchurch South Library site.

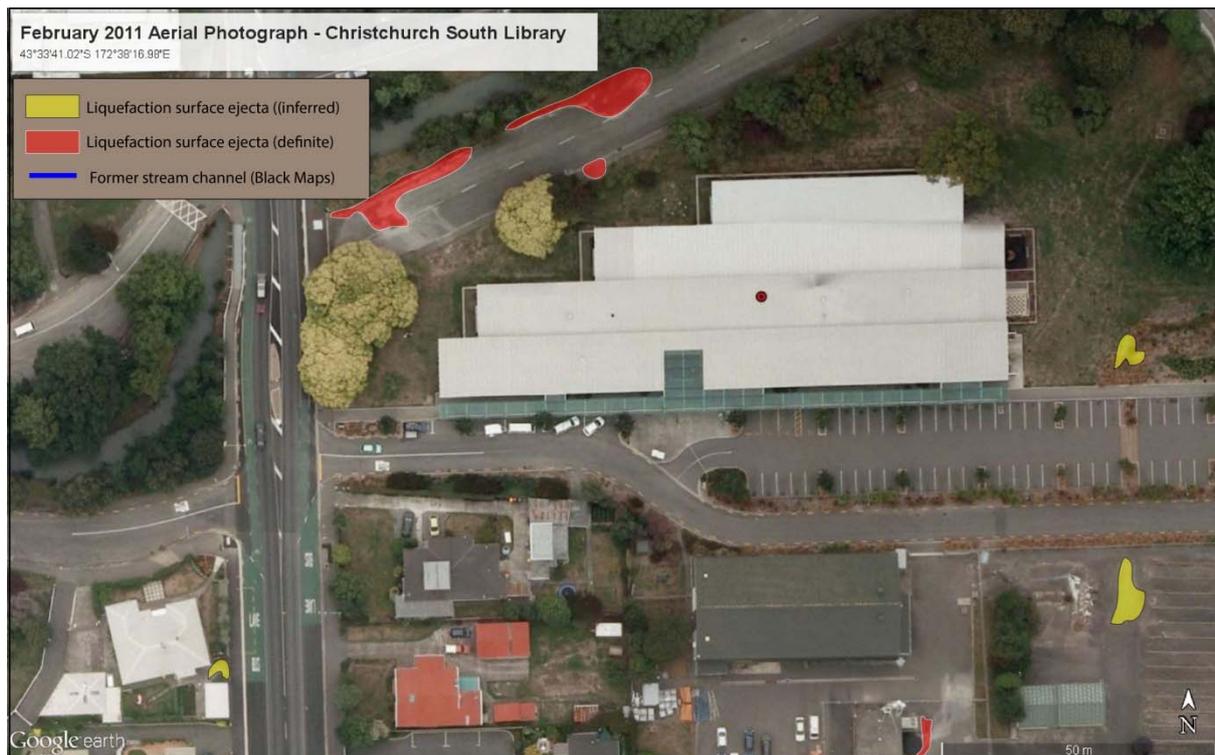
The new map of liquefaction surface ejecta using airphotos obtained immediately following the 22 February earthquake is presented in Fig. 7 in order to better quantify the extent of liquefaction surface ejecta. Distributions of liquefaction were characterised as definite or inferred.

*Figure 7: Map of liquefaction surface ejecta in the Christchurch South Library area following the 22 February 2011 Mw 6.2 Christchurch earthquake.*

1. Surface manifestation of liquefaction is heavily concentrated around southern bank of the Heathcote River with a linear array that is parallel to the river channel. This implies liquefied material was ejected through the surface via lateral spreading cracks resulting from extensional land failure towards the river channel. Isolated small pockets of surface ejecta are also inferred from mapping to have formed to the southeast of the library. This implies that liquefaction at the study site was controlled by local topography and geomorphology.
2. The liquefaction ejecta distributions to the northwest side of the library similarly correspond with increased vertical subsidence ( $\sim 0.3\text{-}0.5$  m) at that location.
