GEOTECHNICAL RECONNAISSANCE OF THE 2010 DARFIELD (NEW ZEALAND) EARTHQUAKE

Version 1: 14 November 2010

EDITORS

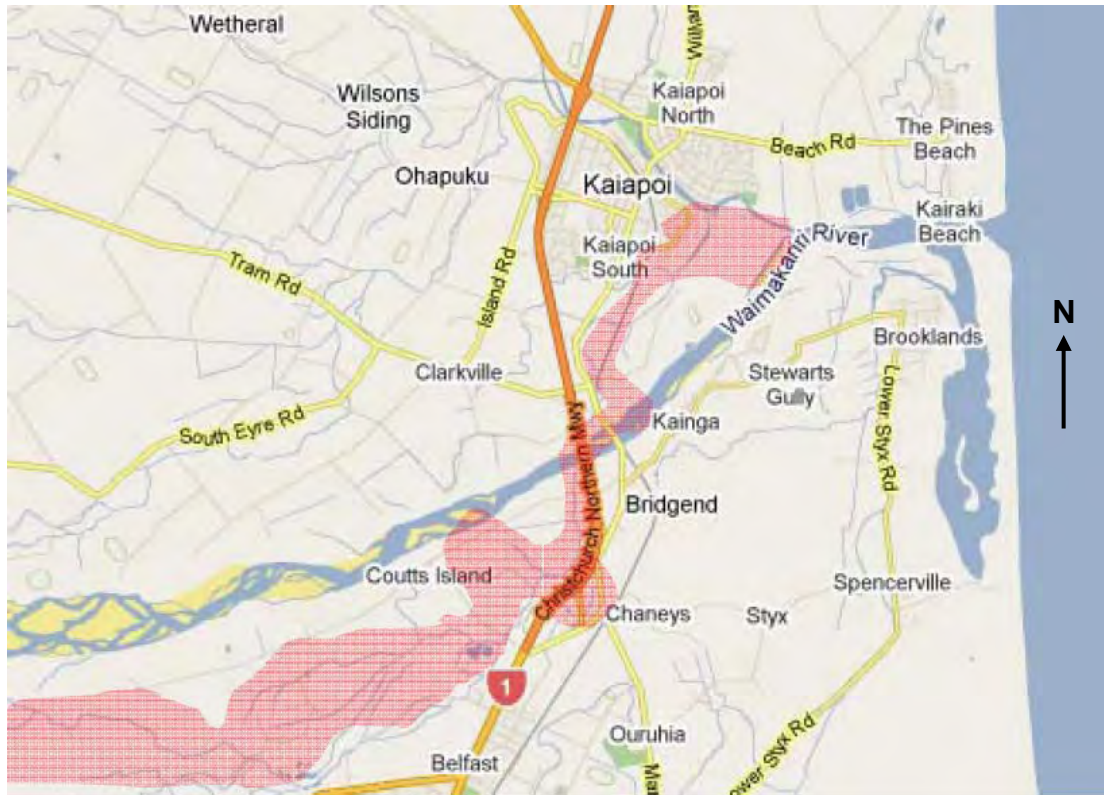
The 1865 position of the south branch of the Waimakariri River is superimposed onto the present day map of the region in Figure 2.9. The old channel covers a large area on the eastern side of South Kaiapoi, coming from the south along the present-day railway line. South of the present-day Waimakariri River, the old channel covers a large part of the Coutts Island area on both sides of State Highway 1, extending west across farms and golf courses on the landside of the present day levees. The implications of the location of the old river channel on the observed liquefaction

and lateral spreading that occurred during Darfield Earthquake are discussed in subsequent chapters.

Figure 2.9 Present day Kaiapoi with position of 1865 river channel highlighted in red. The distance from the left to right edges of the map shown is ~13 km. (Google Inc. 2010)

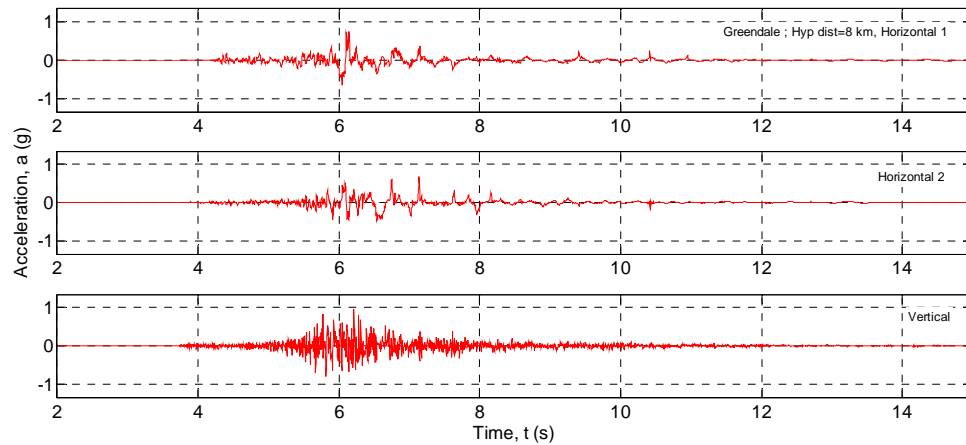
The Greendale seismograph was located almost directly over the fault plane and recorded the strongest ground motion from the mainshock. It can be seen from the horizontal components of the ground motion that cyclic mobility in surficial soil layers may have occurred during the strong ground shaking. The occurrence of cyclic mobility is indicated by the high frequency spikes in the later half of the strong motion record. The spectral accelerations for this set of ground motion records are in line with empirical predictions.

Figure 3.10 Motions recorded by the Greendale seismograph: (a) Acceleration time-histories; and (b) response spectra (Note that "Horiz gm" is the geometric mean of the two horizontal components of motion.).

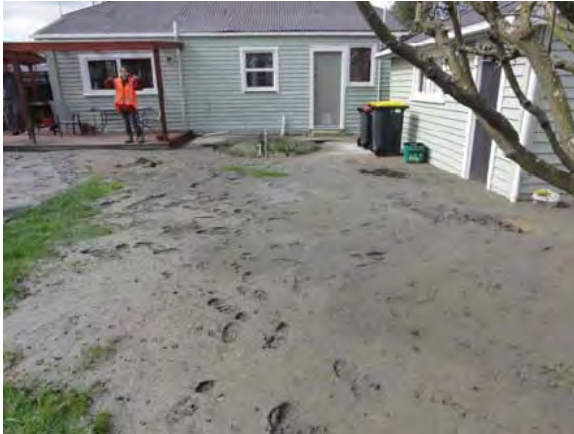
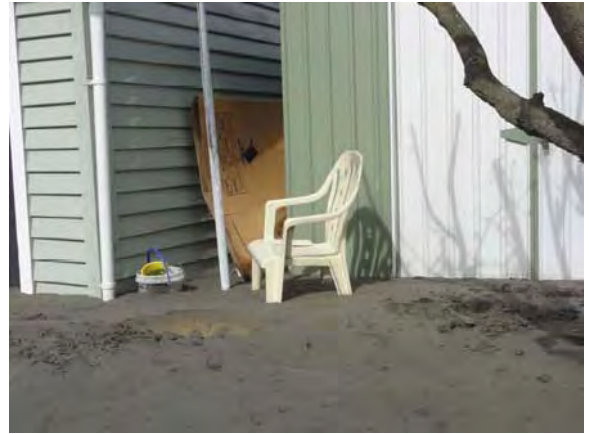
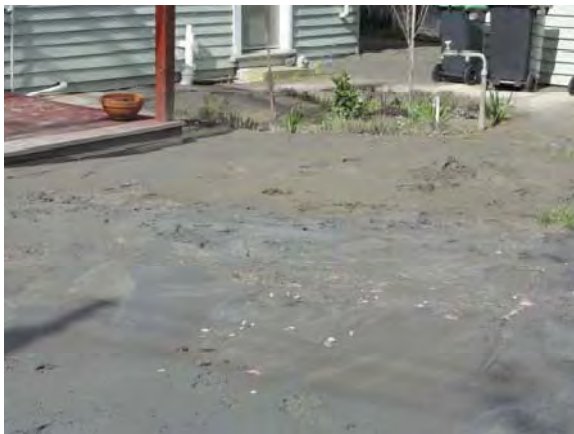
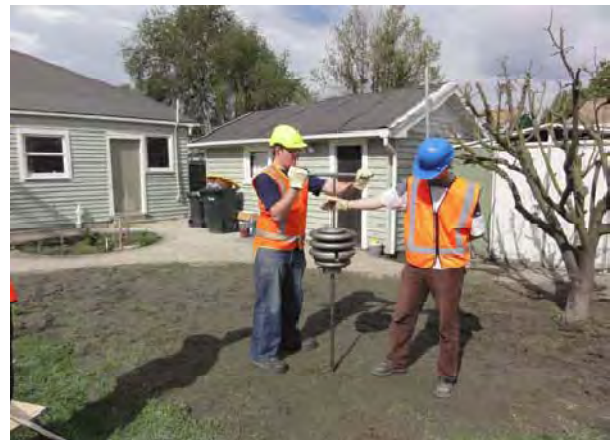
Typical manifestation of liquefaction in the backyard of a residential property is shown in Figure 4.4 (Bracken St, Avonside). Sand boil ejecta covered most of the lawn and was about 20-cm thick in places. There was evidence of massive liquefaction and large surface distortion on Bracken St. The potable water and sewer systems were out of service at the time of the

inspections. Despite significant amounts of liquefaction ejecta and broken utilities throughout the neighbourhood, the house shown in the pictures suffered minor damage in terms of differential settlement and cracking.

Figure 4.4 Evidence of extensive liquefaction in residential areas of Avonside: (a) Massive sand boils in residential area of Avonside (Bracken St); and (b) The sand boil (grey non-plastic silty sand) in the bottom half of the photo to the left was typical of many locations across Christchurch and Kaiapoi where massive liquefaction was observed; at this location, a brown silty sand was also found on the ground surface (upper half of the sand boil); photo to the right: University of Canterbury postgraduate students perform Swedish Weight Sounding (SWS) test (Bracken St: -43.520833° , 172.663750°).

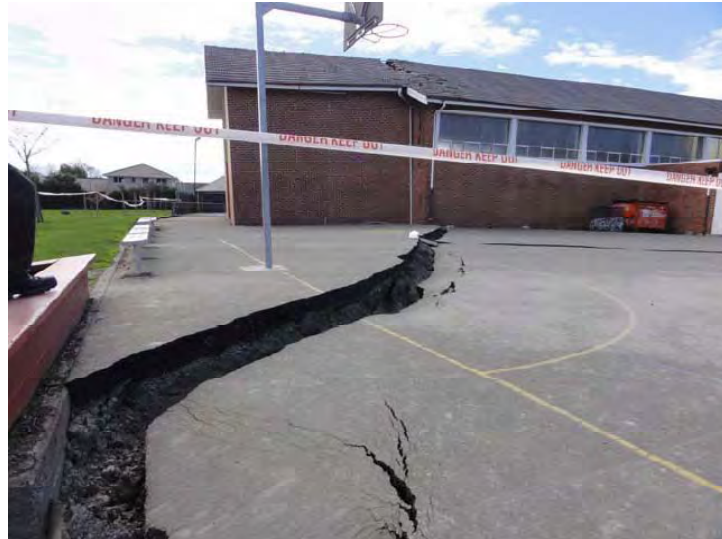
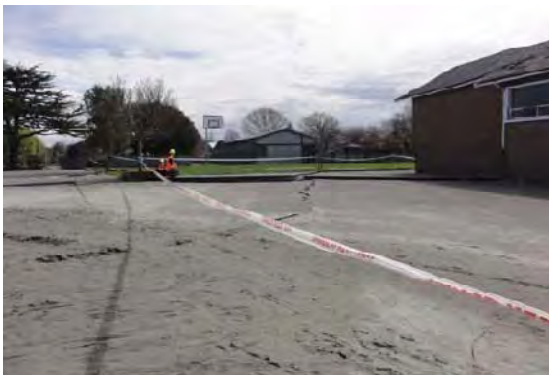
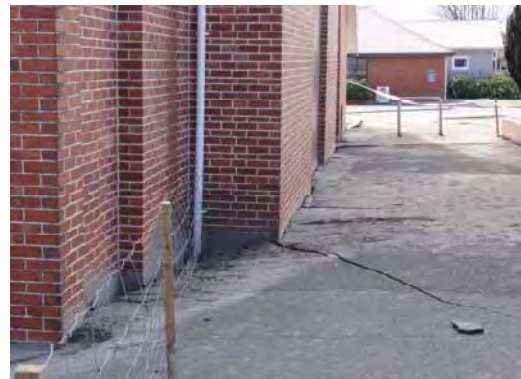
The geotechnical reconnaissance team performed a detailed survey at St Paul's Church (Gayhurst Rd, Dallington), which suffered damage due to liquefaction in the foundation soils (Chapter 5). Figure 4.5 shows a complex pattern of ground distortion including large cracks and vertical offsets around the building. Extensive sand boils covered the paved area around the building, backyard lawn, and around the perimeter of the building and its foundations. The building suffered large differential settlements and severe structural damage.

Figure 4.5 Liquefaction-induced bearing failure at St Paul's Church, Gayhurst Rd, Dallington: (a) Bearing failure in liquefied soils; the crack is 50-90-cm wide with a vertical offset of 33 cm, at its maximum; and (b) Evidence of liquefaction in foundation soils resulting in large total and differential settlements. $(-43.519670^\circ, 172.672240^\circ)$.

Specifically, the northwest side of the building was ripped in half due to a combination of differential settlement and lateral movement. This site is centrally located in a meandering loop of the Avon River and bounded by the river on all sides at distances of about 150-250 m, except to the north/northeast. Lateral spreading was observed in this area, despite being located more than 150 m from the free-face of the river. (Note, however, that this distance is not necessarily anomalous. Evidence of lateral spreading has been found at distances of up to 2 km from a free-face in the New Madrid, Missouri, USA, area (Obermeier, S.F., per. comm.). These features manifested during the 1811-1812 earthquakes that occurred in that region.) The tension cracks and fissures around the building were much bigger than those near the river channel, and hence it is possible that they are not only the result of lateral spreading. Further investigations are required to clarify these details.

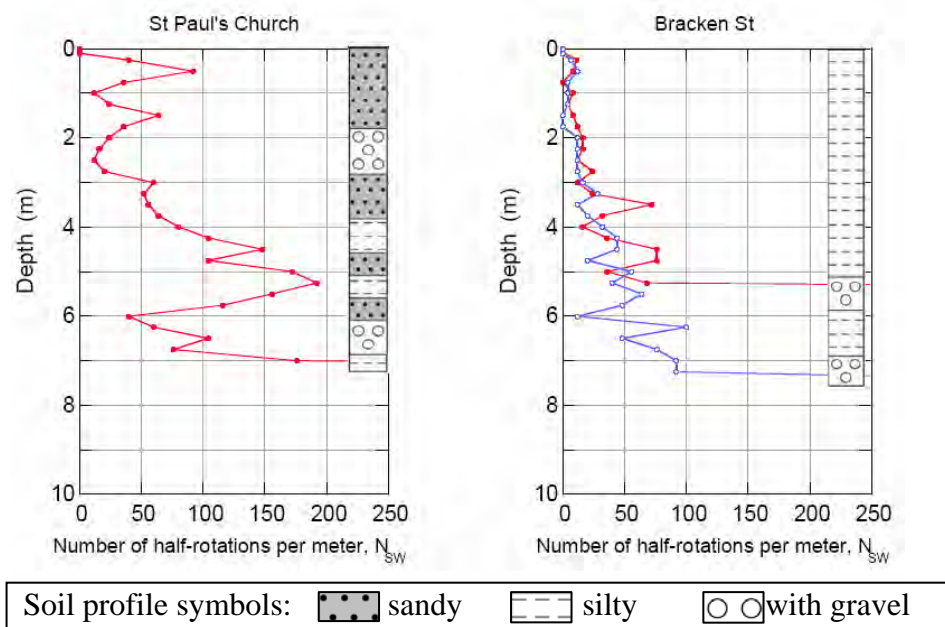
Figure 4.6 Post-event penetration resistance in Dallington (St Paul's Church/School) and Avonside (Bracken St) measured in SWS tests.

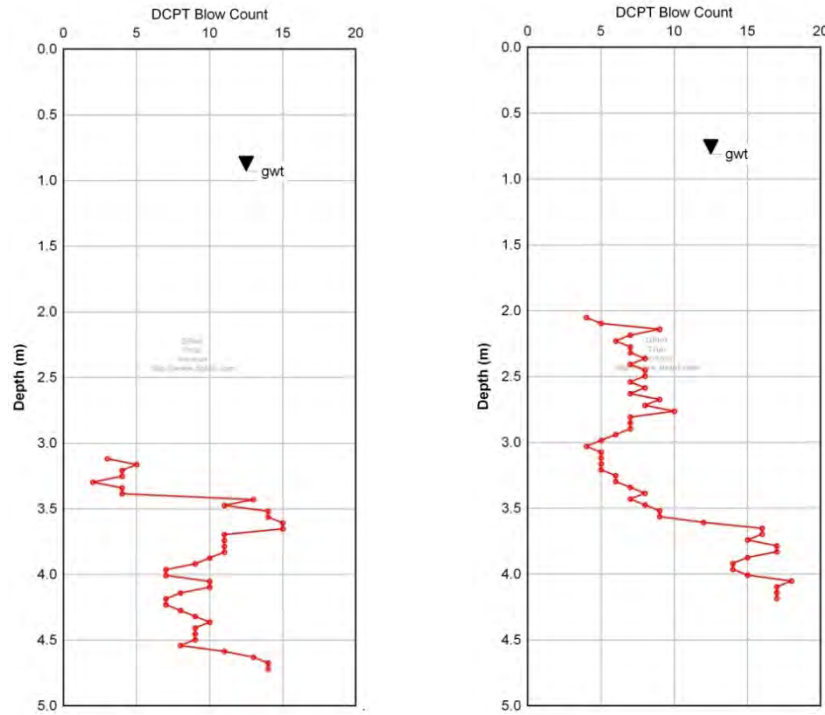
The ground water table at both sounding locations at the Bracken Dr residence was at ~0.8m, and the top of the liquefiable layer was at a depth of ~2.1 to 2.4 m. The strata overlying the liquefiable layer were clayey. For one of the tests, the DCPT rods sank under their own weight 20+ cm, indicating very loose sand. Because no samples are recovered with the DCPT, the thickness of the liquefied sand layer cannot be determined for certain. However, from looking at the results shown in Figure 4.7, the penetration resistance sharply increases at a depth of ~3.5 m. Additionally, there is a very wet, very soft, thin (~10 to 15 cm) clay/plastic silt layer that overlies the liquefied layer. It is unknown whether this is a very sensitive material that softened as a result of earthquake shaking and/or sampling or whether it is a result of a water film that formed between the liquefied layer and the overlying clay layer.

Figure 4.7. Results of DCPT performed at a residence on Bracken St, Avonside.

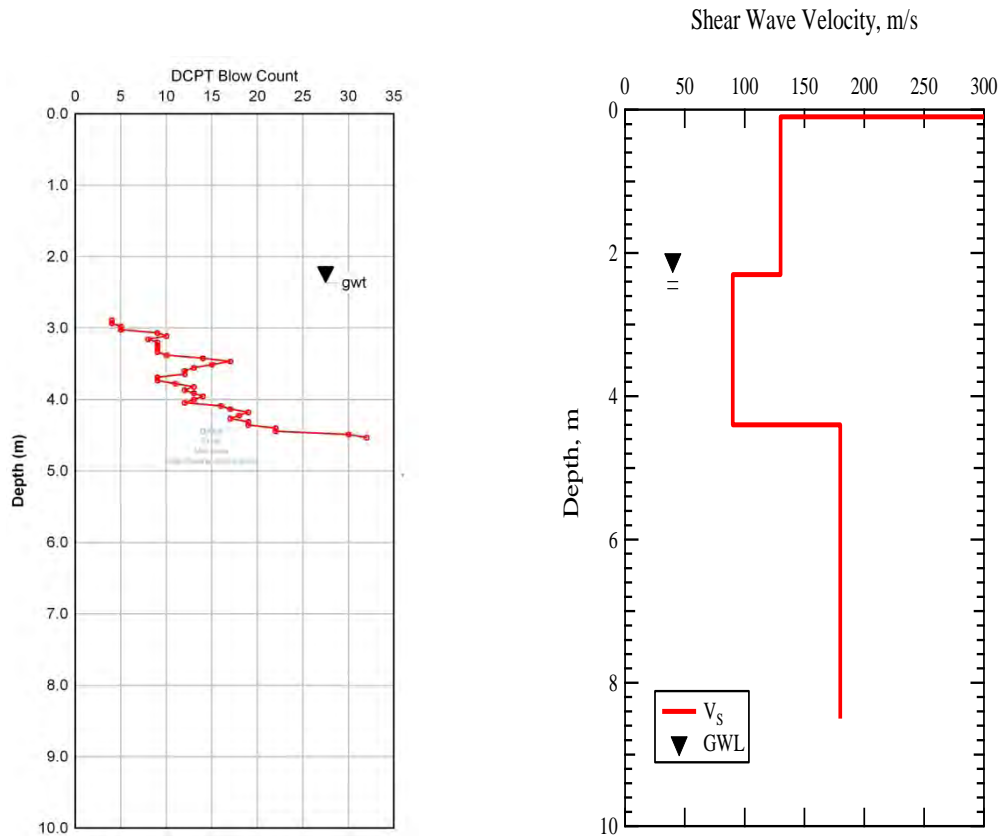
A DCPT and SASW test were also performed at St Paul's Church. The results of these tests are shown in Figure 4.8. Based on the bore hole augered for the DCPT test, the water table was at a depth of about 2.3 m and the top of the liquefied layer was at a depth of about 2.8 m. The SASW test was performed approximately 20 m away from the DCPT location.

Figure 4.8. Results of DCPT and SASW tests performed at St Paul's Church in Dallington.

The V_s profiles must be corrected for overburden pressure (V_{s1}) prior to evaluating soil liquefaction triggering. Generally speaking, even without this correction any soil layers with V_s less than 150 m/s are quite soft and may be potentially liquefiable. However, it will be noted that V_s measurements alone cannot definitively determine liquefaction susceptibility, as the type of soil (i.e. clay or sand), not just its stiffness/velocity, is a key factor. The V_s profile shown in Figure 4.8 indicates soft soils down to 8 m depth, with the softest soils between approximately 2-4 m.

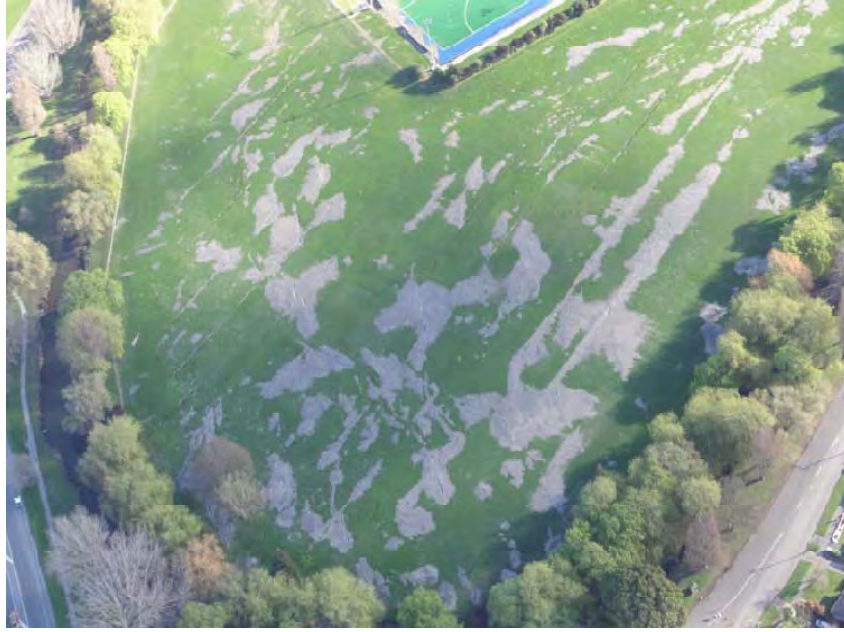
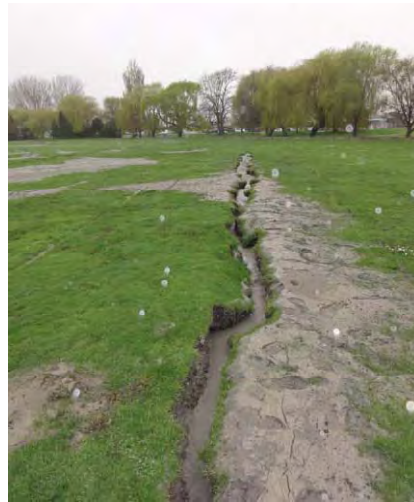
Further to the east of Dallington, extensive liquefaction, including substantial lateral spreading, was observed in Porritt Park (Wainoni), which is enclosed by the Avon River and a diverted stream around the park. Large sand boils covered substantial areas of the park (Figure 4.9). Parallel cracks spaced regularly along drainage lines were indicative of slumping and spreading towards the north and south branches of the stream. Two hockey fields located in the park were severely damaged by the liquefaction, resulting in a very uneven, bumpy surface of the fields.

Figure 4.9 Massive sand boils and lateral spreading cracks at Porritt Park: (a) Aerial view showing massive sand boils with large number of parallel cracks along drainage lines (from a helicopter flyover on the afternoon of Friday, 10 September 2010); and (b) ~ 10 cm wide lateral spread crack. (-43.516278° , 172.689917°).

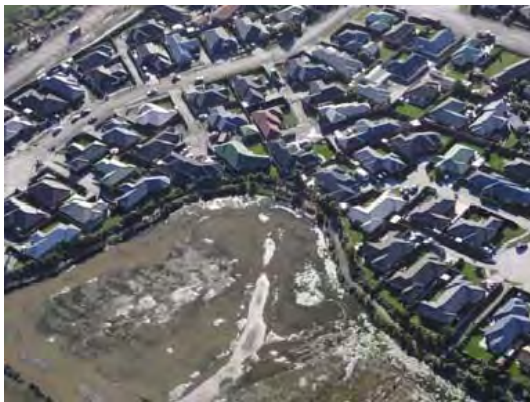
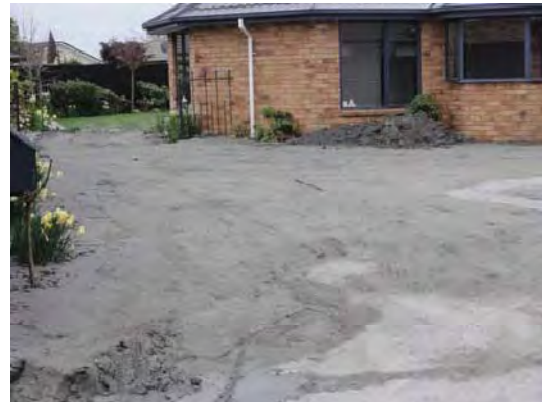
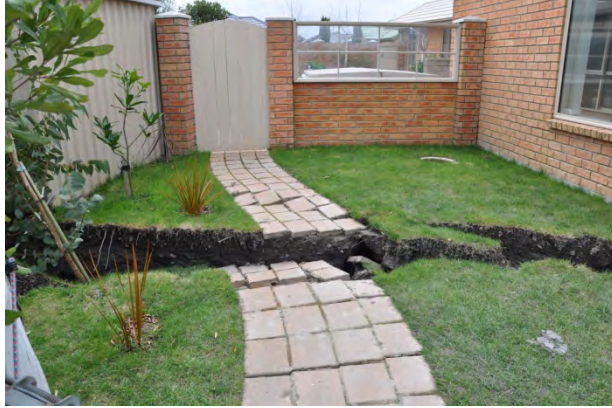
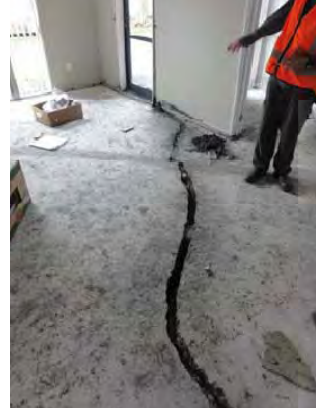
Widespread liquefaction occurred in Bexley, affecting a large number of residential houses (Figure 4.10). Ground distortion (i.e., differential settlement, large ground cracks, deformation of paved surfaces and substantial sand boils) was observed at Seabreeze St and Kokopu Ln. Residential properties along the southern edge of Bexley (along the wetland walkway) were severely affected by lateral spreading. Large movement of the walkway towards the water, slumping of the terrace fill and large ground cracks on residential properties were observed in this area. Similarly, severe manifestation of lateral spreading was observed at the east end of Bexley (Parenga Pl).

Figure 4.10 Evidence of extensive liquefaction severely affecting residential houses in Bexley: (a) Aerial view of the southern edge of Bexley which was severely affected by liquefaction and lateral spreading; (b) Evidence of liquefaction in residential area (Seabreeze St); (c) Large ground cracks due to lateral spreading at Kokopu Pl (-43.5184167°, 172.7221667°); (d) Cracks in unreinforced slab induced by lateral spreading (-43.5193889°, 172.6705555°).

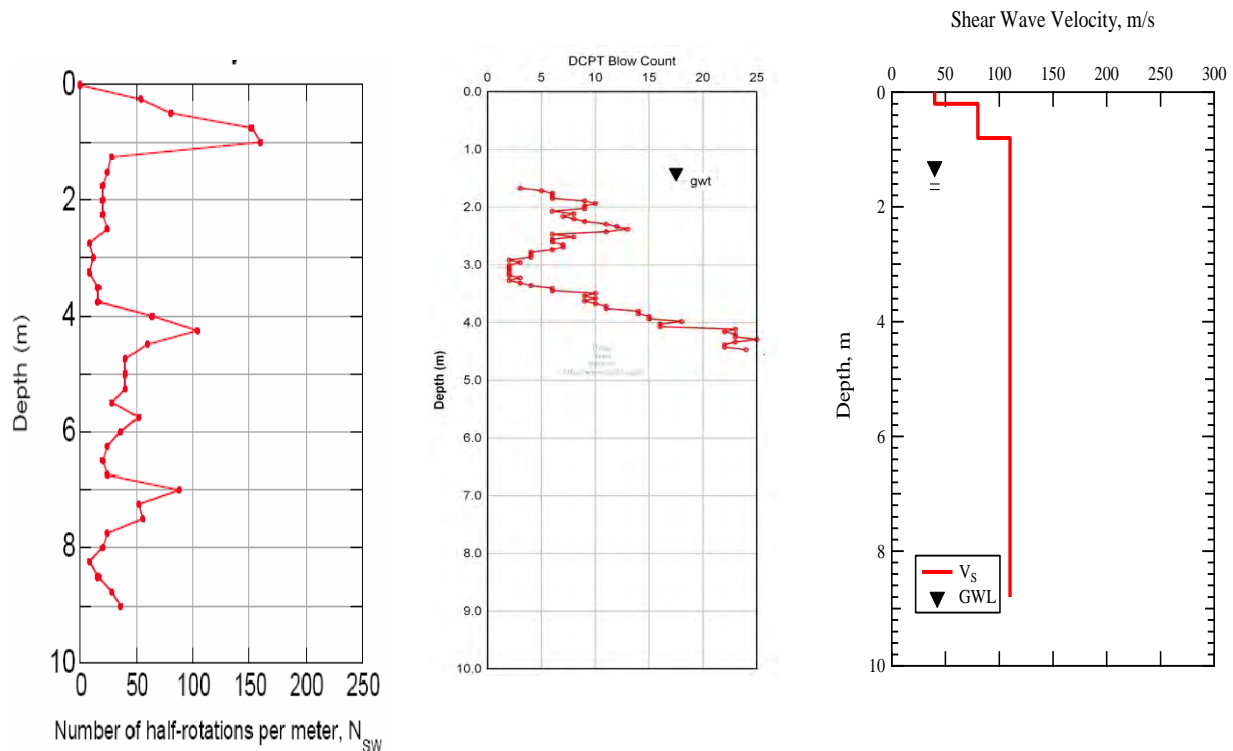
An SWS test, DCPT, and SASW test were performed in the backyard of a house in Bexley; the results are shown in Figure 4.11. Based on the bore hole augered for the DCPT test, the ground water table was at a depth of ~1.5 m and the top of the liquefied layer was at a depth of ~1.6 m. The SASW test was performed ~10 m away from the DCPT sounding.

Figure 4.11 Results of SWS test, DCPT, and SASW test performed in the backyard of a house in Bexley.

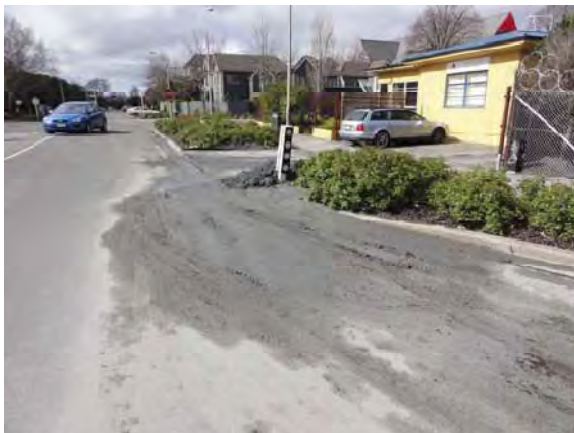
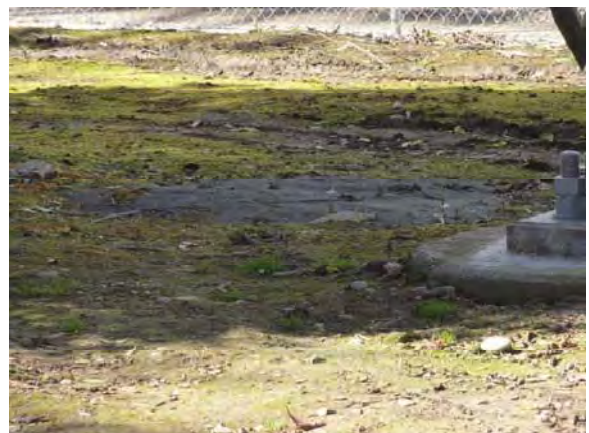
Figure 4.12 Evidence of limited/partial liquefaction in areas of Christchurch: (a) Evidence of liquefaction at Peterborough St - Madras St (CBD) ; (b) Sand boil in the foundation soils of a transmission tower (sub-station northeast of Greens Rd – Ruddenklau Ln, Bishopdale) (-43.4928055°, 172.5918055°).

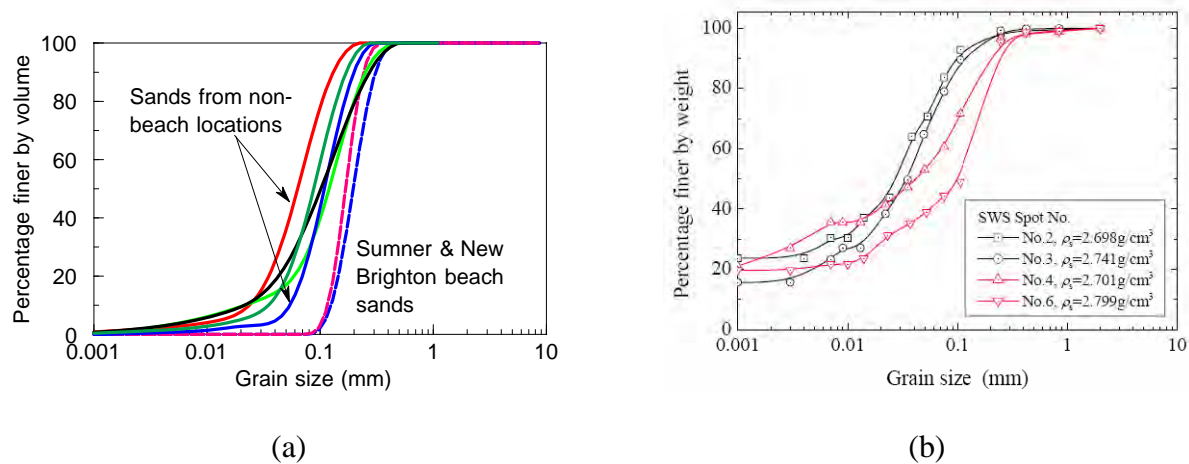
Grain-size distribution curves of ejecta samples taken from Dallington (Gayhurst Rd), Porritt Park and South Kaiapoi (Courtenay Dr) are shown in Figure 4.13a. Figure 4.13b shows grain size distribution of soil samples taken from the SWS screw point (representative of the deepest layer penetrated in a SWS test), which shows significantly higher fines content.

Figure 4.13 Grain-size distribution curves of Christchurch and Kaiapoi soils: (a) Grain size distribution curves of sand boil samples obtained by laser diffraction analysis; and (b) Grain size distribution curves of soil samples taken from the SWS screw point (deepest tested layer) obtained by sieve and hydrometer analyses: Dallington (No. 2 and 3) and Bexley (No. 4 and 6).

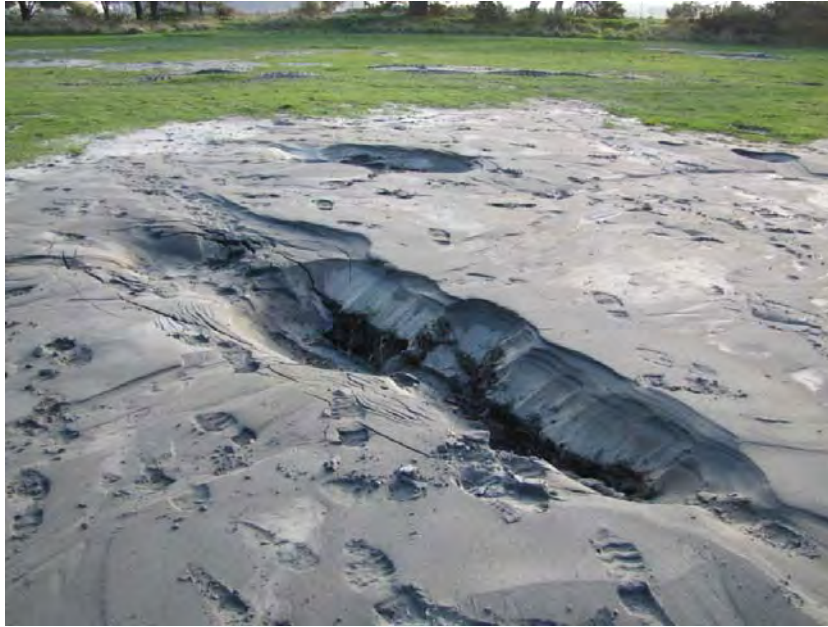
Figure 4.14 shows the large sandboil at Featherstone Reserve at Pines Beach, from which a bulk sample of the sand was recovered. Figures 4.15-4.18 give electron micrographs of various fractions of the sand in relation to sieve size. The micrographs are all at the same magnification, 100 times, and show that the particles tend to be angular to subrounded in shape. As the particle size decreases the angularity of the particles increases.

Figure 4.14 Sandboil in the Featherstone Reserve Pines Beach from which sand was taken for electron microscope pictures. (Approximate position: -43.381111° , 172.703611°)

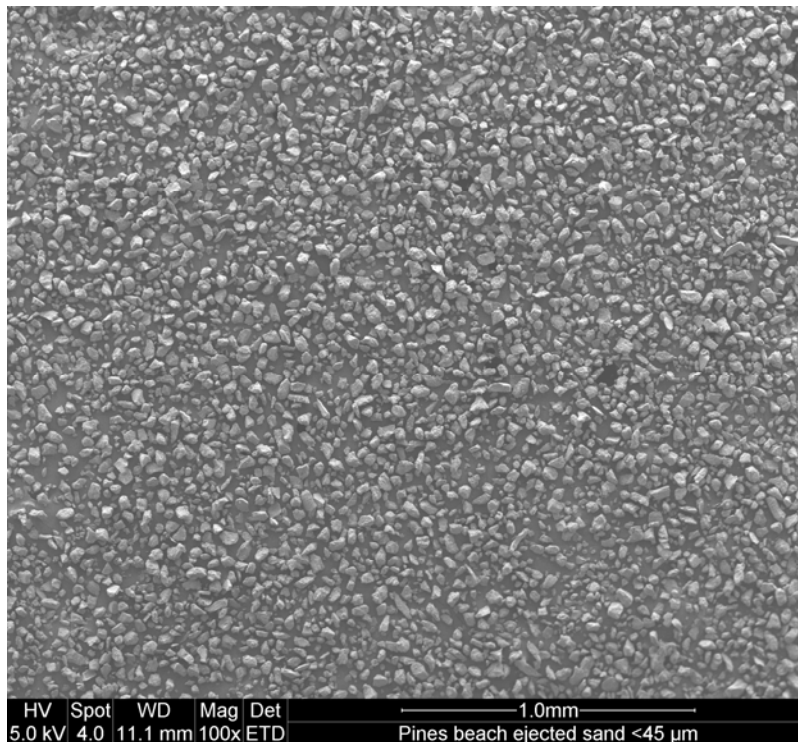
Figure 4.15 Sand particles passing the 0.045 mm sieve (No. 325).

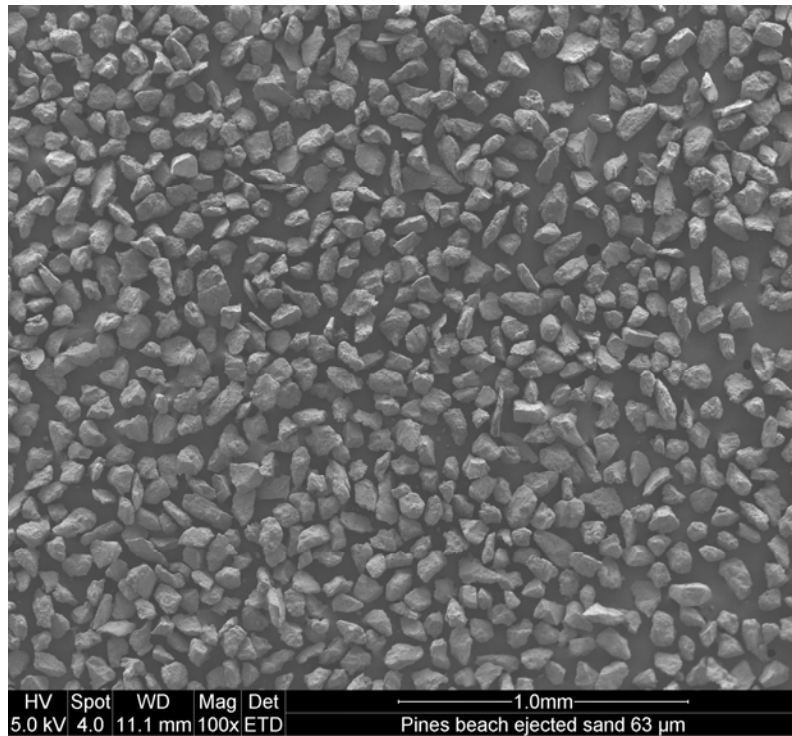
Figure 4.16 Sand particles retained on the 0.063 mm sieve (No. 230).

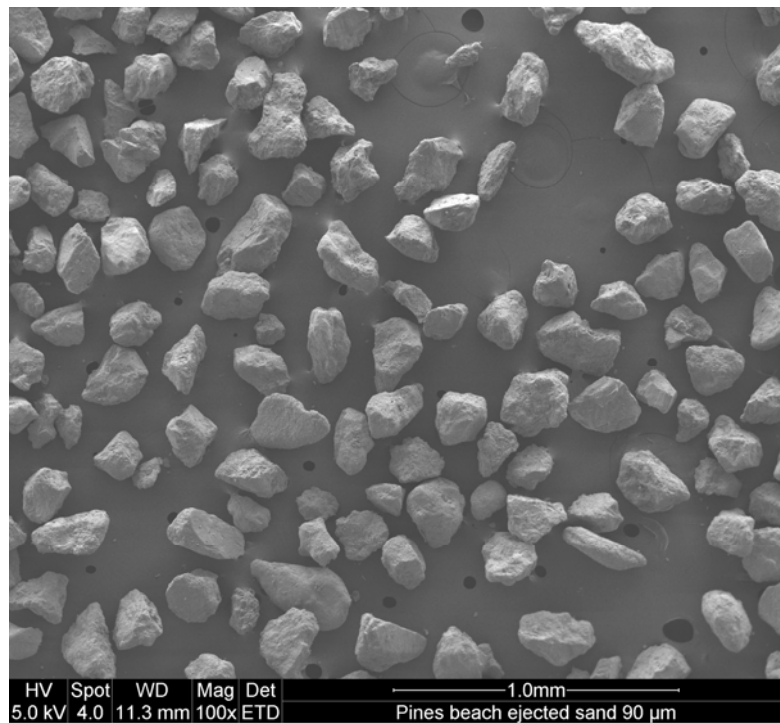
Figure 4.17 Sand particles retained on the 0.090 mm sieve (No. 170).

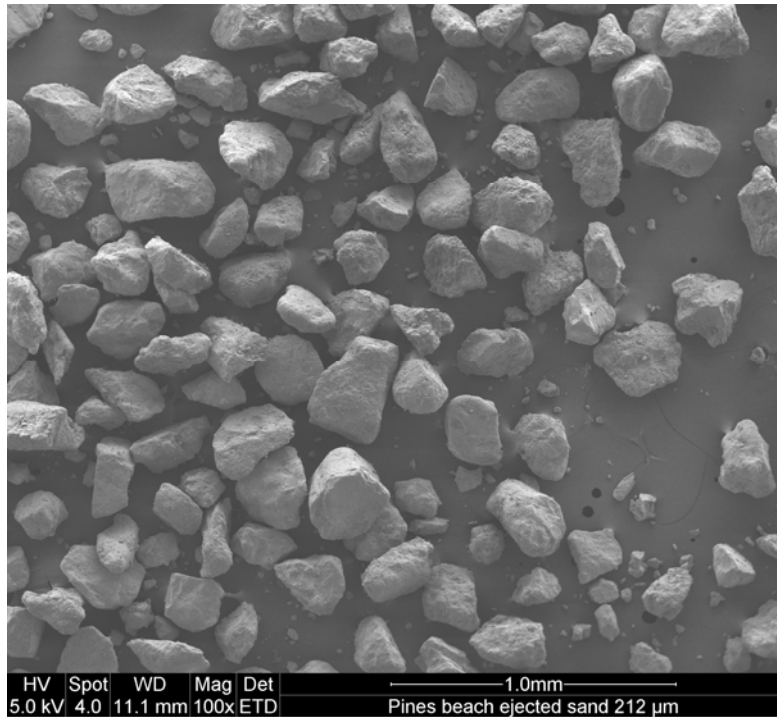
Figure 4.18 Sand particles retained on the 0.212 mm sieve (No. 70).

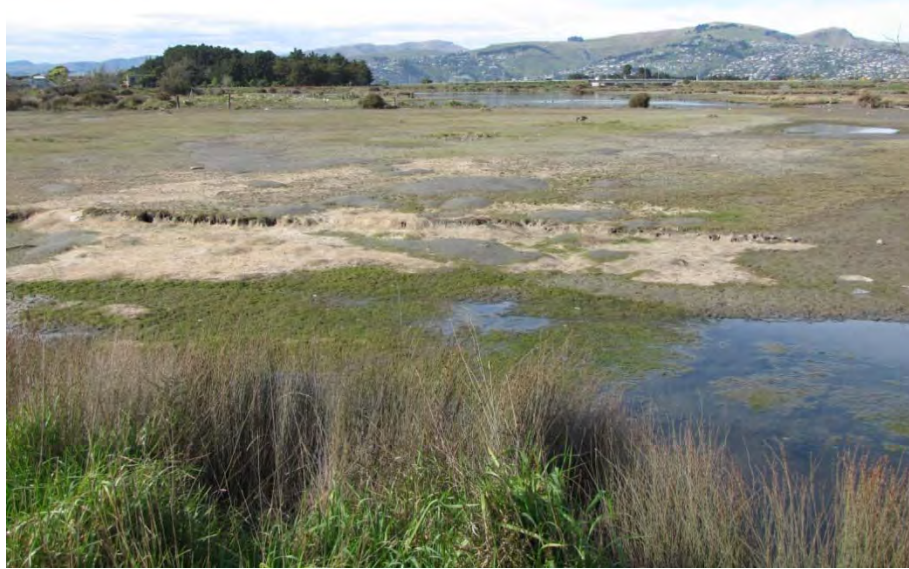
Residents of the Bexley area commented on the effect of the earthquake on the Bexley Wetlands. Figure 4.19 shows a view from walking path around the south of the subdivision. Many sand boils are seen in the bed of the wetland area (at high tide on 29 September) which was inundated at high tide prior to the earthquake.

Figure 4.19 View of the Bexley Wetland at near high tide on Wednesday 29 September 2010. Prior to the earthquake this area was inundated at high tide.

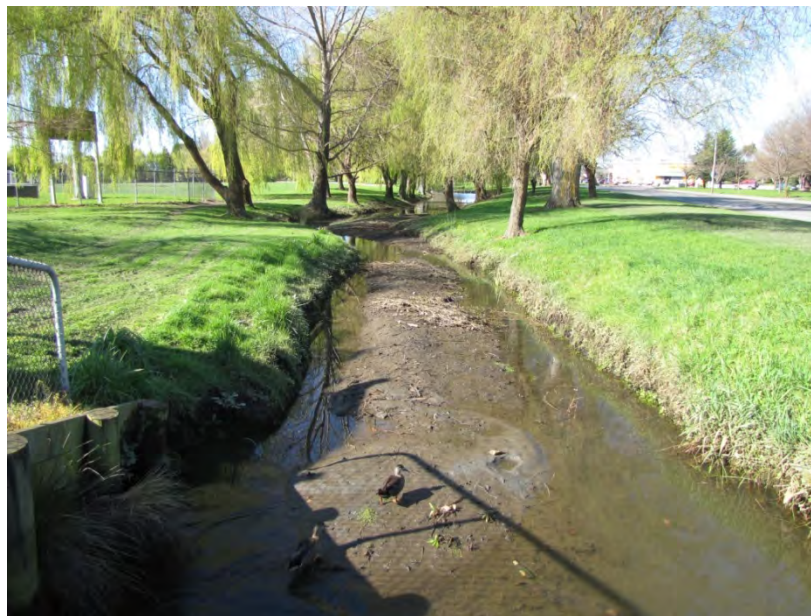
Stream beds were also noticed to be heaved (Figure 4.20). A local resident confirmed that this was not how the stream bed appeared prior to the earthquake. In some places it was necessary to clear the stream bed soon after the earthquake.

Figure 4.20 Photograph of the stream near Porritt Park on Wednesday, 15 September 2010. There is lateral spreading towards this stream from both sides. It is just possible to make out a sand boil in the midst of the stream bed debris to the right of the duck. Several other sand boils were visible along the stretch of heaved stream bed.

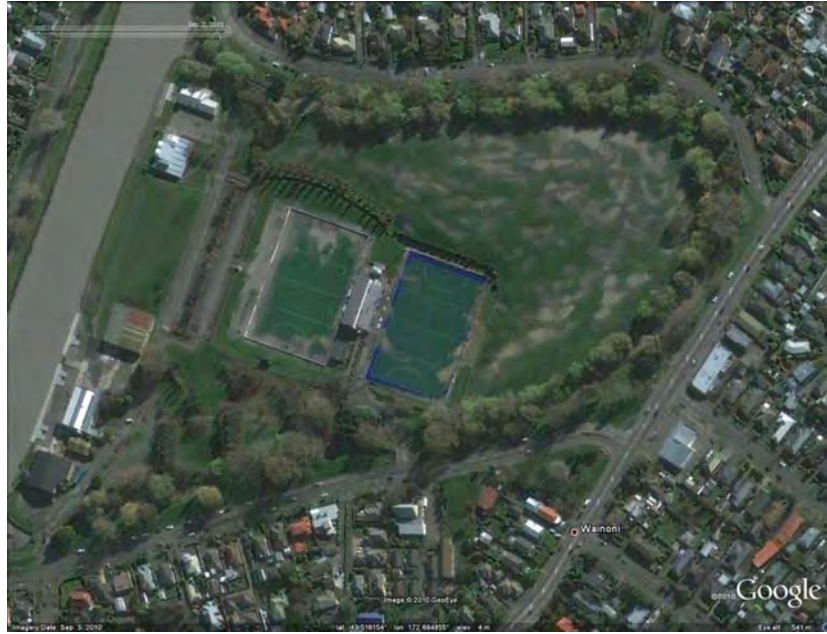
A few hours after the earthquake, a GeoEye image of part of the area affected by the earthquake was captured. Since Saturday 4 September 2010 was a clear day, this image provided good evidence of liquefaction in some parts of the city. Figure 4.21 shows part of the GeoEye image covering Porritt Park. Figure 4.9a shows a picture of Porritt Park taken from a helicopter on the afternoon of Friday, 10 September 2010.

Figure 4.21 Image of Porritt Park extracted from the GeoEye image taken a few hours after the earthquake. From the left to the right edge of the image is ~0.62 km (Google Inc., 2010).
 (-43.516154°, 172.684855°)

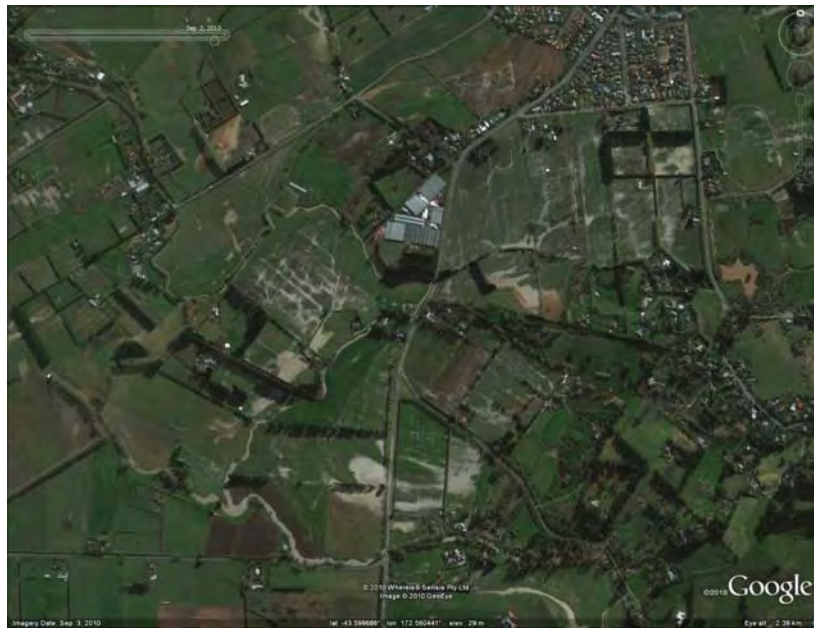
In conclusion, comparison of the GeoEye image with on-ground reconnaissance confirms that, provided there is enough color contrast between the ejecta and the surrounding ground, the satellite image can be used to identify liquefaction. However, when large volumes of water are ejected with the sand there may be a false indication of the amount of ejecta present.

Figure 4.22 Part of Halswell as imaged by GeoEye after the earthquake. The ejected sand is accompanied by considerable volumes of water forming mini-lakes having a similar color to the ejected sand. From the left to the right edge of the image is ~2.74 km (Google Inc., 2010).
 (-43.598349°, 172.566383°)

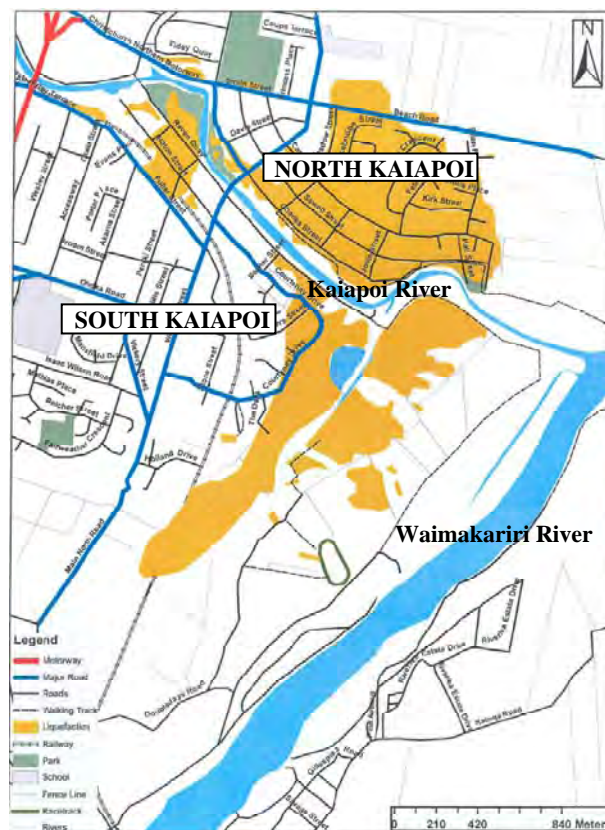
Figure 4.24 Areas of observed liquefaction in the town of Kaiapoi due to the 2010 Darfield earthquake (the liquefaction map is based on surface manifestation of liquefaction visible on aerial photographs and compiled evidence from ground surveys).

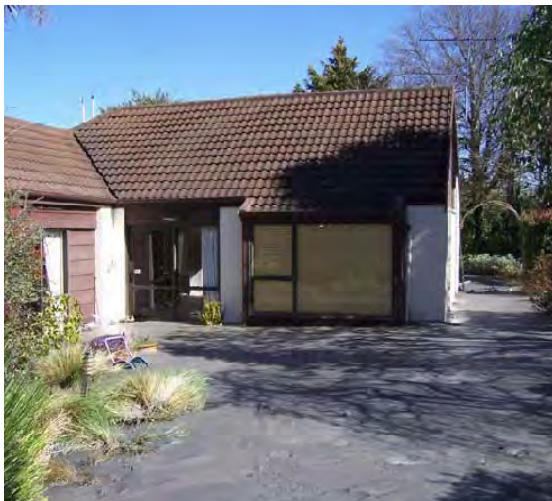
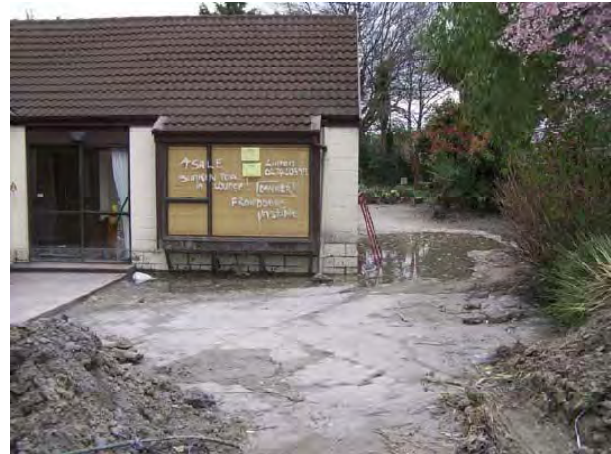
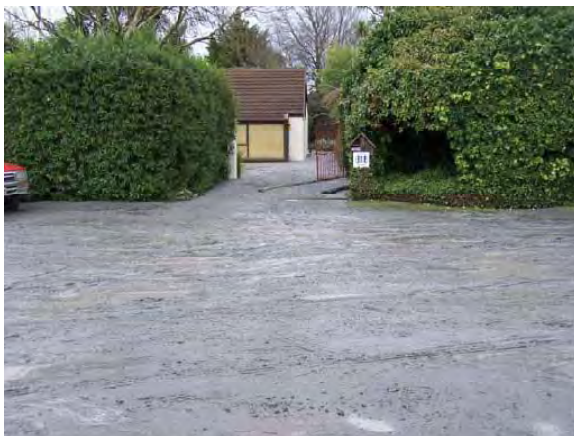
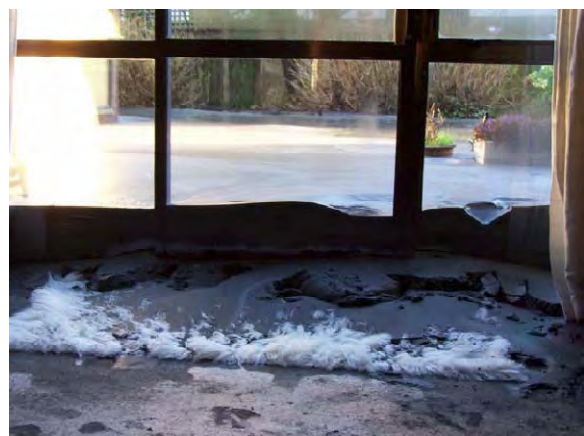
The liquefaction was particularly intense, producing massive sand boils of grey, silty sand, at Cassia Place and at the east end of Charles and Sewell Streets. In the worst hit area, the silty sand ejecta was about 400-mm thick, as shown in Figure 4.25. Some residents reported geysers appearing in the backyard following the earthquake, often forming a small pond near the house that remained for several days after the event. An SWS test and DPTs were performed by the GEER-NZ Team in this area, with the SWS test indicating loose/soft soils up to depths of 8-9 m (Figure 4.26).

Figure 4.25 Manifestation of very severe liquefaction in residential area at Cass Pl, North Kaiapoi (-43.387944° , 172.670111°): (a) ~40 cm thick layer of silt-sand-water mixture covering a residential property affected by very severe liquefaction; (b) same-angle view, but after the clean up of sand boils; (c) View from the street (before clean up); and (d) liquefied silt-sand-water mixture covering the ground outside the house and a rug inside the house (seen through a window from inside the house).

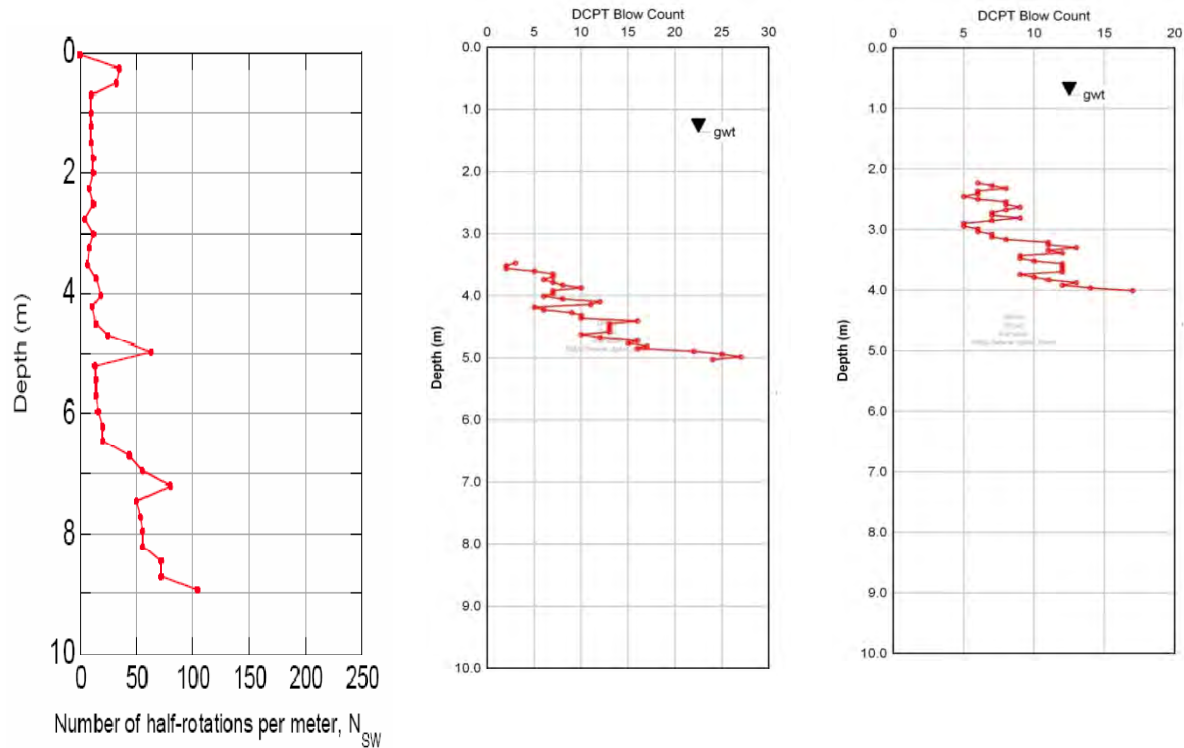
Figure 4.26 Results of SWS test and DCPTs performed in the backyard of a house at Cassia Pl.

As determined from the bore holes augered for the DCPTs, the depth to the ground water table and to the top of the liquefied layer differed between the two test locations at Cassia Pl although the test locations were only ~25 m apart. However, the surface elevation of the two test locations differed by about 0.5 m. As a result, the elevations of the ground water table are similar for the two test locations, with the depth to the top of the liquefied layer differing slightly. As with the site on Bracken St (Figure 4.4), a 10- to 15-cm thick, very wet, very soft clay/plastic silt layer overlies the liquefied layer.

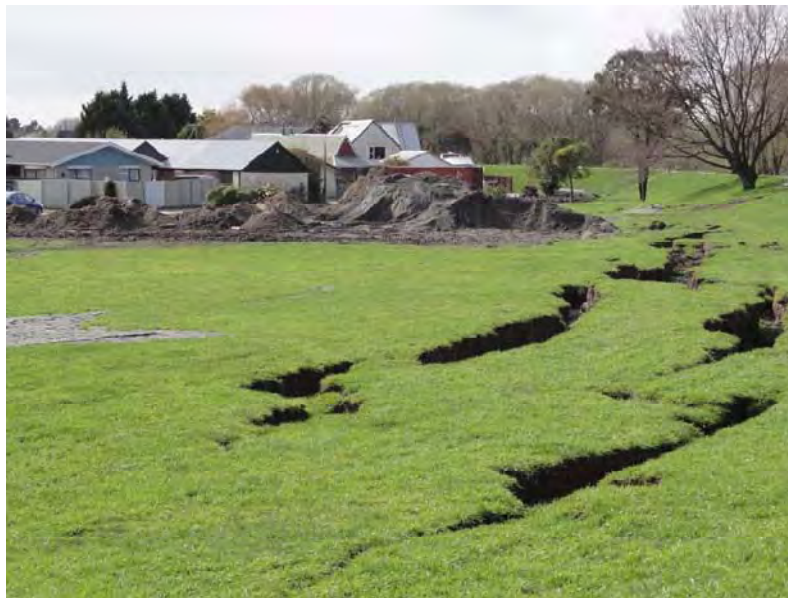
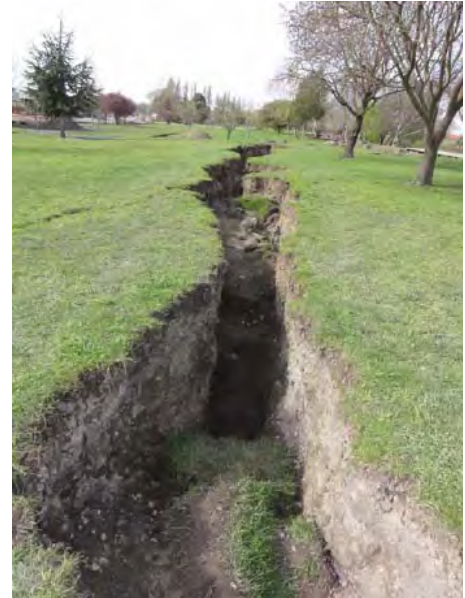
The area along the Pegasus Bay Walkway (from the Kaiapoi Visitor Information Center on the east to Askeaton Park on the west) was affected by significant lateral spreading with large cracks and fissures in the sloping ground towards Charles St (Figure 4.27). Residential houses in this area were affected both by liquefaction and lateral spreading (Figure 4.28). The reconnaissance team carried out detailed ground surveys of lateral spreading along several profiles at this

Figure 4.27 Evidence of liquefaction and lateral spreading along Charles St and the north levee of the Kaiapoi River (-43.384694°, 172.660944°). Note the huge piles of cleaned up sand obstructing the view of the houses in (a).

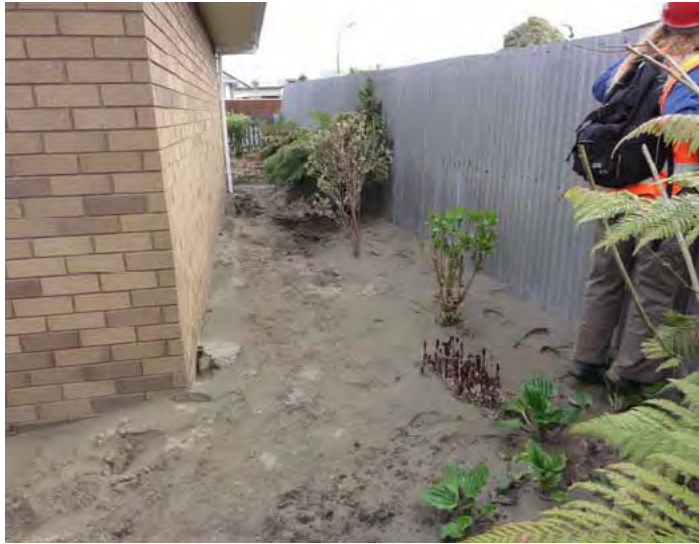
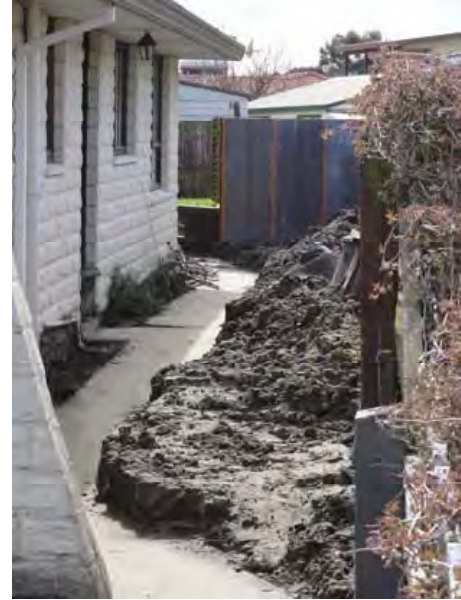
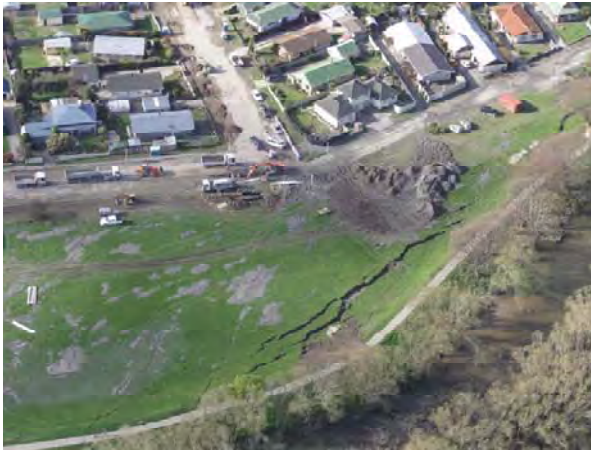
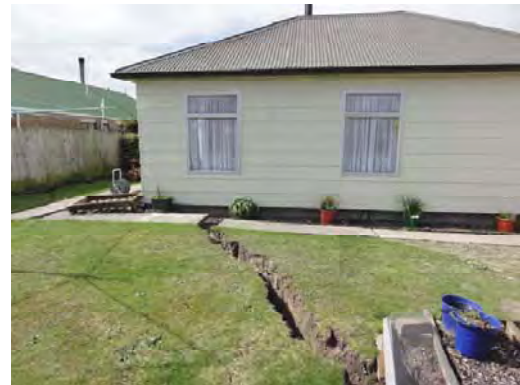
Figure 4.28 Liquefaction and lateral spreading in North Kaiapoi: (a) Evidence of extensive liquefaction at the east end of Charles St (-43.386805° , 172.667166°); and (b) lateral spreading resulting in a large ground distortion in foundation soils (Charles St) (-43.386666° , 172.666111°)
