GEOTECHNICAL RECONNAISSANCE OF THE 2010 DARFIELD (NEW ZEALAND) EARTHQUAKE

Version 1: 14 November 2010

EDITORS

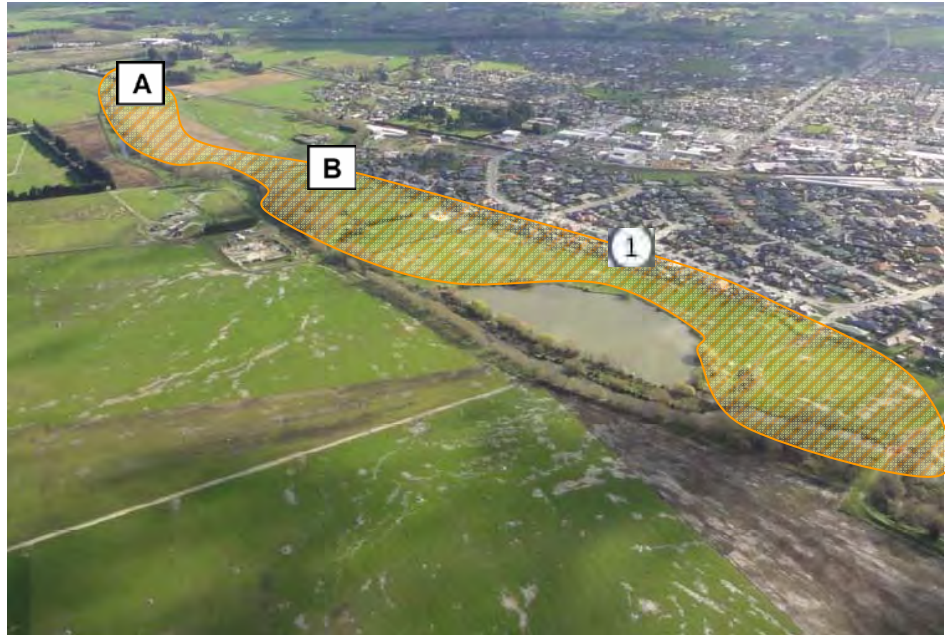
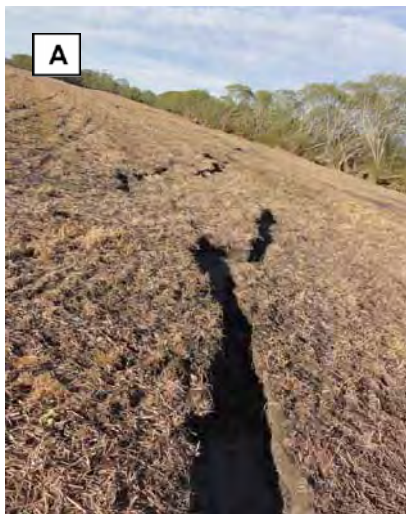
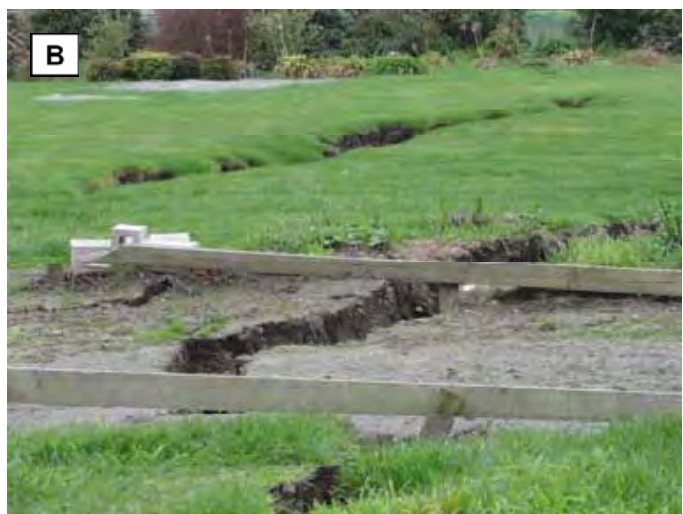
In South Kaiapoi, the most dominant ground failure feature was the liquefaction and massive lateral spreading that affected the eastern branch of Courtenay Drive. The area affected by lateral spreading, shown in Figure 4.29, was approximately 1-km long in the north-south direction and

Figure 4.29 Massive lateral spreading at South Kaiapoi: (a) Sand boils and area affected by lateral spreading around Courtenay Lake (from a helicopter flyover on Friday, 10 September 2010); and (b) Large lateral spread cracks in farm land (at B: -43.3941389° , 172.659750°).

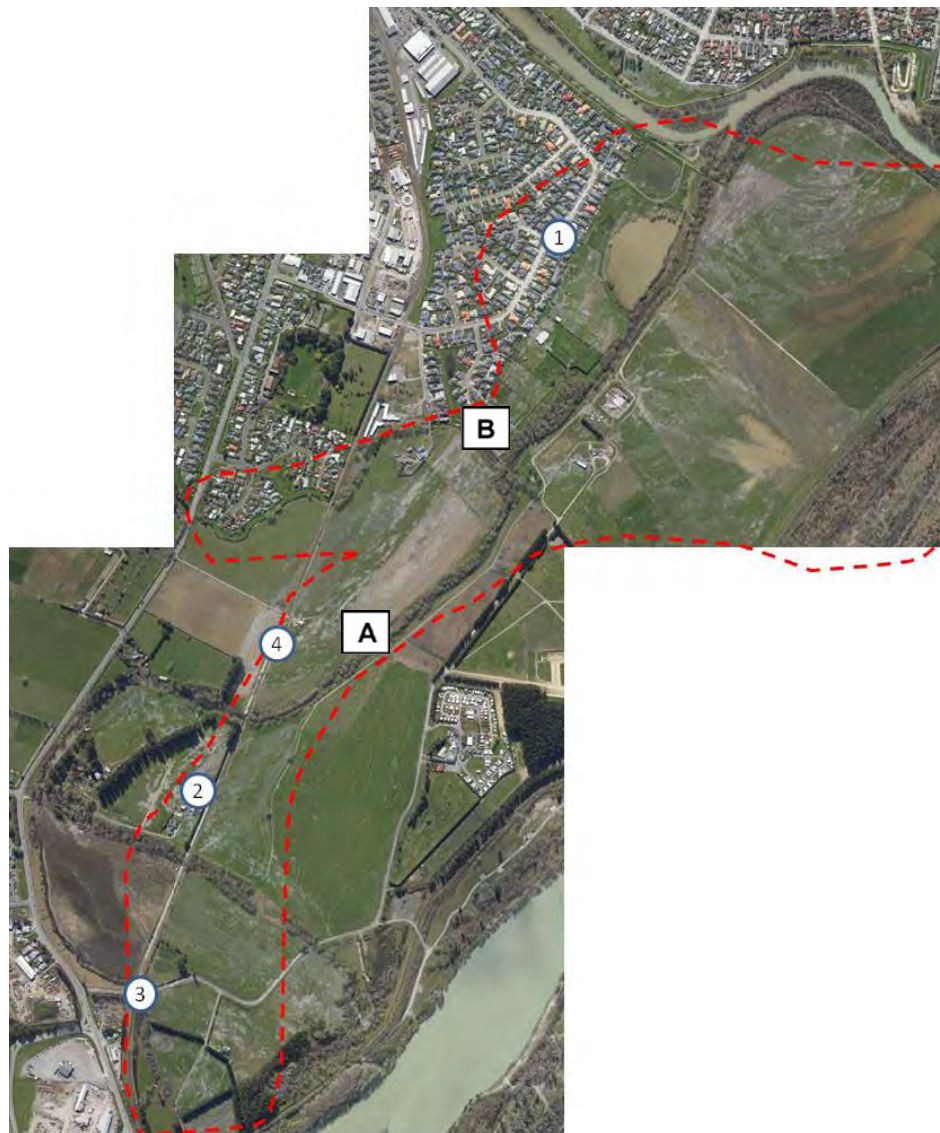
The eastern edge of Kaiapoi is shown in aerial photographs taken after the Darfield earthquake (Figure 4.30). The outline of the 1865 Waimakariri river channel (Figure 2.9) is shown by the dashed red line. On the eastern side of Kaiapoi, the old channel passes underneath the present day Courtenay Dr area shown as position 1, where severe damage to residential properties occurred due to lateral spreading (Figure 4.34). Further south at positions A and B (Figure 4.29), large cracks due to lateral spreading towards Courtenay Stream are evident. Along this stretch from position A to the north-east corner of Courtenay Dr (slightly north of position 1), detailed ground surveys were conducted along ten transects including measurement and mapping of width of cracks, vertical offsets, and geo-tagging of major cracks and other lateral spreading features. Figure 4.31 indicates geo-tagged major cracks and four transects of detailed measurements at position A.

Figure 4.30 Aerial view of the lateral spreading area at South Kaiapoi.

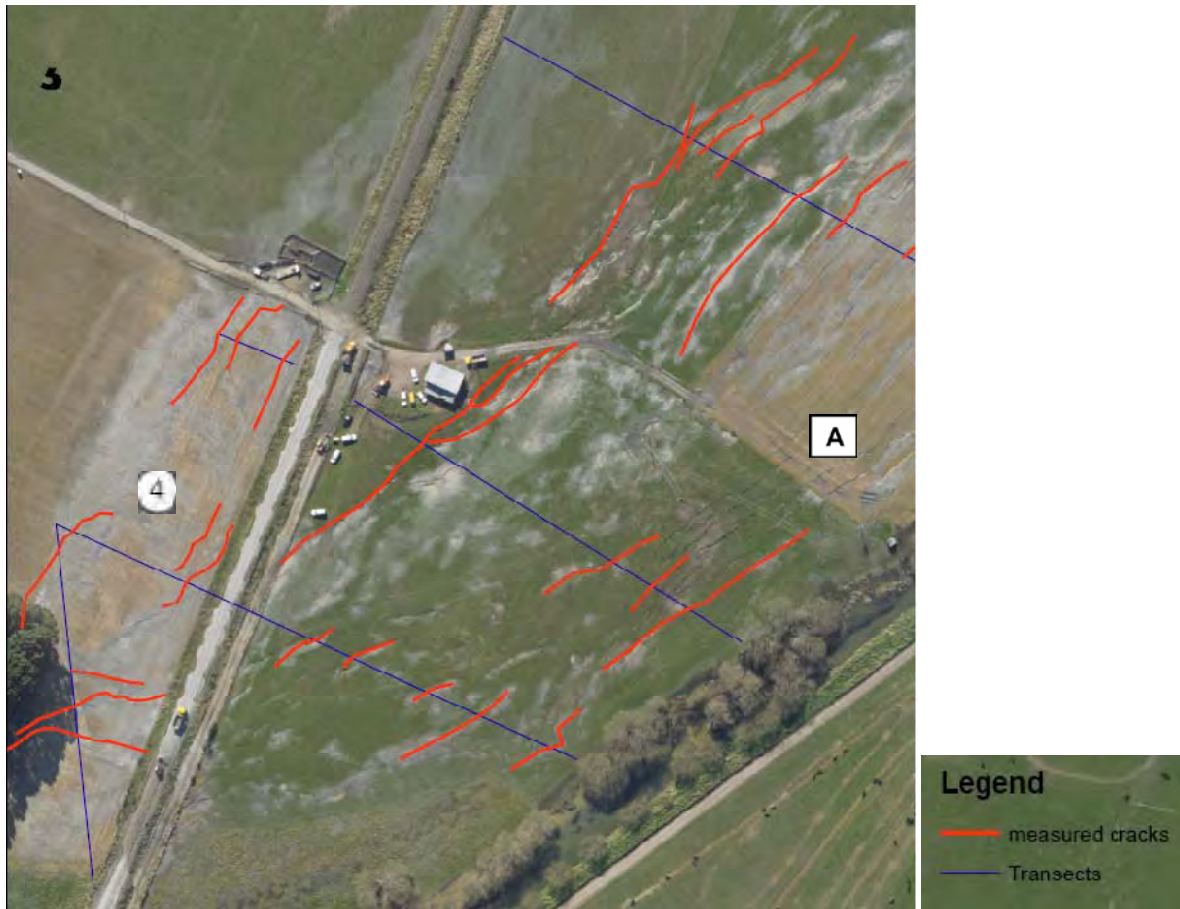
Figure 4.31 Aerial view of the lateral spreading area at position A at South Kaiapoi showing four transects of detailed ground surveys.

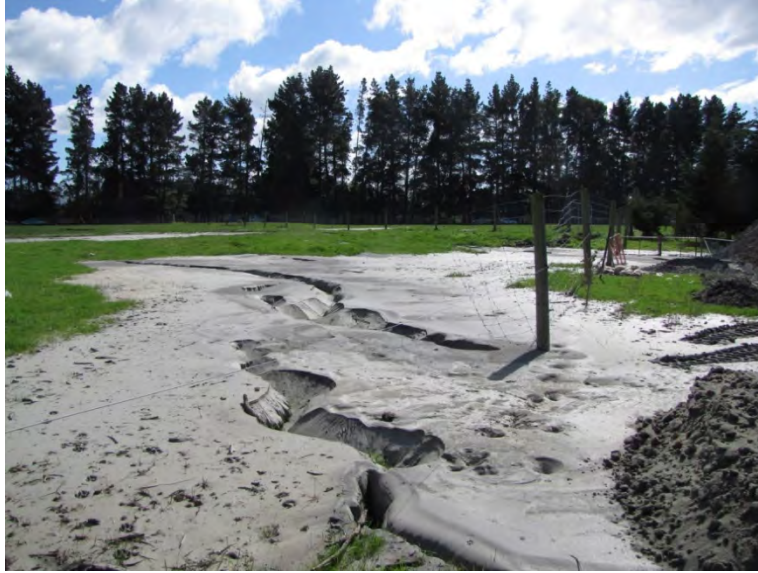
Further south near the train tracks at position 2 (Figure 4.30), large sand boils formed (Figure 4.32). At position 3 (Figure 4.33), liquefaction resulted in damage to the train tracks. The photo in Figure 4.33 was taken from a position on Doubleday's Rd in a NNE direction along the tracks, indicating ground deformation and track movement. Moving north along the train tracks to positions 4 and A (Figure 4.30), Figure 4.31 provides a more detailed aerial view of liquefaction and lateral spreading crossing the tracks just south of Kaiapoi. Using the vehicles in the photo for scale gives a good indication of the significant size of these cracks and the volume of ejecta.

Figure 4.32 Sand boils in fields. (Position 2; -43.4026°, 172.6503°)

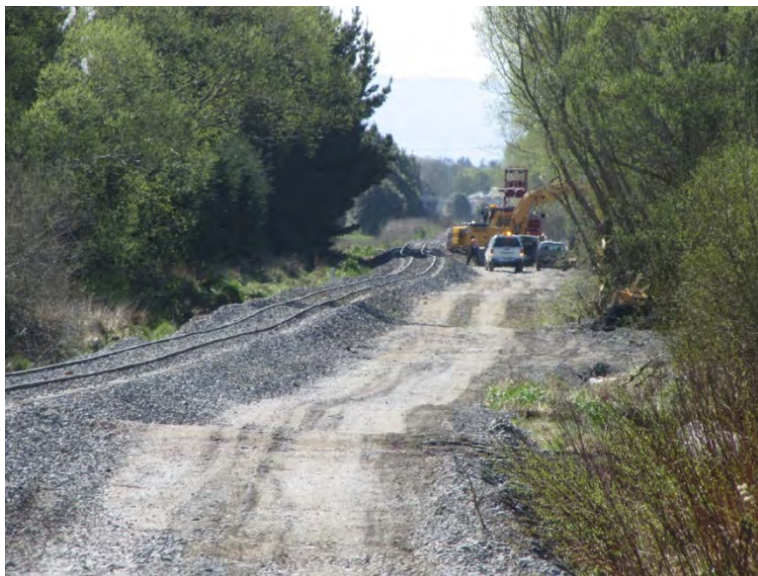
Figure 4.33 Damage to train tracks due to ground movement. (Position 3; -43.4068°, 172.6489°)

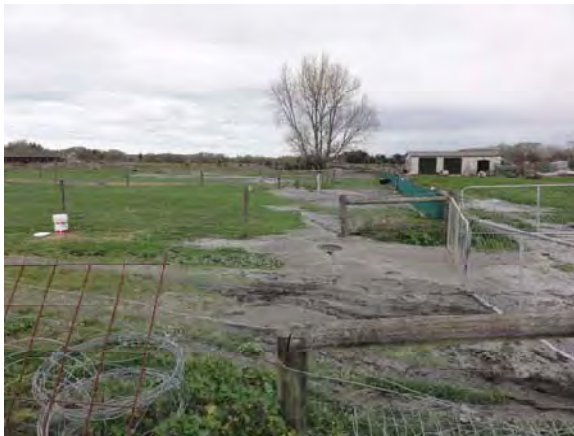
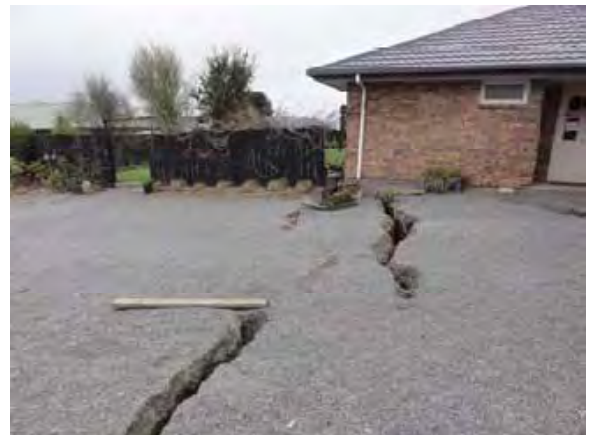
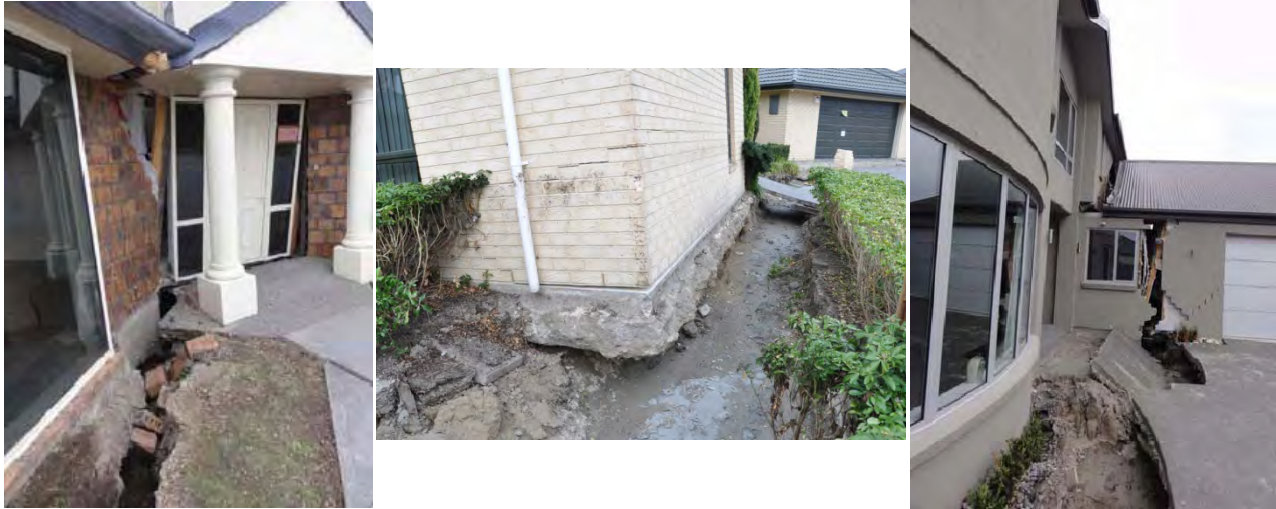
Lateral spreading resulted in large permanent lateral displacements on the order of 1.0-3.5 m with large ground cracks of about 0.5-1.5-m wide running through residential properties and houses along the east branch of Courtenay Dr. In this area, single story and two story houses suffered very severe damage due to large lateral ground movements including large tilt, loss of foundation support, tension cracks in foundations and slabs (Figure 4.34). It was significant that

despite the extreme lateral movement of the immediate foundation soils and the foundations themselves, all houses showed large ductile deformation capacity and continued to carry gravity loads, despite literally being ripped in half in some cases. The reconnaissance team visited the area and conducted detailed inspections and measurements of the distorted houses on several occasions. There was clear evidence that the lateral movement, at least in some parts of the affected area, continued to develop/increase well after the main event. Two consecutive measurements of the width of a large ground crack carried out on 11 and 15 September showed an increase in width of 20 cm over this period (i.e. from 1.4 m to 1.6 m). The residents of the neighboring property reported new extensive cracks appearing in their house over the same time period. It is believed that this continued deformation was the result of a combination of creep due to static driving shear stresses, significantly softened soils and effects of aftershocks on a structure marginally stable under gravity loads.

Figure 4.34 Lateral spreading at Courtenay Dr, South Kaiapoi: (a) Sand boils and lateral spread cracks; and (b) effects of lateral spreading in residential area.

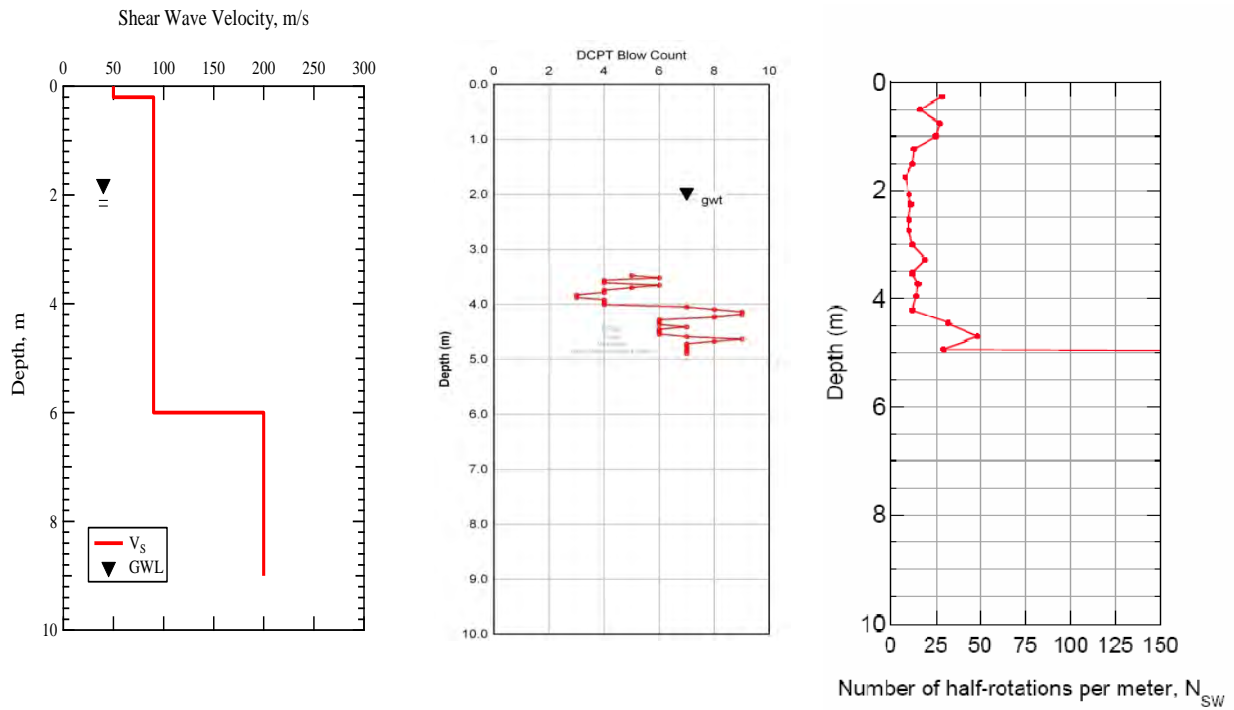
An SASW test, DCPT and SWS test were performed at a home along Courtenay Dr. The results are presented in Figure 4.35.

Figure 4.35 Results of SAWS test, DCPT and SWS test performed at a residential property along Courtenay Dr.

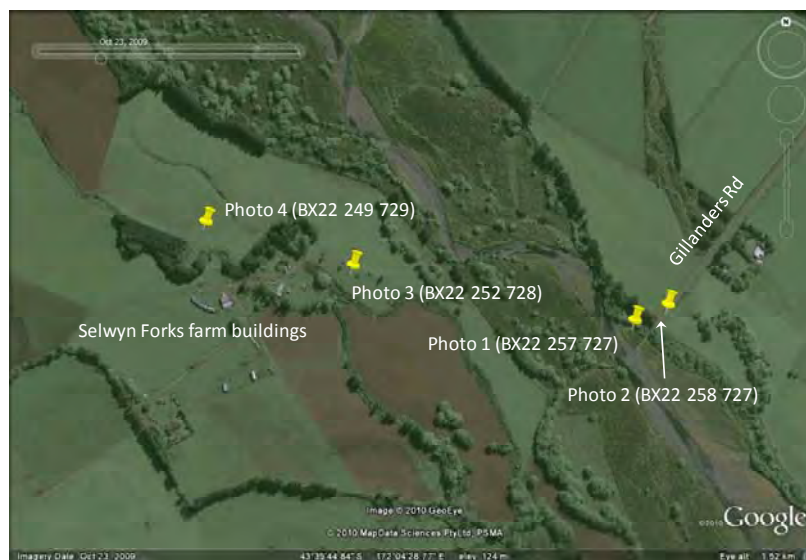
At the evening meeting of Sunday, 12 September 2010, Pilar Villamor of GNS reported to the Team that she had seen liquefaction in a farm paddock at the Greendale end of the fault trace. The paddock was on the Selwyn Forks property which is accessed from the Hororata - Dunsandel Rd on the southern side of the Hororata and Selwyn rivers. The locations of the liquefaction are shown in Figure 4.36.

Figure 4.36 Location of the liquefaction along the Selwyn River in the Greendale region. (Date of Google image 23 October 2009)

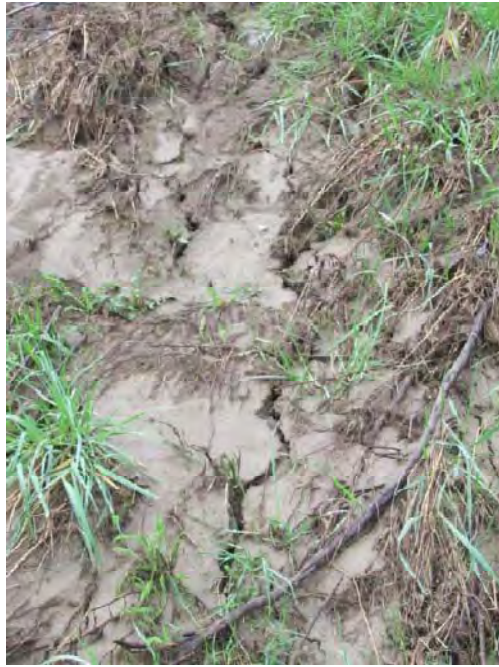
The GEER-NZ Team visited the area on Monday, 13 September 2010. On the evening of Sunday, 12 September 2010, there had been heavy rain in the area, so on Monday the river channels were running high and the Hororata River was flowing in new areas because of the levee damage during the earthquake. The Team first looked at end of Gillanders Rd, on the Darfield side, and found an area with ground damage off the end of the track, close to one of the river channels (Figure 4.37).

Figure 4.37 Ground damage adjacent to the bank of the Selwyn tributary near the end of Gillanders Rd (Darfield side). (Position marked as Photo 1 in Fig. 4.36; -43.596667°, 172.080000°)

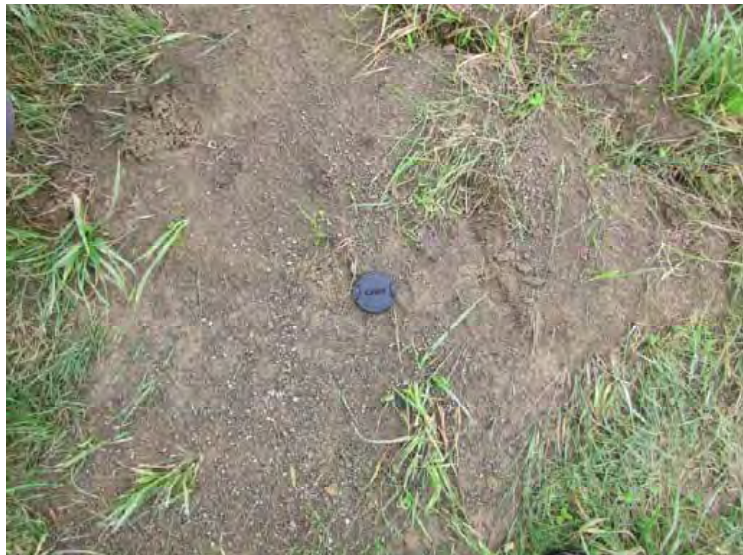
A short distance from here at the end of Gillanders Rd, the team found damage to the unsealed pavement and in the grass verge nearby. Evidence of liquefaction was seen (Figure 4.38). Notable here was the fine gravel on the surface of the sand. Also note that rain had fallen the previous evening so the surface of the ejected material would have been altered somewhat.

Figure 4.38 Liquefaction on the grass verge adjacent to the end of Gillanders Rd (Darfield side). Note the fine gravel particles on the surface and the fissure towards the top right hand side - it was possible to push the sampling spoon to a depth of about 300 mm into the fissure. (Position marked as Photo 2 in Fig. 4.36)

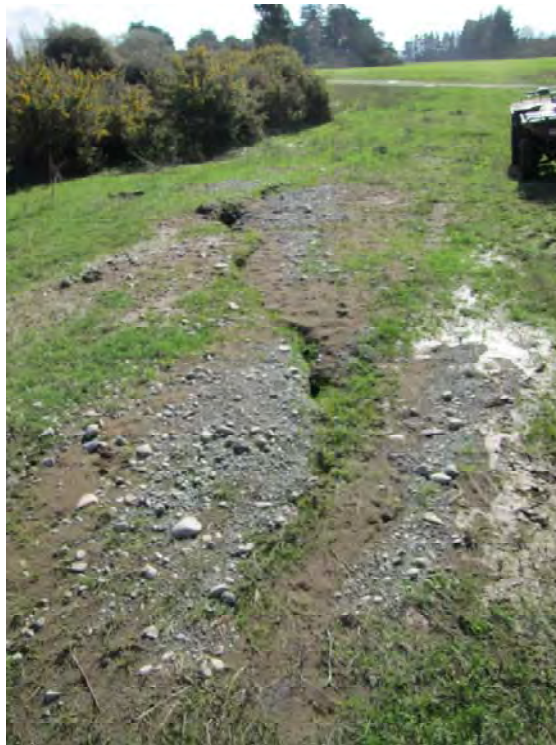
The liquefaction was located on the Selwyn Forks property (map reference BX22 250727). Access was a little difficult because a farm creek was being fed from an errant tributary of the Hororata River. The liquefaction was distributed across several fields. Material was ejected from fissures in the ground, which are likely to be lateral spreads given the stream channels nearby. The ejected material was topped off with a layer of coarse gravel (Figure 4.39). Figure 4.40 shows not only sand and gravel but also clods of topsoil. It is not clear if the gravel was part of the liquefied layer or was carried to the surface with the ejected sand. When questioned, Mr Ridgen suggested that the ground profile consisted of topsoil, gravel and then sand. If this profile is confirmed then the gravel was probably carried to the surface by the liquefied sand coming from below.

Figure 4.39 Material ejected from a fissure on the Selwyn Forks farm (front paddock). Note the gravel overlying the brown colored sand. This is what was visible after a night of rain. (Position marked as Photo 3 in Fig. 4.36.)

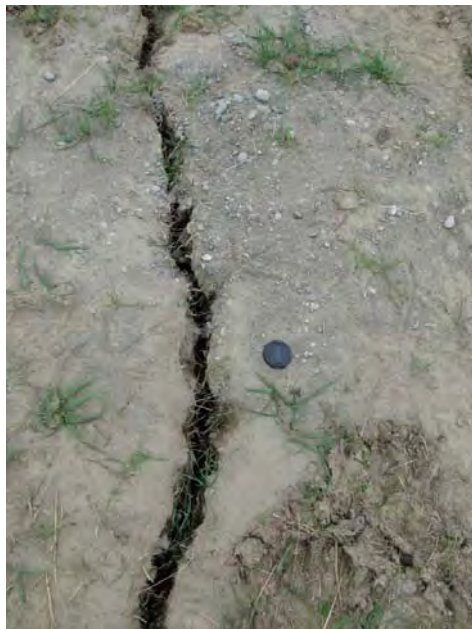
Figure 4.42 shows the material ejected at the position labeled Photo 5 in Figure 4.41 illustrating that the material ejected consisted of sand with some gravel. Comparison of photos in Figures 4.39, 4.40 ,and 4.42, shows that the materials ejected at Selwyn Forks and at Willow Lea were similar.

The farmer at Willow Lea, Mr Mark Fleming, reported that the fissures he observed were at least 2-m deep based on probing with a length of number 8 fencing wire. He also explained that the width of the fissures had increased gradually since the earthquake and that the prominence of the ejected sand had decreased with time (the photograph in Figure 4.42 was taken on 29 September 2010). More instances of liquefaction have been reported on other properties further down the Selwyn River, but the team has not confirmed this by site visits.

Figure 4.42 Ejected sand and gravel at the Willow Lea property. (Position marked as Photo 5 in Fig. 4.41; -43.688056° , 172.353333°)

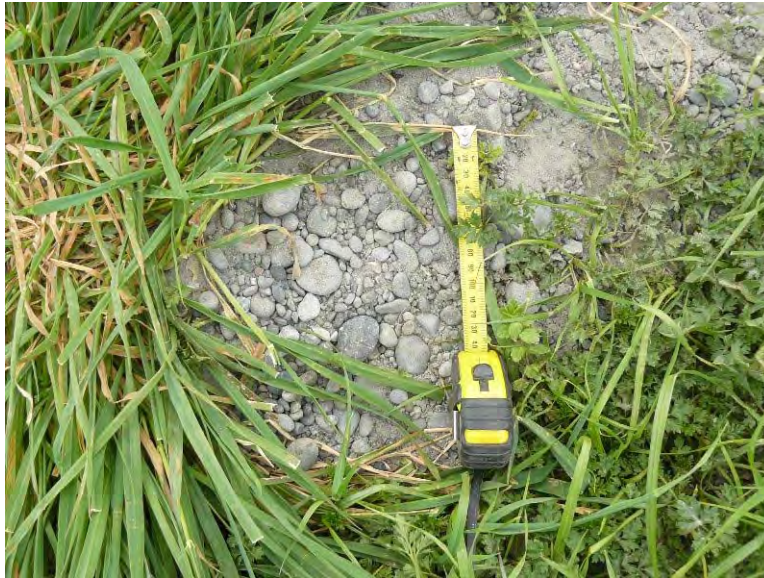
Liquefaction also occurred near the Clearwater development along Johns Road (-43.454433°, 172.595247°). Figure 4.43 shows that gravel was ejected in addition to sand. There were a

number of other instances of liquefaction in the open ground adjacent to the location shown in Figure 4.43.

Figure 4.43 Ejected sand and gravel in the Clearwater area. (photo by Ian McCahon)

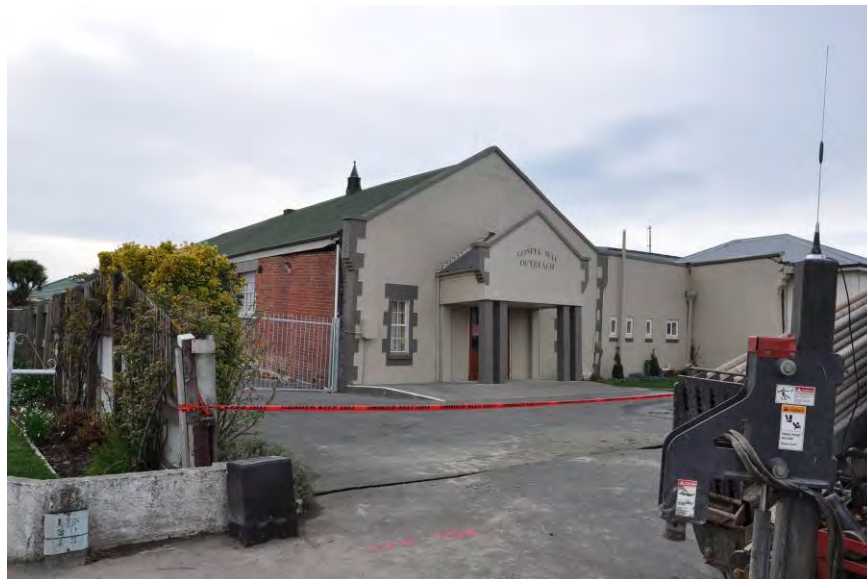
Figure 5.3 Front facing (view looking northeast) of the Gospel Way church in Kaiapoi along Charles St. (-43.3812° , 172.6579° ; 1000 hrs on 11 September 2010)

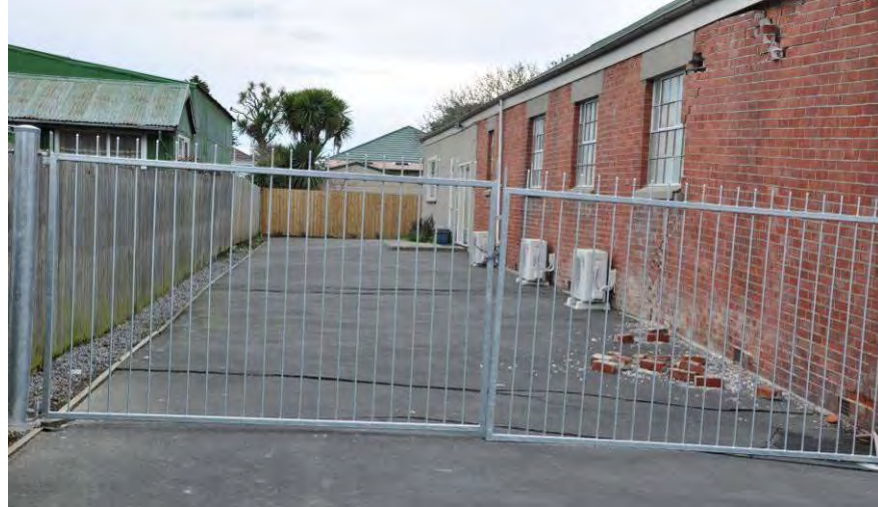
Figure 5.4 Lateral spread patterns extending east along the longitudinal axis of the Gospel Way church in Kaiapoi along Charles St. (-43.3812° , 172.6579° ; 1000 hrs on 11 September 2010)

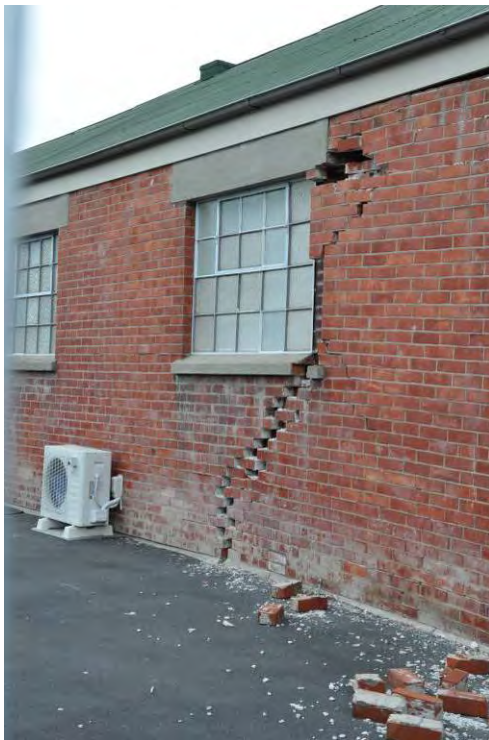
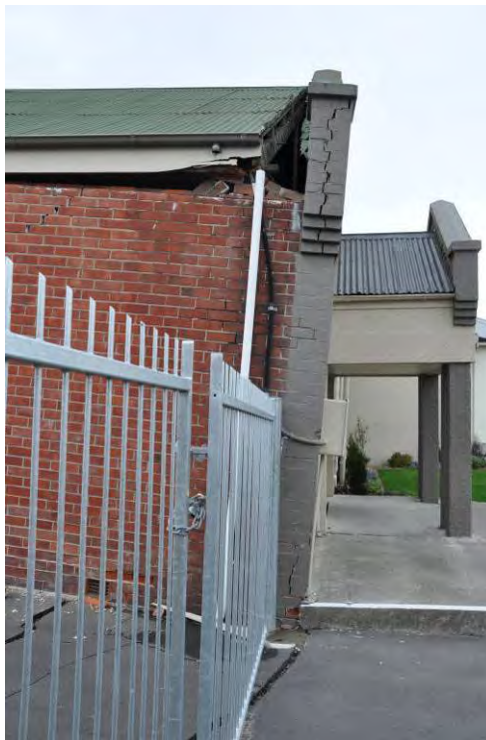
Small businesses line the fronts of Charles St paralleling the Kaiapoi River from approximately Jones St to Davie St (Figure 5.2). The vintage of these structures vary, however, most are single or 2 stories and constructed of light wood framing with brick façade, or stucco, or solely of concrete masonry block. Extensive lateral spreading parallel to the Kaiapoi River extended into the small business and residential regions impacting numerous structures within this community. Liquefaction was evident beyond the lateral spread as discussed in Chapter 4. The most severe damage to structures within the small business community along Charles St is shown in Figures 5.3-5.9. The Gospel Way church for example, a single story structure of brick construction, suffered separation of its heavy front structure from its orthogonal support walls due to lateral movement of the ground towards Charles St (Figures 5.3-5.5). The large lateral ground spreads extended northeast along the longitudinal axis of the building as evident in the adjacent parking area (Figure 5.4). This ground movement manifested into distinct shear cracks at the brick-mortar joints (Figure 5.5a). Structural separation such as that evident in Figure 5.5a was visible at several distinct locations extending along the longitudinal axis of the building. The most severe damage was evident at the front of this building, which settled approximately 15 cm, while the eastern length of the building remained approximately level (Figure 5.5b).

Figure 5.5 Gospel Way Church in Kaiapoi: (a) Shear crack pattern developed at brick-mortar joints along the northern side of the building and (b) separation (settlement and rotation) of the west face of the building. (-43.3812° , 172.6579° ; 1000 hrs on 11 September 2010)

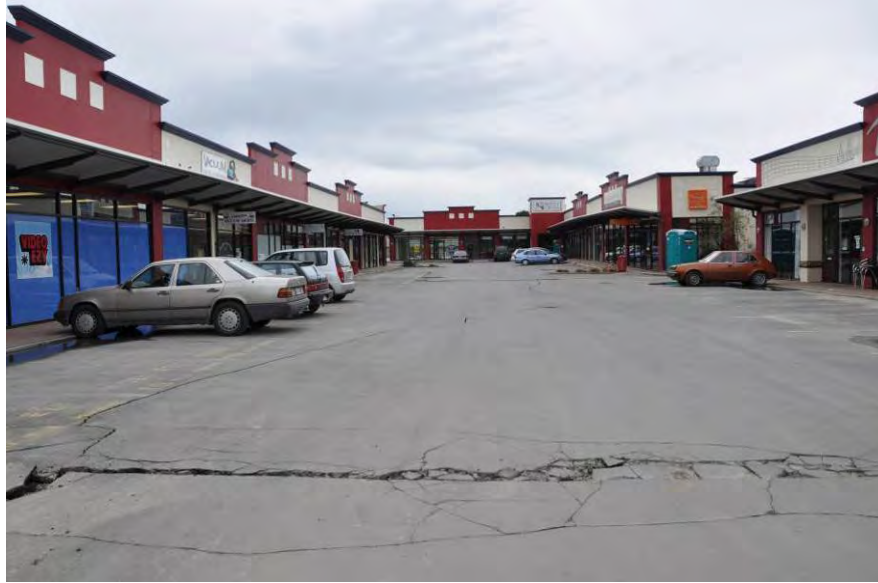
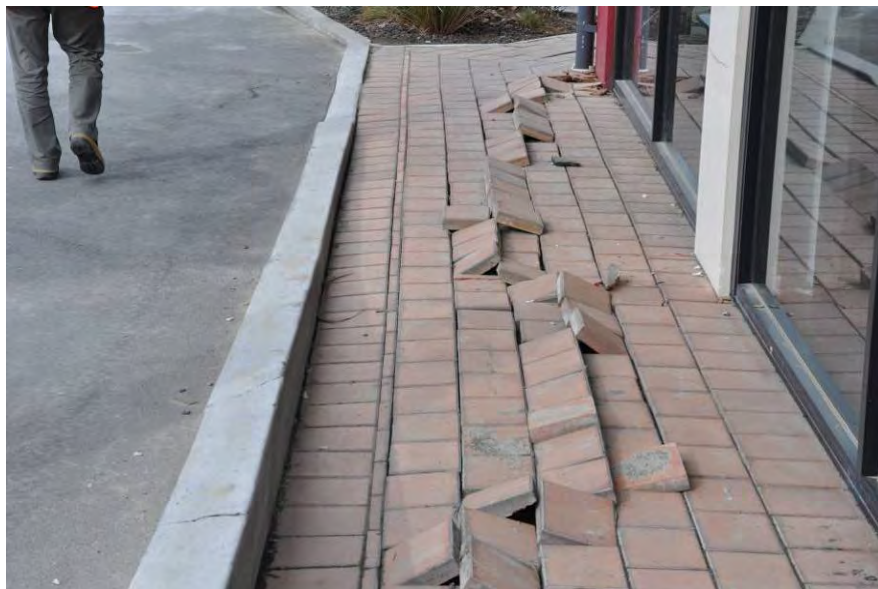
A small shopping area neighboring the New World supermarket in Kaiapoi (between Williams and Jones Streets north-south and Sewell and Charles Streets east-west) showed patterns of extensive ground damage and resulted in many business closures (Figure 5.6a). Closures were primarily prompted by extensive hardscape and interior flooring damage (Figure 5.6b). These buildings attached units of one story wood framed construction supported on slabs on grade and with glass front (open) facing as is common of walking business districts. The tallest structure to suffer damage in the direct adjacency to these business units was a red-tagged 3-story property and family law office constructed of concrete masonry block units (CMU) (Figures 5.7-5.8). This structure is rectangular in footprint with little to no lateral resistance along the longitudinal axis of the building (as evident from the perimeter full facing glass openings – Figure 5.7a). The short axis of the building provides resistance to lateral movement and loads via stiff full length CMU walls at exterior ends of the structure (Figure 5.7b). The front of this building appeared to have settled and rotated towards the direction (southwest) (Figure 5.8). Lateral spread ground failure and liquefaction ejecta were evident directly adjacent to this building (Figure 5.9). A sample of material taken adjacent to this building was tested using laser diffraction scanning (Figure 5.10, denoted WP24).

Figure 5.6 Small business attached units neighboring the Small World supermarket in Kaiapoi (52 Charles St): (a) View looking east showing ground damage pattern and (b) resulting hardscape damage at the front of one business unit. (-43.3827°, 172.6592°; 1045 hrs on 11 September 2010)

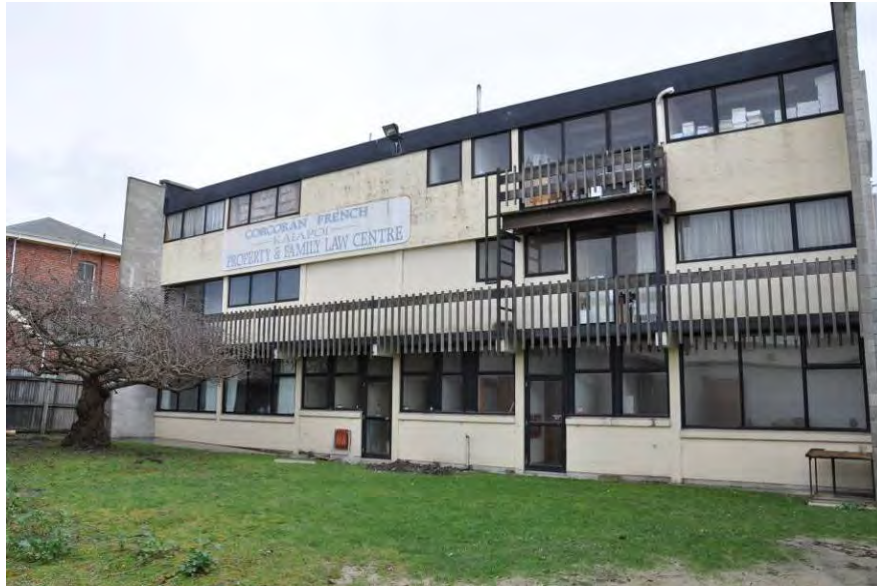
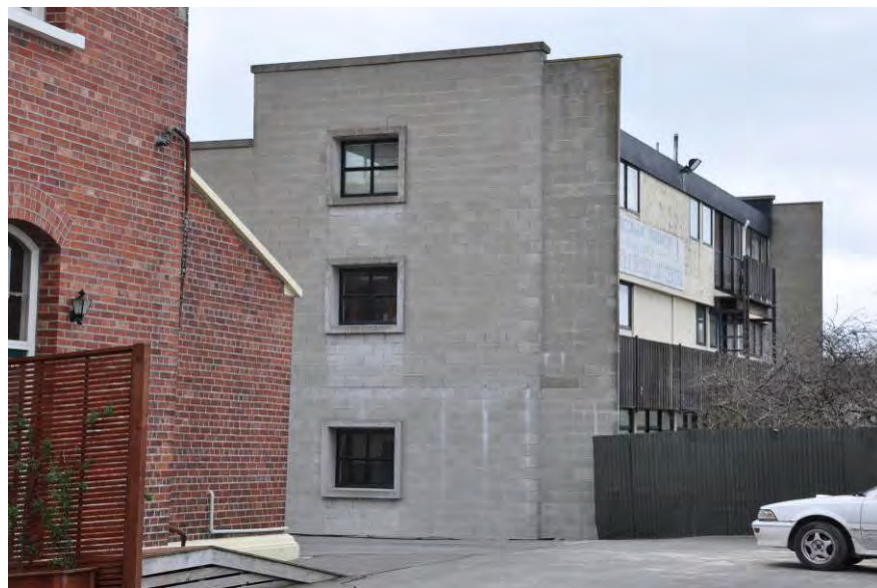
Figure 5.7 Property and Family Law Offices in Kaiapoi business district, 190 Williams St: (a) View looking northwest (at long axis end) of building and (b) view looking northeast showing shearwall ends of short axis of building. (-43.3812°, 172.6579°; 1100 hrs on 11 September 2010)

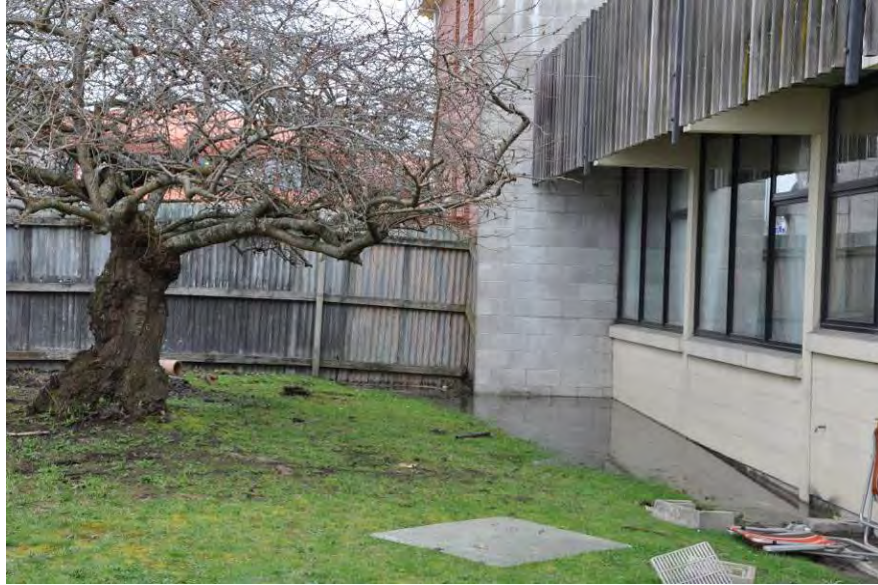
Figure 5.8 Property and Family Law Offices in Kaiapoi business district, 190 Williams St. View looking at west short axis end of the building (-43.3819° , 172.6591° ; 1100 hrs on 11 September 2010)

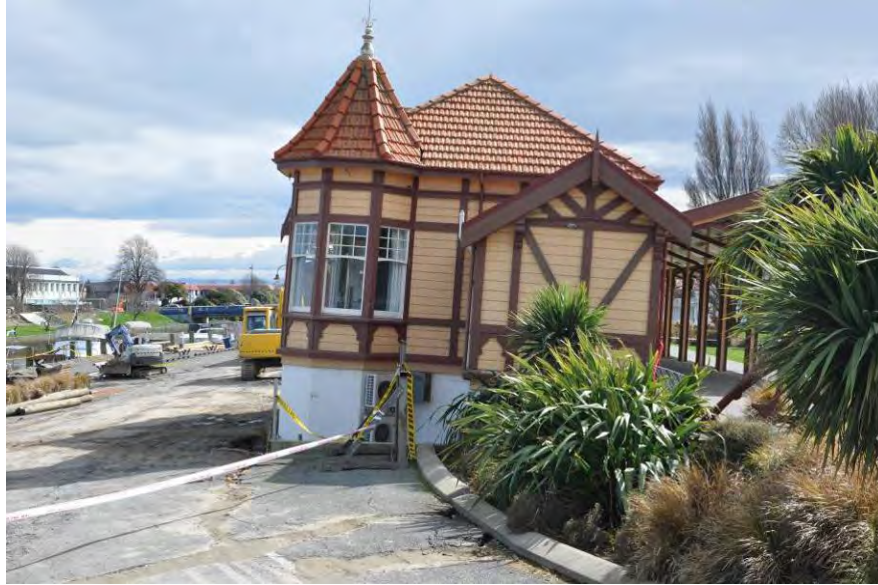
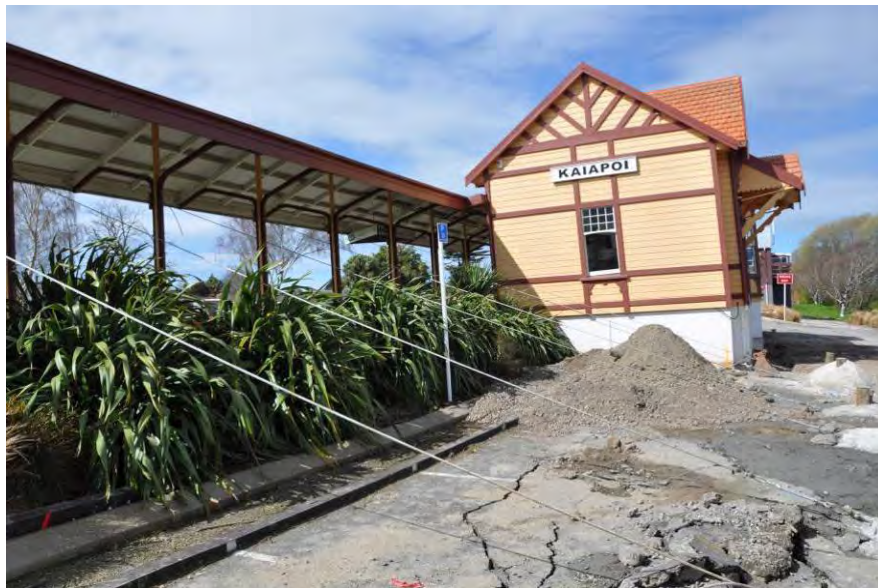
Movement of the Kaiapoi wharf resulted in damage to the historic Kaiapoi Railway Station, which is now renovated and used as the Kaiapoi Information Center (-43.3838° , 172.6596°) and its neighboring Harbor Building (-43.3834° , 172.6591°). The Kaiapoi Information Centre building is a renovated wood framed building on an elevated foundation (Figure 5.11). As a result of loss of ground support, this building tilted approximately 5 degrees northeast (away from the river). Rapid stabilization of the building had been complete by the time of the GEER-NZ Team's visit on 11 September 2010 in the form of concrete footings poured on the exposed (near river) foundation side of the building (Figure 5.11b). In addition, tension tie-backs anchored from newly poured concrete footings to a patio area were used to stabilize the upper pavement during the continuing ground movement. The Harbor building is a one-story masonry block building that suffered tilting towards the river and separation from the wharf of approximately 15-25 cm on its west face (Figure 5.12).

Figure 5.11 Renovated Kaiapoi Railway building now used the Kaiapoi Information Center, adjacent to the Kaiapoi Wharf. (a) View looking northwest and (b) view looking southeast (note the temporary elevated patio support tie-backs and newly poured footings at the front (river side) of the building. (-43.3838°, 172.6596°; 1300 hrs on 11 September 2010).

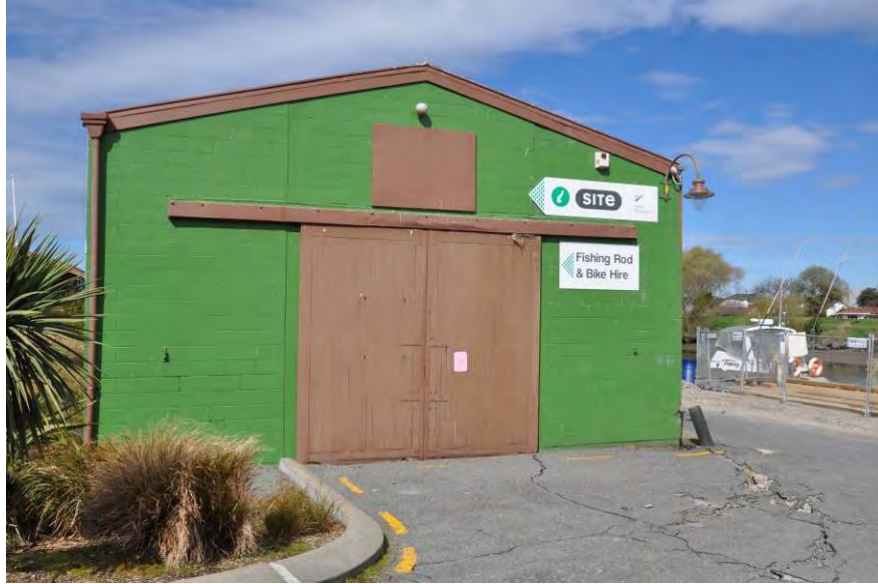
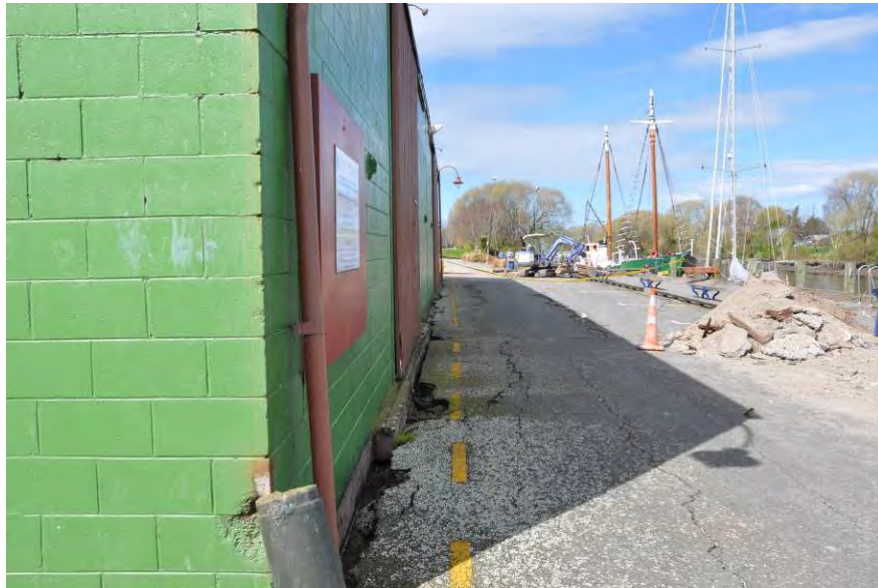
Figure 5.12 Harbor building adjacent to the Kaiapoi River and wharf structures: (a) View looking southeast and (b) view of the northwest corner of the building. Note the approximate 15-25cm gap between the pavement and building. (-43.3834°, 172.6591°; 1345 hrs on 11 September 2010).

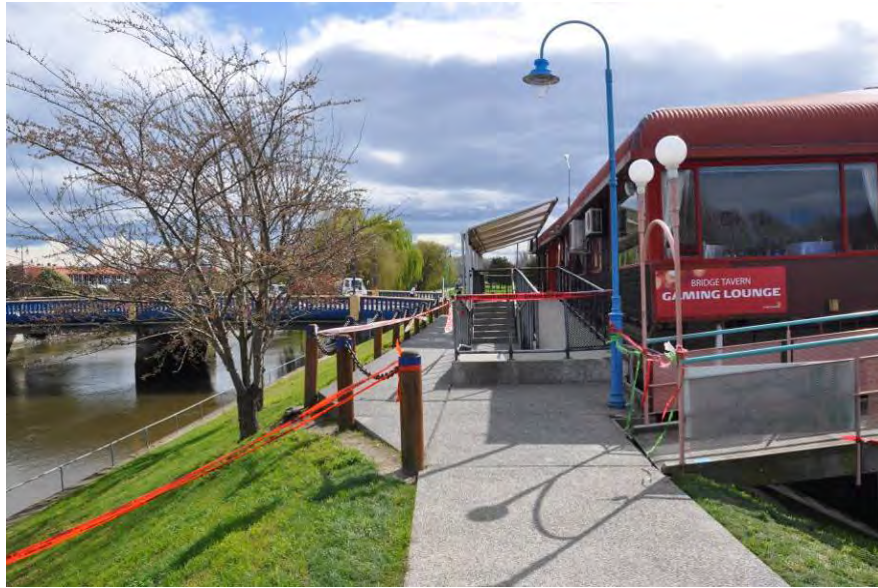
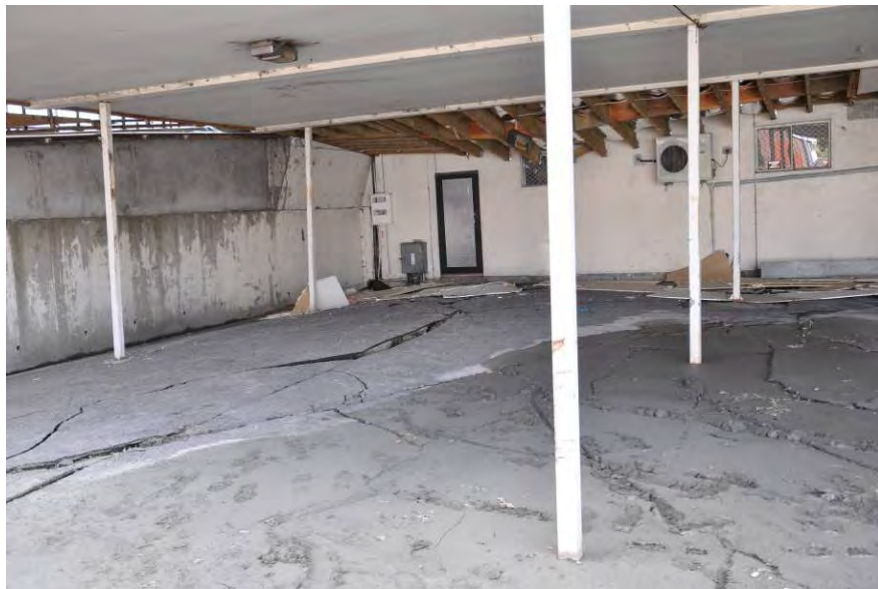
North of the Kaiapoi Information Center and Harbor Buildings, a two story wood frame building with subterranean parking (nearest to river) and a full floor level (nearest to Charles Street) currently housing the Bridge Tavern building was extensively damaged due to ground movement (Figure 5.13). Although movement of the retaining wall adjacent to the Kaiapoi River was not evident, the east embankment side, which supported the first story subterranean parking area showed evidence of ground settlement and cracking. This damage precipitated movement of columns supporting the upper story of the building (Figure 5.13b).

Figure 5.13 Bridge Tavern adjacent to the Kaiapoi River: (a) View looking northwest at Williams St bridge and (b) view looking northwest at subterranean parking. (-43.3826° , 172.6582° ; 1345 hrs on 11 September 2010)

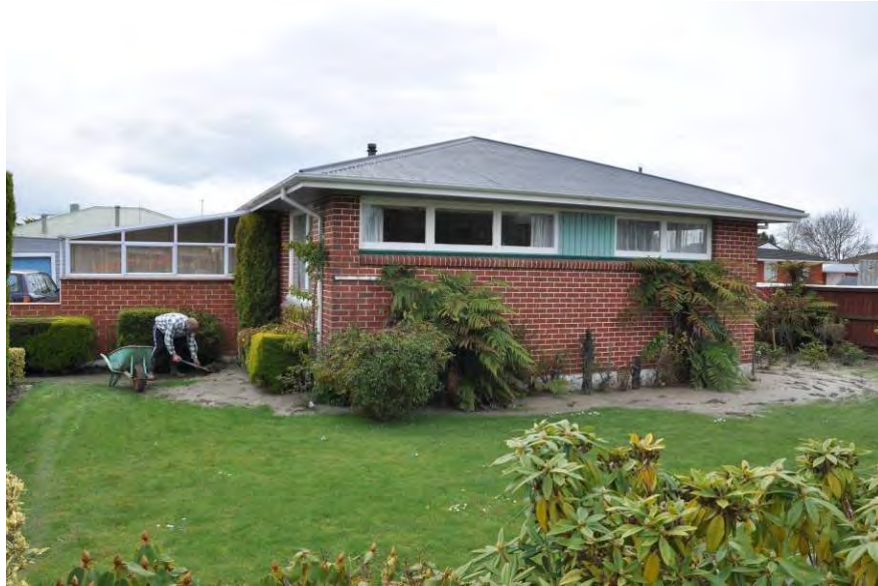
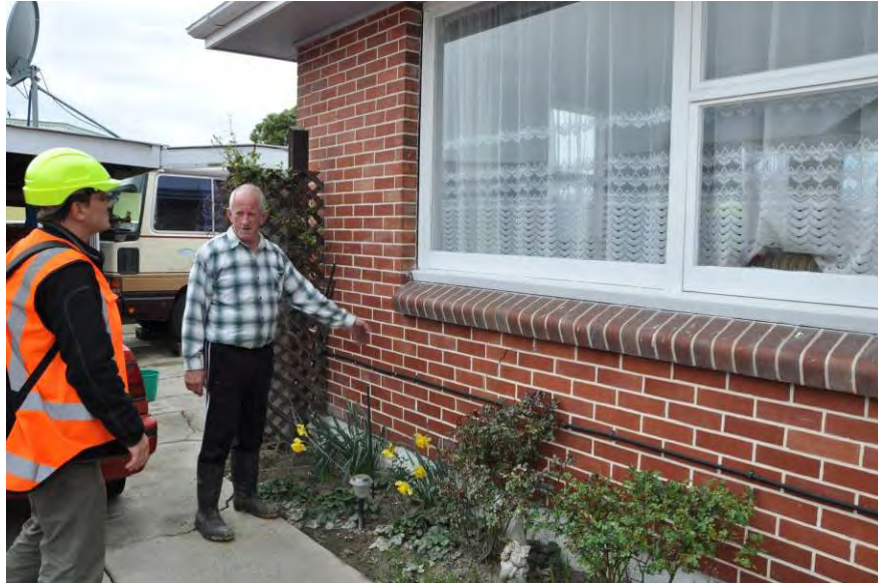
Figure 5.15 Residence along Charles St: (a) Ejecta surrounding home and (b) owner points out shear cracking and gapping developed between window and brick due to structures movement. (-43.3836°, 172.6604°; 1115 hrs on 11 September 2010)

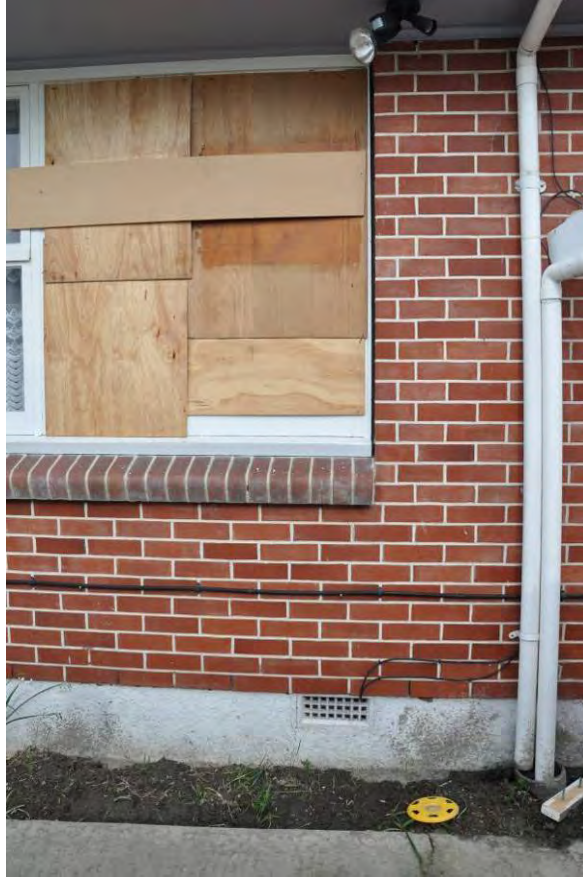
Figure 5.16 Residence along Charles St (same structure as Figure 5.16). Damage to glass windows and between window and wall. (-43.3836°, 172.6604°; 1115 hrs on 11 September 2010)
