GEOTECHNICAL RECONNAISSANCE OF THE 2010 DARFIELD (NEW ZEALAND) EARTHQUAKE

Version 1: 14 November 2010

EDITORS

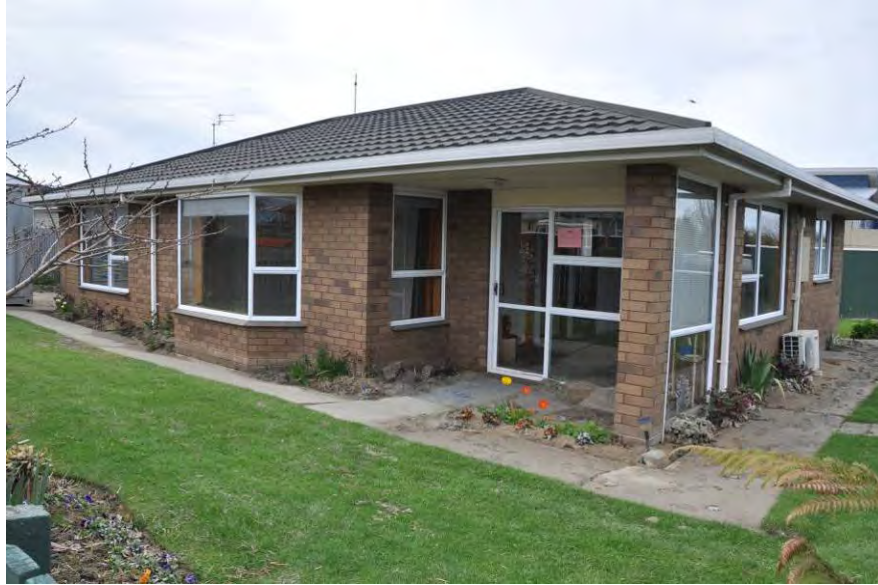
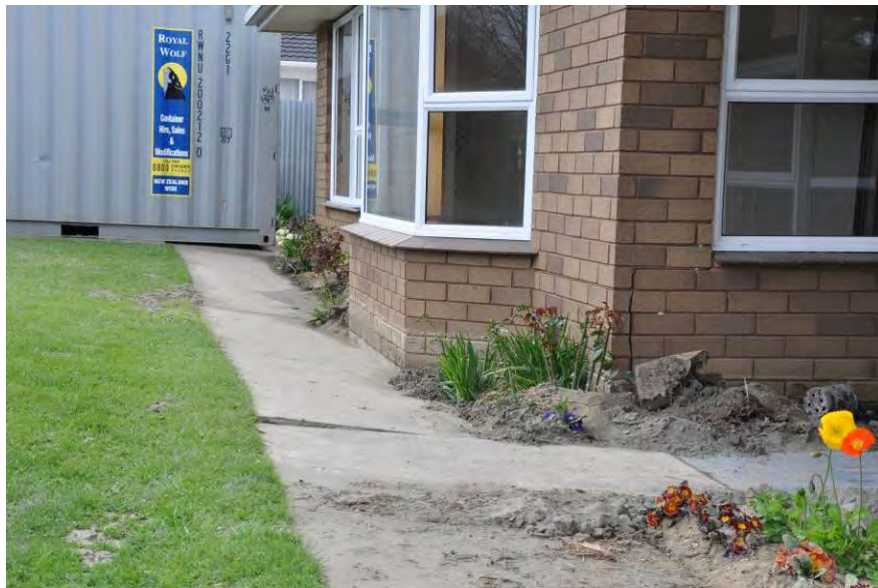
Kaiapoi North – Residential construction within the Kaiapoi North community consists of 1-2 story wood or concrete block framed houses. A number of houses are also constructed of brick or wood with brick façade units. The vintage of these homes appeared to extend as early as 1960's construction, to more recent completely rebuilt or remodeled homes. Uniform settlement of the heavier brick houses in this area, such as shown in Figure 5.15, were measured as large as 20-25 cm. Brick houses consistently observed shear cracking, discontinuities between window and door openings and brick, popped out and/or damaged glass windows, and damage to floor slabs and hardscape (Figure 5.16). Houses along Charles St at the time of the GEER-NZ Team's visit (11 September 2010) were either red or yellow tagged. Very few houses were occupied, with most suffering extensive sand ejecta surrounding the home as well as settlement. In a number of cases, residents of severely damaged homes had moved out completely (e.g. Figures 5.17-5.18). This house at Charles St experienced ~0.4 m of settlement along its North face (Figure 5.17b).

Figure 5.17 Red tagged residence on Charles St: (a) View looking east and (b) north end of house, view looking North-East. (-43.3838° , 172.6607° ; 1130 hrs on 11 September 2010)

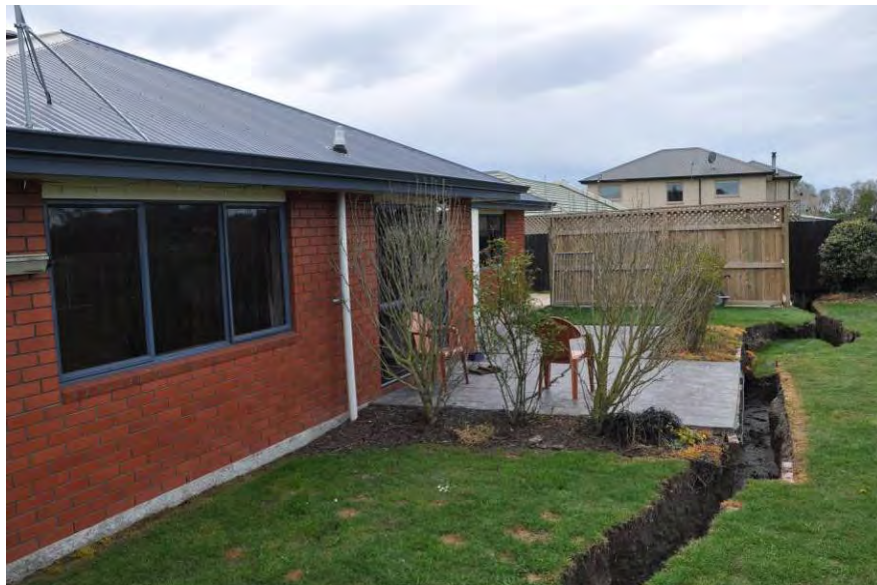
Figure 5.20 Ground failure feature extending through the backyard of a house on the south side of Courtenay Dr in the South Kaiapoi residential community. (-43.3894°, 172.6633°; 1500 hrs on 11 September 2010)

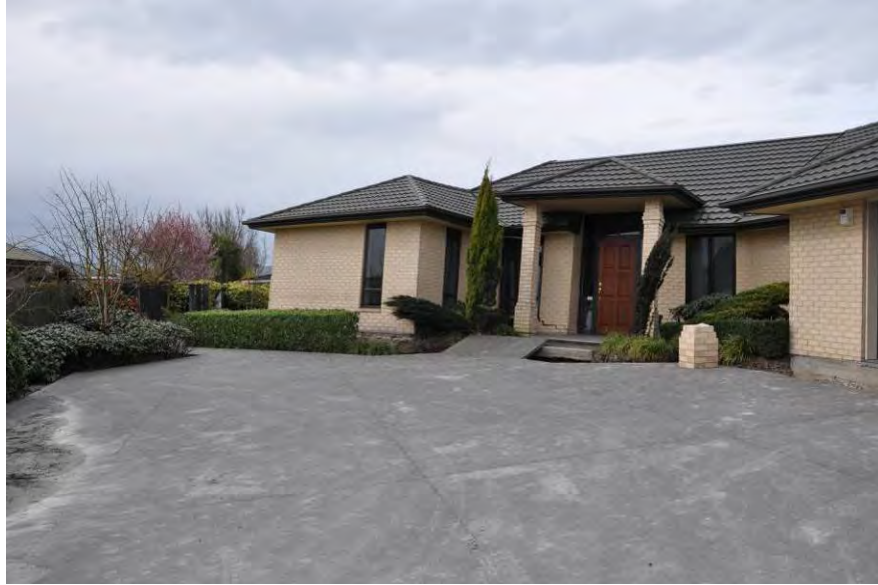
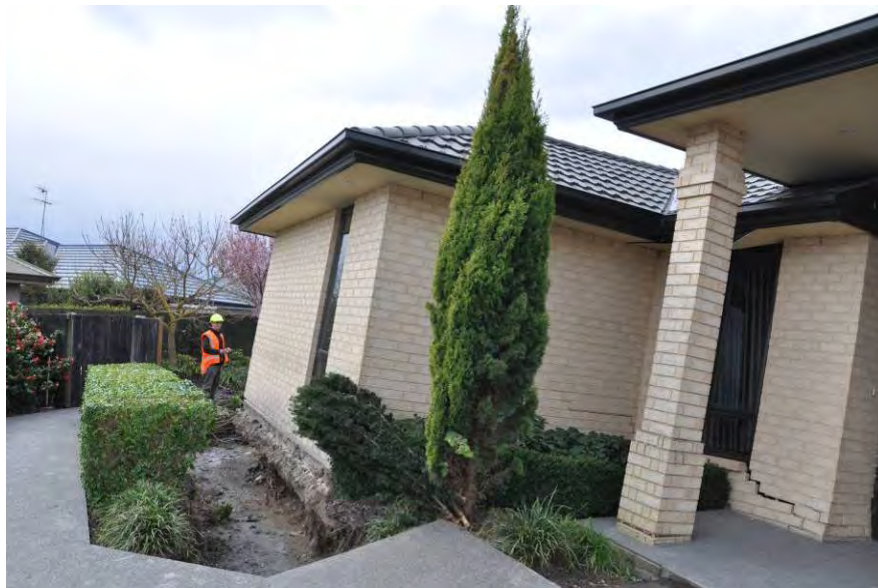
Figure 5.21 Damage to a residence at Courtenay Dr in the South Kaiapoi residential community (front of house articulating excessive tilt and separation of foundation from surrounding hardscape). (-43.390920°, 172.662007°; 1545 hrs on 11 September 2010)

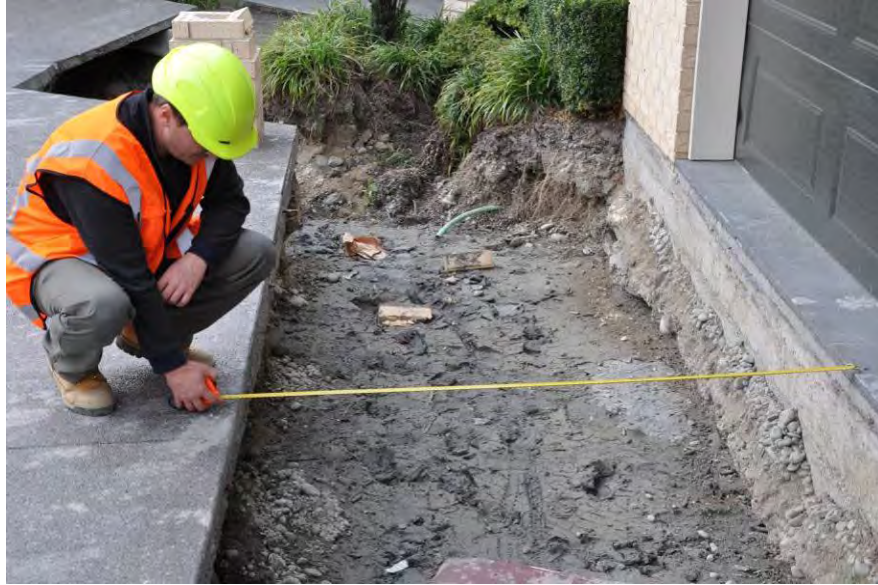
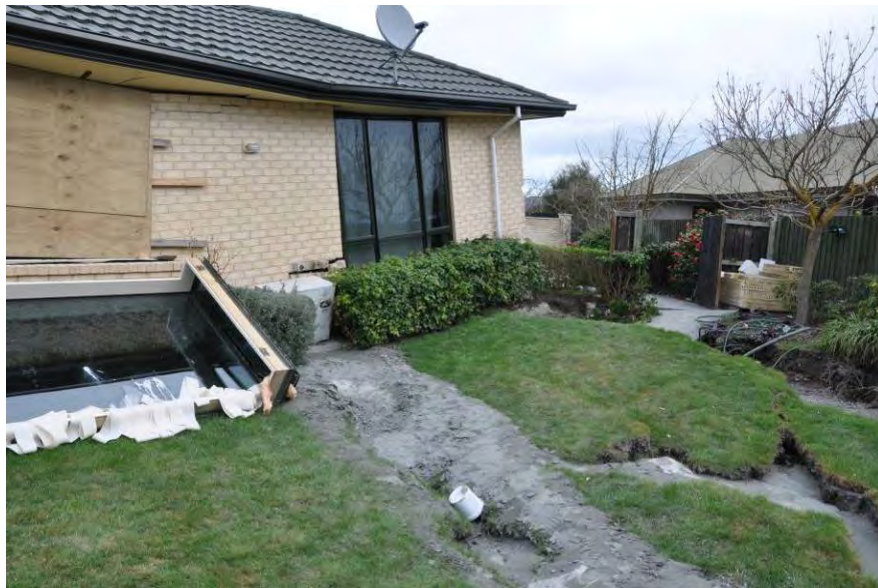
Figure 5.22 Damage to a residence at Courtenay Dr in the South Kaiapoi residential community (a) front of home (1.5-m separation between garage and approach slab) and (b) back of home. (-43.390920°, 172.662007°; 1545 hrs on 11 September 2010)

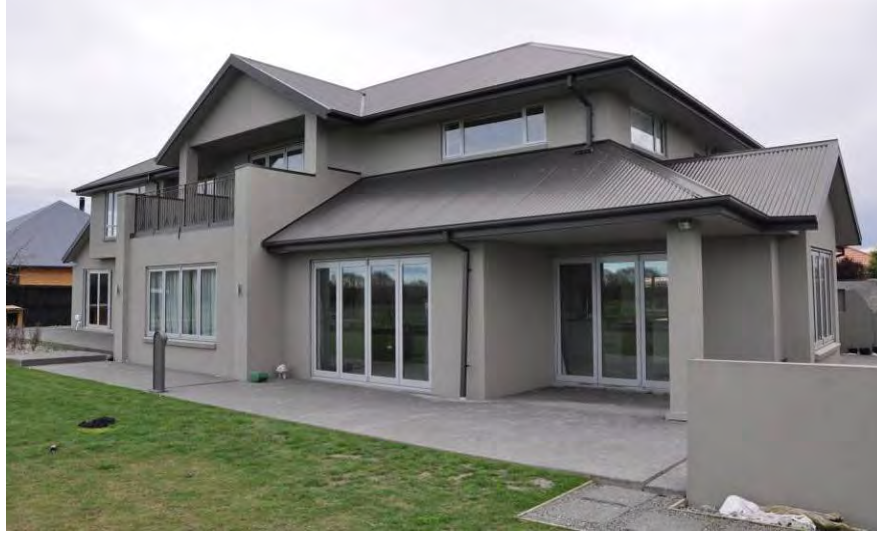
Kaiapoi South – In general damage to building structures in the Kaiapoi South community was limited to Courtenay Dr between Kaikanui St and ending at Parish Ln. This is a residential neighborhood with relatively new homes, all constructed within the last ten years. Most houses are one-story light wood framing or brick supported on unreinforced slabs with perimeter stemwall foundations and light metal roofing. An example of the typical construction style in this area is shown in Figure 5.19. Liquefaction was reported to inundate the neighborhood north of Courtenay Dr towards Charters St, however much of this had been cleaned up by the time of the GEER-NZ Team's visit and appeared to have minimal impact on the houses. The impact to houses along Courtenay Dr however, and particularly those on the east side of the drive, with direct facing to a paddocks' field as well as a branch of the Courtenay Stream, was extensive. Ground failure in this region manifested in large lateral spread zones coupled with liquefaction (Figure 5.20). A manual survey by the GEER-NZ Team indicated that of the 44 houses along this drive 48% suffered severe structural damage induced by ground failure, while 15 (36%) suffered moderate and minor damage, respectively. Laterally spreading ground was observed to extend through the backyards of these houses, with the lack of reinforcement within slab foundations and general light construction styles resulting in severe separation of the home directly in-line with the ground failure. The residences shown in Figures 5.21-5.24 demonstrate the observed damage due to excessive ground movement. The structure shown in Figures 5.21-5.22 suffered excessive tilting and a separation of 1.5 m from its approach driveway to the front of the home (Figure 5.22a), while the rear of the house collapsed inward due to surrounding ground fissures (Figure 5.22b). Similarly, the residence in Figures 5.23-5.24 articulated little to no damage at the backside of the house (Figure 5.23), however the front entry of the house at the interface between

Figure 5.23 Damage to a residence along Courtenay Dr in the South Kaiapoi residential community. Backside of home facing Paddocks field articulates relatively no damage. (-43.391168°, 172.661894°; 1600 hrs on 11 September 2010)

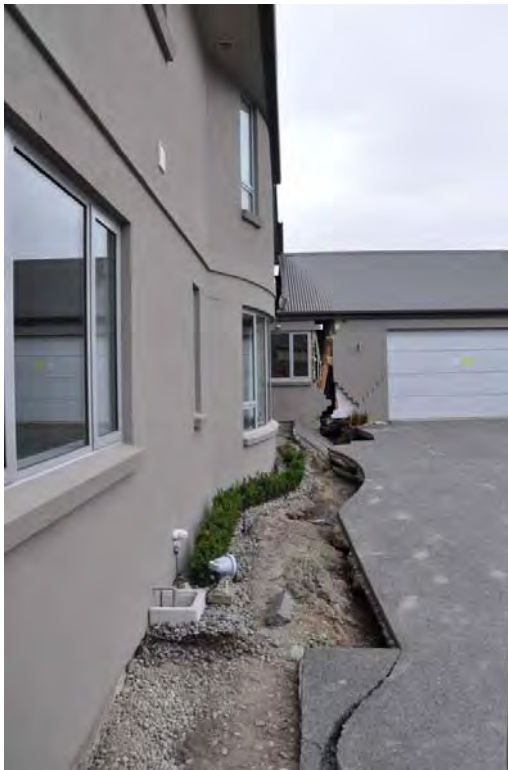
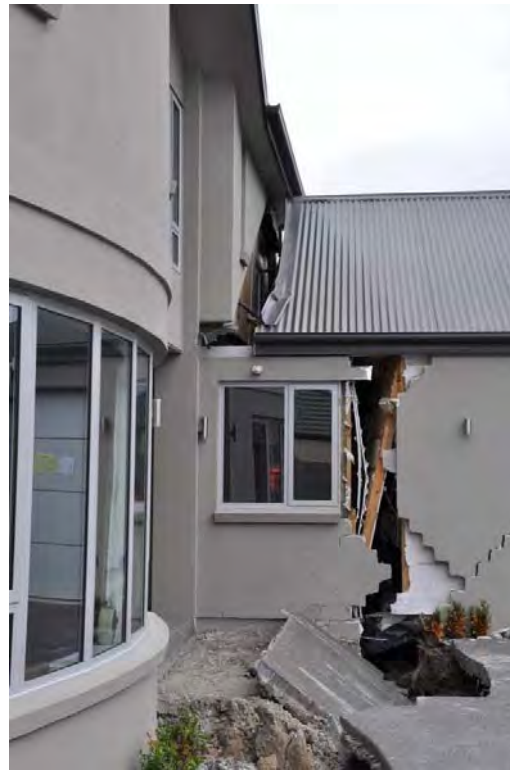
the garage and main portion of the residence suffered a separation of about 1 m due to lateral ground movement (Figure 5.24).

Figure 5.24 Damage to a residence along Courtenay Dr in the South Kaiapoi residential community. Front entry articulates extensive damage as large ground spreading subtends into the superstructure. (-43.391168°, 172.661894°; 1600 hrs on 11 September 2010)

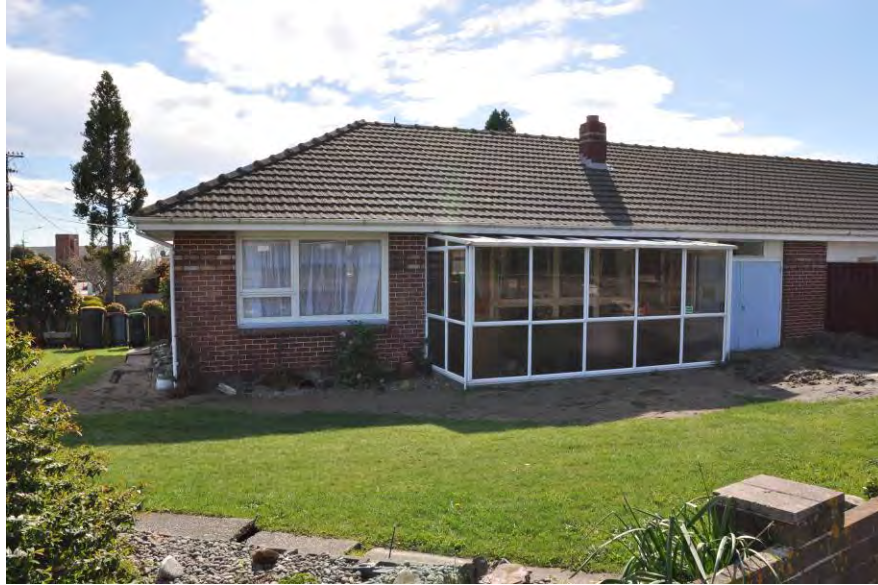
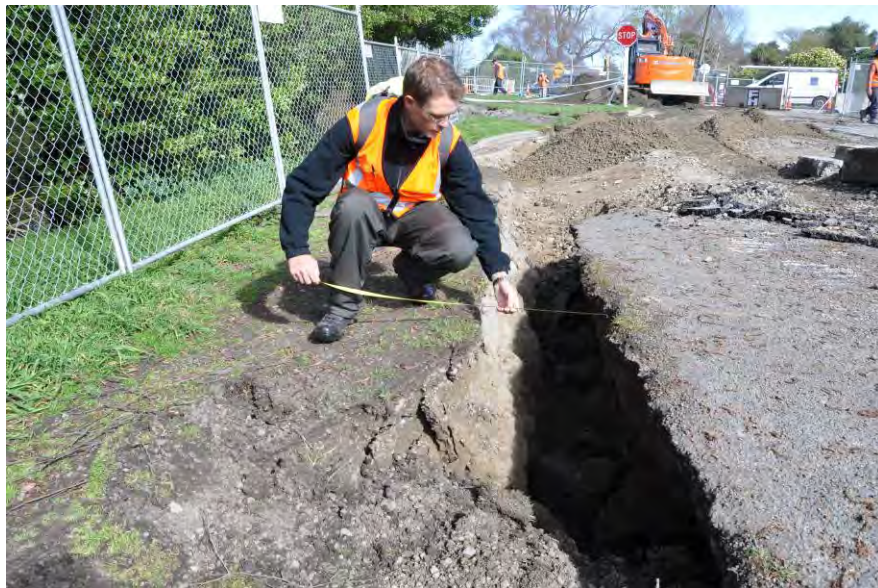
Two common types of damage to residential structures within this community are shown in Figures 5.25 and 5.26. Both of these structures are located near the Avon River. The residence shown in Figure 5.25a directly fronts the Avon River and experienced approximately 3 degrees of rigid body tilt directly south towards the river. Structurally the home was in good condition, though inspection of the interior articulated extensive floor and nonstructural damage. Lateral spreading extension features were observed at the front of the residence at the river and continued north behind this residence (Figure 5.25b). Transects taken by the GEER-NZ Team on 14 September 2010 at this location indicate 85 cm of lateral extension fronted the residence, with vertical offsets in extensions as large as 19 cm and cracks extending as great as 105 cm (T7 in Figure 5.27). Figure 5.26 shows a house in Locksley Avenue, which illustrates a loss of ground support subtended along the structure length. At this location lateral spreading towards the Avon River (behind the position from where the photo was taken) is evident in the driveway. Differential settlement along the length of the house manifests itself as shear cracking and separation of the mortar-brick within the brick veneer wall. This mode of deformation is similar, but less intense, to that imposed on the slab-on-ground foundations of the houses illustrated in Figures 5.20-5.24.

Figure 5.25 (a) Rigid body rotation of a residence in Dallington (Locksley Ave) due to liquefaction and $(-43.5212^\circ, 172.6731^\circ)$; (b) lateral spread features directly fronting the home. Surveys of ground features at this location are associated with T7 $(-43.5212^\circ, 172.6731^\circ)$ (refer to Figure 5.27).

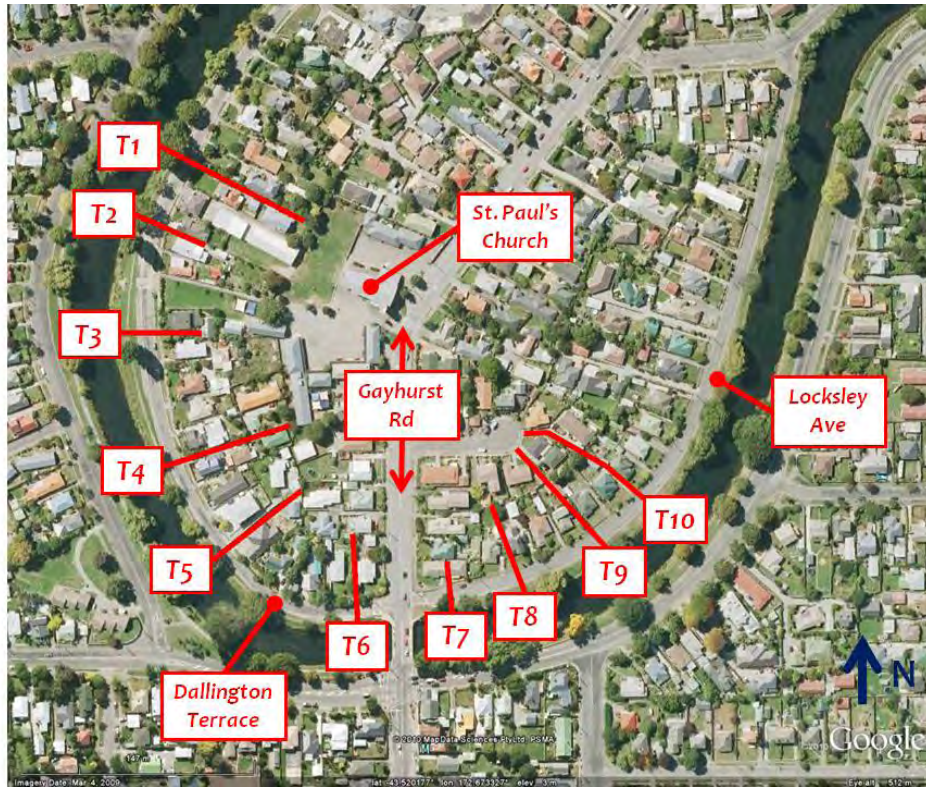
Detailed mapping of lateral spreading features extending from the Avon River into the Dallington residential community were performed by a NZ-GEER team on 14 September 2010. A map of these transect locations is shown in Figure 5.27. Future reports will include elevations and additional details of these ground features.

Figure 5.27 Ground feature mapping locations taken by the GEER-NZ Team on 14 September 2010. The distance from the left to right edge of this image is ~0.58 km. (Annotations overlaid with GoogleEarth image)

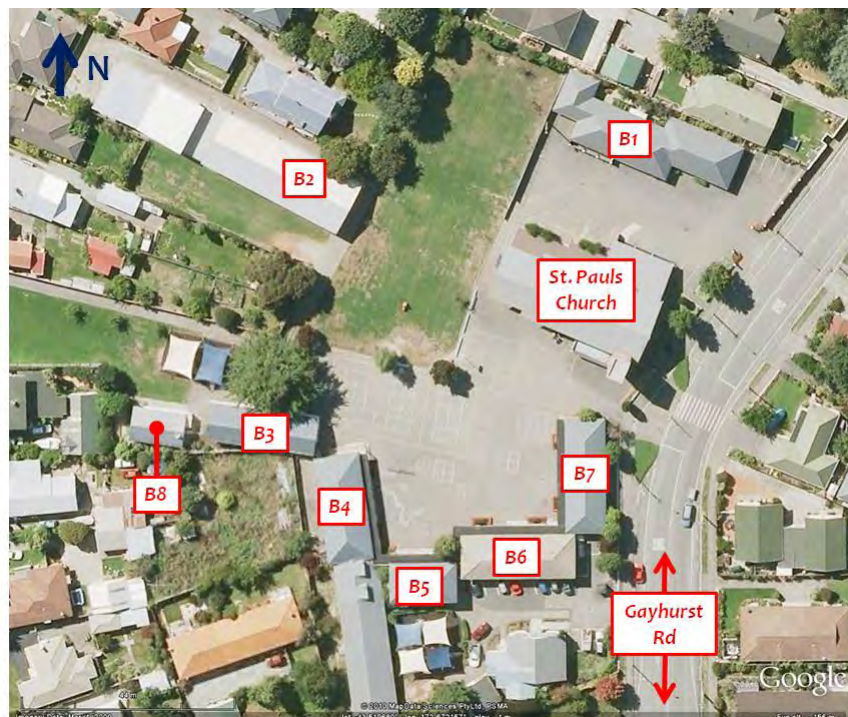
A historically significant feature in the neighbourhood of Dallington is the St. Paul's church and surrounding school (Figure 5.28). St. Paul's church was severely damaged due to surrounding ground movement, which was precipitated by extensive liquefaction within the general area shown in Figure 5.28. Most significantly the structure suffered through building separation due to ground extension and vertical offset subtending north-south approximately one-third of the length along the west end (orange separation location denoted in Figure 5.29). This resulted in separation of the building into two distinct pieces. The West end of the building rotated 2 degrees south and 4 degrees west (Figures 5.30-5.33), resulting in 46 cm of settlement of the south-west corner (estimated with reference to prior ground elevation). No significant lateral translation of the building was measured at its perimeter, rather structural movement was confined to rotation and settlement as described in Figure 5.29. This relatively heavy single story structure was constructed of running bond brick perimeter walls, with a timber (truss) roof. Wall heights were approximately 10 m at the perimeter of the sloping roof and 7m at flat portions. An ~12-m tall tower is articulated at the southeast corner of the structure (Figure 5.33b). The

Surrounding St. Paul's church is an Integrated State School affiliated with the church (buildings denoted B1-B8 in Figure 5.28). Building B1 (Figure 5.34) and B6 (Figure 5.36) are constructed of running bond brick perimeter walls with light metal roofs, whereas buildings B4, B5, and B7 incorporate light wood framing along their longitudinal axes and brick along their transverse axes. Building B2 is constructed of concrete masonry block units (Figure 5.35). All structures within the school appeared to be supported on elevated stem wall footings with interior wood joists, with the exception of B2, which appeared to be at grade with a slab on ground. Buildings B1-B8 are all single story with wall heights ranging from 7-8 m. Stiff brick and CMU buildings within this school complex suffered shear cracking and in some cases significant separation of brick-mortar joints (e.g. Figures 5.35b and 5.36b). Likewise mixed construction structures, such as building B7 suffered damage due to relative movement between contrasting materials (Figure 5.37b). Flexible wood buildings suffered little observable structural damage with the exception of hairline cracks in stucco aligned with ground movement features.

Figure 5.28 St Paul's church and school in Dallington area (-43.5196° , 172.6725°). Notation "B#" is used for reference only to identify adjacent buildings (see discussion). The distance from the left to right edge of this image is ~ 0.17 km. (Annotated GoogleEarth image).

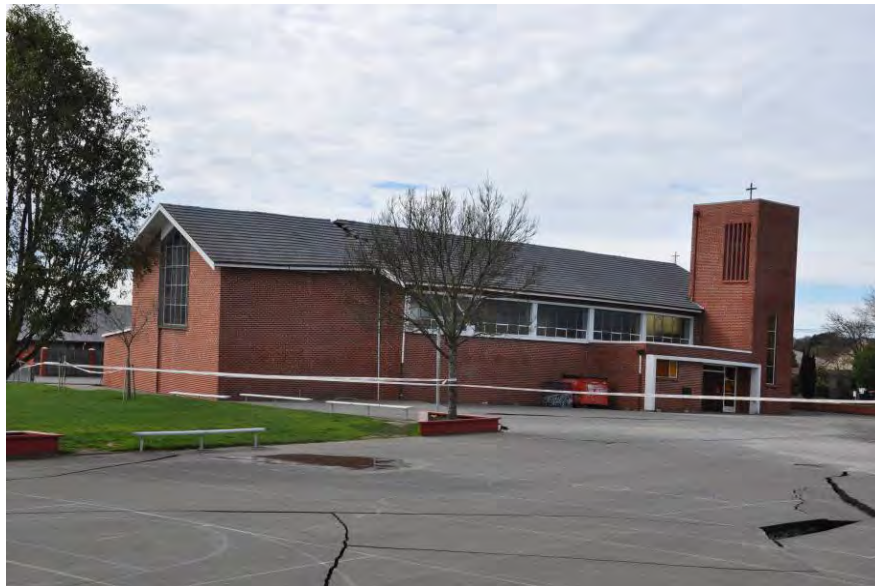
Figure 5.30 St Paul's church in Dallington area - overall view of building looking north-east (-43.5196°, 172.6725°; 1345 hrs on 12 September 2010)

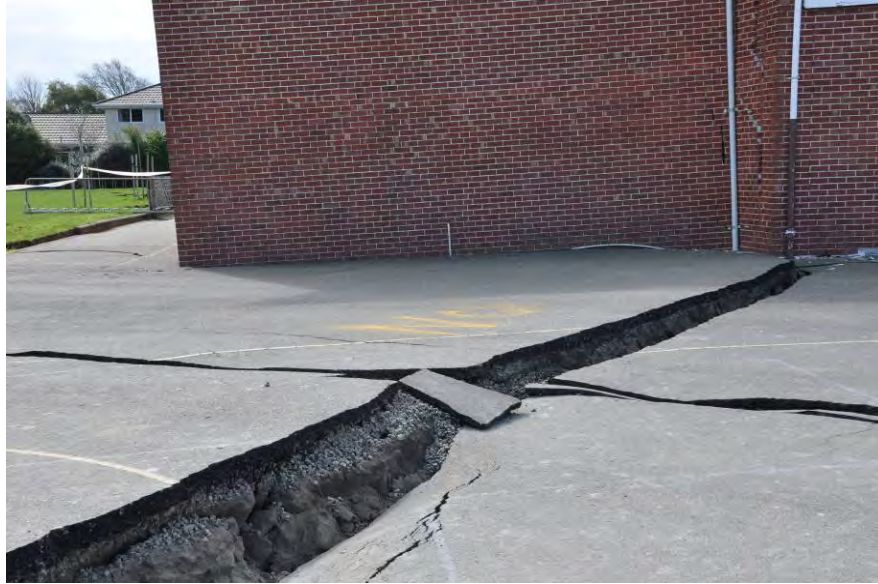
Figure 5.31 St Paul's church in Dallington area - view looking north at ground failure, which continued through building. (-43.5196°, 172.6725°; 1400 hrs on 12 September 2010)

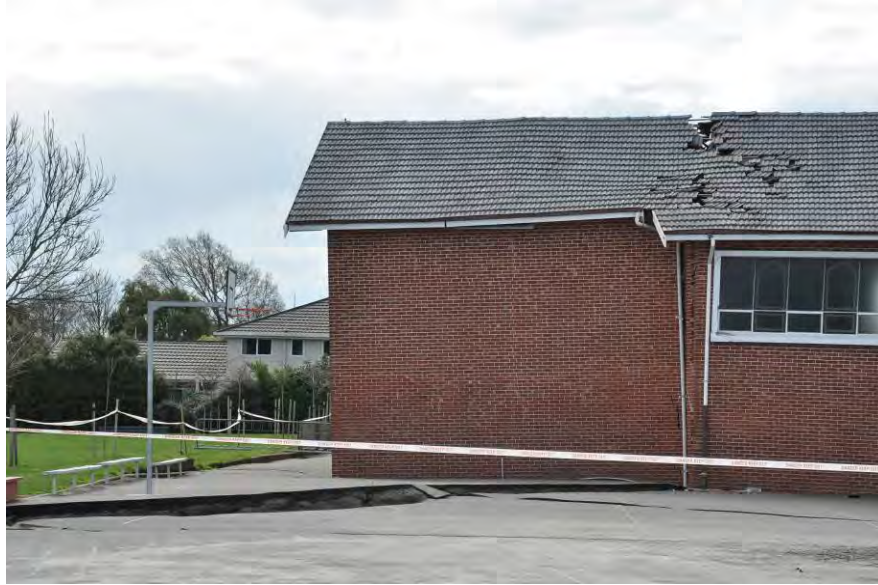
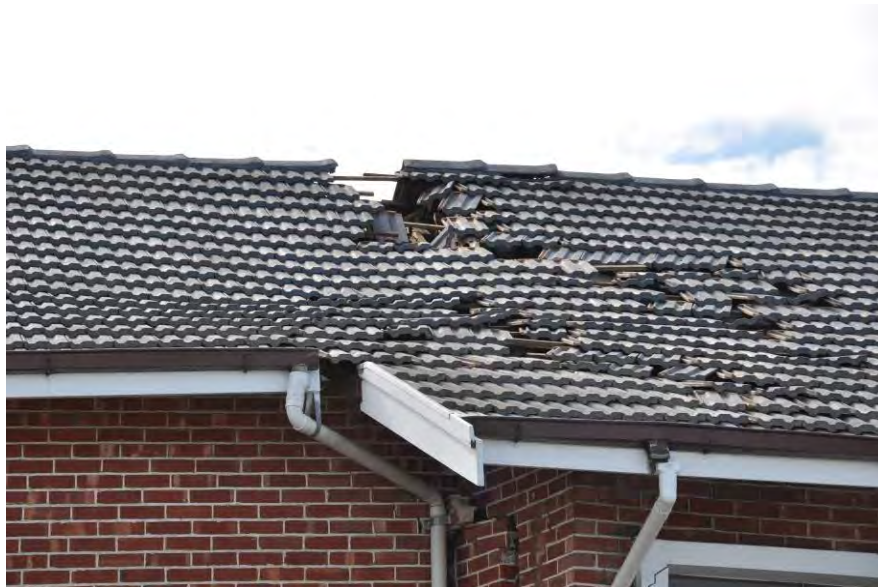
Figure 5.32 St Paul's church in Dallington area - view looking north (a) far view of separated west end of building and (b) close-up view of structural separation. (-43.5196° , 172.6725° ; 1400 hrs on September 2010)

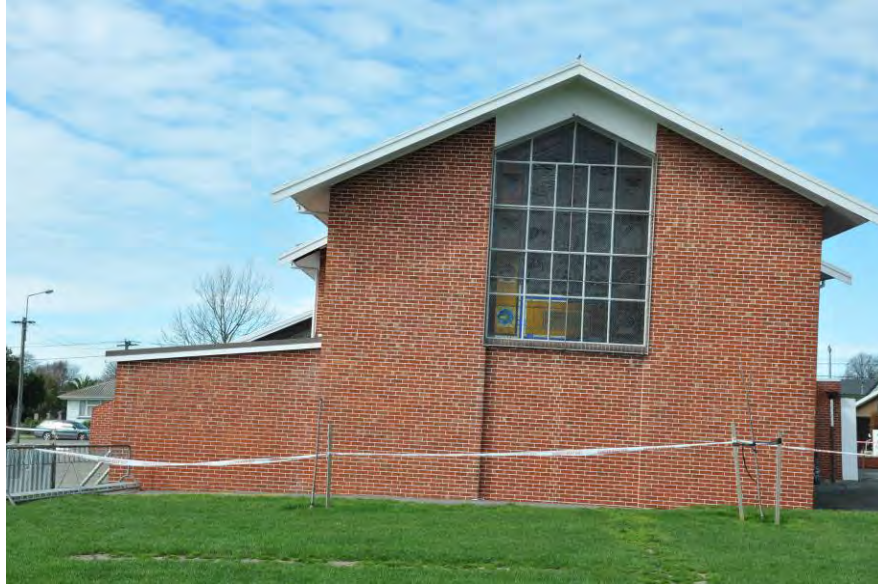
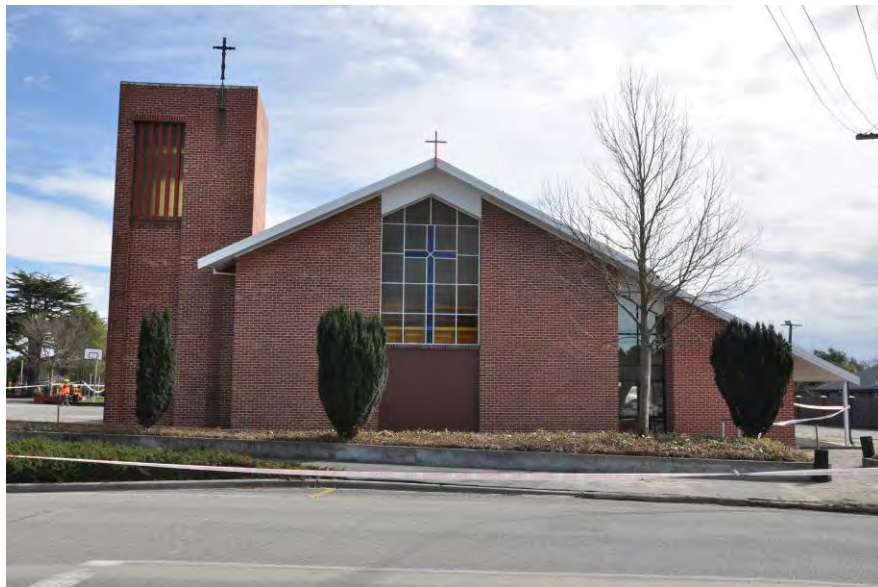
ridgeline extends across the longitudinal axis (running approximately east-west) along the building. The north and south (long axis ends) of the building articulate approximately 25% glass windows. Similarly the East entry facing Gayhurst Road presents stained glass features surrounded by brick walls (Figure 5.33b). The foundation was not accessible at the time of the GEER-NZ Team's visit.

Figure 5.33 St Paul's church in Dallington area: (a) view looking east at the west end and (b) view looking west at the east end (-43.5196° , 172.6725° ; 1400 hrs on 12 September 2010)

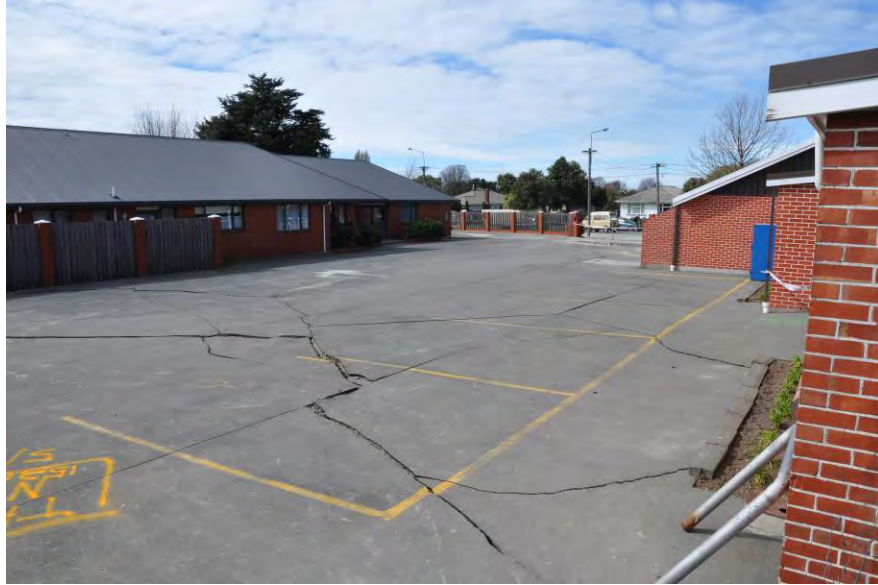
Figure 5.34 St Paul's church and surrounding school - Building B1 (on left) and St Paul's church (on right). (-43.519262°, 172.672636°; 1345 hrs on 12 September 2010)

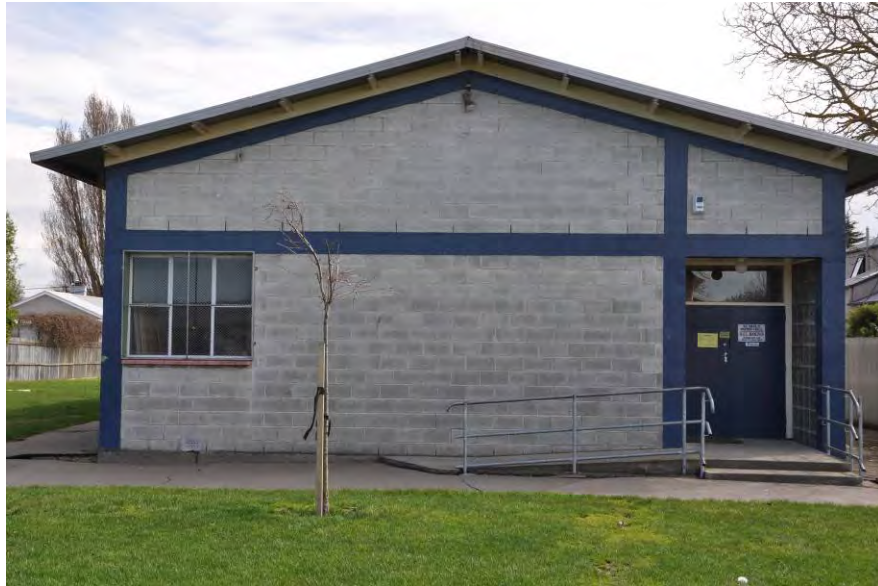
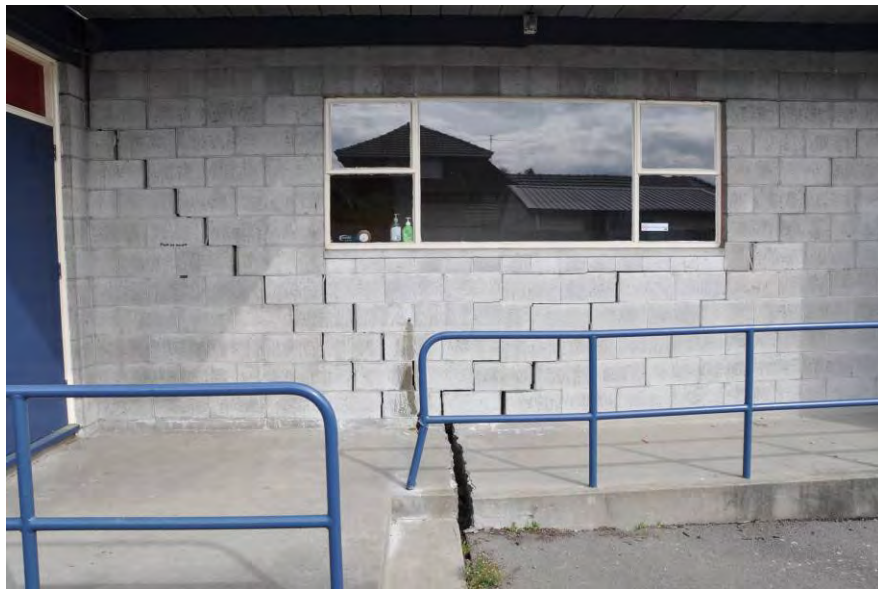
Figure 5.35 St Paul's church and surrounding school - Building B2: (a) view looking west and (b) view from north side of building, looking south. (-43.5193°, 172.6717°; 1300 hrs on 12 September 2010)

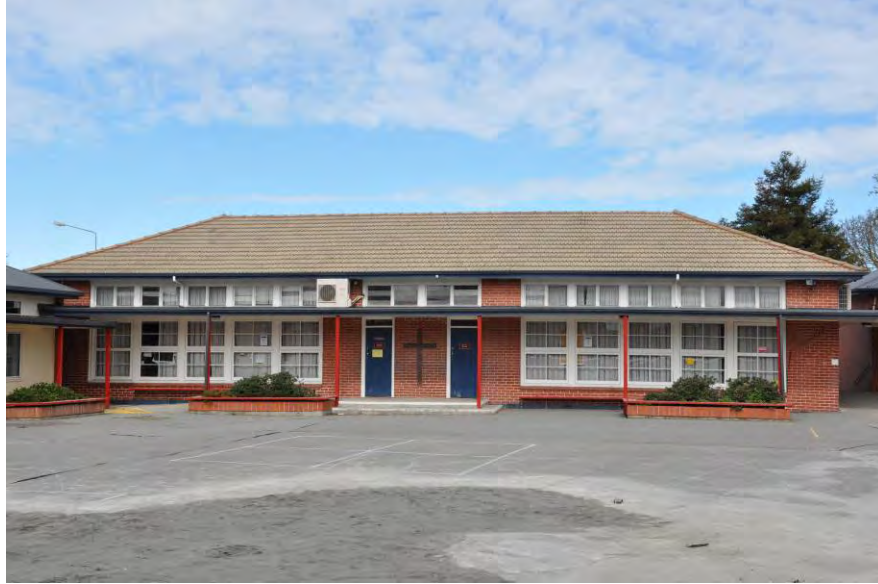
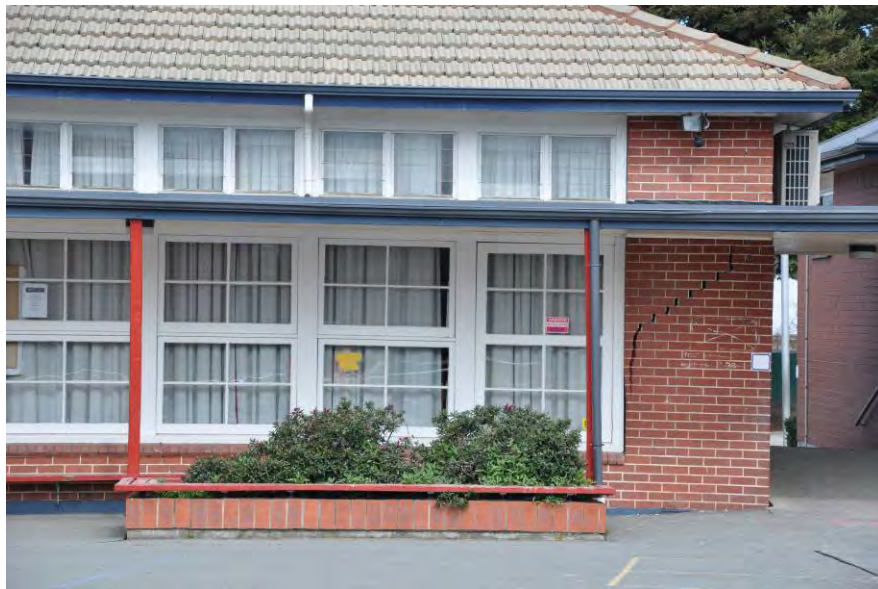
Figure 5.36 St Paul's church and surrounding school - Building B6 view looking south: (a) overall view of building and (b) West end of building. (-43.5200°, 172.6724°; 1300 hrs on 12 September 2010)

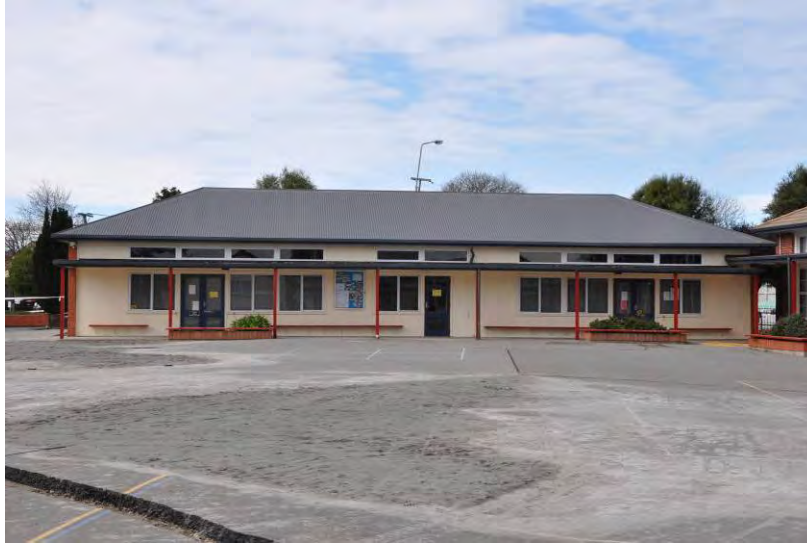
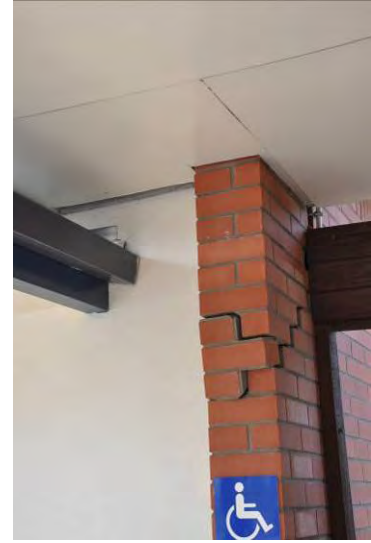
Figure 5.37 St Paul's church and surrounding school - Building B7: (a) view looking east and (b) view of south-west corner of building articulating column damage at wood-brick interface. (-43.5199°, 172.6726°; 1400 hrs on 12 September 2010)

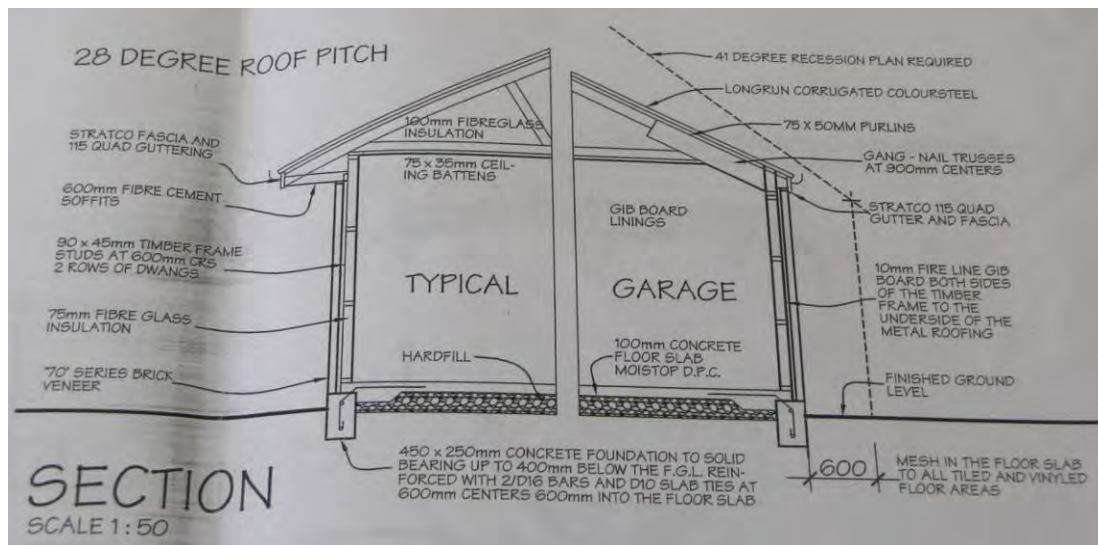
Foundation details for one house in Bexley are shown in Figure 5.40. The system set-out in Figure 5.40 is a perimeter beam with two D16 bars, D10 starter bars 600-mm long at 600 mm centers around the edges. The cavity inside the perimeter beam is filled with coarse gravel, covered with dampcourse, and then topped with a 100-mm thick concrete slab, which, apart from the starter bars, is mostly unreinforced. The drawing in Figure 5.40 specifies mesh reinforcing in areas that are to be tiled or covered in vinyl. Nonetheless, reinforcing was not observed to cross any fissure as noted in the drawing.

Figure 5.40. Concrete slab-on-ground details for the Bexley houses.

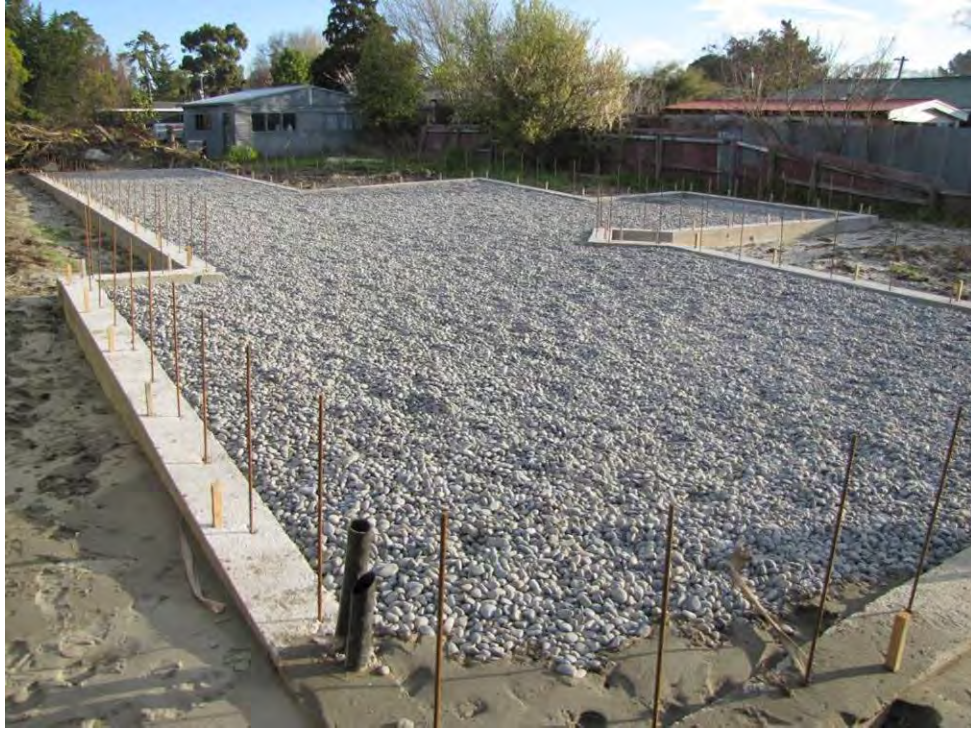
For contrast, an open foundation construction in the Pines Beach area (near Kaiapoi) was observed on 12 September 2010. The perimeter footing had been completed and the gravel fill was in place, the concrete slab was yet to come. Assuming the top of the perimeter footing was

close to level before the event, it was apparent that the footing was not capable of withstanding the ground deformation during the earthquake as the footing was no longer level (Figure 5.41). Two D16 reinforcing bars were observed in this footing where cracking had occurred.

Figure 5.41. Site at Pines Beach which appears to be using the same slab-on-grade system as at Bexley (Chichester St; -43.3877°, 172.70304°; 1800hrs on 12 September 2010)

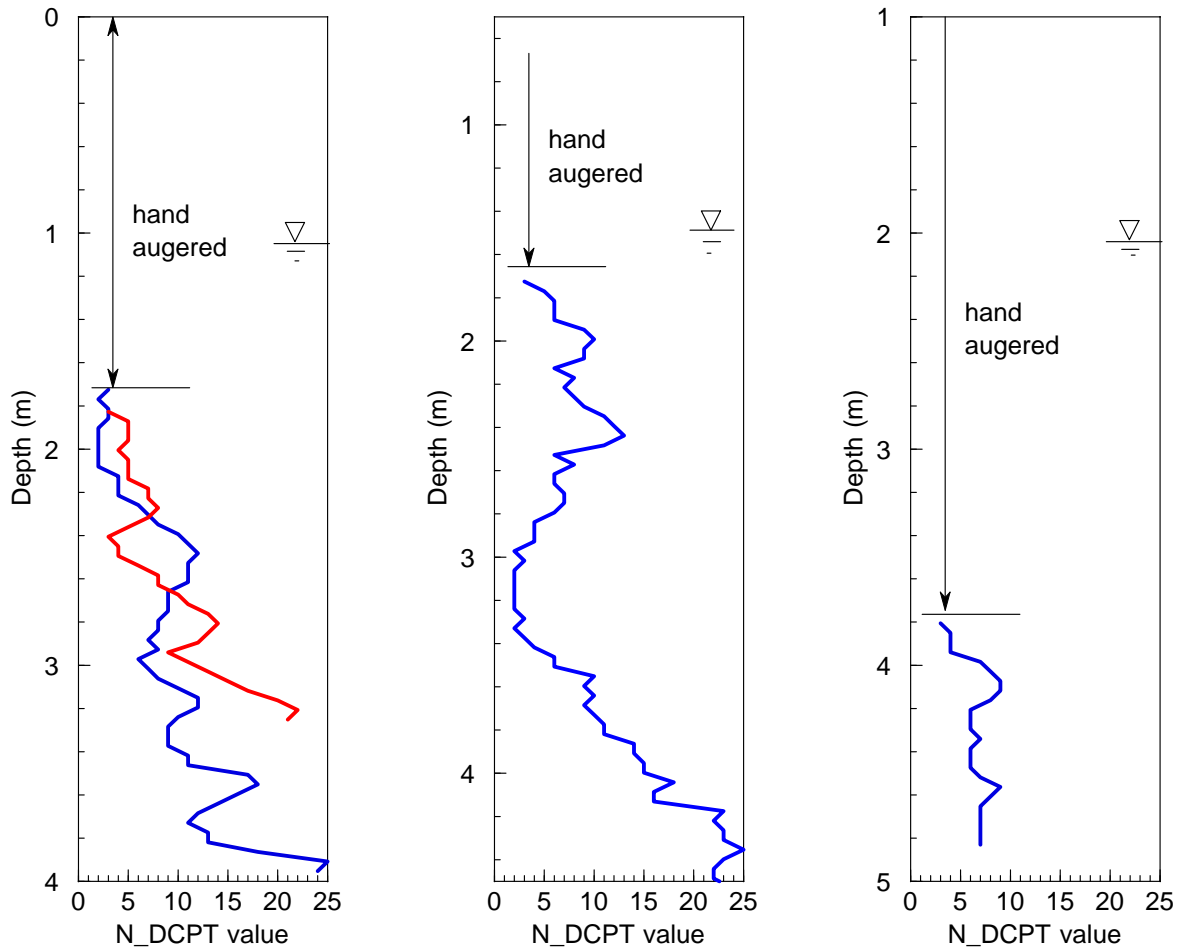
Figure 5.42. N_{DCPT} for the liquefiable layer for Spencerville (left: -43.43075° , 172.693000° ; -43.431583° , 172.693233°), Bexley (middle: -43.518370° , 172.722050°) and Courtenay Dr (right: -43.390010° , 172.662640°)

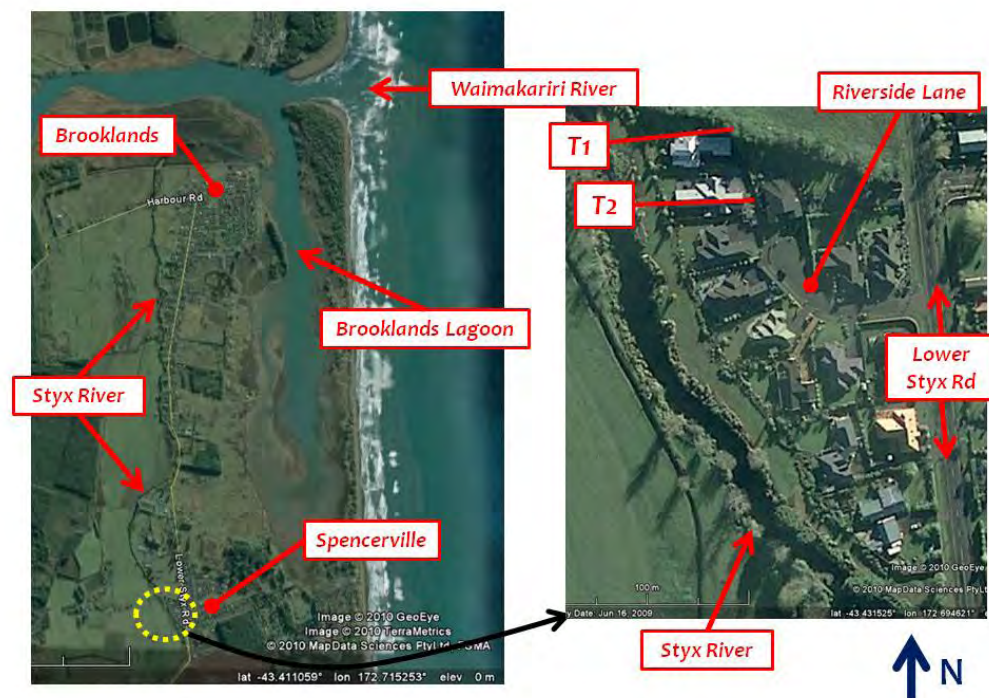
The residential communities of Spencerville and Brooklands were significantly impacted by liquefaction and lateral spreading. Lateral spreading was confined to regions along the Styx River (Figure 5.43), whereas liquefaction was pervasive throughout these two small communities, but particularly along the regions nearest the Brooklands Lagoon. Particularly significant structural damage due to laterally spreading was observed along Riverside Ln paralleling the Styx River (inset on right of Figure 5.43). Here five large and newly constructed (all within the last 10 years) houses were severely damaged due to laterally spreading (Figures 5.44-5.47). These houses were relatively large structures ($200\text{-}300\text{ m}^2$), compared to other developments in or surrounding Christchurch, and each appeared to be a custom design. All appeared to be resting on slab foundations with either light wood framing or brick/CMU walls.

Figure 5.43 Spencerville and Brooklands communities (inset on right identifies surveys conducted by GEER-NZ Team on 14 September 2010 along Riverside Ln). The distances from the left to right edges of the left and right images are ~3.9 and ~ 0.21 km, respectively. (Annotated GoogleEarth image)

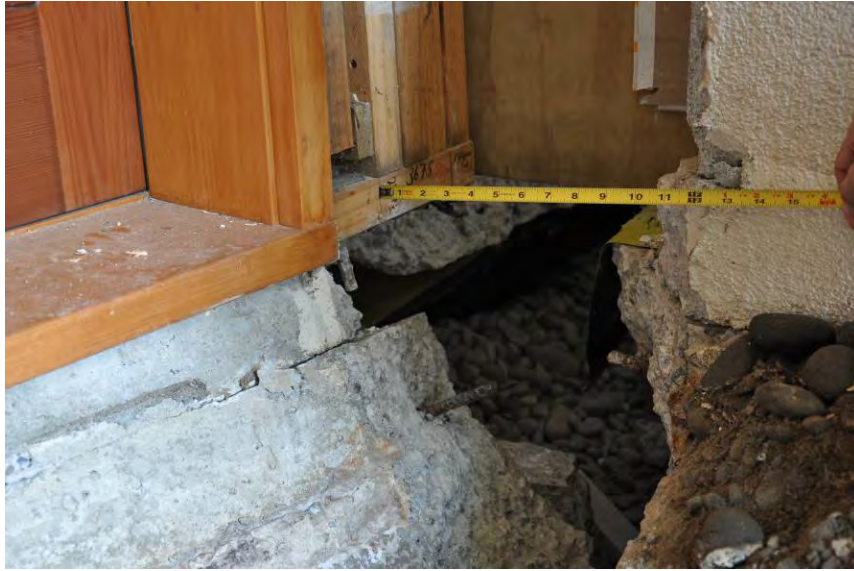
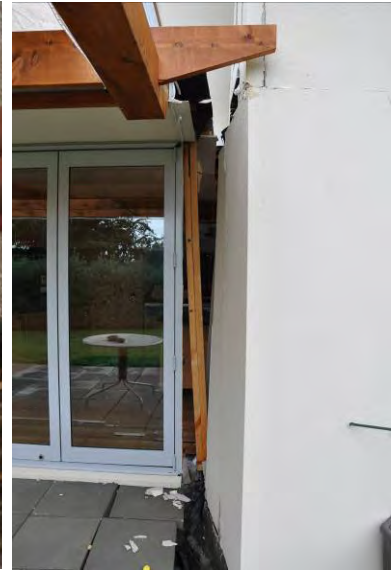
Unlike other areas affected by the earthquake, little ejected sand was observed, however strain relief manifested in the form of large lateral spreading fissures up to 400-500 mm in width in the worst places. The houses suffered only minimal settlement, however the laterally spreading continued through the houses, tearing ground slabs apart and propagating structural damage upwards towards the roofline (the roofline damage pattern here was not unlike that seen at St Paul's church in Dallington). From perimeter and interior views of the foundations of these homes, no reinforcing steel appeared to be present in the main slab. Residential structures in this area with the most severe damage were those with their longitudinal axis in the direction of the lateral spreading. Lateral spread features were long and extended through many properties (e.g. Figure 5.48). One home oriented with its long axis perpendicular to the direction of lateral spread had some damage at the connection between the garage and the house proper, but, unlike the others, was still occupied.

Figure 5.44. Ruptured floor slab near the front entrance of Riverside Ln. Clearly visible is the gravel infill shown in Figure 5.41 (note that there appears to be no ejected sand present). (a) ground fissure separating front entry of the house and (b) same ground feature propagated through the house and departing on opposing side. (-43.43096° , 172.6931° ; 1230hrs on 13 September 2010)

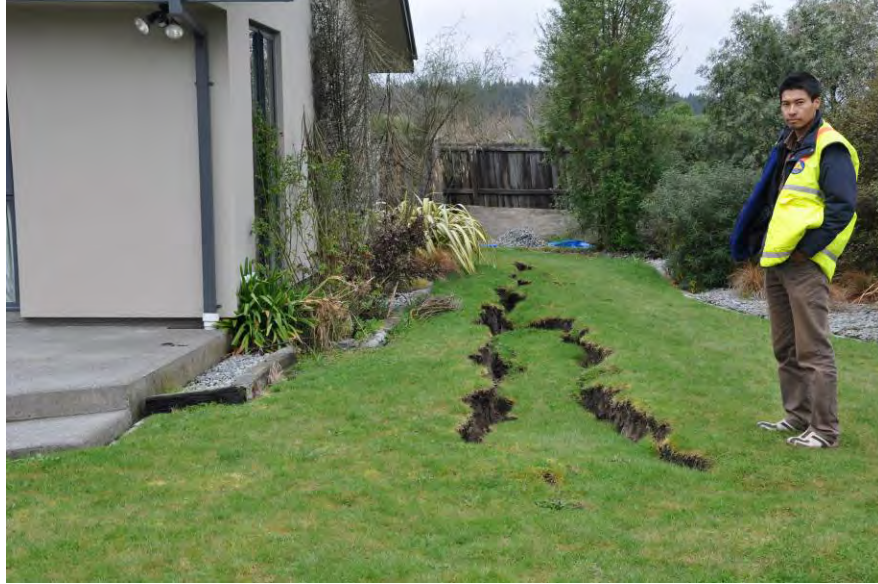
Figure 5.46. Lateral spread adjacent to residence at Riverside Ln. The location of this fissure is ~26 m from the nearby Styx River. (-43.4308° , 172.6930° ; 1230 hrs on 13 September 2010)
