GEOTECHNICAL RECONNAISSANCE OF THE 2010 DARFIELD (NEW ZEALAND) EARTHQUAKE

Version 1: 14 November 2010

EDITORS

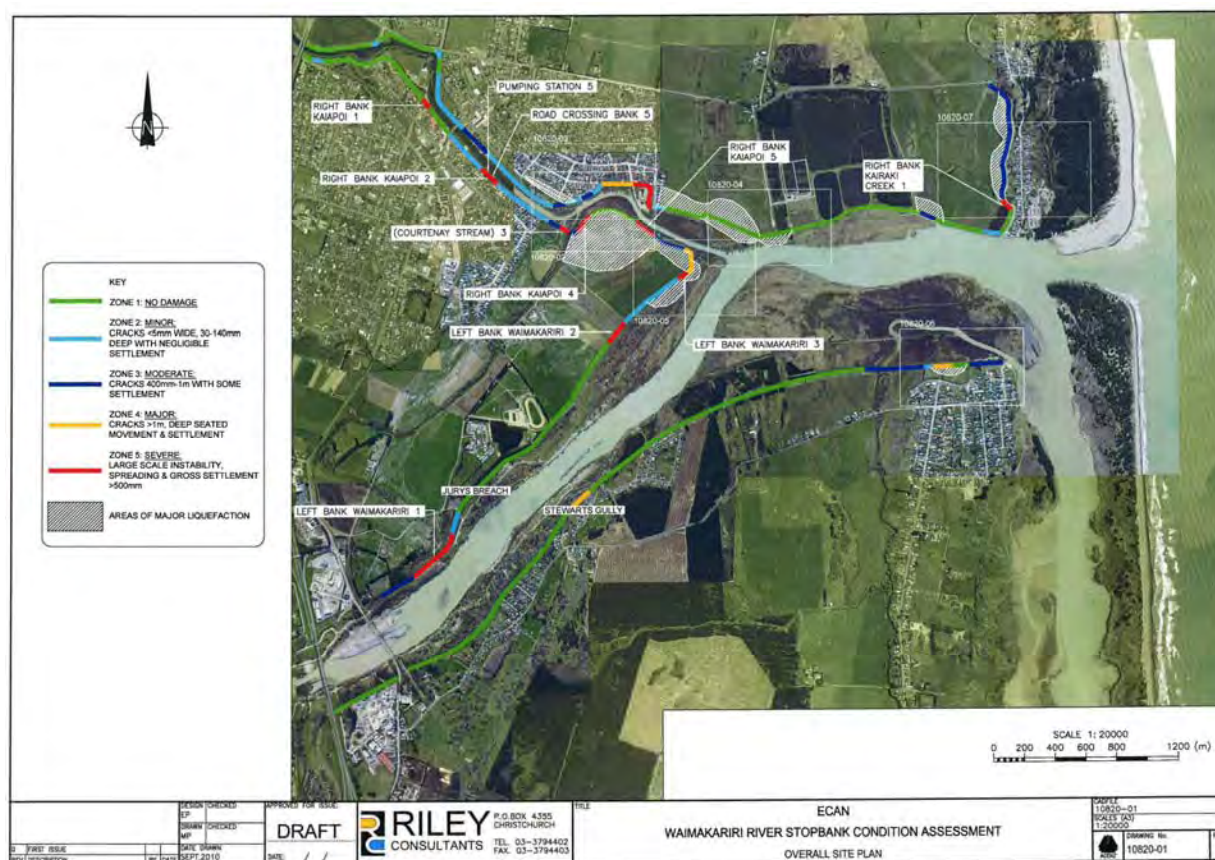
Overall, the levees along the Waimakariri River performed well during the earthquake, with only ~4 km out of ~17 km of levees requiring repair (Boyle, 2010). The majority of the damage along the Waimakariri River was downstream of SH1 (Figure 6.5). On the day of the Darfield event, ECan estimated that flood protection had been reduced from the 500 year event ($5000 \text{ m}^3/\text{sec}$) to the 15 year event ($1500 \text{ m}^3/\text{sec}$) in the lower reaches of the river, east of SH1. The river rose to $1000 \text{ m}^3/\text{sec}$ within days after the earthquake, raising concerns.

Figure 6.5 Post-earthquake damage survey of levees performed by Riley Consultants for Environment Canterbury along the Waimakariri River, downstream of SH1, and Kaipoi River. (Riley Consultants, 2010; courtesy of Ian Heslop and Tony Boyle, ECan)

Repairs to the high priority sites were expected to be completed within a few weeks after the earthquake, with medium priority sites expected to be completed in a couple of months. The cost of the repairs to the high and medium priority sites is estimated to be ~\$NZ 3million with total cost for all repair to be ~\$NZ 4million (Boyle, 2010, Heslop, 2010). ECan annual budget for maintenance and construction is \$NZ 4million.

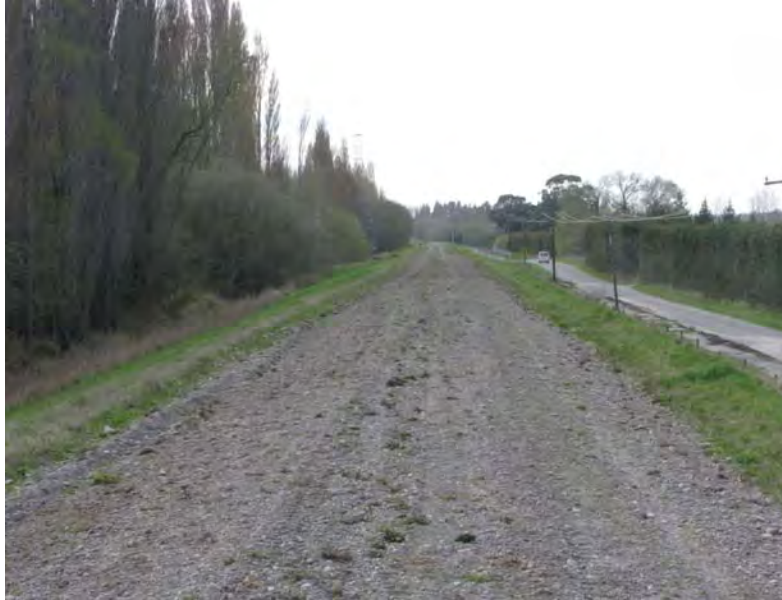
Figures 6.6-6.11 are photographs of the levees for the Waimakariri River along Coutts Island Rd. Numerous sand boils were found along the base of the levee for an ~0.5 km stretch (Figures 6.6-6.8), on both the river and land sides. By the time of the team's damage survey on 11 September 2010, the top of levee along this stretch had already been regraded (Figure 6.9), likely to fill in longitudinal cracks that formed along the crest of the levee. Figure 6.10 is of a ~2-cm wide longitudinal crack in the crest of the levee, located just outside of the ~0.5 km stretch where the crest road had been regraded. It is assumed that the longitudinal cracks in the stretch of levee where the crest road had been regraded were more significant than that crack shown in Figure 6.10, thus warranting the regrading. The liquefaction along the base of the levee and longitudinal cracks in the crest abruptly stopped outside of the ~0.5 km stretch; this may be seen in Figure 6.11, where no damage to the levee could be found.

Figure 6.9 Photo 4: Road on top of levee that had recently been reggraded, presumably after the earthquake to fill in longitudinal cracks formed during the earthquake. Liquefaction was observed along the base of both sides of the levee along this stretch. The location of this photograph is denoted in Figure 6.4. (-43.423943° , 172.631045°)

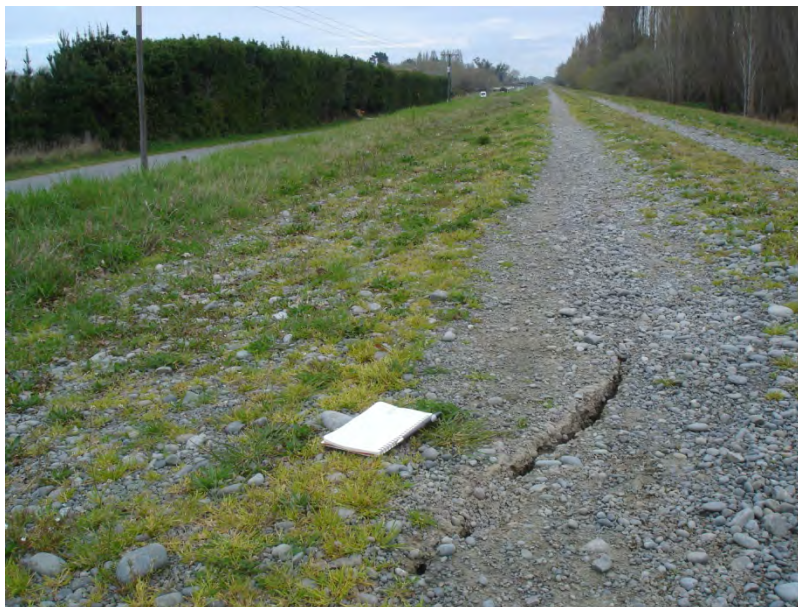
Figure 6.10 Photo 5: ~2-cm wide crack running lengthwise along the top of the levee on Coutts Island Rd. This crack was at the edge of the ~0.5 km stretch of the levee where significant liquefaction was observed. Photo taken looking southwest. The location of this photograph is denoted in Figure 6.4. (-43.423440° , 172.632349°)

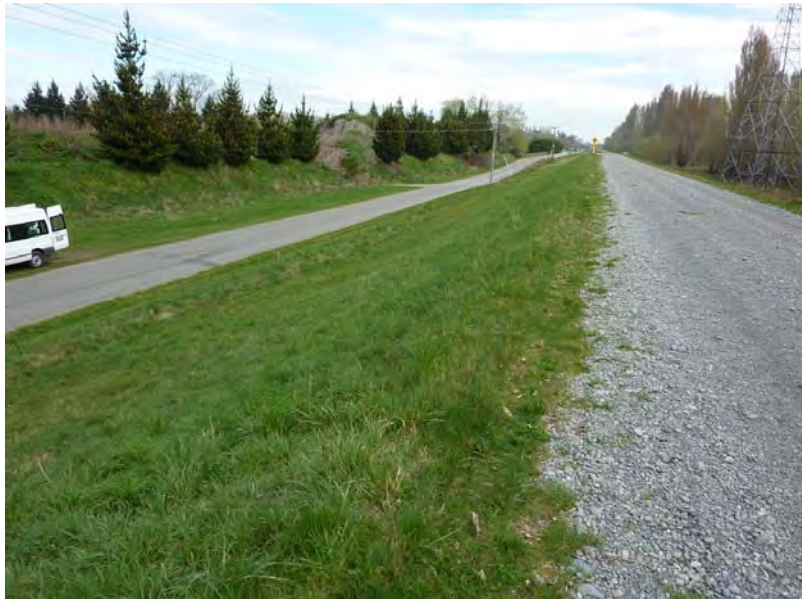
Figure 6.11 Photo 6: Stretch of levee without evidence of liquefaction. In the distance, a small rise can be seen in the road. This rise is the start of the ~0.5 km stretch where liquefaction was observed along the base of the levee. The location of this photograph is denoted in Figure 6.4. (-43.4225°, 172.6350°)

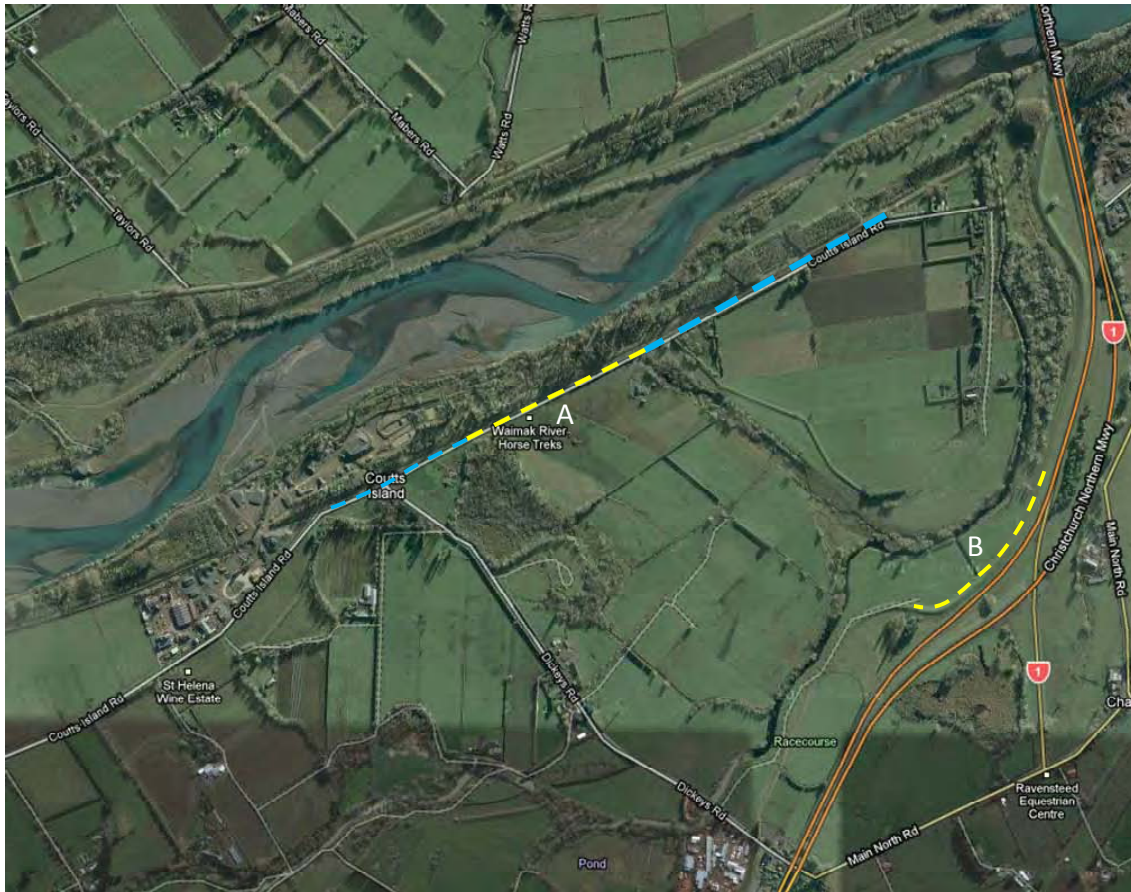
From interviews with local land owners, this section of the land that experienced widespread liquefaction was part of an old river channel. This was confirmed by review of old maps of the area. Figure 6.12 is an aerial image of the Coutts Island Rd area with the 1865 south branch of the Waimaikariri River channel highlighted in red. The ~0.5 km stretch of the levee where liquefaction was observed is denoted by the dashed yellow line (A) in this figure. As may be seen in this figure, the area that liquefied coincides with the location of the old river channel, while the stretches of levee with no observed liquefaction (dashed blue line) lie outside of the old river channel.

Figure 6.12 Overlay of 1865 stream channel on present day Coutts Island Rd. This image is ~3.5 km across (center -43.4266°, 172.6302°) (Google Inc. 2010)

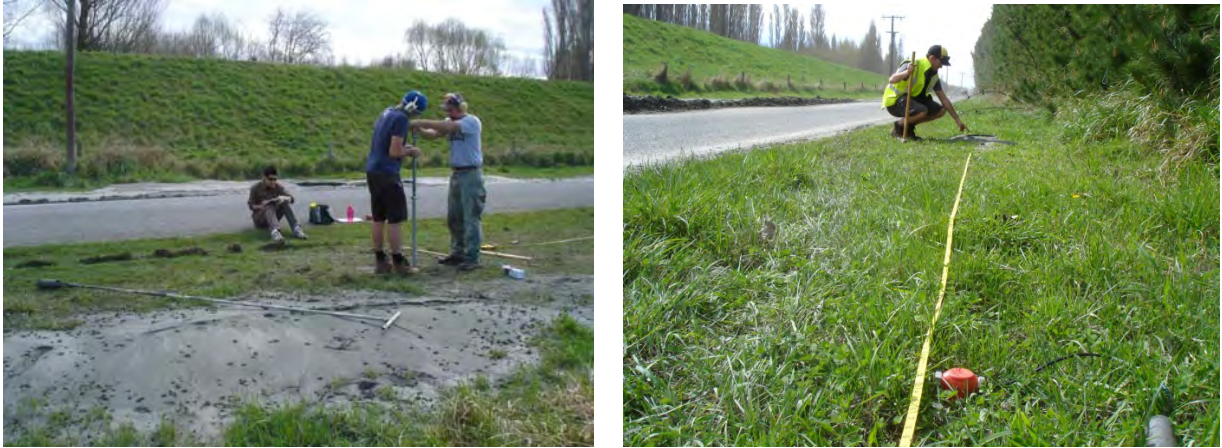
Three Dynamic Cone Penetration Tests (DCPT) and four Spectral Analysis of Surface Waves (SASW) tests were performed along the base of the levees along Coutts Island Rd, both in the areas that did and did not liquefy (Figure 6.13). The results of these tests are presented in Figures 6.14-6.16. The DCPT were performed in holes hand augered down to the top of the respective liquefied layers, with the layers identified by comparing sand boil ejecta with soil extracted with the auger at various depths. The test were performed until there was a noticeable increase in the DCPT N-value or we ran out of rods (~4.6 m from the top of the ground surface). (See the Liquefaction and Lateral Spreading chapter for a more detailed description of the DCPT test).

Figure 6.13 Photos 7 and 8: DCPT (left: -43.425137° , 172.628619°) and SASW test (right: -43.424342° , 172.630473°) performed in areas that did and did not liquefy along the levee on Coutts Island Rd. The locations of these photographs are denoted in Figure 6.4.

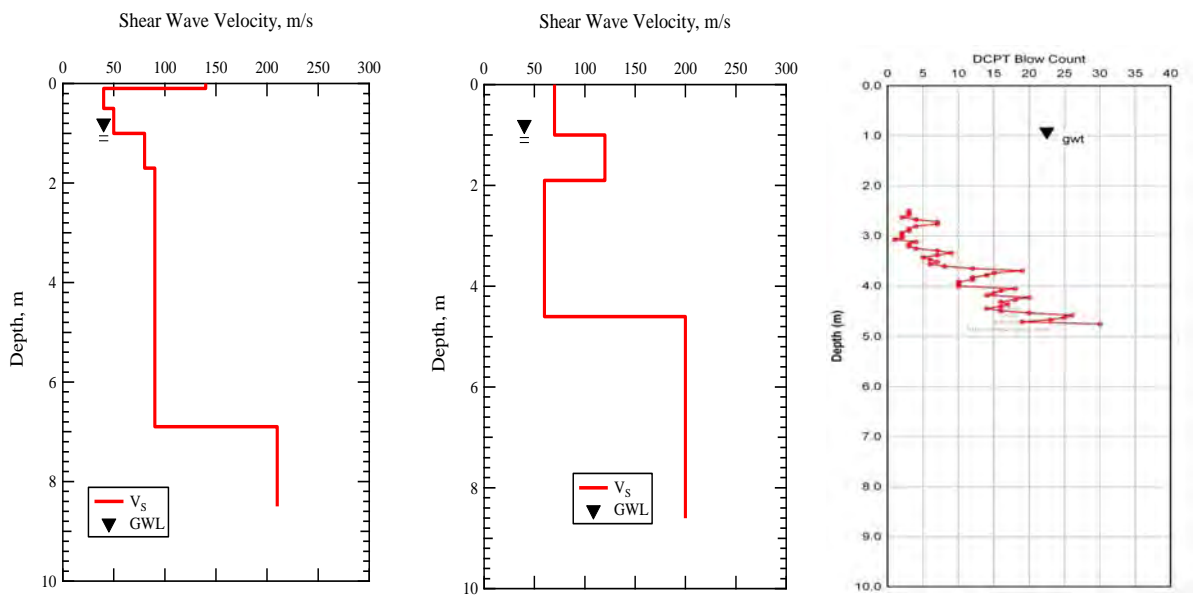
Figure 6.14 Results from SASW tests (left: SASW1 -43.425029° , 172.628676° ; middle: SASW3 -43.424351° , 172.630475°) and DCPT (right: DCPT1 -43.425139° , 172.628618°) performed along the base of the levee on Coutts Island Rd in an area that liquefied.

Other than SASW3 and DCPT1, performed about 175 m from each other in an area that liquefied, the agreement between the SASW and DCPT results is not very good in terms of depth to a stiff, presumably nonliquefiable layer. Further analyses are required to fully understand why. However, the sites that did not liquefy were along the banks of the old river channel. A liquefiable layer could not be found in these areas using the hand auger, and the soil profiles (DCPT2 and DCPT3) consisted of clayey sand and peat. Given the depositional environment of these profiles, it is likely that the strata varied significantly laterally, which could be the explanation for the poor agreement between the DCPT and SASW test results.

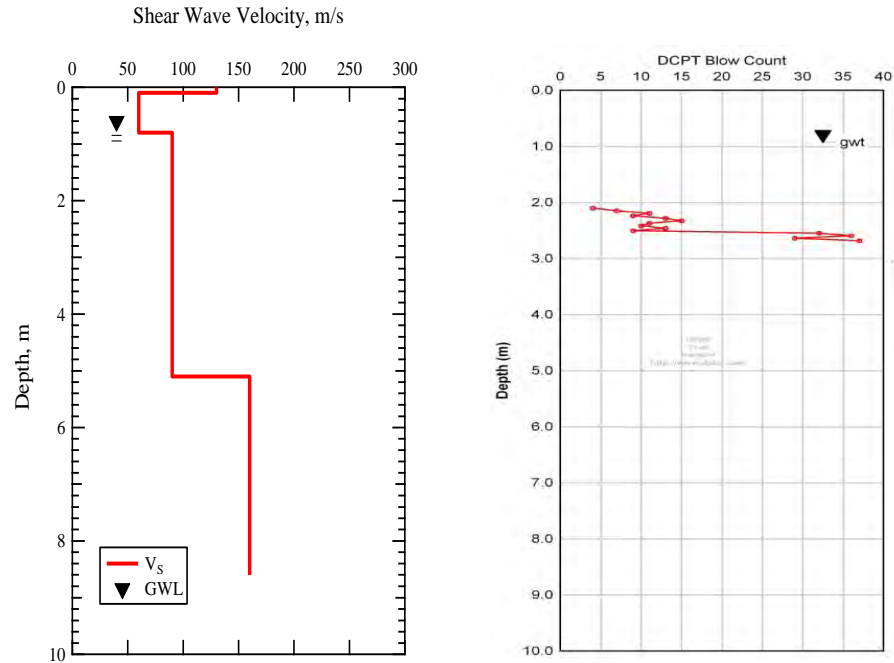
Figure 6.15 Results from SASW test (left: SASW2 -43.426294°, 172.625439°) and DCPT (right: DCPT1 -43.426186°, 172.625673°) performed along the base of the levee on Coutts Island Rd in an area that did not liquefy.

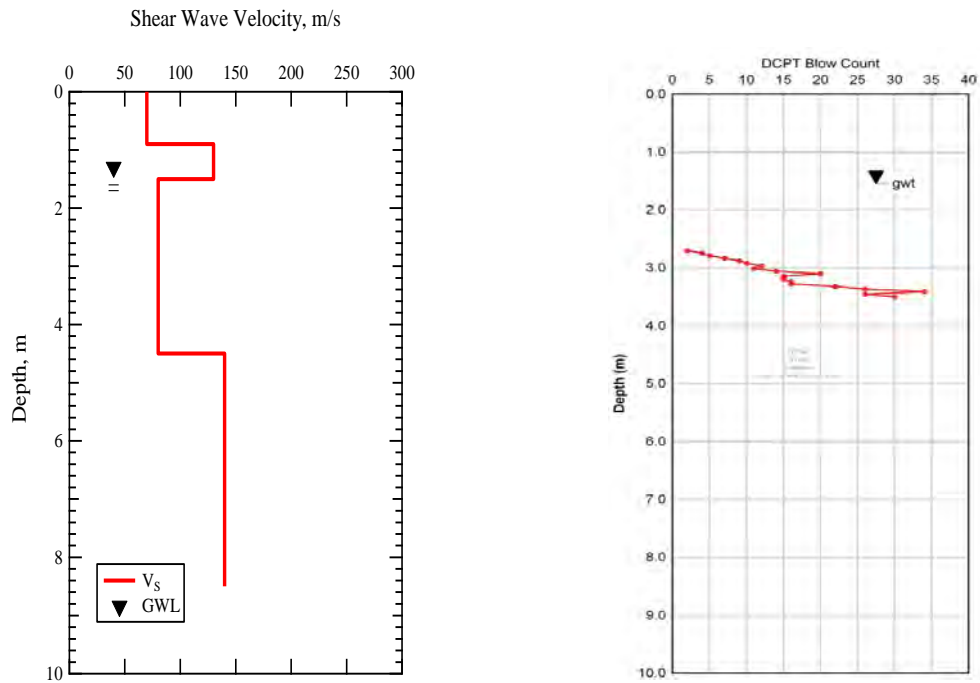
Figure 6.16 Results from SASW test (left: SASW4 -43.422635°, 172.635038°) and DCPT (right: DCPT3 -43.422685°, 172.635081°) performed along the base of the levee on Coutts Island Rd in an area that did not liquefy.

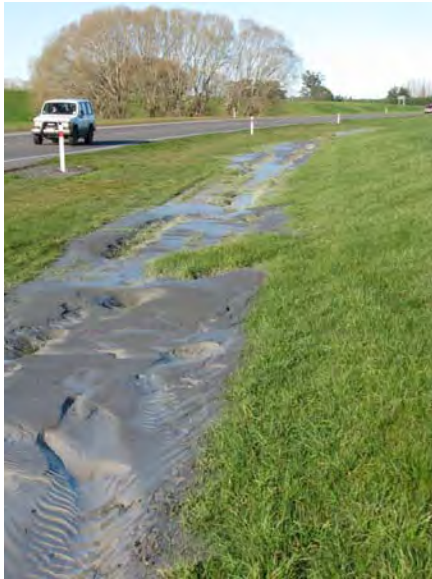
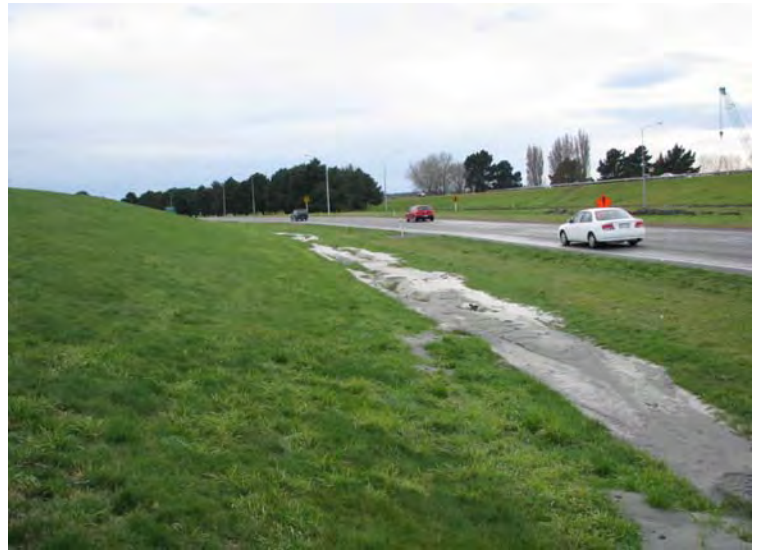
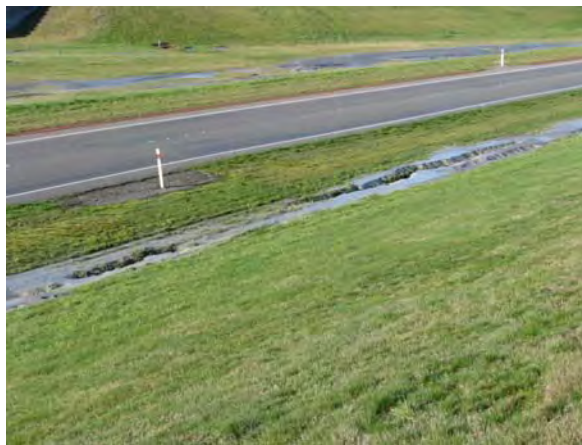
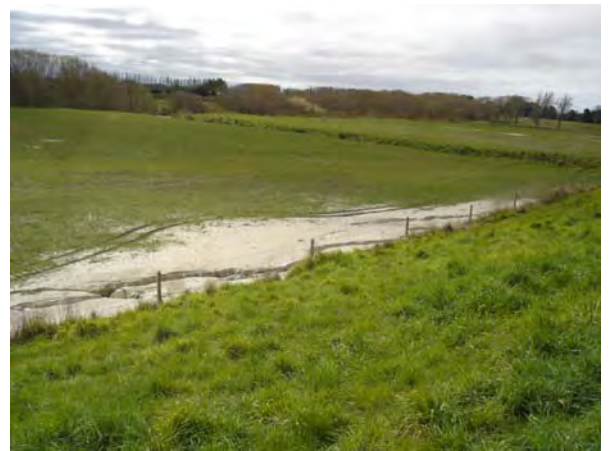
Figures 6.17 and 6.18 are photographs of a secondary levee for the Waimakariri River along State Highway 1. This stretch of levee is denoted by a dashed yellow line (B) in Figure 6.12. Liquefaction was observed on both sides of the levee and longitudinal cracks were observed running along the crest and sides of the levee (Figures 6.17 and 6.18). As may be seen from Figure 6.12, this stretch of the levee lies within the abandoned river channel of the old south branch of the Waimakariri River.

Figure 6.18 Photos 11 - 14: Liquefaction ejecta on both the river and landsides of the levee. The locations of these photographs are denoted in Figure 6.4. (-43.428968° , 172.645435°)

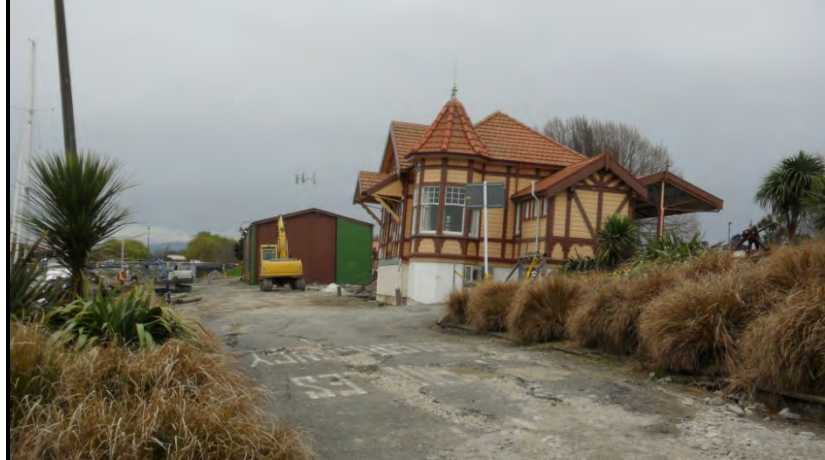
In downtown Kaiapoi adjacent to the river, the Visitors' Information Center on the north side of the river sank and tilted as a result of liquefaction and lateral spreading (Figure 6.19). Ground cracks, as wide as 30 cm and as deep as 100 cm, were observed running parallel to the river near this structure. The two-story Waimakariri-Ashley Coastguard building adjacent to the Visitor Center also suffered the same effects. Just east of this building (~100 m), ground cracks, on the order of 100-cm wide and 185-cm deep were also observed along the gentle inboard (land-side) slope of the levee (Figure 6.20). Lateral spread cracks with massive ejecta were observed at the toe of the embankment (Figure 6.21). Also, a skate park that was located about midway up the gently sloping inboard side of the levee was severely damaged by lateral spreading (Figure 6.22). Settlement/slumping of the foot path on the crest of the levee on the order of 10-30 cm were also noted. Detailed maps of the largest lateral spread cracks will be provided in subsequent versions of this report.

Figure 6.19 Photo 15: Visitors Information Center on the levee on the north side of the Kaiapoi River. The location of this photograph is denoted in Figure 6.4. (-43.387384° , 172.659743°)

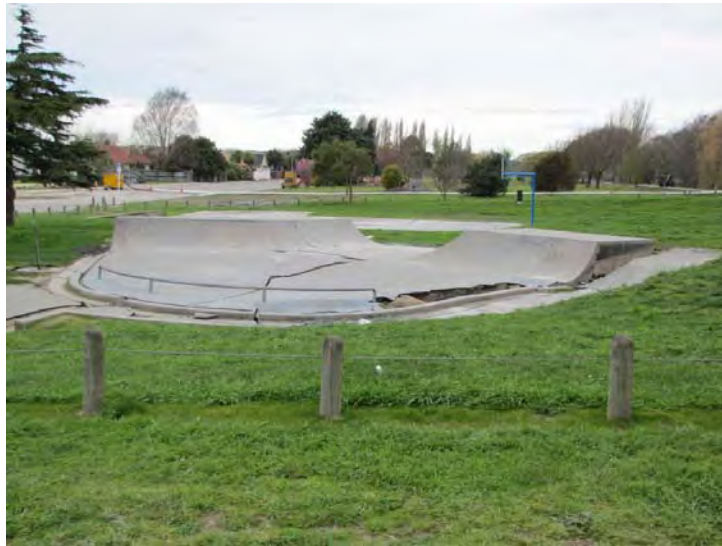
Figure 6.22 Photo 21: Skate park on the levee on the north side of the Kaiapoi River. The location of this photograph is denoted in Figure 6.4. (-43.384094° , 172.660370°)

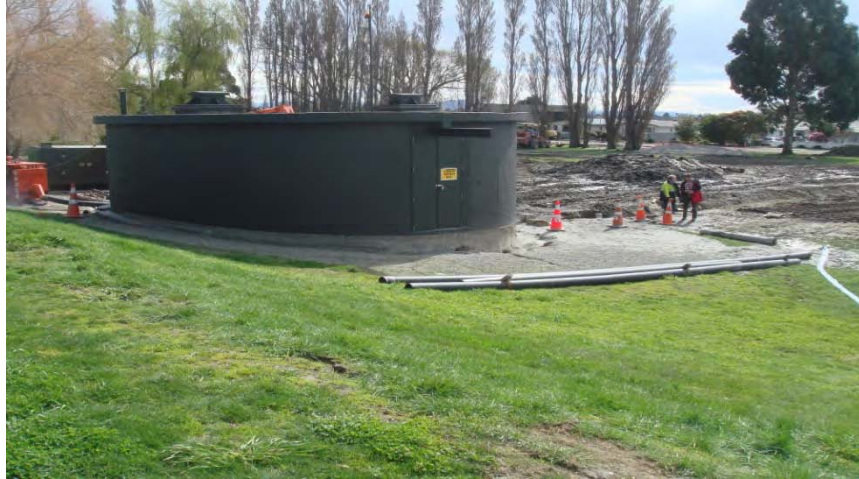
Further east along the Kaiapoi River (~400 m), the ground adjacent to a 6-m diameter structure (containing an underground tank and control equipment) settled by about 30 cm, resulting in damage to pipes attached to the tank (Figure 6.23). Additionally, aerial photographs of lateral spreading along the north bank of the Kaiapoi River going east from the town center are shown in Figure 6.24.

Figure 6.23 Photo 22: Tank that settled ~30 cm resulting in damage to attached pipes. The photograph numbers correspond to the locations denoted in Figure 6.4. (-43.386918° , 172.664412°)

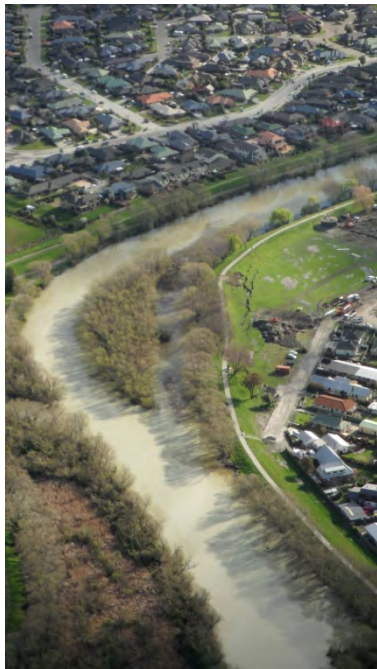
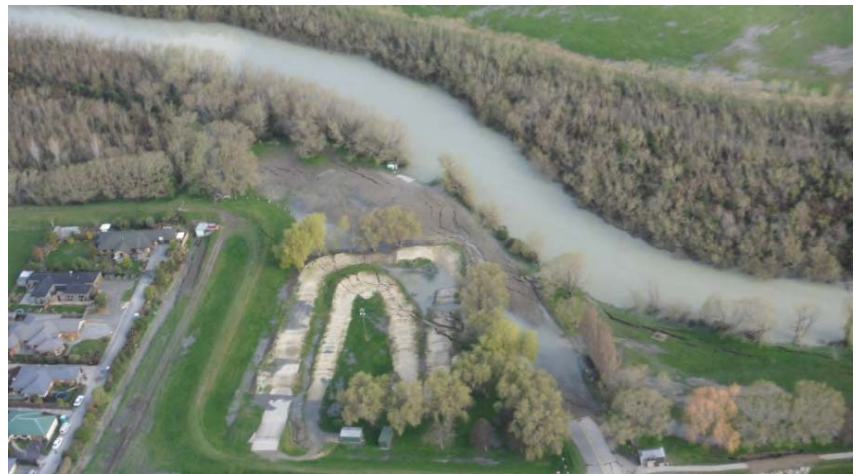
Figure 6.24 Photos 23 and 24: Aerial photographs of lateral spreading of levees on the north bank of the Kaiapoi River. The locations of these photographs are denoted in Figure 6.4. (left: -43.387389° , 172.666173° ; right: -43.386875° , 172.672297°)

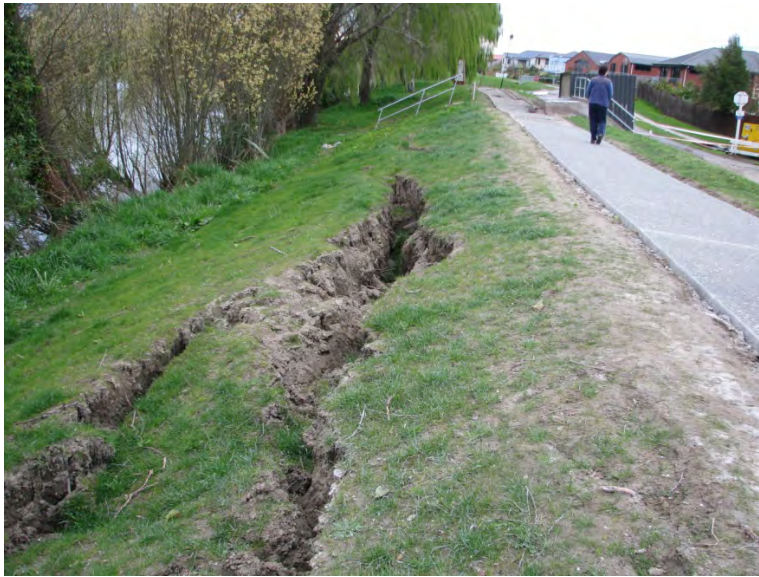
The levee along the south bank of the Kaiapoi River also experienced extensive lateral cracking, and the adjacent homes on Raven Quay experienced significant post-earthquake settlement. Figures 6.25-6.28 are photographs of the levee on the south bank of the river.

Figure 6.25 Photo 25: Lateral spread cracks along riverside levee on the south side of the Kaiapoi River. The location of this photograph is denoted in Figure 6.4. (-43.385254°, 172.660131°)

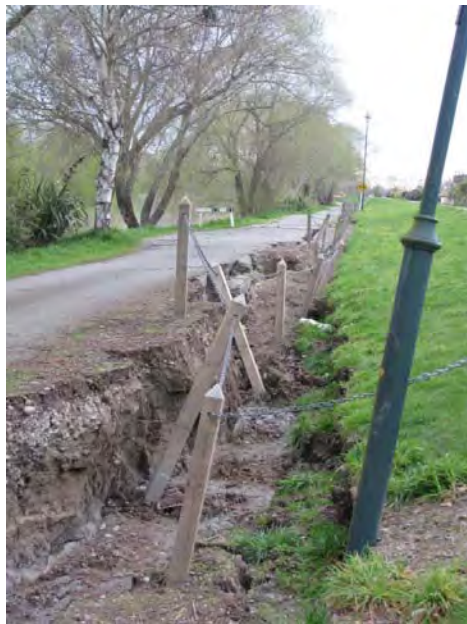
Figure 6.26 Photo 26: Lateral spread cracks along riverside levee on the south side of the Kaiapoi River. The location of this photograph is denoted in Figure 6.4. (-43.385839°, 172.660941°)

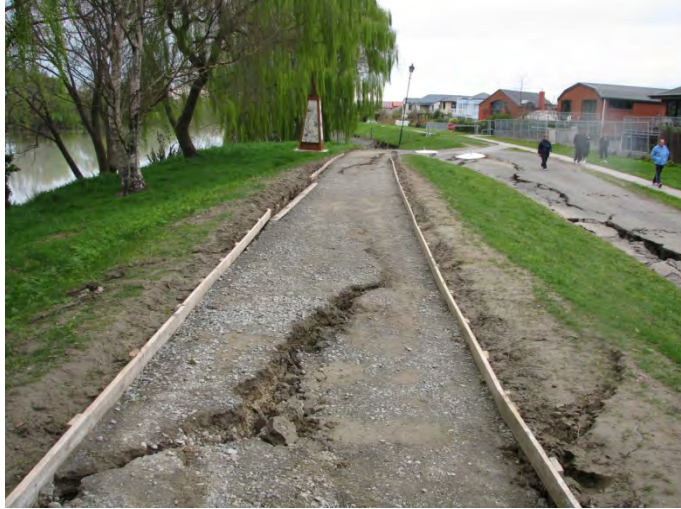
Figure 6.27 Photo 27: Lateral spread cracks along the top of the levee on the south side of the Kaiapoi River. The location of this photograph is denoted in Figure 6.4. (-43.385693°, 172.660688°)

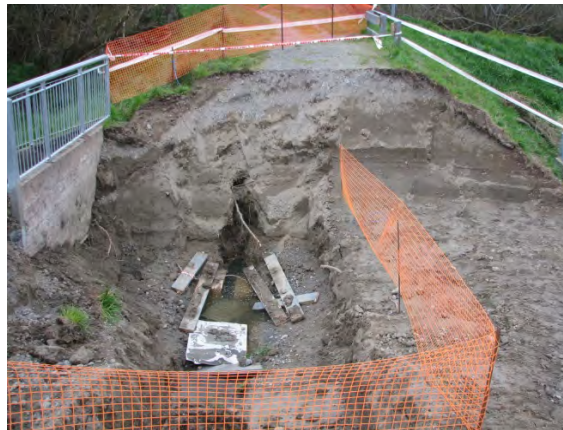
Figure 6.28 Photo 28: Failed drainage conduits running underneath the levee on the southside of the Kaiapoi River. The location of this photograph is denoted in Figure 6.4. (-43.388679°, 172.666203°)

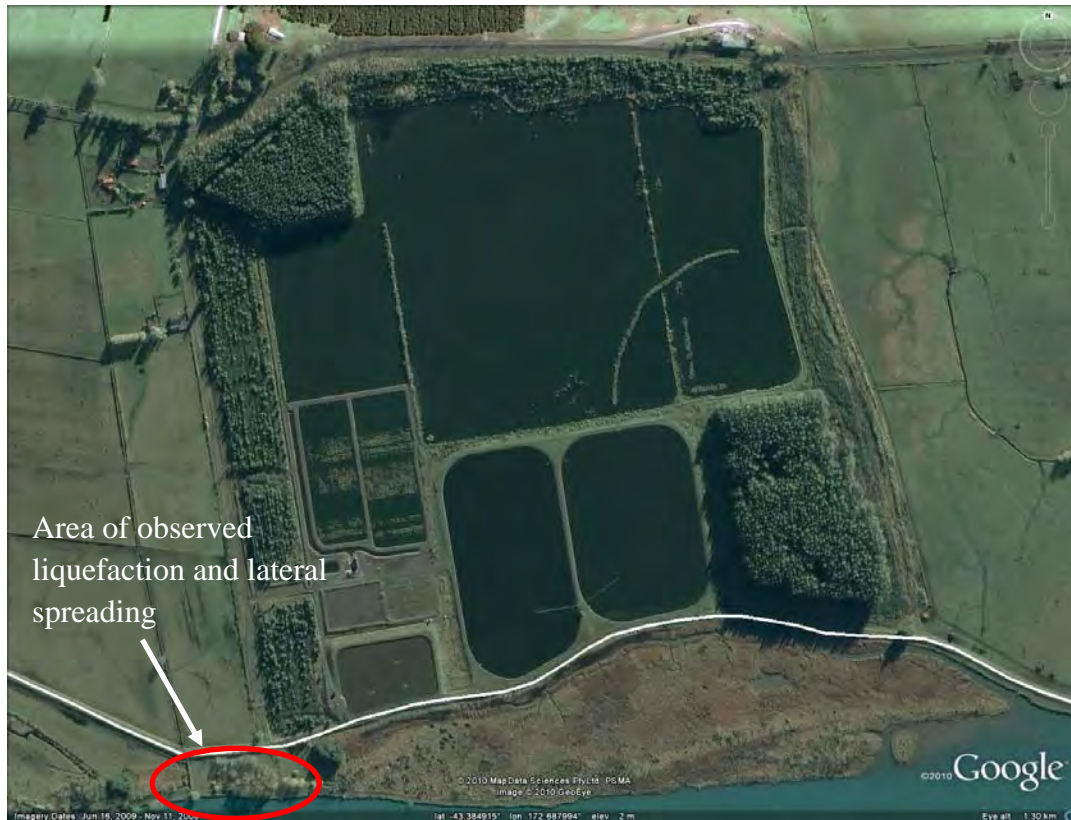
Figure 6.29 Aerial image of the Kaiapoi Sewage Treatment Plant. The southern perimeter (~0.6 km) of the oxidation ponds (bottom of image) forms the levees of the northside of the Waimakariri River. The distance from the left to the right edge of this image is ~1.5 km. (-43.384583°, 172.688240°)

The geotechnical reconnaissance team performed a damage survey on foot of the levees along the southern perimeter of the plant, denoted by the white line in Figure 6.29. No damage was observed along this stretch of the levees, although the team observed large lateral spread cracks (~30-cm wide) in the levees and shoreline about 100 m west of the southwest corner of the plant

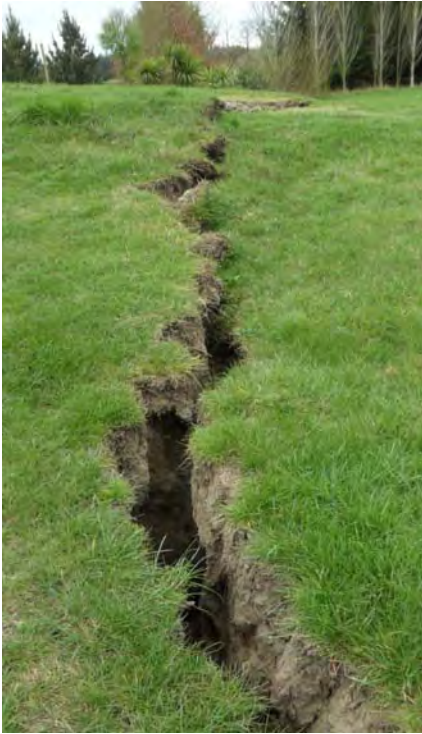
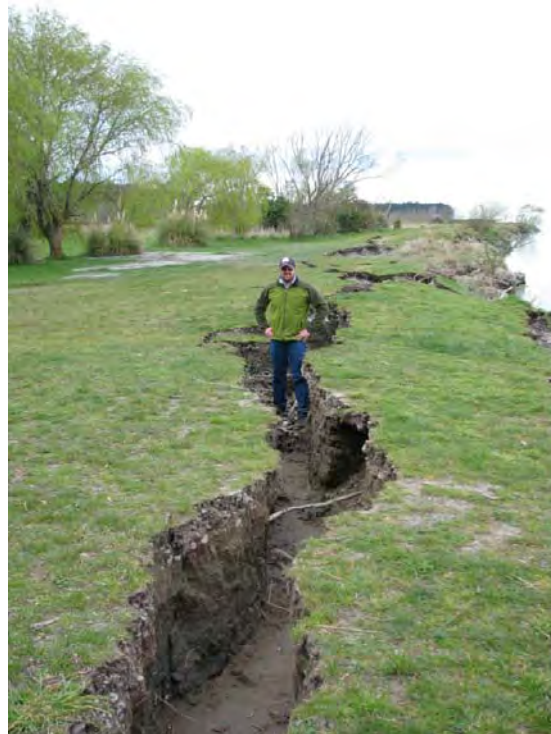
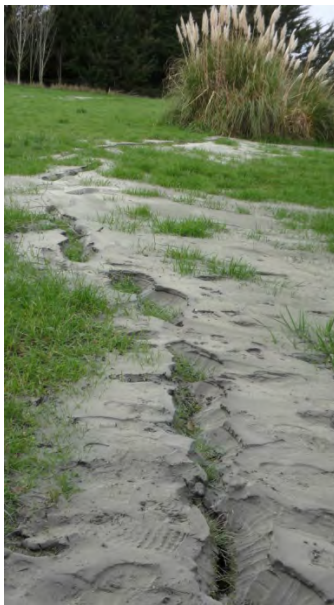
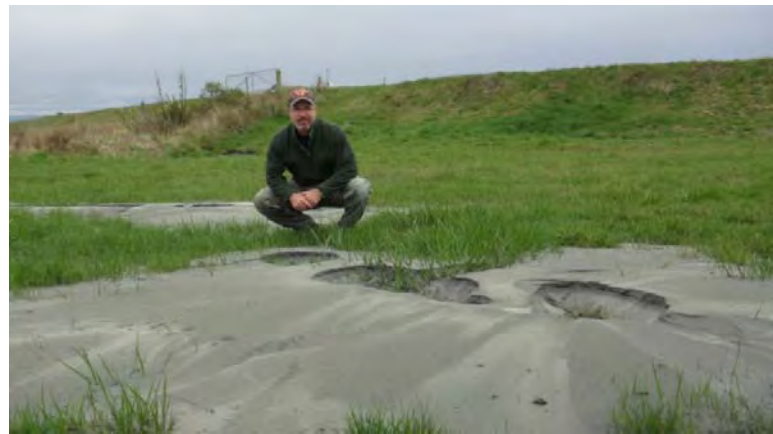
(Figure 6.29). Photographs of the liquefaction and lateral spread features at this location are shown in Figure 6.30.

Figure 6.30 Liquefaction and lateral spread features on or near levees located about 100 to 200 m west of the Kaiapoi Sewage Treatment Plant. (upper left: -43.389175° , 172.683235° ; upper right: -43.389701° , 172.683390° ; bottom left: -43.389519° , 172.682203° ; bottom right: -43.389432° , 172.6682060°)

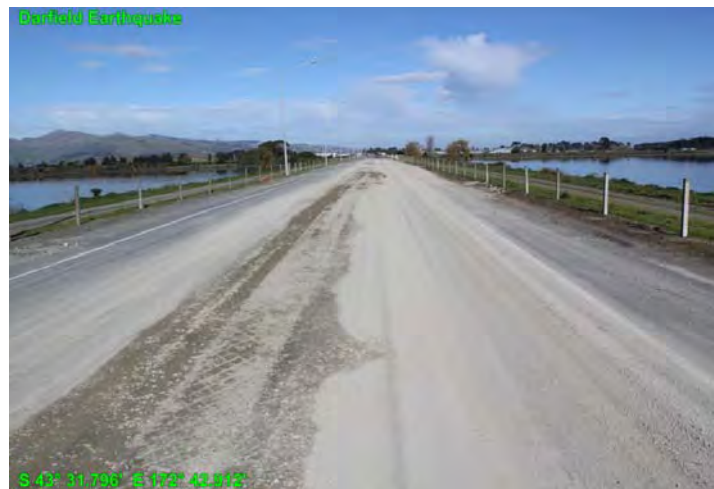
Dyers Road along State Highway 74 cuts through the oxidation ponds and connects the northern approaches to Christchurch with the port of Lyttelton to the south. Road pavements were cracked at the side of the oxidation ponds (between Ponds 2A and 3) and the road was impassable following the earthquake. According to the engineer interviewed at the site, a 50-cm wide crack had opened near the centerline of the road, although it was already filled with compacted dense graded aggregate during the site visit (Figure 6.32). Nevertheless, longitudinal cracks were still evident on the side of the road (Figure 6.33).

Figure 6.32 Repaired Dyers road that runs between Ponds 2A and 3. (-43.529933° , 172.715200°)

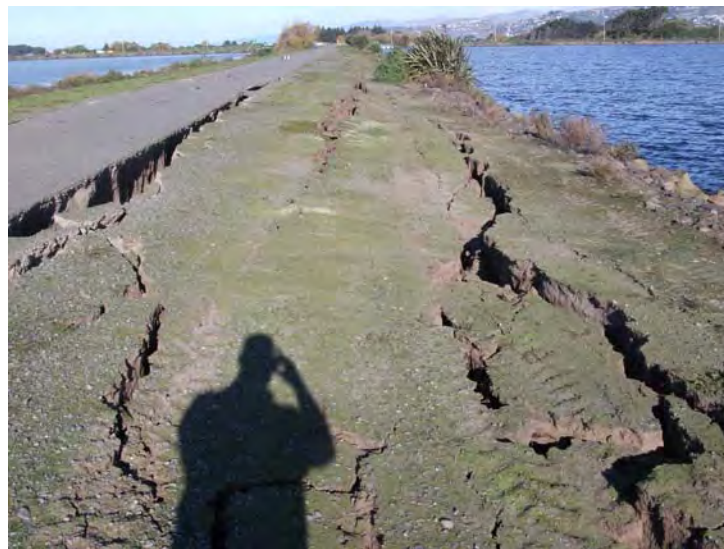
Figure 6.33 Lateral spread cracks running parallel to Dyers Road adjacent to Pond 2A. (-43.531393° , 172.712473°)

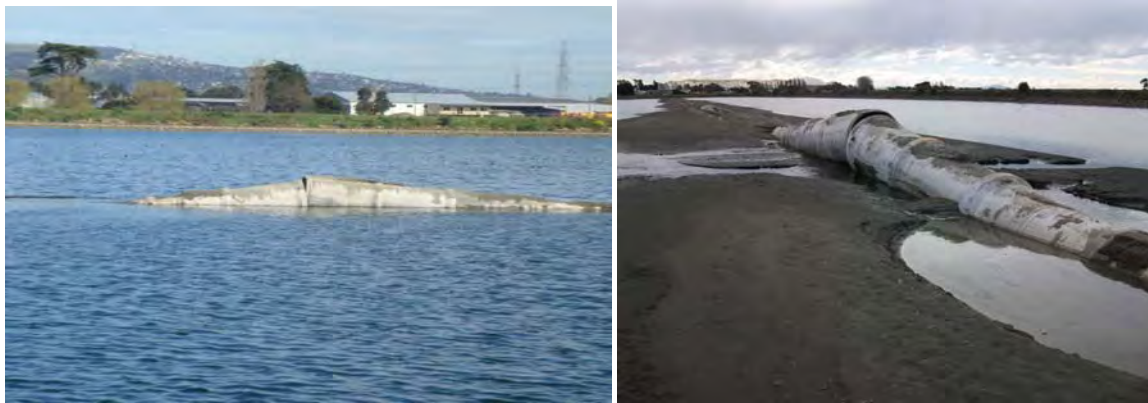
The distortion of the embankments noted above is indicative of bearing failure of the embankment as it has settled and spread in to the liquefied sub-soils, with large tension cracks forming through the fill used to form the embankments and pulling apart of concrete pipelines as the fill has spread. Site investigations undertaken indicate that the soils beneath the pond embankments are potentially liquefiable to depths of 10 m to 15 m.

Figure 6.34 Buckled pipe protruding from Pond 1 during pond dewatering, and after pond level was lowered. Pipeline crown was at the pond invert prior to the earthquake. (-43.530867°, 172.705190°)

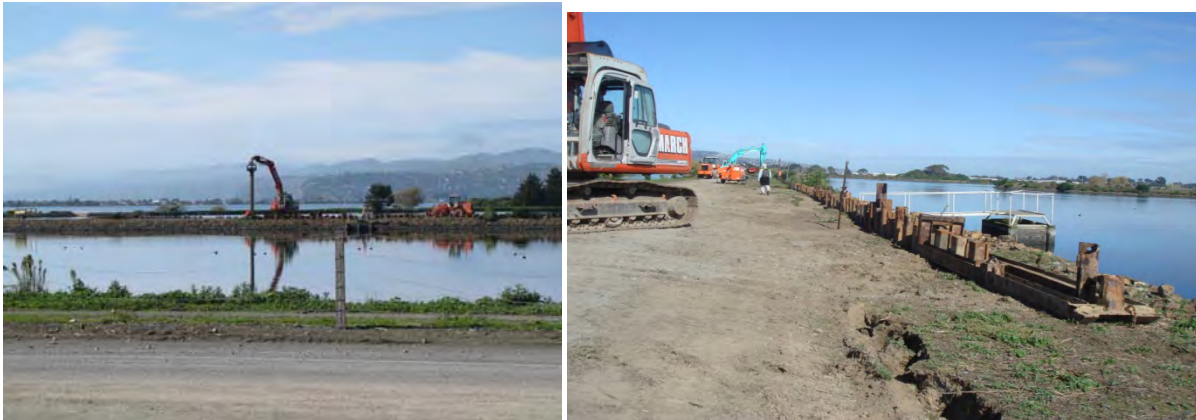
Figure 6.36 Sheet piles being driven to stabilize the pond embankment to arrest further movement. (-43.530563° , 172.718349°)

Because of the slumping of the pond banks, engineers decided to drop the pond water levels and reduce the hydraulic pressures on the embankments. At the time of the reconnaissance team visit, sheet piles were being driven into the Pond 3/6 embankment to stabilize it and arrest further movement (Figure 6.36). Furthermore, the pipelines beneath Dyers Road were being replaced.

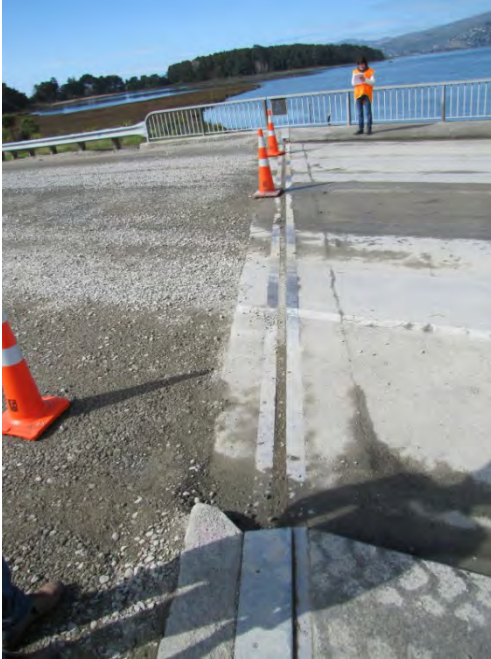
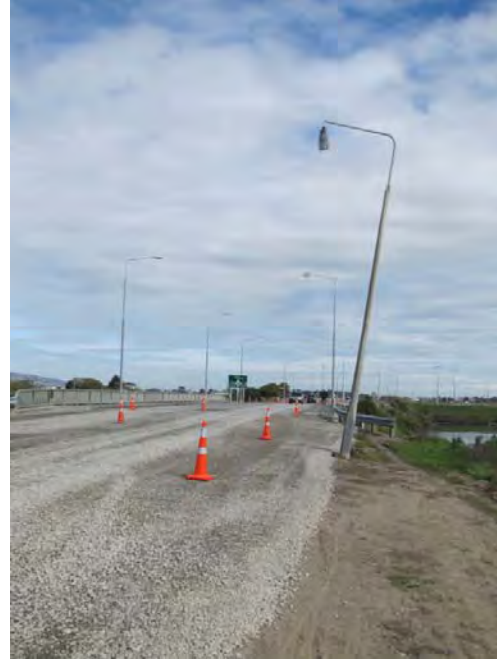
Perhaps the most significant damage at the road bridges observed by the GEER-NZ Team was at the Bridge Street bridge in South Brighton (-43.5253° , 172.7242°), an approximately 70-m span with a center pier and seat type abutments and a slight skew (less than 30 degrees) spanning the Avon River. The bridge was reportedly closed for approximately 10 days following the earthquake due to differential settlement at the east abutment. When the Team arrived on the 11th day after the earthquake, dense graded aggregate had been placed and compacted on the approach to the east abutment (Figure 7.1) and traffic was moving across the bridge once again. Cracking along the margins of the roadway and incipient lateral spreading perpendicular to the roadway was observed (Figure 7.2). There was also incipient spreading along the river bank on both sides of the east abutment (Figure 7.3). Closure of the gap between the bridge deck and abutment at the seat for the deck (Figure 7.4) as well as displacement on the bearing pads (Figure 7.5) suggests that the abutment moved slightly towards the channel. However, the abutment wall is supported on several rows of 14 inch octagonal precast, pre-stressed concrete piles, including a row of battered piles with a 3H:1V batter, as observed at the west abutment where the piles are exposed (Figure 7.6). Incipient lateral spreading of the bridge abutment, lateral spreading along the banks of the river (Figure 7.7), and closure of the gap at the bridge seat were also observed at the west abutment. The west abutment also appeared to have back-rotated slightly, possibly due to liquefaction-induced settlement of the approach fill, as evidenced by a gap between the back wall and the end fill (Figure 7.8) and tilting of the approach slab at the wing wall (Figure 7.9). There also appeared to have been some pounding between the south edge of the west end of the bridge deck and the abutment wall (Figure 7.4). The New Zealand Natural Hazard Platform Bridge Research Group has reported a thin horizontal crack just above the water line on the

Figure 7.1 Repaired east approach to the Bridge Street Bridge. (-43.5253°, 172.7242°)

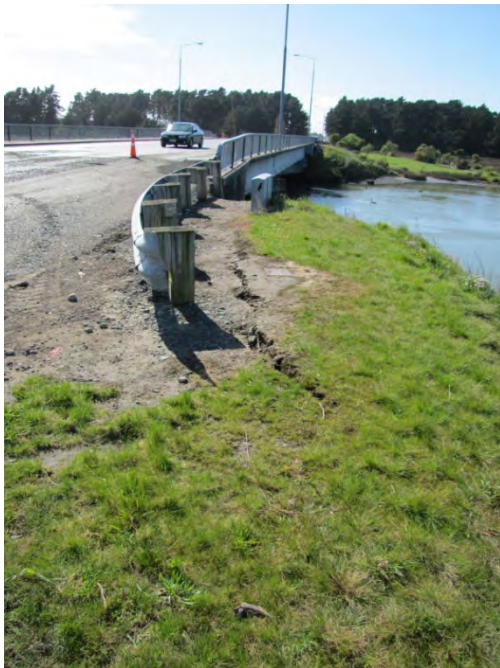
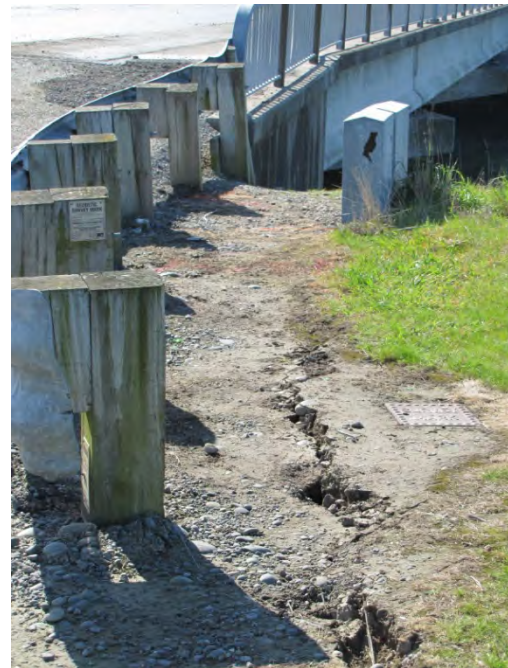
Figure 7.2 Cracking on margins of west approach embankment, Bridge Street Bridge. (-43.5253°, 172.7242°)

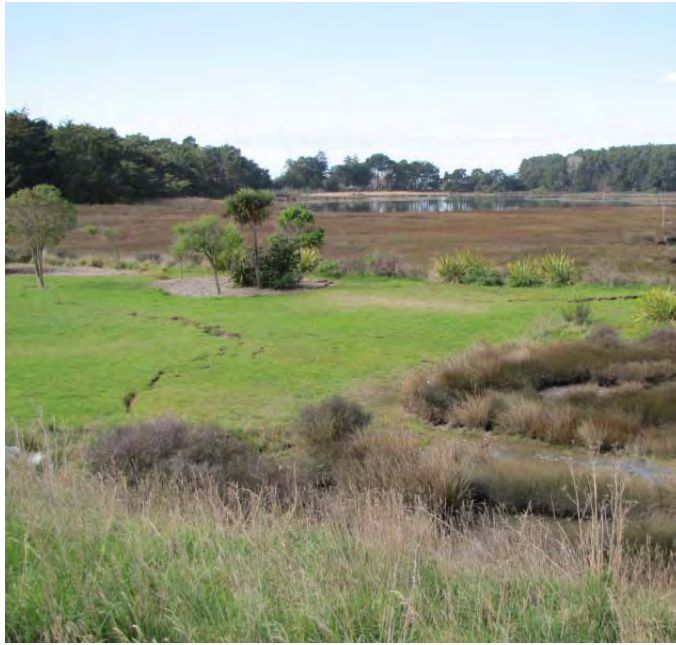
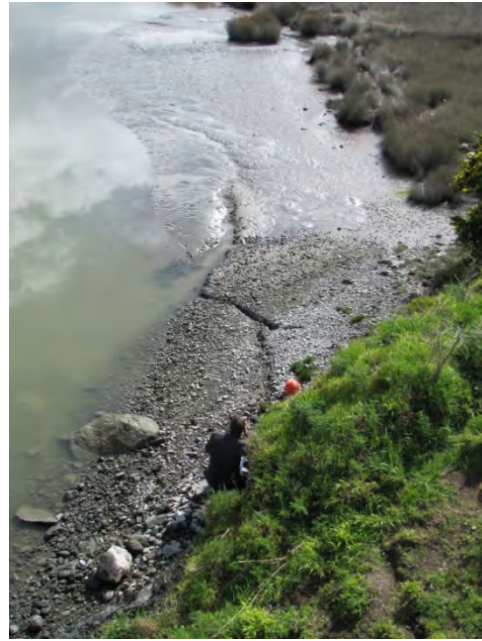
Figure 7.3 Lateral spreading of east banks adjacent to the Bridge Street Bridge. (-43.5253° , 172.7242°)

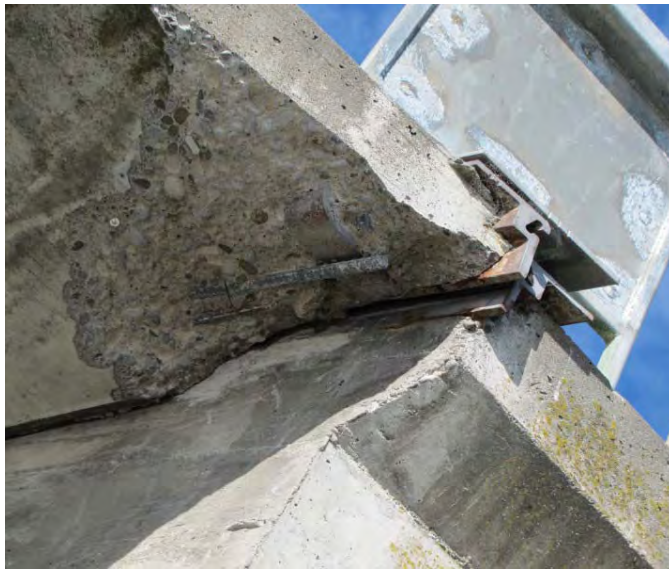
Figure 7.4 Bridge Street Bridge expansion gap closure: (a) West abutment gap closure and spalling; and (b) East abutment gap closure. (-43.5253° , 172.7242°)

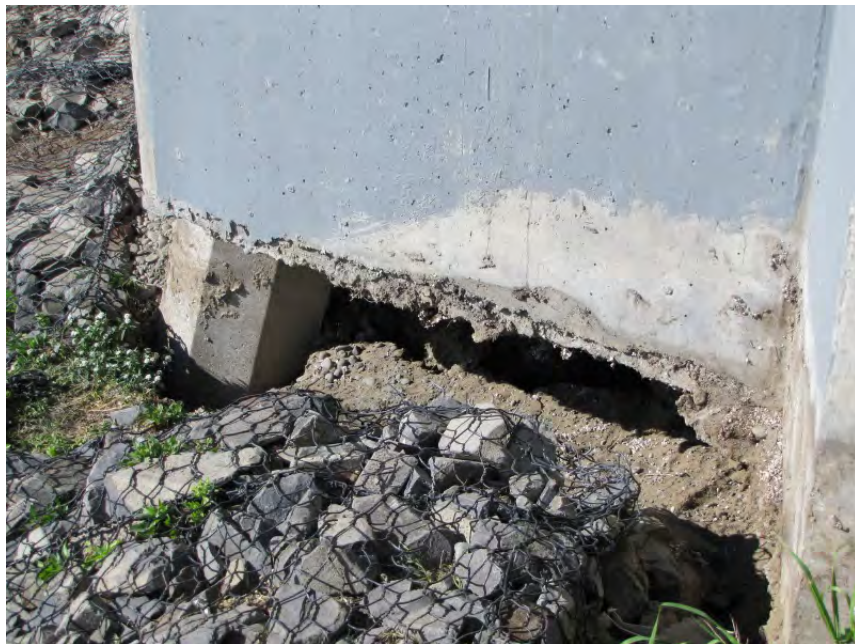
Figure 7.6 West abutment battered pile, Bridge Street Bridge. (-43.5253°, 172.7242°)

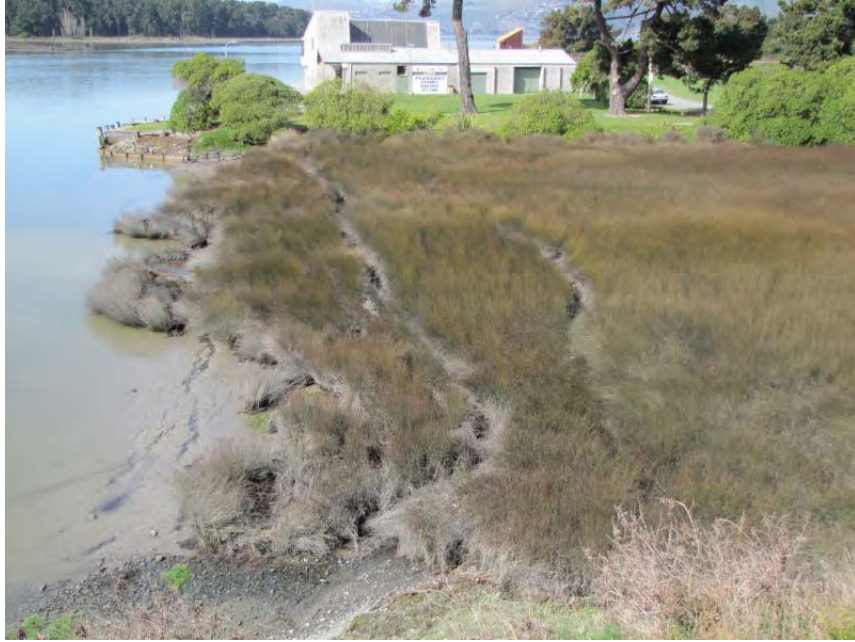
Figure 7.7 Lateral spreading on west bank, Bridge Street Bridge. (-43.5253°, 172.7242°)

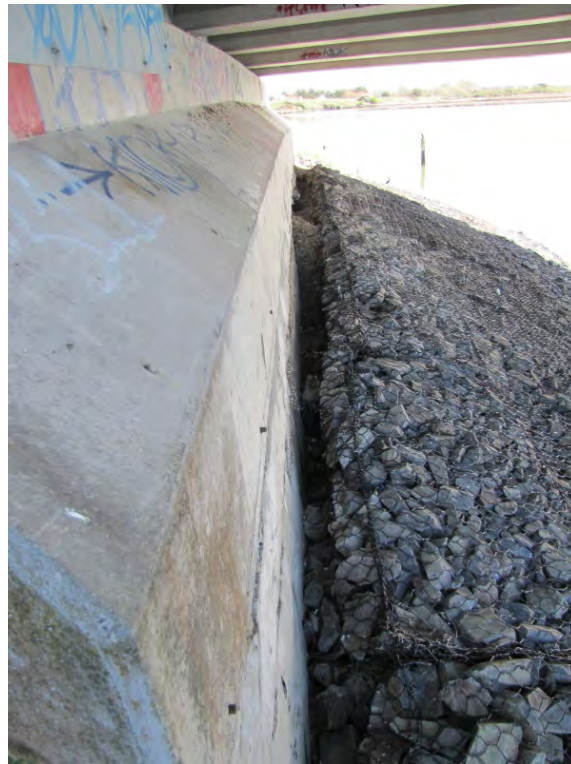
Figure 7.8 Gap between west abutment backwall and end embankment, Bridge Street Bridge. (-43.5253°, 172.7242°)
