GEOTECHNICAL RECONNAISSANCE OF THE 2010 DARFIELD (NEW ZEALAND) EARTHQUAKE

Version 1: 14 November 2010

EDITORS

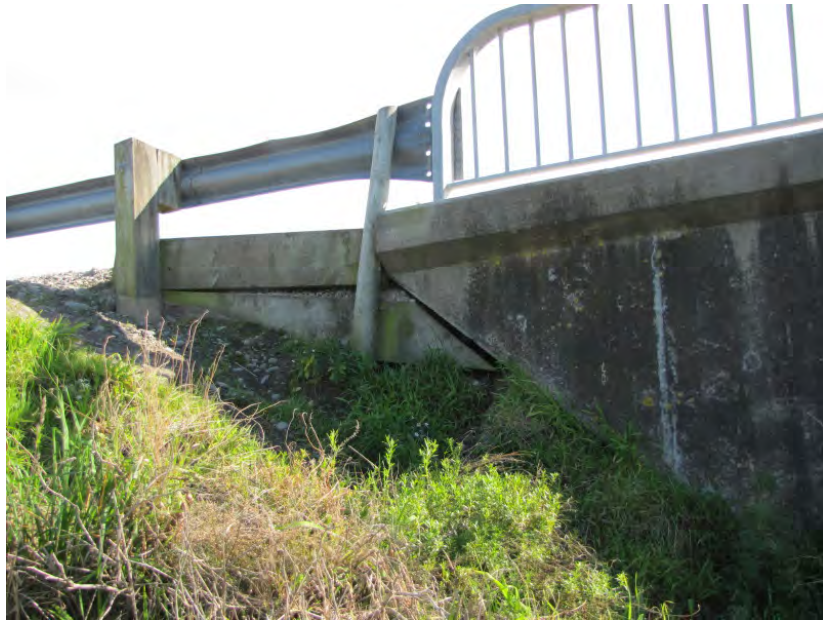
Figure 7.9 Back rotation of west abutment, Bridge Street Bridge. (-43.5253°, 172.7242°)

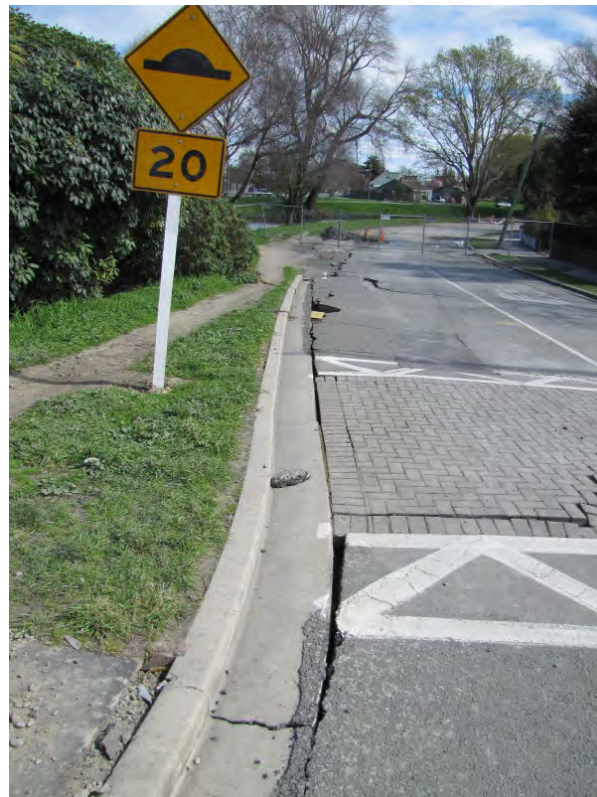
Incipient lateral spreading of the bridge approach fills and abutments walls and cracking of abutment walls were observed at bridges across the Avon River in Christchurch at Swanns Road (-43.5222° , 172.6600°) and Gayhurst Road (-43.5217° , 172.6728°). Both bridges are relative small (approximately 30 m) simple spans with integral abutments constructed in 1954. At both locations cracking in the roadway on the approaches to the bridge (Figure 7.10) and at Swanns Road lateral spreading of the approach fill (Figure 7.11), incipient lateral spreading at the abutments (Figures 7.12 and 7.13), and cracking of the abutment and retaining walls (Figure 7.14 and 7.15) was observed. However, both bridges remained serviceable. At the footbridge crossing over the river approximately midway between the Swanns Road and Gayhurst Road bridges, just south of where Medway Road joins River Road on the west bank of the Avon River (-43.531° , 172.6656°), the rather light deck of the bridge buckled to accommodate the lateral spreading at the abutments (Figure 7.16).

Figure 7.10 Cracking of roadway on west approach fill, Swanns Road Bridge. (-43.5222°, 172.6600°)

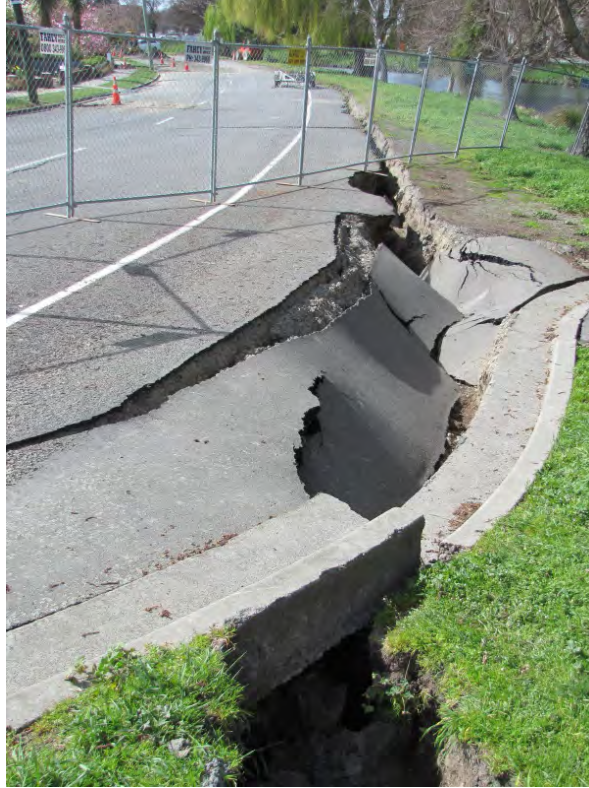
Figure 7.11 Lateral spreading on west approach fill, Swanns Road Bridge. (-43.5222° , 172.6600°)

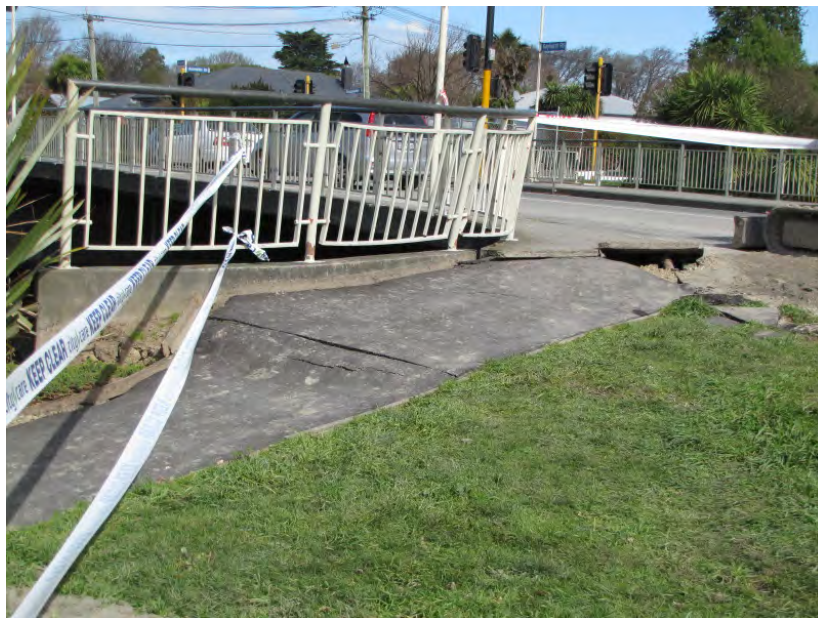
Figure 7.12 Incipient lateral spreading at west abutment, Swanns Road Bridge. (-43.5222° , 172.6600°)

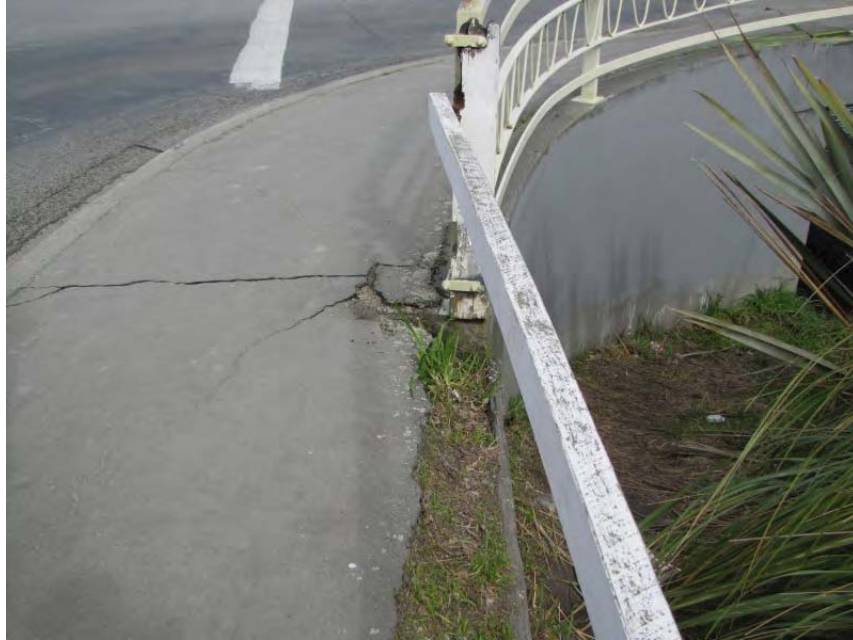
Figure 7.13 Incipient lateral spreading at north abutment, Gayhurst Road Bridge. (-43.52172° , 172.6728°)

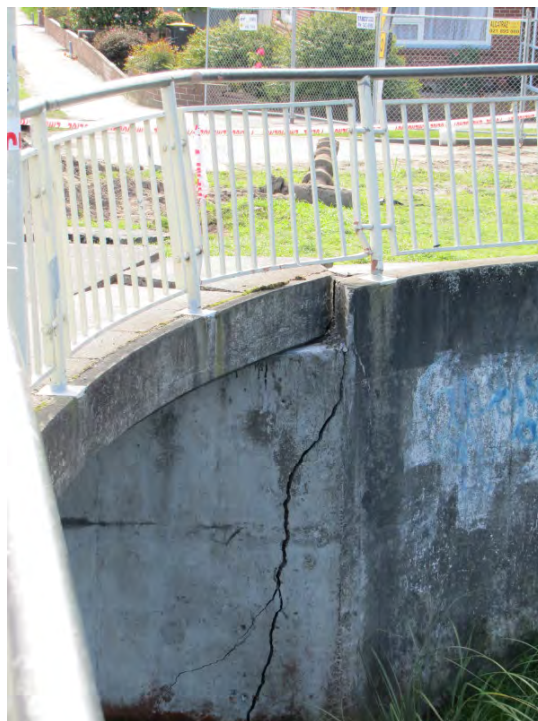
Figure 7.14 Cracking of north abutment, Swanns Road Bridge. (-43.5222° , 172.6600°)

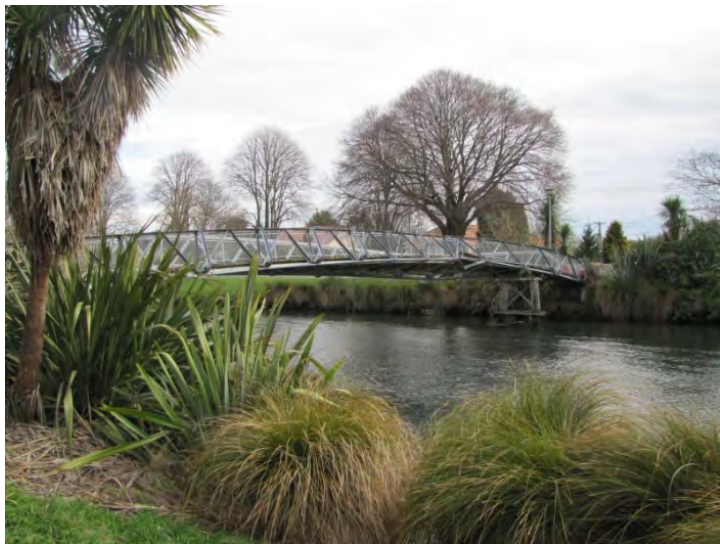
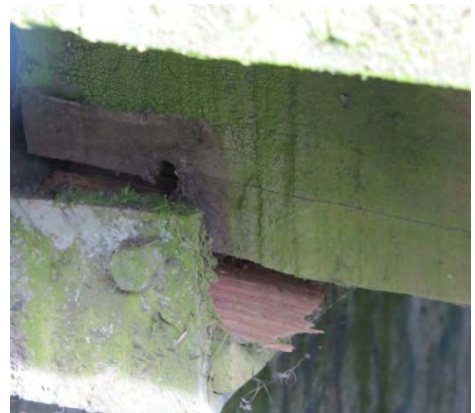
Figure 7.16 Footbridge on the Avon River near Medway Road: (a) Buckled span; and (b) Sheared bearing on east bank. (-43.5310° , 172.6656°)

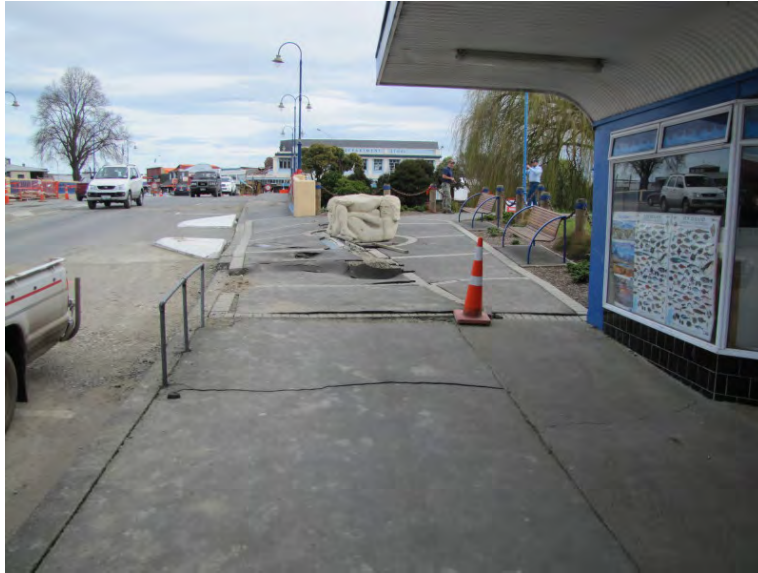
Behaviour similar to that observed along the Avon River in Christchurch was also observed at Kaiapoi River crossings. Incipient lateral spreading, cracking in the approach roadway, and cracking in the abutment walls was observed at the Williams Street Bridge (-43.3825° , 172.6575°) (Figures 7.17 and 7.18) and buckling of the lightweight deck of a pedestrian bridge due to convergence of abutments as a result of lateral spreading was observed just north of Williams Street, in the vicinity of Trousselot Park (-43.3811° , 172.6558°) (Figure 7.19). Evidence of liquefaction and incipient lateral spreading was also observed along the walking path from the Williams Street Bridge to Trousselot Park and in the park itself (Figure 7.20).

Figure 7.17 Cracking of east approach roadway, Williams Road Bridge. (-43.3825°, 172.6575°)

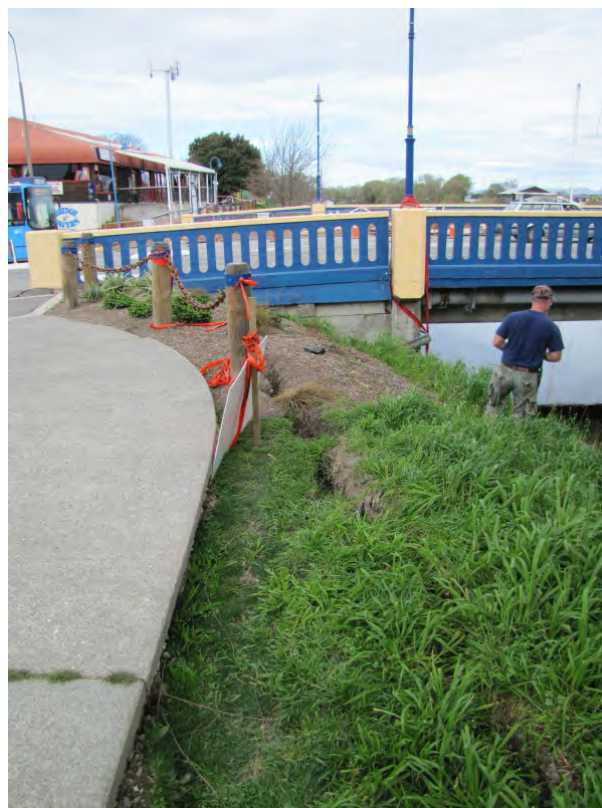
Figure 7.18 Incipient lateral spreading of east abutment, Williams Road Bridge. (-43.3825°, 172.6575°)

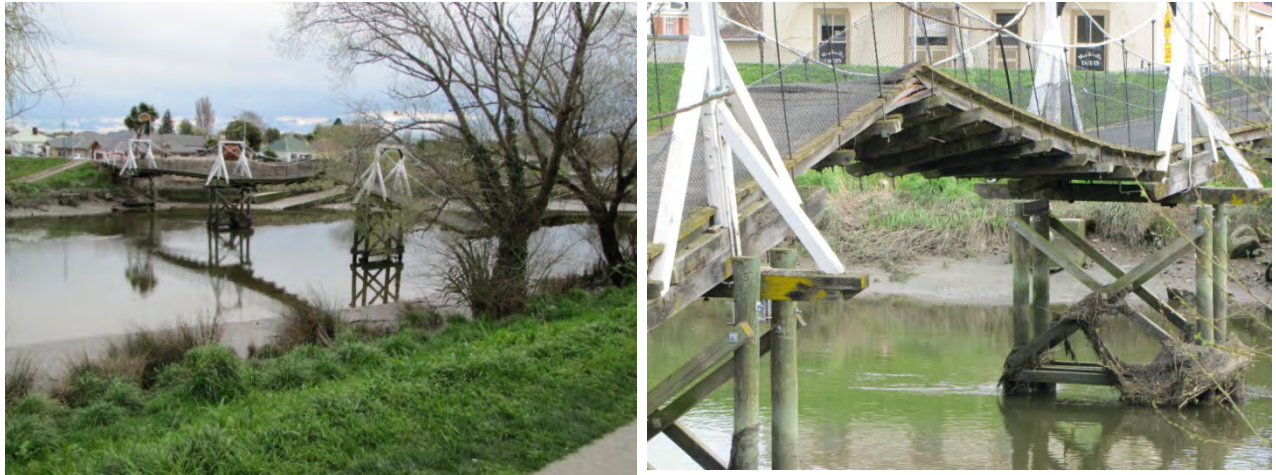
Figure 7.19 Buckling of footbridge near Trousselot Park. (-43.3811° , 172.6558°)

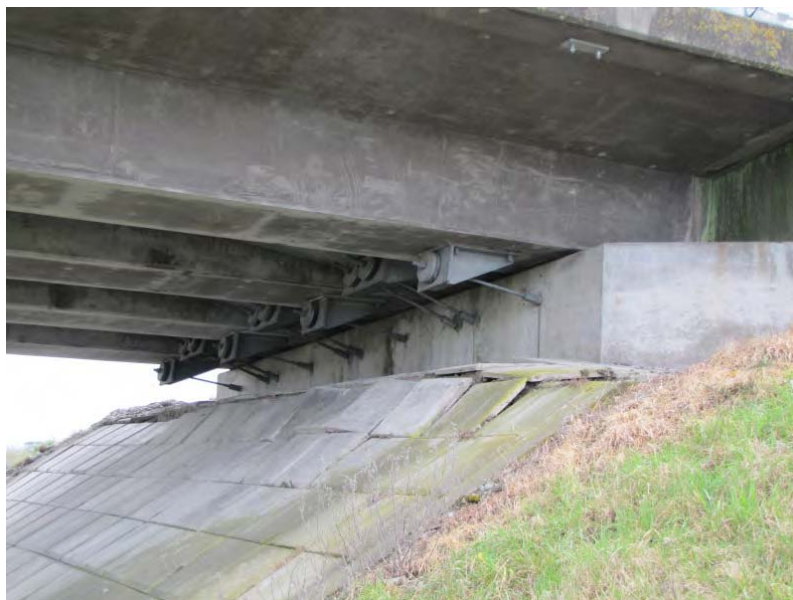
Figure 7.22 Cable Restrainers at north abutment, Chaney's Overpass. (-43.4300°, 172.6464°)

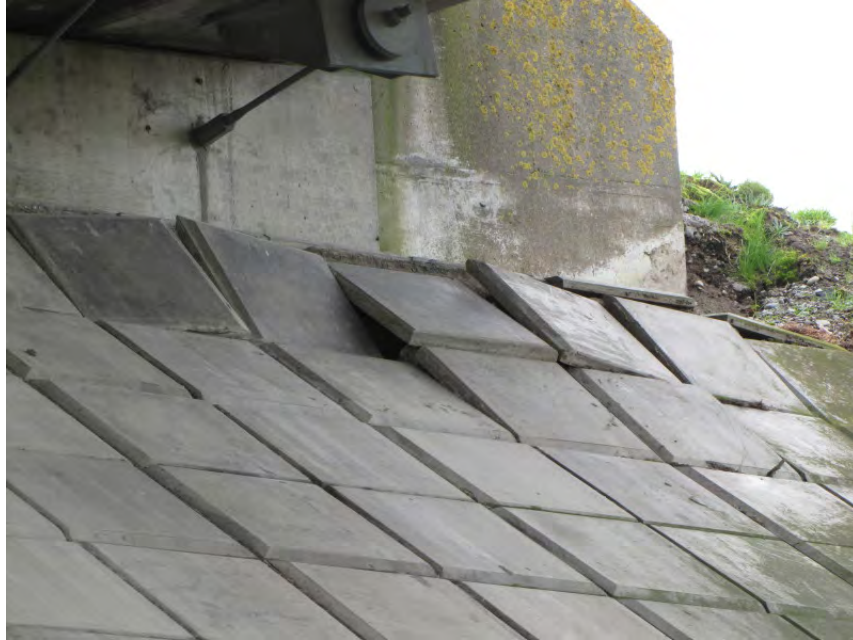
Figure 7.23 Displaced concrete tiles on end embankment for north abutment, Chaney's Overpass. (-43.4300°, 172.6464°)

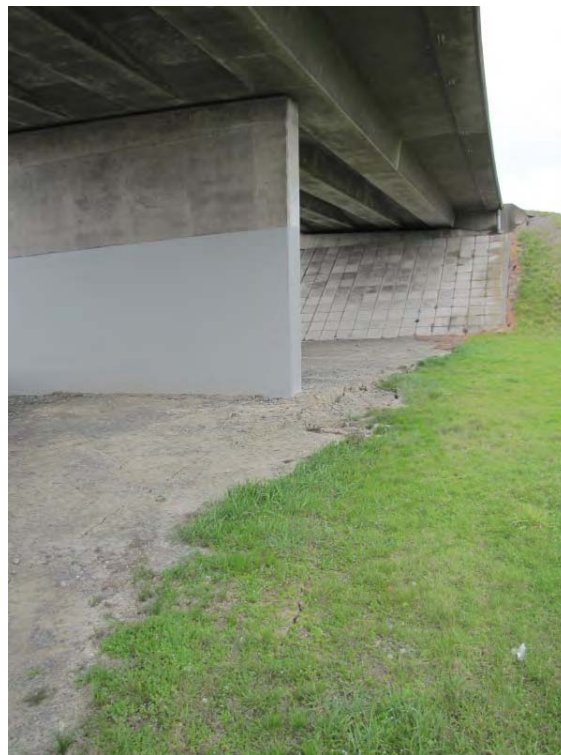
Figure 7.24 Evidence of liquefaction beneath Chaney's Overpass. (-43.4300°, 172.6464°)

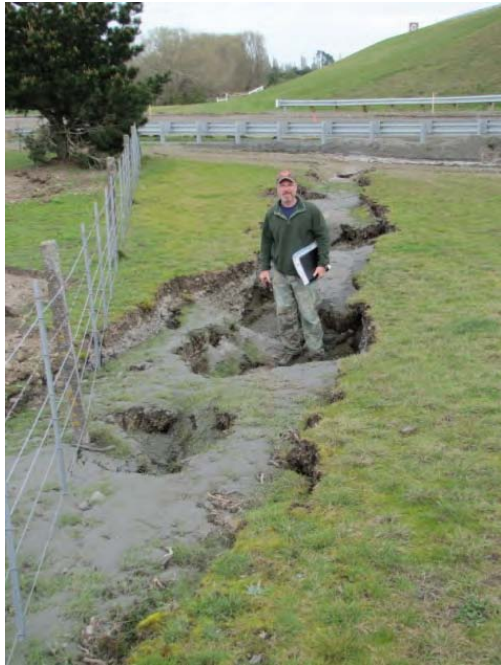
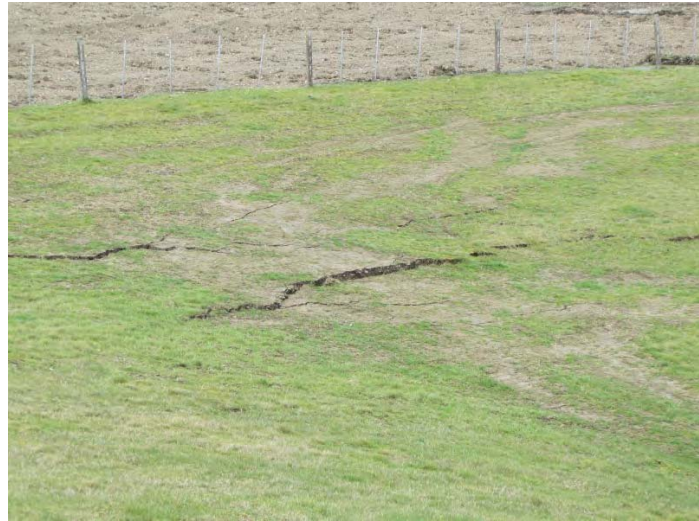
Figure 7.25 Evidence of liquefaction adjacent to Chaney's Overpass. (-43.4300° , 172.6464°)

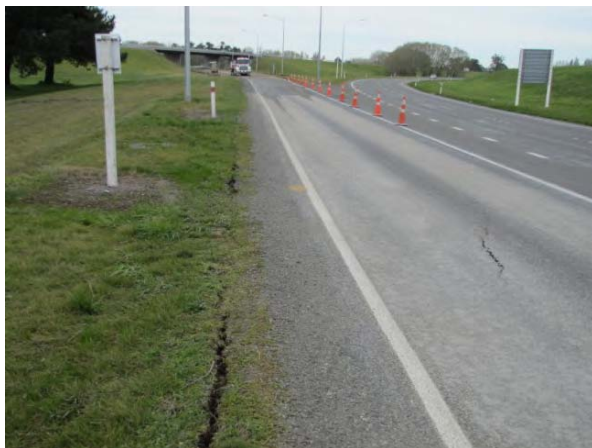
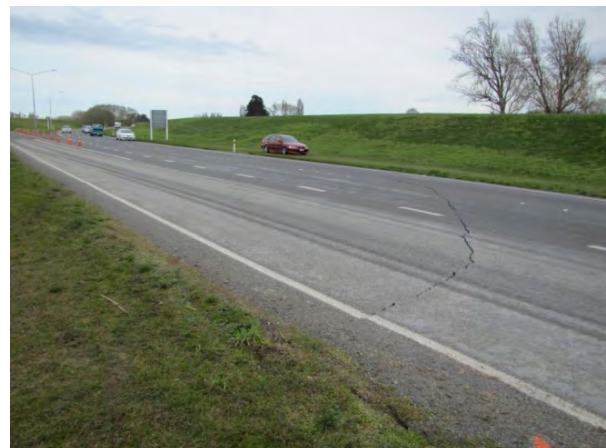
Figure 7.26 Cracking in and along roadway adjacent to Chaney's Overpass. (-43.4300° , 172.6464°)

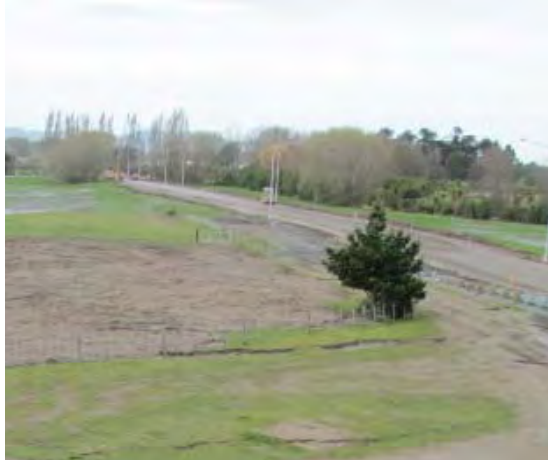
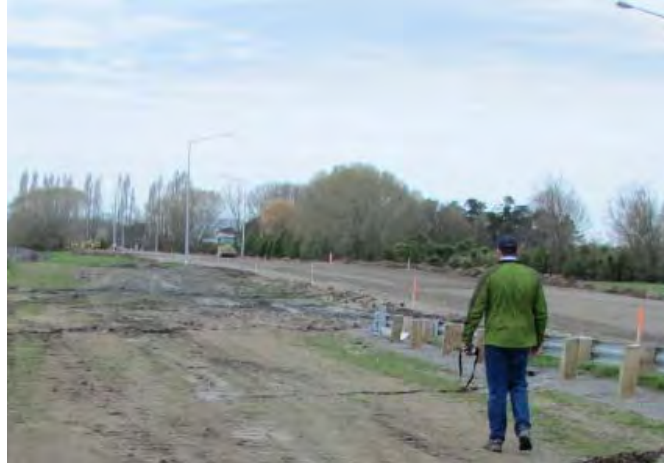
Cracking and incipient lateral spreading was observed at the northern transition between the approach embankment and the abutment at Chaney's overpass (Figure 7.21), where Highway 1 crosses over the Christchurch Northern Motorway (-43.4300° , 172.6464°). The bridge is a three span bridge of about 80 m with what appeared to be seat-type abutments retrofit with cable restrainers (Figure 7.22). However, other than a few ruptured precast concrete tiles that covered the end embankment for the north abutment (Figure 7.23), there was no apparent damage to the bridge structure or its foundation, despite ample evidence of liquefaction beneath the bridge (Figure 7.24). The overpass is located in a low lying area that appears to be the flood plain of the Waimakariri River that was subject to extensive liquefaction (Figure 7.25). Cracking was observed in and adjacent to the roadway in the vicinity of the overpass (Figure 7.26) and road crews were busy regrading and paving the approach to the roadway that passed under the overpass (Figure 7.27), though it was not clear if this work was earthquake related.

Figure 7.27 Road being repaved adjacent on south approach to Chaney's Overpass. (-43.4300° , 172.6464°)

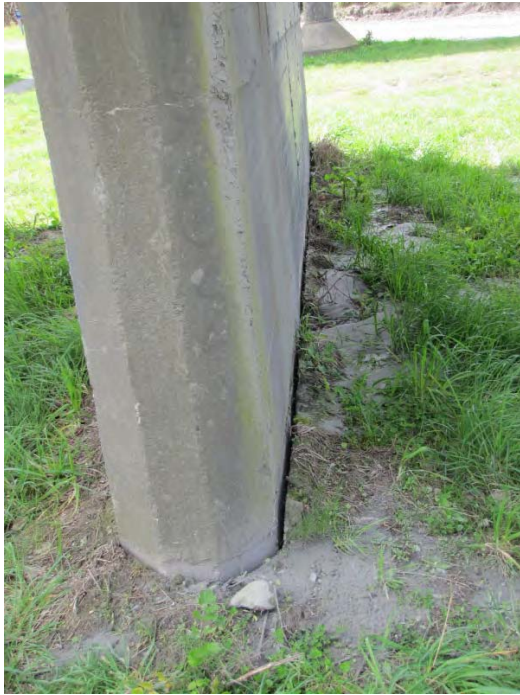
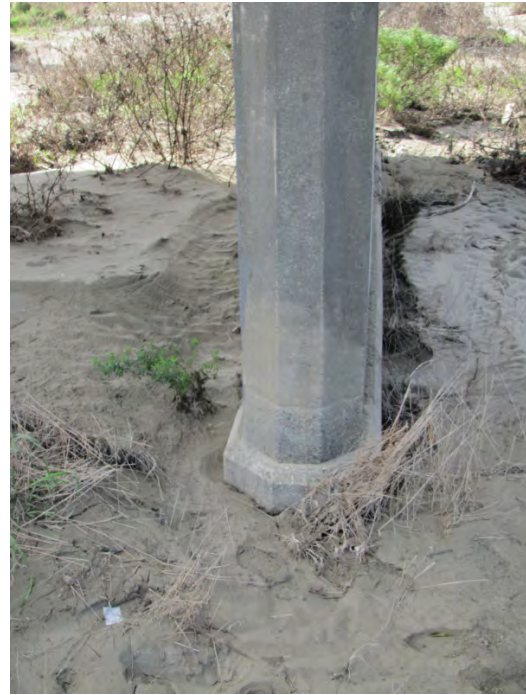
The GEER-NZ Team also inspected the two main spans for the Highway 1 crossing of the Waimakariri River (-43.4153°, 172.6467°) (Figure 7.28) and the adjacent railroad bridge (-43.4128°, 172.6508°). While there was some evidence of liquefaction adjacent to several of the piers for the east span of the Highway 1 crossing (Figure 7.29), there was no indication of displacement of the foundation piers or structural damage to the bridge.

Figure 7.29 Evidence of liquefaction at Highway 1 bridge piers on the north side of the Waimakariri River. (-43.4153° , 172.6467°)

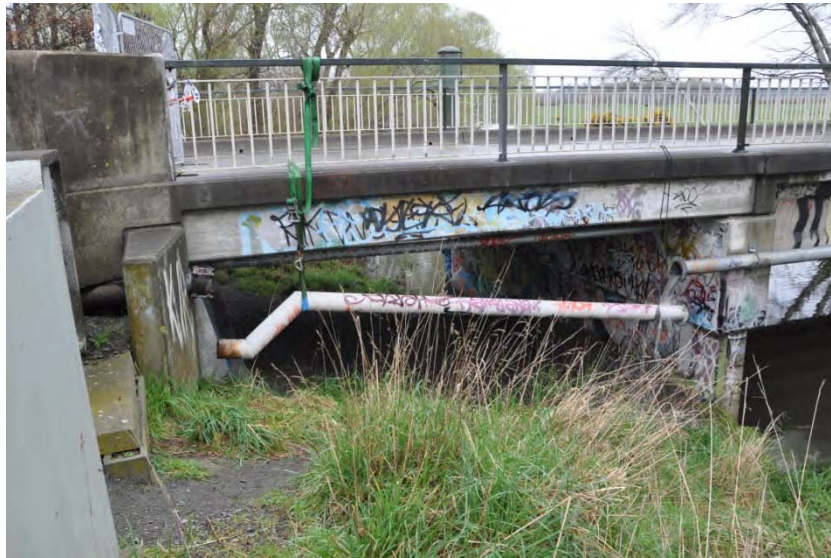
Figure 7.31 Damage to sewage pipe at the Kainga Road Bridge (-43.3997° , 172.6916°)

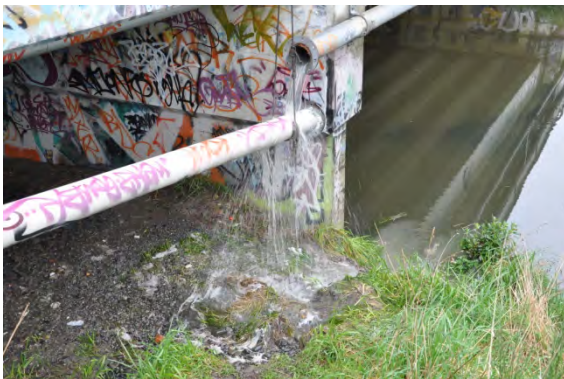
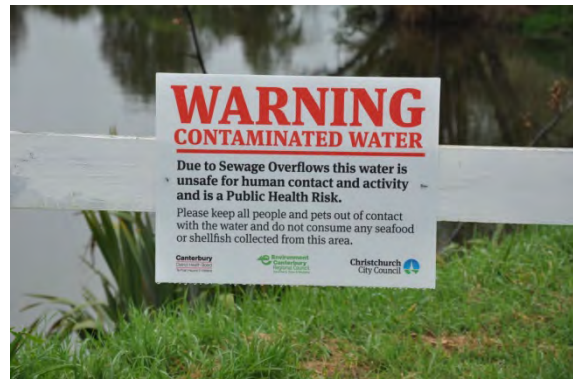
Figure 7.32 Outflow from damaged pipe at Kainga Road Bridge and surrounding warnings to the community. (-43.3997° , 172.6916°)

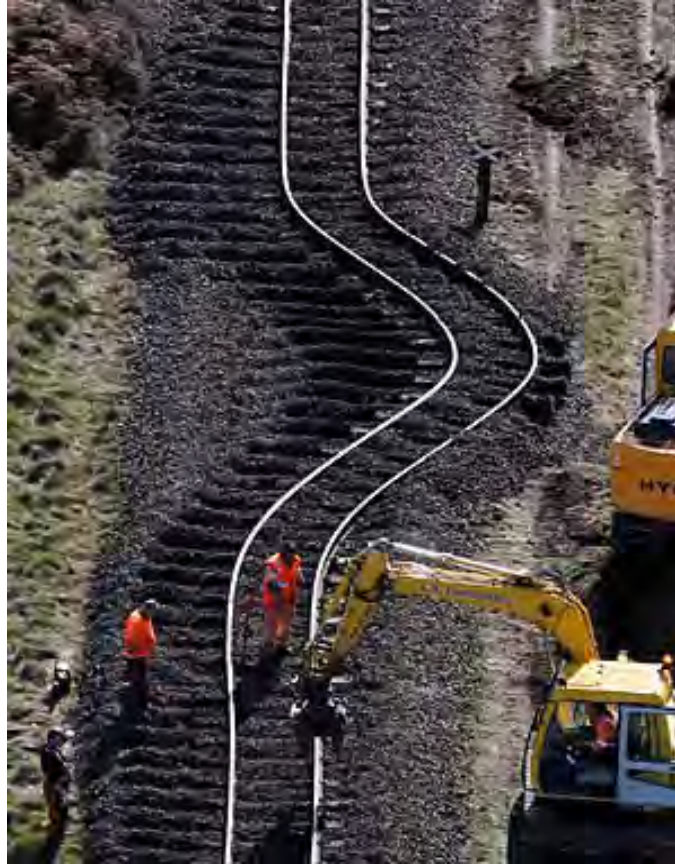
Damage to railways embankments occurred near Rolleston (Figure 7.35) and Woodward Glenn, just south of Kaiapoi (Figure 7.36). In the former case, the damage was due to fault offset, while in the latter case the damage resulted from liquefaction and lateral spreading. By the Time the team arrived in Rolleston (13 days after the earthquake), the damage to the tracks had been repaired. The Team was informed that the damaged rail line at Rolleston was fixed the day of or the day after the earthquake and that the slumping rail lines at Woodford Glen had been repaired 4 days after the earthquake.

Figure 7.35 Railway Embankment at Rolleston. (photo by I. McGregor)

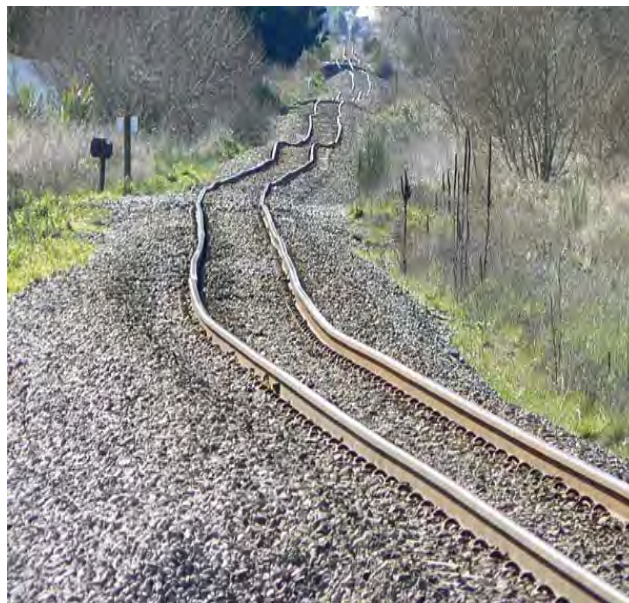
Figure 7.36 Damage to rail line at Woodford Glen. (photo by L. Matthews and J. Overend)

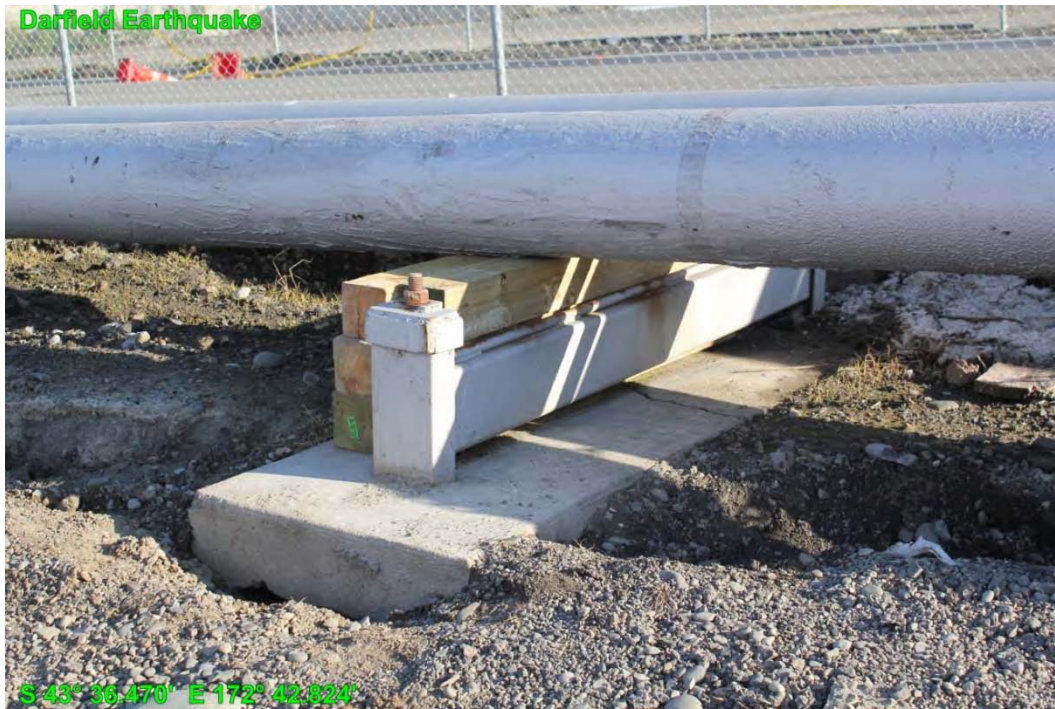
All the wharves underwent limited settlement and lateral deformation, though limited to 0.2 to 0.3 m. Typical damage from settlement and lateral deformation are shown in Figures 7.37-7.39 .

Figure 7.38 Temporary wooden support to accommodate settlement under fuel line (-43.60783°, 172.71373°)

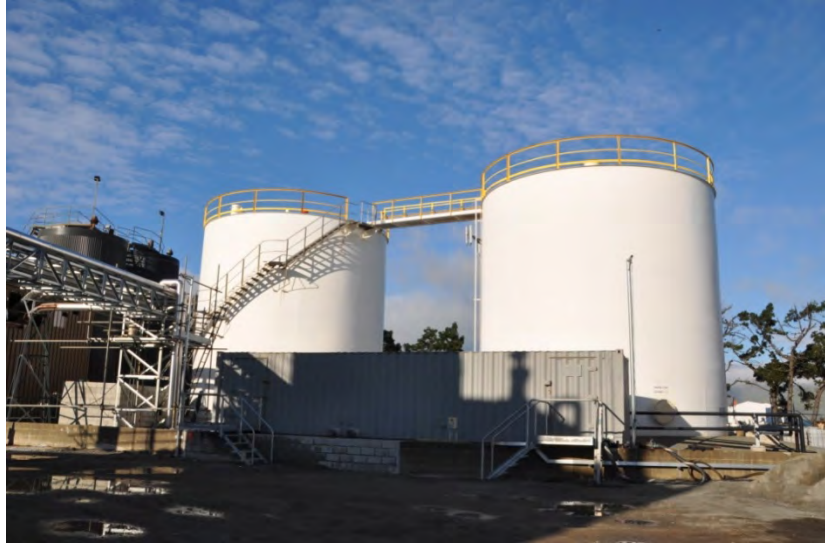
As a result of the lateral spreading, as well as liquefaction within the bitumen plant, four tanks and some supporting piping suffered movement and damage. These are noted in Figure 7.41 as Tanks 1-4. The most severe lateral movement was that of Tank 1 (located at -43.6085° , 172.7149°), which moved laterally 50 mm towards the water. Tank 2 (-43.608768° , 172.714651°) settled uniformly about 30 mm causing separation of the connecting bridge between it and a neighboring tank of like geometry (Figure 7.42). This tank, with dimensions of 12.8-m high by 13-m diameter, housed used oil and was nearly filled to capacity at the time of the main shock, weighing an estimated 550 tons. Tanks 3 and 4 (-43.6085° , 172.7149°) were side-by-side and each experienced movement that resulted in pullout of nearly all perimeter anchor bolts at their base. These tanks were 12.5-m tall by 6-m diameter with an estimated 150-ton weight at the time of the main shock. Crews were repairing the support anchorage for Tanks 3 and 4 with the retrofit shown in Figure 7.43. No structural damage to the tanks was observed and flexible connections survived the strong shaking with only minor leakage. Asphalt repair using cement injection to fill the lateral spread cracks was on-going during the Team's visit (Figure 7.44). Sand boils were also observed at several locations within the plants boundaries. Soil samples of the ejecta indicated the material was clean sand with little to no fines (Figure 7.45).

Figure 7.42 Tank 2 (right most large white tank) with Tanks 3 and 4 shown to the left (smaller grey tanks) at the Fulton Hogan Bitumen Plant (-43.6088°, 172.7147°).

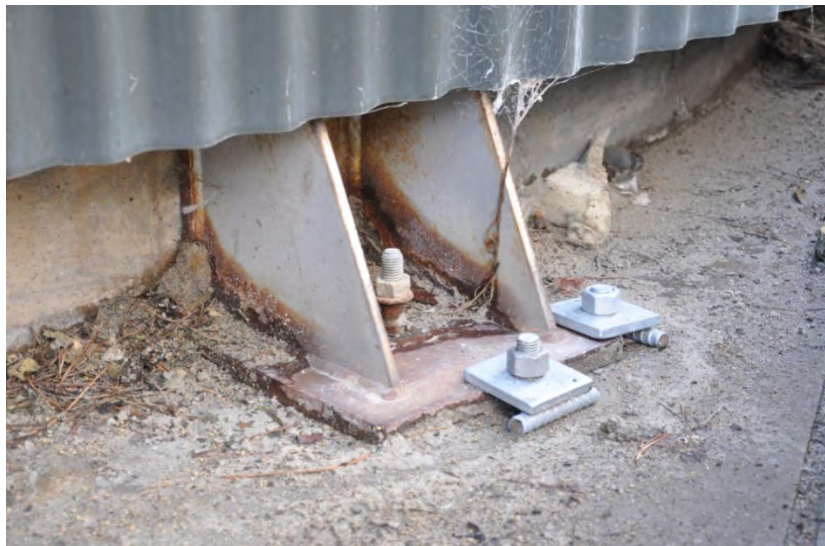
Figure 7.43 Typical repair to Tank 3 and 4 (addition of clamp plates). Note the pullout of the original anchorage. Fulton Hogan Bitumen Plant. (-43.6085°, 172.7149°).

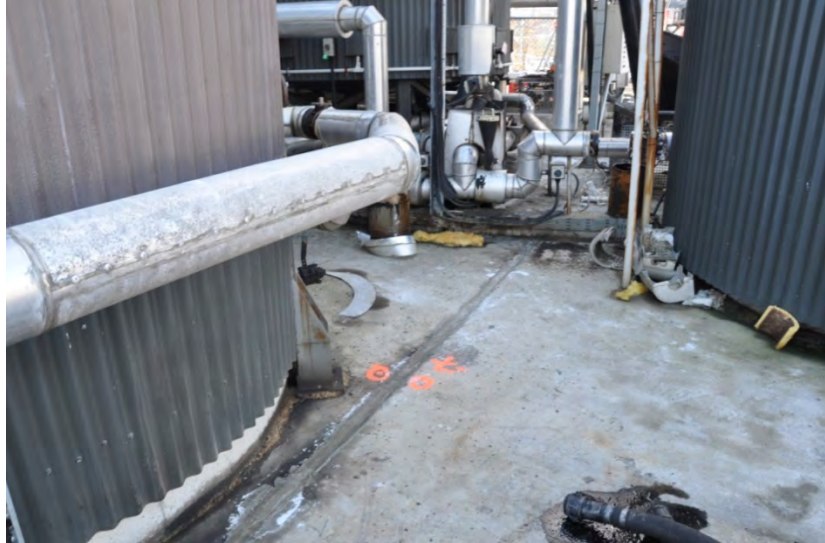
Figure 7.44 Repair of lateral spread cracks within the Fulton Hogan Bitumen Plant, nearby Tank 3. (-43.6085°, 172.7150°)

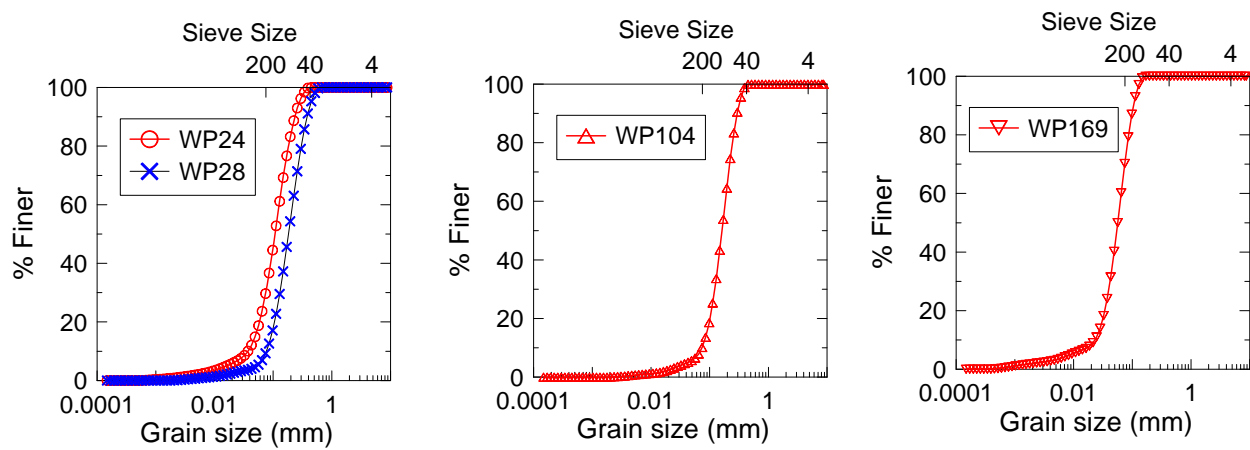
Figure 7.45 Laser diffraction tests of samples taken from ejecta observed at the Fulton Hogan Bitumen Plant. Sample WP169 taken at -43.6087°, 172.7142°.

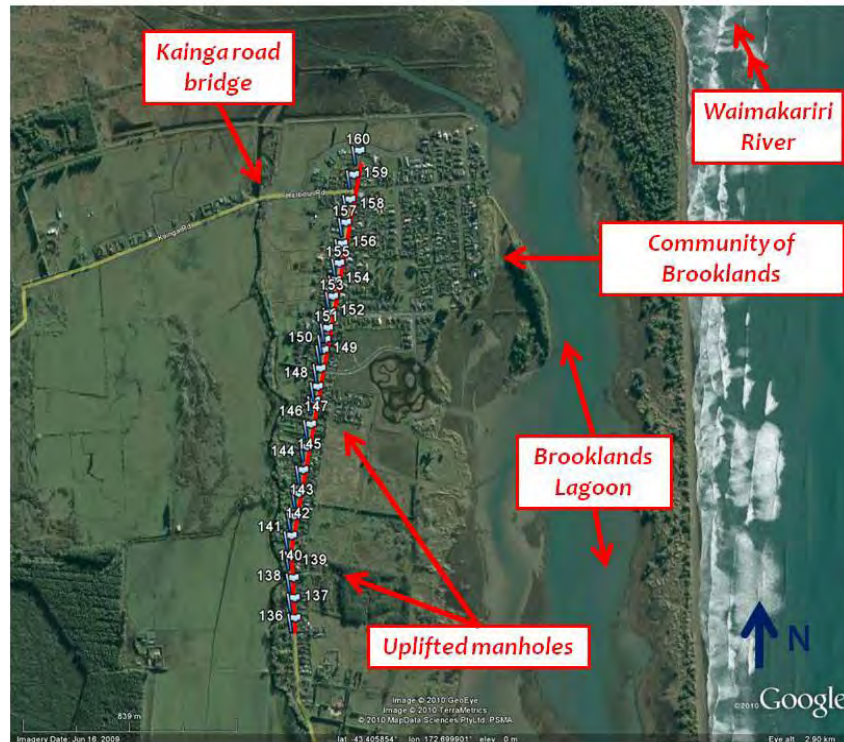
In a number of residential communities, sewage and potable water were problematic immediately following the main shock. Perhaps hardest hit were the communities of Spencerville and Brooklands. At the time of the Team's visit on 13 September 2010, neither community had functioning wastewater collection systems, and Brooklands did not have potable water. Liquefaction along Lower Styx road, the primary connection between these two communities, caused ground subsidence, a rise in the water table, and uplifting of 25 manholes (Figure 7.46). Construction workers were dewatering the region during the Team's visit and informed us that the manholes were 4-m deep. The manholes were approximately 28-46 cm above the existing road surface (Figure 7.47).

Figure 7.46 Approximately 2 km stretch along Lower Styx Road with observed uplifted manholes. (GoogleEarth image; -43.4059° , 172.6999°). Waypoints 136-160 represent locations of elevated manholes.

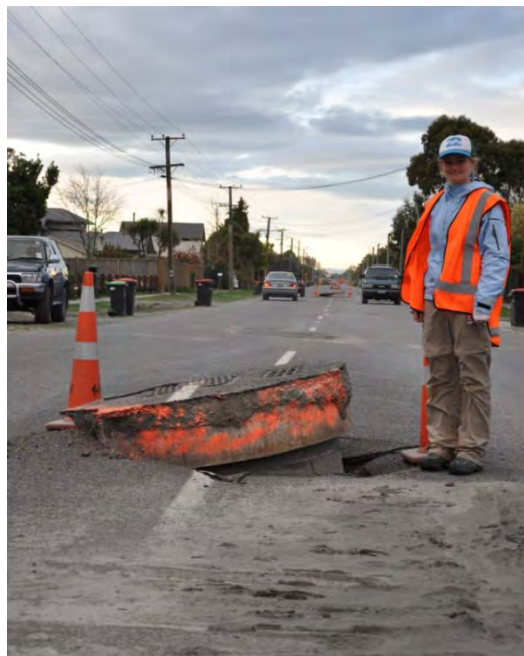
Figure 7.47 Uplifted manholes along Lower Styx Road, note the uplifted manholes in the background too. (-43.4113° , 172.6930°).
