GEOTECHNICAL & FLOODING RECONNAISSANCE OF THE 2014 MARCH FLOOD EVENT POST 2010-2011 CANTERBURY EARTHQUAKE SEQUENCE, NEW ZEALAND

Version 1: 19 June 2014

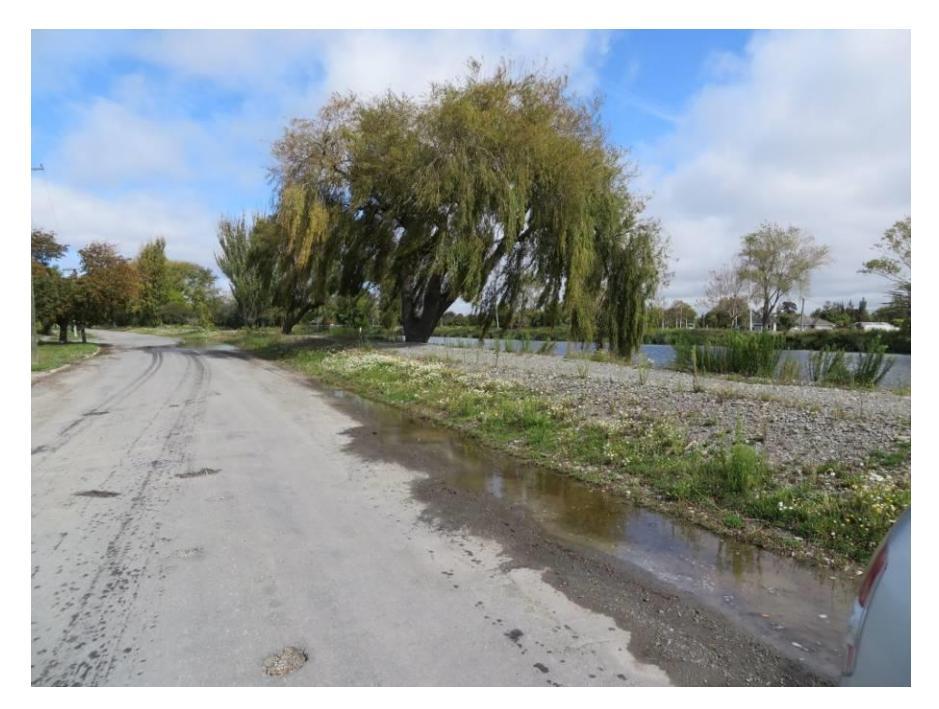
In the Avon River basin, over 30 floods since 1883 have been documented and have caused damage ranging from stormwater ponding to river breakouts. In July 1955, March 1957 and August 1992, high tides exacerbated the flooding. Flood control measures, including stopbanks, are installed along the lower Avon to protect property from flood damage. The performance of these stopbanks is detailed in Chapter 6 of this report. Following the 2010-2011 earthquake sequence, the suburb of Avonside experienced extensive subsidence. As a result, the stopbanks were increased in height by up to 1 meter in some places (Figure 2-5).

Figure 2-5 Stopbank along the Avon River on Avonside Drive (-43.503590°, 172.683632°).

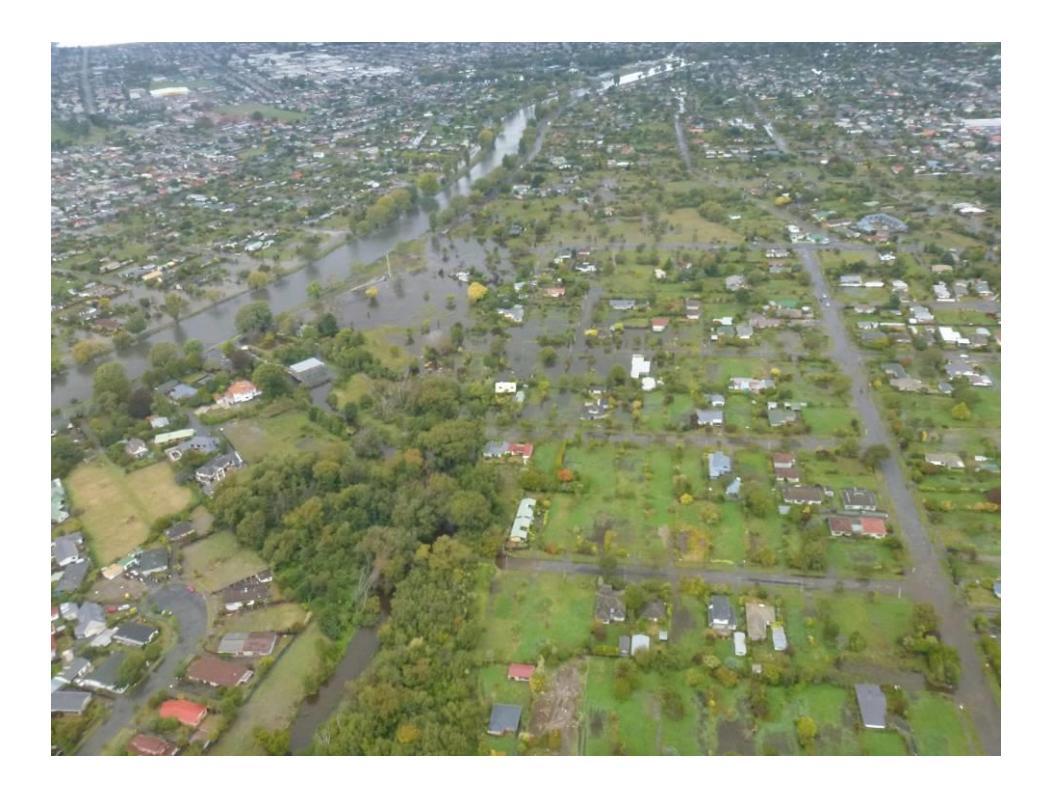
Figure 2-11 Lower Avon River at New Brighton Road (-43°30'02.52"S, 172°41'03.65"E). Photo courtesy of Tonkin & Taylor 2014.

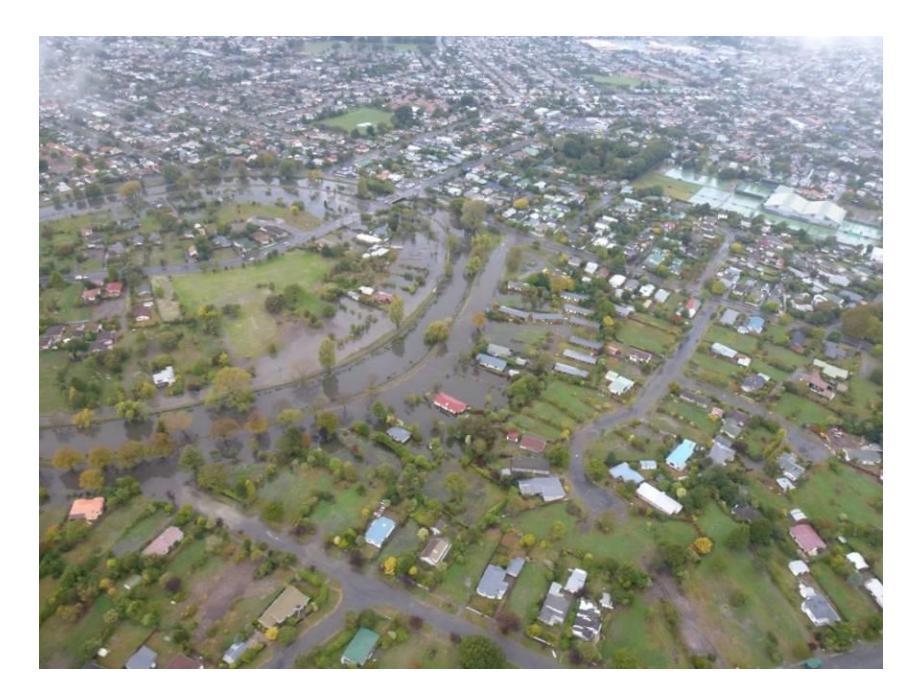
Figure 2-12 Avon River at Gayhurst Road (43°31'17.58"S, 172°, 40'21.96"E). Photo courtesy of Tonkin & Taylor 2014.

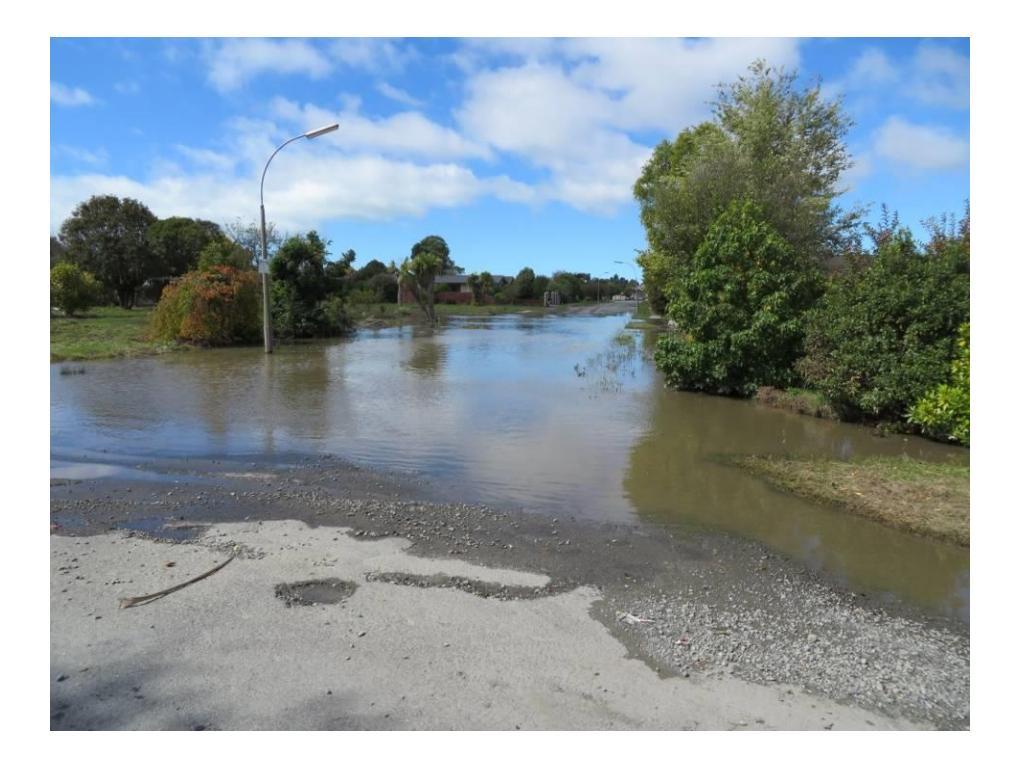
Figure 2-13 Localized flooding at the intersection of Prestwick Street and Avonside Drive (-43.503590°, 172.683632°). Photo courtesy of Tonkin & Taylor 2014.

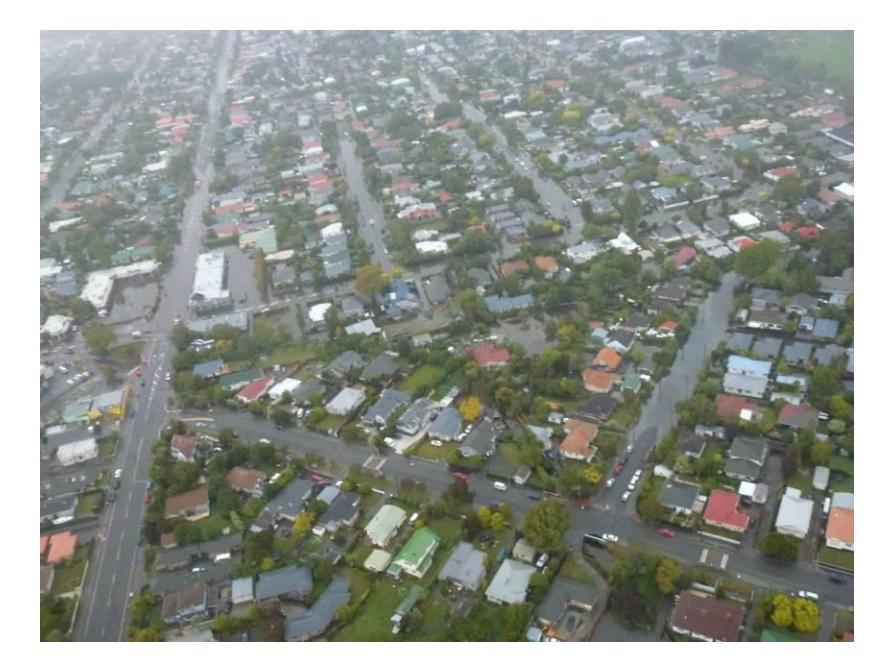
Figure 2-14 Flockton area from Woodville Street (43°30'33.65 S", 172°39'00.65"E). Photo courtesy of Tonkin & Taylor 2014.

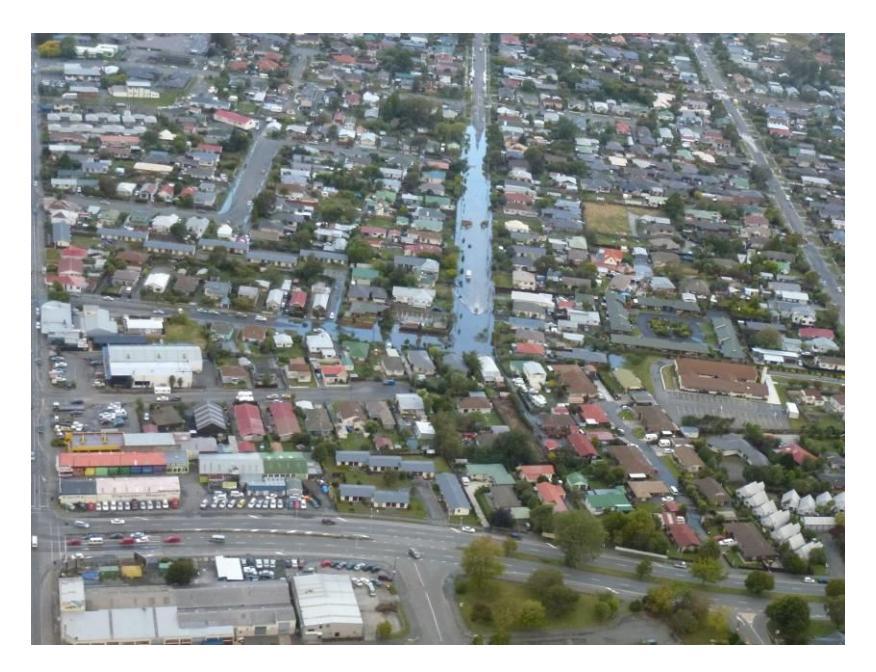
Figure 2-15 Localized flooding in Manning Place & Wilberry Street (43°32'41.63 S", 172°39'58.28"E). Photo courtesy of Tonkin & Taylor 2014.

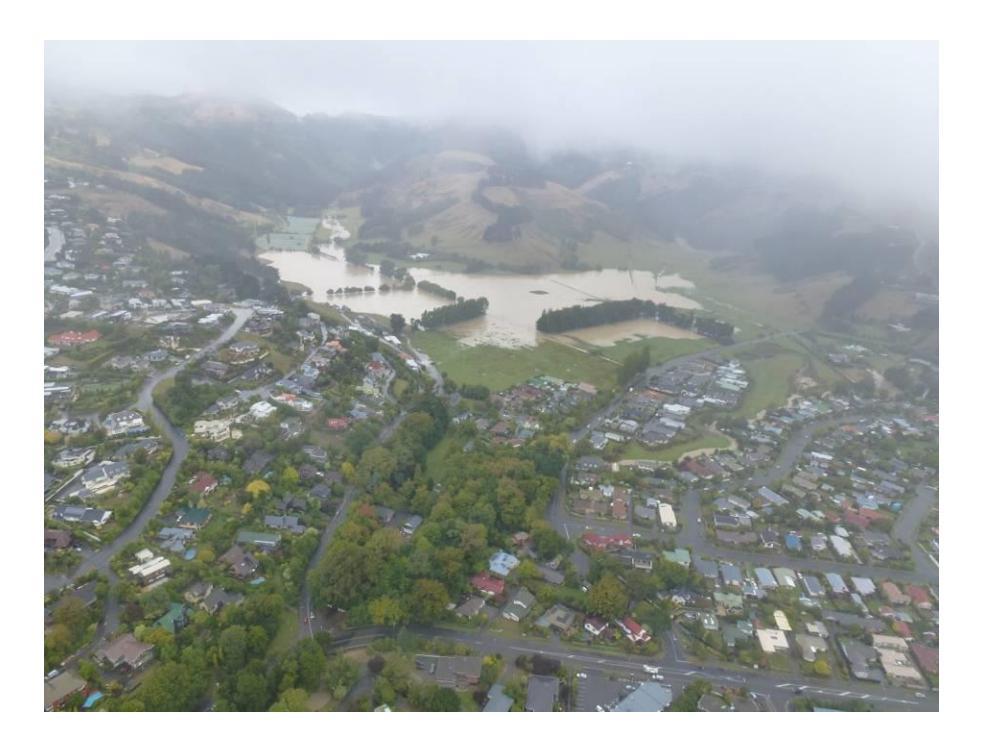
Similar to the Avon, the Heathcote also experienced flooding (Figure 2-16 through Figure 2-18). The photos provided from Tonkin and Taylor begin at the top of the basin and proceed towards the ocean. The upper part of the basin had ponding (Figure 2-16). This area has been identified by the Christchurch City Council as a natural ponding basin and has been left without development to capture flood waters. Figures 2-11 to 2-18 present photographs showing flood waters within the City of Christchurch. The Mayoral Task Force (Christchurch City Council, 2014) report provides more detailed descriptions of local flood impacts and temporary defense measures and the later chapters in this report summarize flood effects on geotechnical and lifeline systems.

Figure 2-16 Heathcote River off Worsley Road (-43.580827°, 172.616142°). Photo courtesy of Tonkin & Taylor 2014.

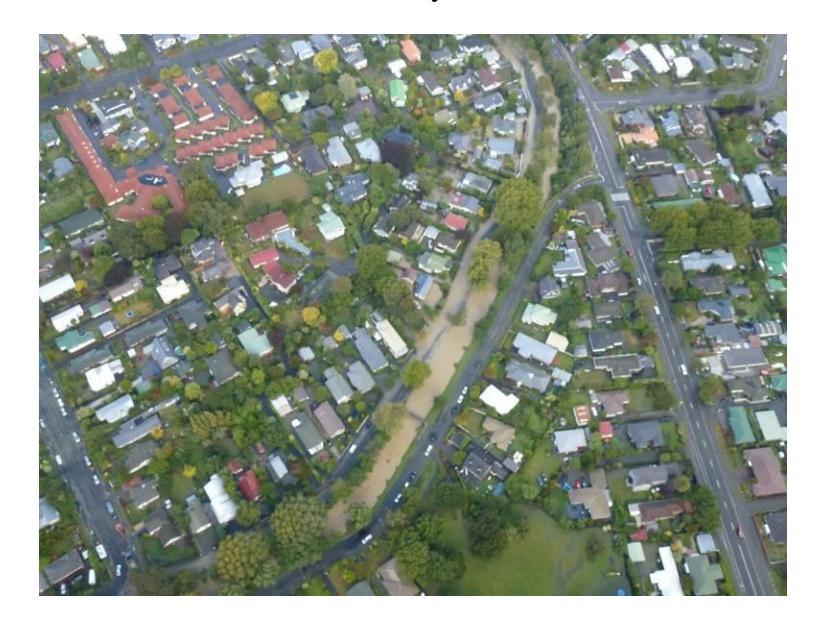
Figure 2-17 Heathcote River Waimea Tce (43°34'08.59' S, 172°38'22.22" E). Photo courtesy of Tonkin & Taylor 2014.

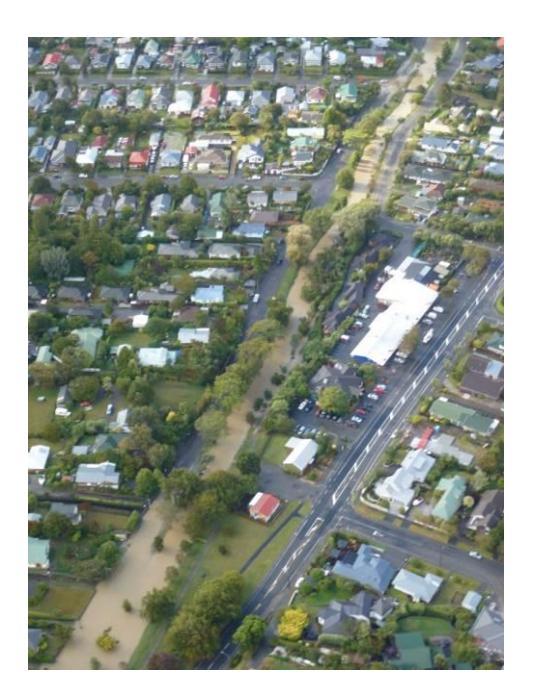
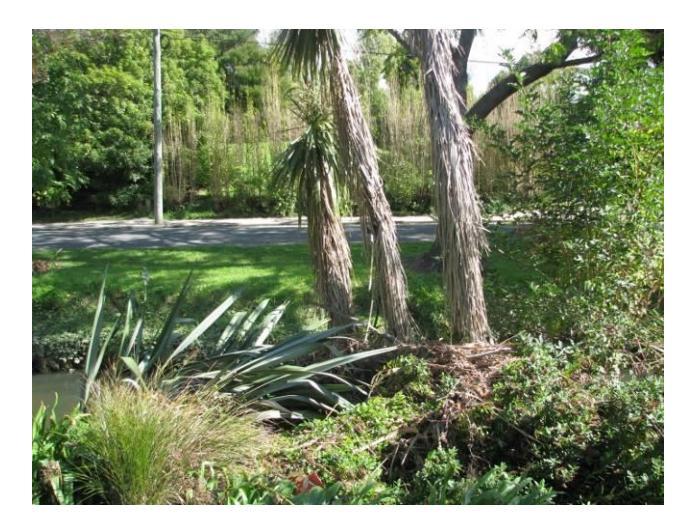
Figure 2-18 Heathcote River off Centaurus Road illustrating (a) flooding on March 5, 2014 (Credit: Tonkin & Taylor 2014) and (b) normal flow during GEER visit March 19, 2014. (43°34'01.69"S, 172°38'45.85"E).

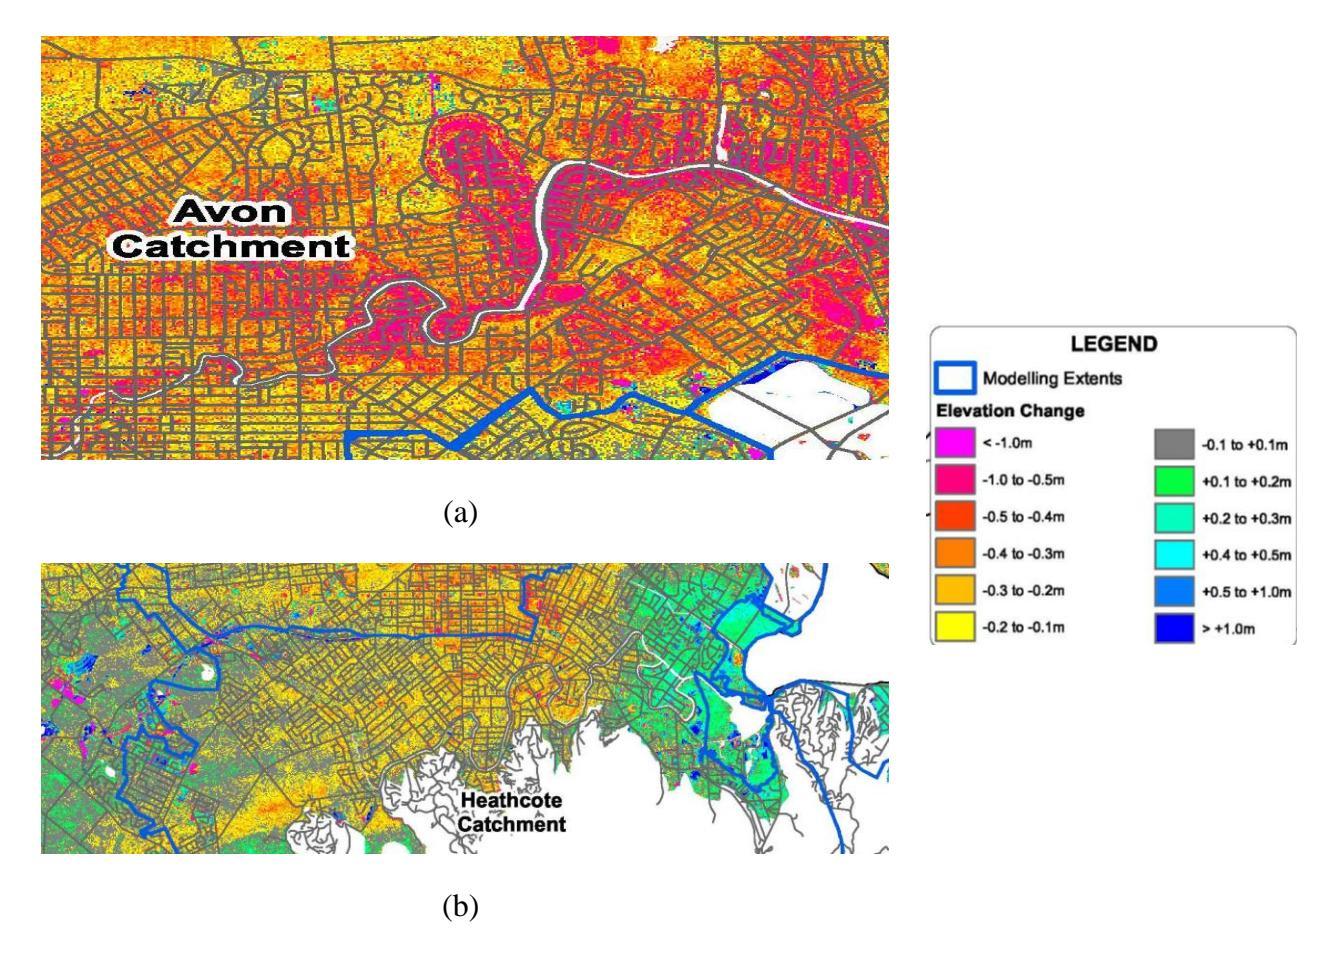
Liquefaction induced settlement was documented in Christchurch and the surrounding communities after the four events making up the 2010-2011 Canterbury earthquake sequence. Pre 2010 to post December 2011, elevation changes for the city were documented by Tonkin & Taylor (2013). Figure 3-5 shows cumulative settlements as a result of the four events in the Avon and Heathcote catchment areas. Cumulative settlements in excess of 1 m can be found within the Avon River catchment area. In the Heathcote catchment area both settlements and uplift of ≤ 0.3 m can be found. Van Ballegooy et al. (2014) found that > 87% of the settlement in Christchurch was associated with ejected soil.

Figure 3-5 Cumulative elevation change along the Avon and Heathcote Rivers pre-2010 and post June/December 2011; (a) Avon Catchment and (b) Heathcote catchment. Maps (a) and (b) have different scales. (Tonkin & Taylor Ltd, 2013, Figure A10)

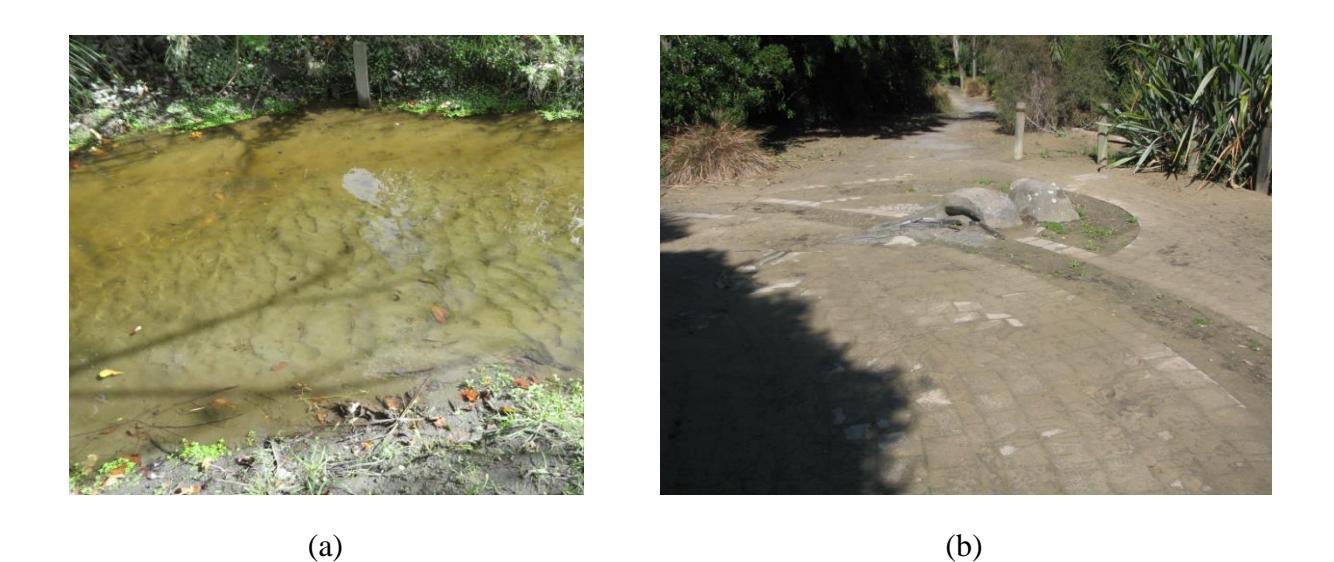
GEER team members classified the ejected material as non-plastic fine sands and silty sands, during the Darfield Earthquake reconnaissance (NZ-GEER, 2010). Much of the silts and sands ejected due to liquefaction in the city were cleaned up after each of the events and placed in stock piles near the Bromley oxidation ponds and at the Burwood Landfill (NZ-GEER, 2011). Evidence of ejected material, as shown in Figure 3-6 was still found in Dudley Creek and along the banks of the Heathcote River near the high water marks during the GEER visit. CCC's Land Drainage Recovery Programme (2014) identified sediment volumes in excess of 350 truckloads have been removed since June of 2013 in ongoing attempts to restore channel morphology, and thus, flow capacity.

Figure 3-6 (a) Traces of ejected sand in Dudley Creek (Stapletons Rd: -43.511154°, 172.655033°) and (b) similar sediments deposited during the March 5^{th} Heathcote flooding (Centaurus Rd: -43.567442°, 172.645985°).

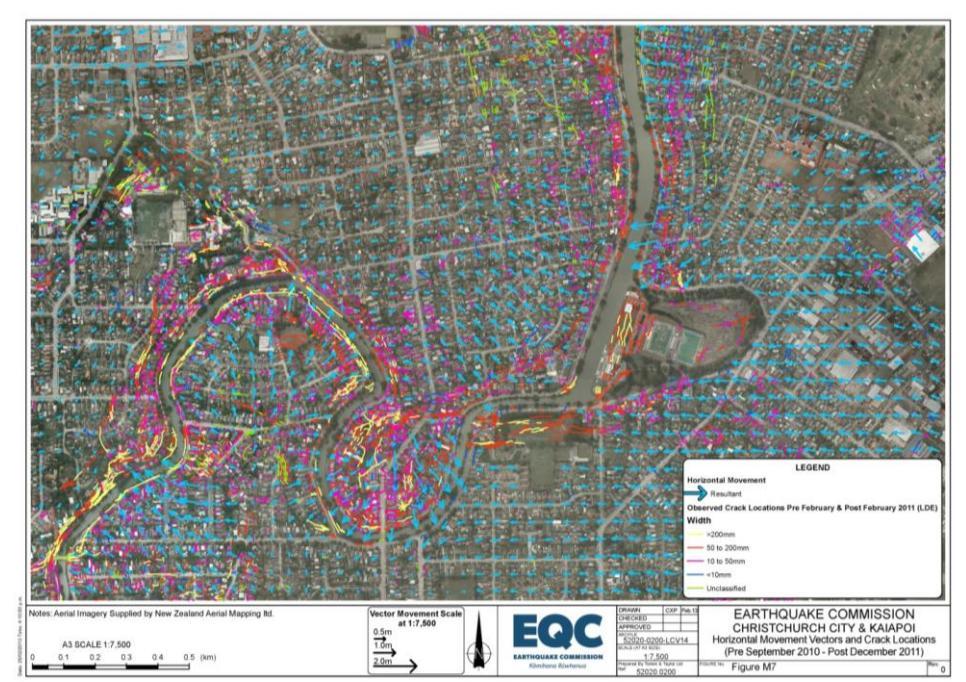
Lateral spreading damage within Christchurch was also documented in the previous two GEER reports (NZ-GEER 2010; NZ-GEER 2011) and subsequent publications, and is outside the scope of this report. Horizontal movement towards the center of the channel due to lateral spreading was documented throughout Christchurch and its surrounding communities in the previous GEER reports. This type of ground movement reduced the channel capacities and increased flood risk. Extensive mapping of the lateral spreading throughout the city was later conducted and presented by Tonkin & Taylor (2013). Figure 3-7 shows the mapped lateral spreading along the Avon River and resulting horizontal land movement.

Figure 3-7 Lateral spreading and horizontal movement along the Avon River pre 2010 and post June/December 2011earthquakes (Tonkin & Taylor Ltd, 2013, Appendix M Figure 13)

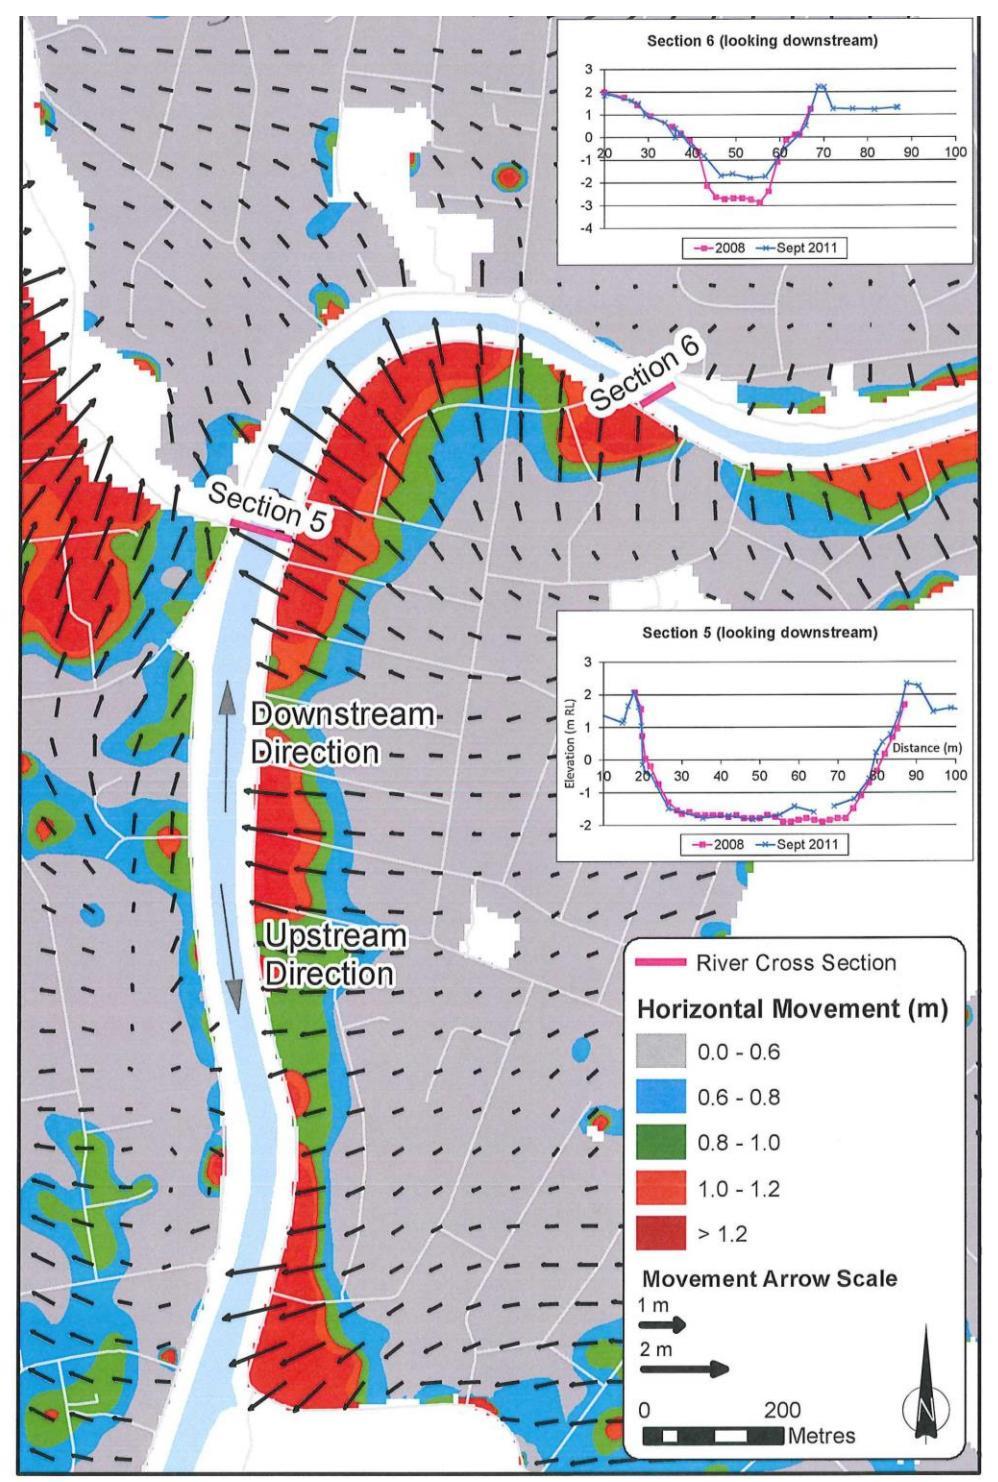
More insights are given in a study by Tonkin & Taylor relating changes in river morphology to horizontal ground motion. In Figure 3-10, two Avon River cross-section topographies are shown. Both cross-sections represented sites at which major horizontal movement (>1.2 m) occurred. Cross-section 6 located between Avondale Bridge and Anzac Bridge is a rather narrow (ca. 22 m) and deep (~2.8 m in 2008) part of the Avon River, and was subject to significant earthquake-

Figure 3-10 Map of earthquake induced horizontal ground movement along the Avon River section covering the area hugging Avonside Drive and a part of the Avon River between Avondale Bridge and Anzac Bridge (courtesy of Tonkin and Taylor), including the topographies of two river cross-sections in 2008 and September 2011.

After 2011, large sections of the rivers have been subject to dredging activities to restore the original river morphology and decrease flood risks associated with the smaller river cross-sectional areas (discussions with representatives of the Christchurch City Council). Dredging activities and post-dredging investigations of river morphology were overseen by the Christchurch City Council and confirmed the restoration of approximately pre-earthquake conditions at a large number of critical river sections. Specific data has not been published yet. According to these results, the increased flood risk at these rivers has likely been adequately
mitigated by restoring the river morphology to pre-earthquake conditions. New and improved dredging equipment will also ensure future stability of the river morphology.

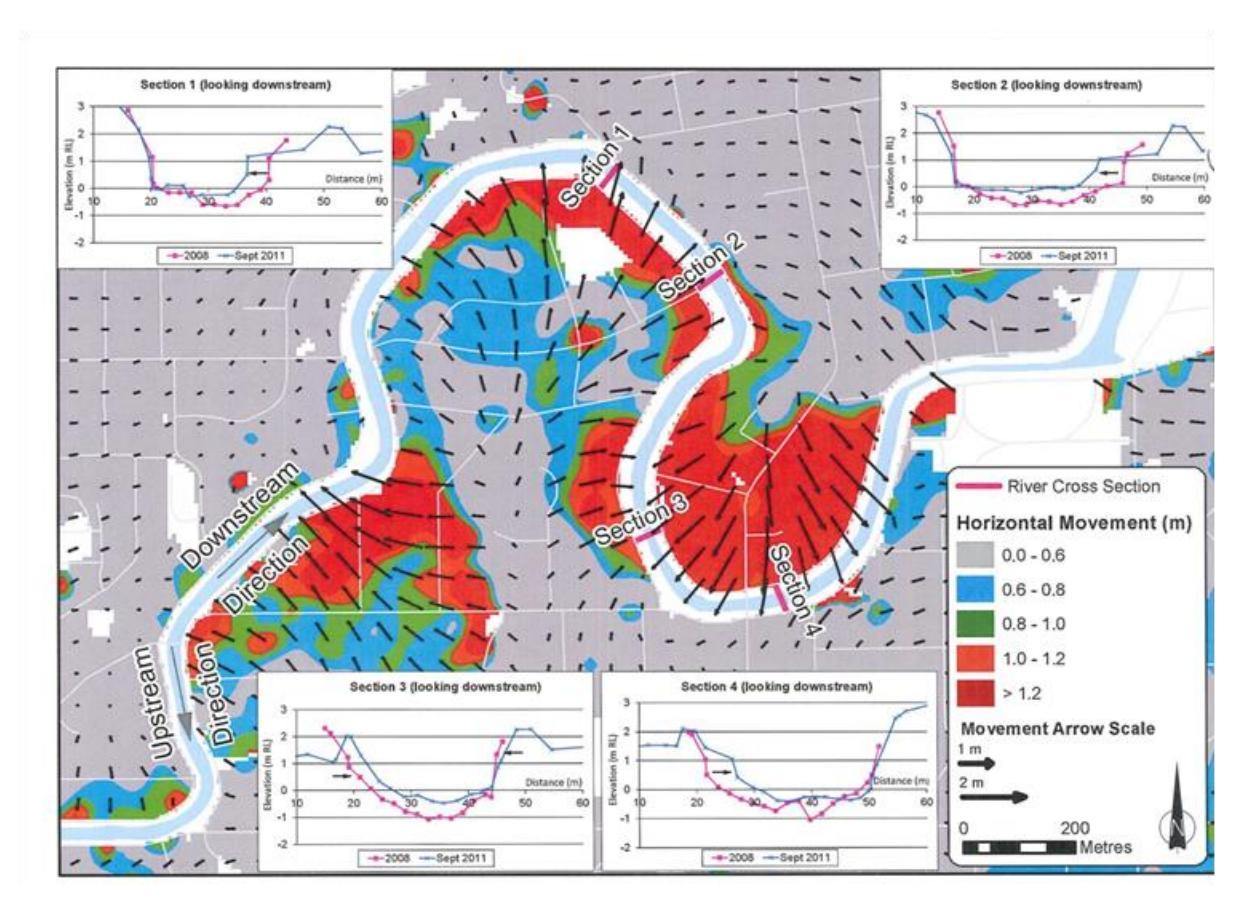
Four more cross-sections were examined in Figure 3-11 along the Avon River going upstream from the previous river section. Cross-section 4 is located between Ngarimu St and Gloucester St Bridge. In 2008, this cross-section was characterized by a width of ~24 m, a maximum water depth of ~ 1 m and shoal (water depth ~ 0.4 m) approximately in the center of the channel. This area was subject to significant horizontal movement southwards. This led to a shift of the northern bank narrowing the river to a width of ~20 m. Furthermore, the river depth decreased to a depth approximately equal to the depth of the previous shoal (~ 0.4 m). The deeper channel south of the shoal was entirely filled in, while the southern side of the channel steepened. Crosssection 3 is located approximately where Bowie Place turns off Avonside Drive, and was affected by significant horizontal movement pushing from both sides into the river. However, regarding river infill, the stronger southwestward movement clearly dominated and shifted the eastern bank about 3 m into the river, narrowing the river width to ~ 16 m. At the same time, the water depth was decreased from ~ 1 m to ~ 0.4 m. Cross-section 2 (approx. at the eastern end of Robson Abe) and cross-section 1 (just downstream of Banks Ave) were both mainly impacted by horizontal movement from the south/west. In both cases, the northern/north-eastern bank remained steady, while the southern/south-western bank was shifted by ~ 5 m into the river and the water depth at the deeper part of the channel decreased by ~ 0.5 m to 0 to 0.3 m. This confirmed the previous observation and expectation that the narrower river sections suffered more from horizontal movement, while the sediment contribution at wider section appeared rather insignificant.

Figure 3-11 Map of earthquake induced horizontal ground movement along the Avon River section covering the area from Avonside Drive and to Stanmore Road Bridge (courtesy of Tonkin and Taylor), including the topographies of four river cross-sections in 2008 and September 2011.

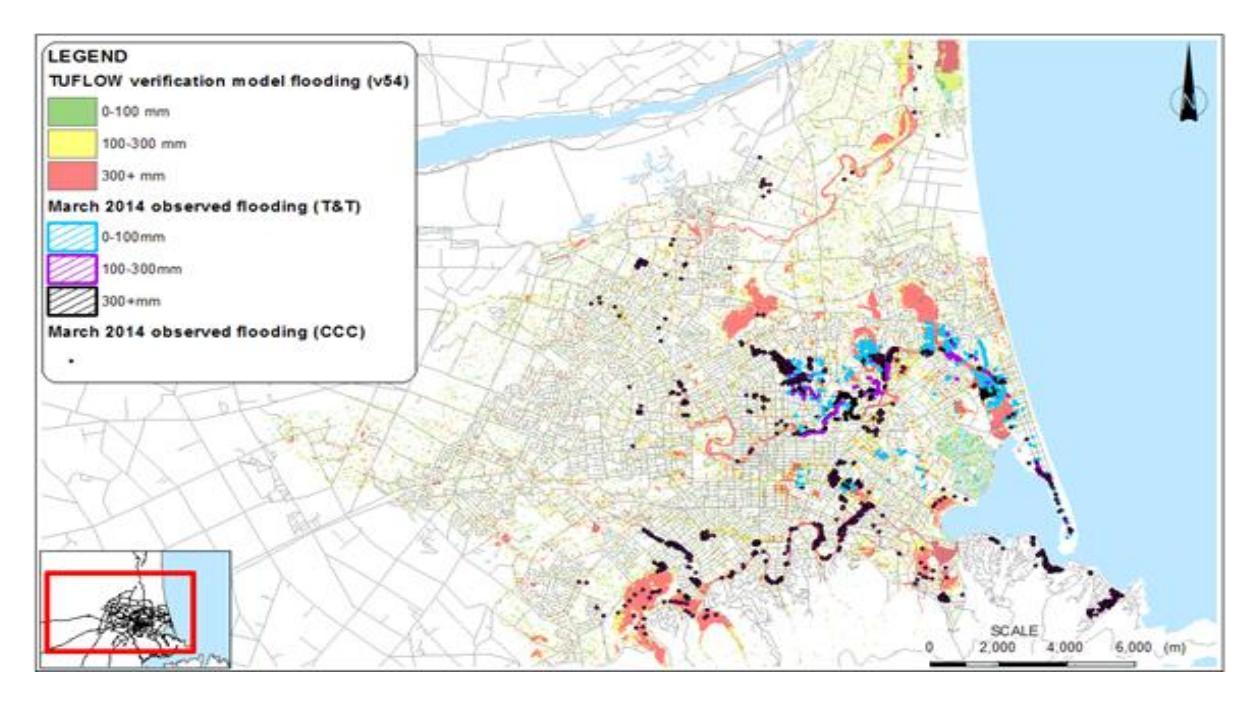
The flooding observations carried out by both CCC and T&T are shown in Figure 4-4 The map is compiled from the March flood event observations that had been mapped at the time of this report. Note that no reconciliation of the frequency attributed to the flood event had been carried out to date. Hind-cast simulation modelling of the March 5th event was carried out using the TUFLOW software package and is shown in Figure 4-4 (Tonkin & Taylor, 2014).

Figure 4-4 Observed flooding in Christchurch March 2014 versus hind-cast model predictions (Tonkin & Taylor, 2014).

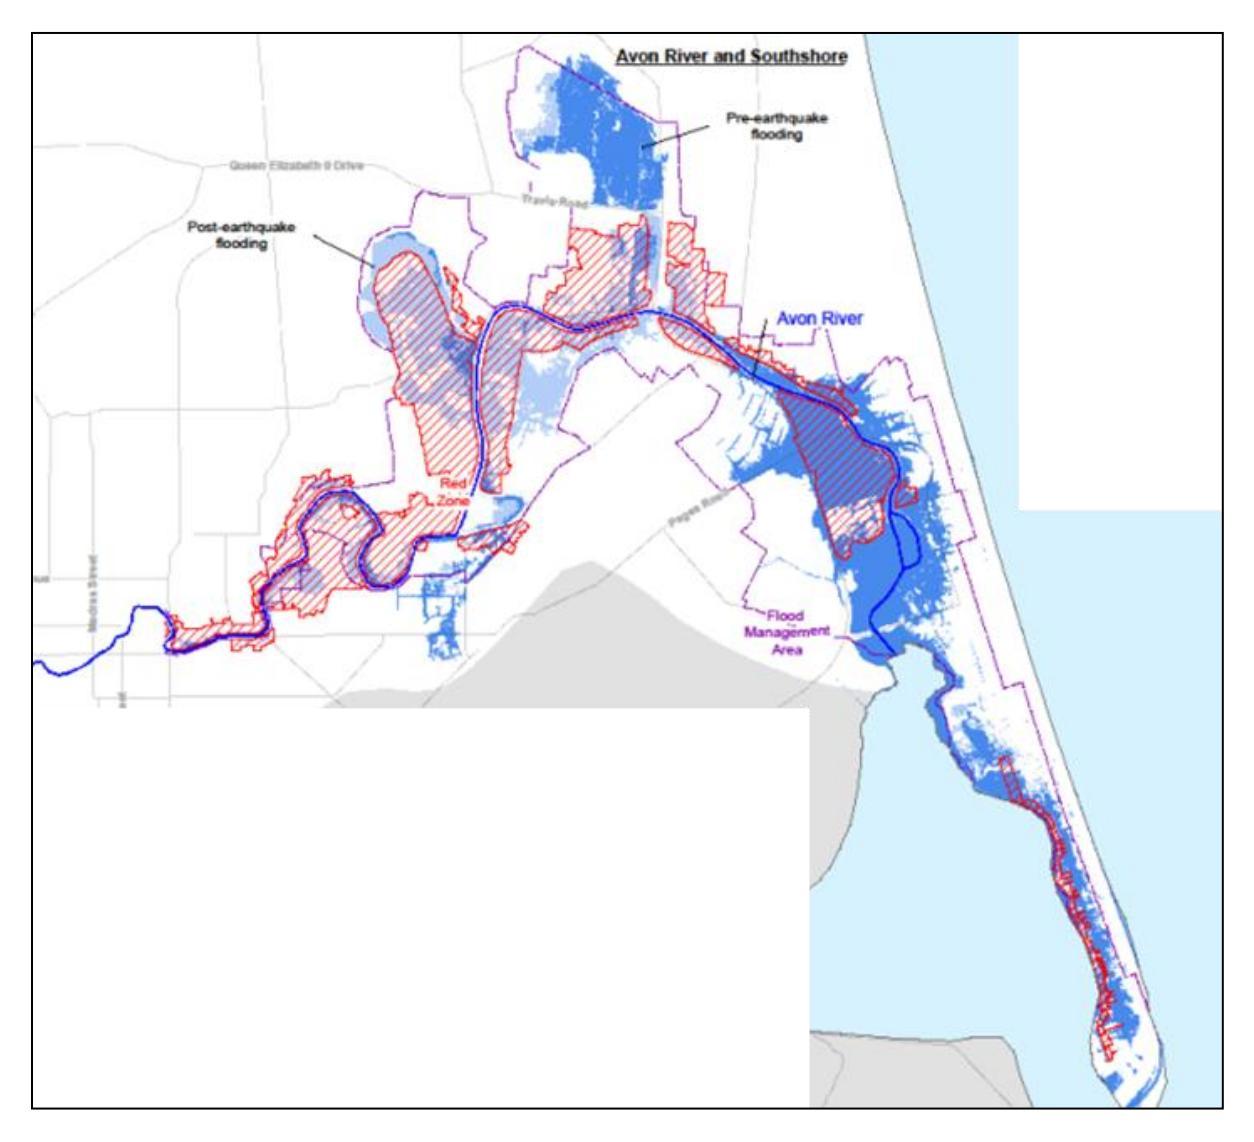
CCC has modelled the change in 100-year return period flood events for Christchurch in a post vs pre-earthquake scenario. Graham Harrington kindly provided the modelled pre- and post-earthquake 100-year return event maps for the Avon and Heathcote Rivers, noting that stopbanks were not included in the modelling. The Avon River and Southshore area changes in 100-year rainfall event flooding are shown in Figure 4-5 with the post-earthquake increase in flood extents indicated by the lighter blue color. Modelling indicates that under pre-earthquake conditions 1,820 properties could have be affected while in the post-earthquake scenario an estimated 3,720 properties could now be affected by flooding, showing the earthquake effects have more than doubled the number of properties at risk of flooding in this one area of the city.

Figure 4-5 Avon River and Southshore change in 100-year predicted flood extents, with no stop banks. Dark blue indicates pre-earthquake flooding, light blue indicates the increase in flood extents post- earthquake (Harrington, 2014).

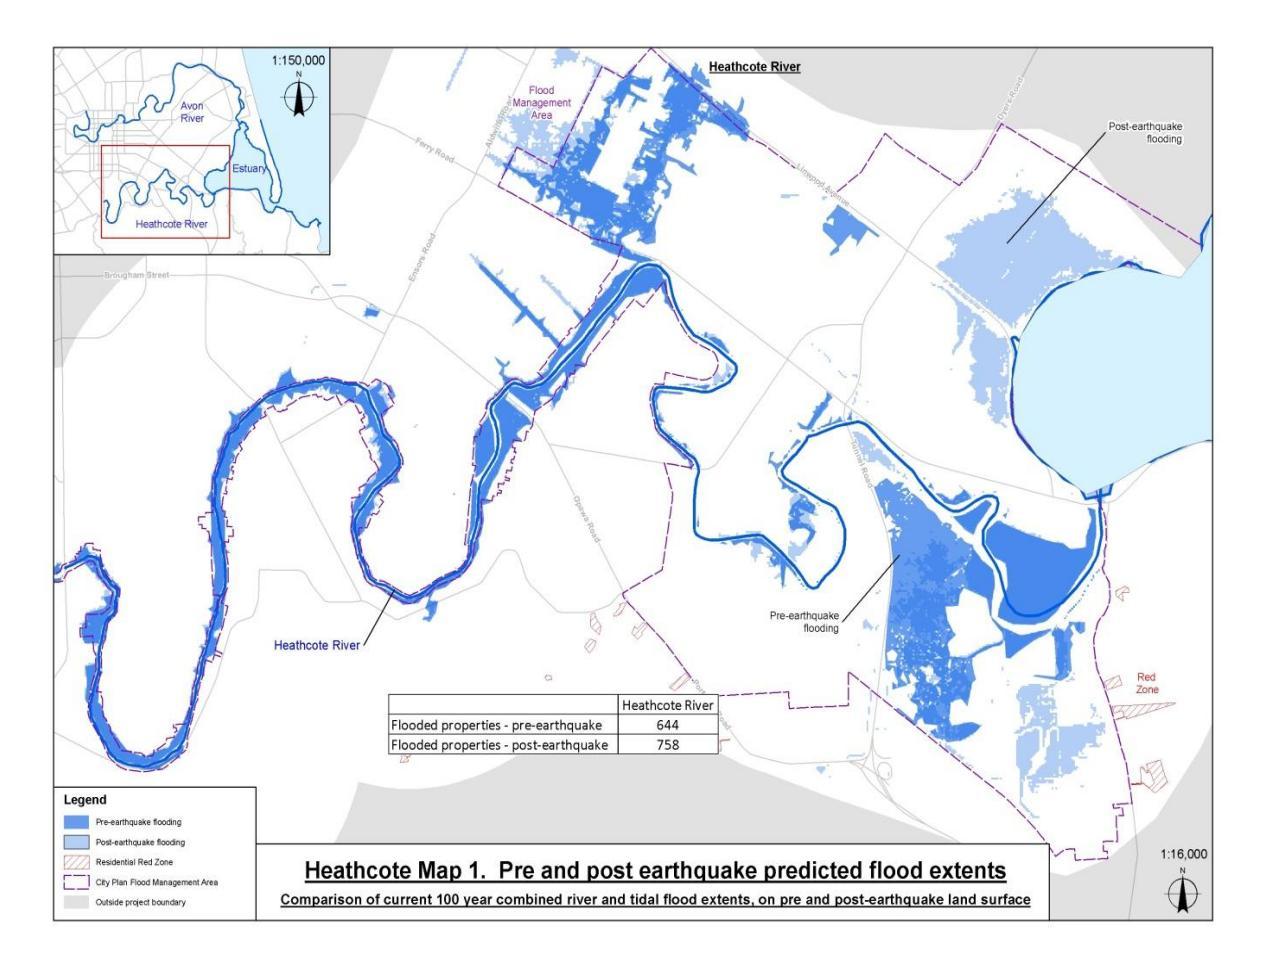
The above flood predictions cover the lower Avon catchment. As explained in Chapter 2 of this report, this river represents one of the two main urban rivers flowing through Christchurch and draining into the Avon-Heathcote Estuary Ihutai. The other main urban river in Christchurch is the Heathcote, which lies to the south and west of the estuary. The Heathcote River changes in predicted 100-year flood extents are shown in Figure 4-6.

Figure 4-6 Heathcote River pre and post-earthquake 100 year predicted flood extents, (Harrington, 2014).

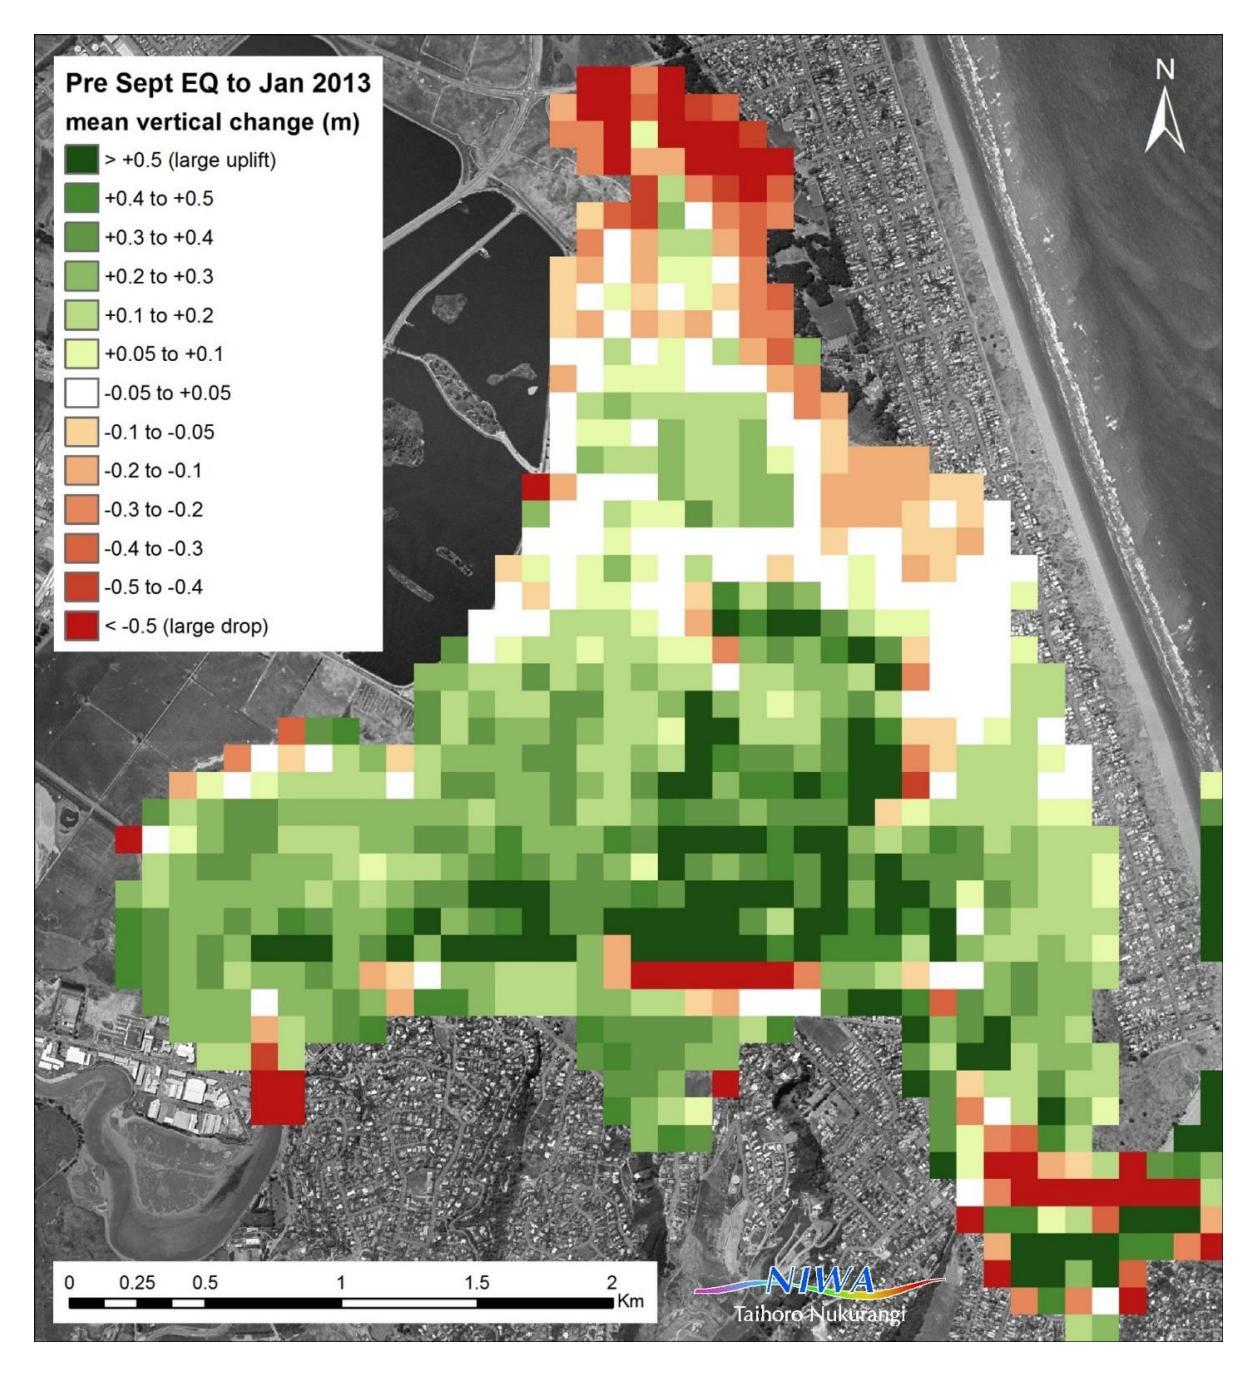
The Avon Heathcote Estuary Ihutai, Christchurch's main coastal waterbody, underwent significant changes in ground surface elevation during the 2010-2011 earthquake sequence (Figure 4-9). These ground changes, including mainly uplift, suggest possible impacts for the entire system including physical and ecological characteristics.

Figure 4-9 Bathymetric changes in the Avon Heathcote Estuary calculated from digital elevation models derived from a composite of LiDAR and echosounder survey data. The change analysis shows that the main body of the estuary has experienced uplift with some subsidence in the northern end around the mouth of the Avon River. Uplift patchiness in the southern part of the estuary represents morphological change between surveys rather than earthquake effects. A full description of the digital elevation models used for this analysis is contained in Measures (2013).

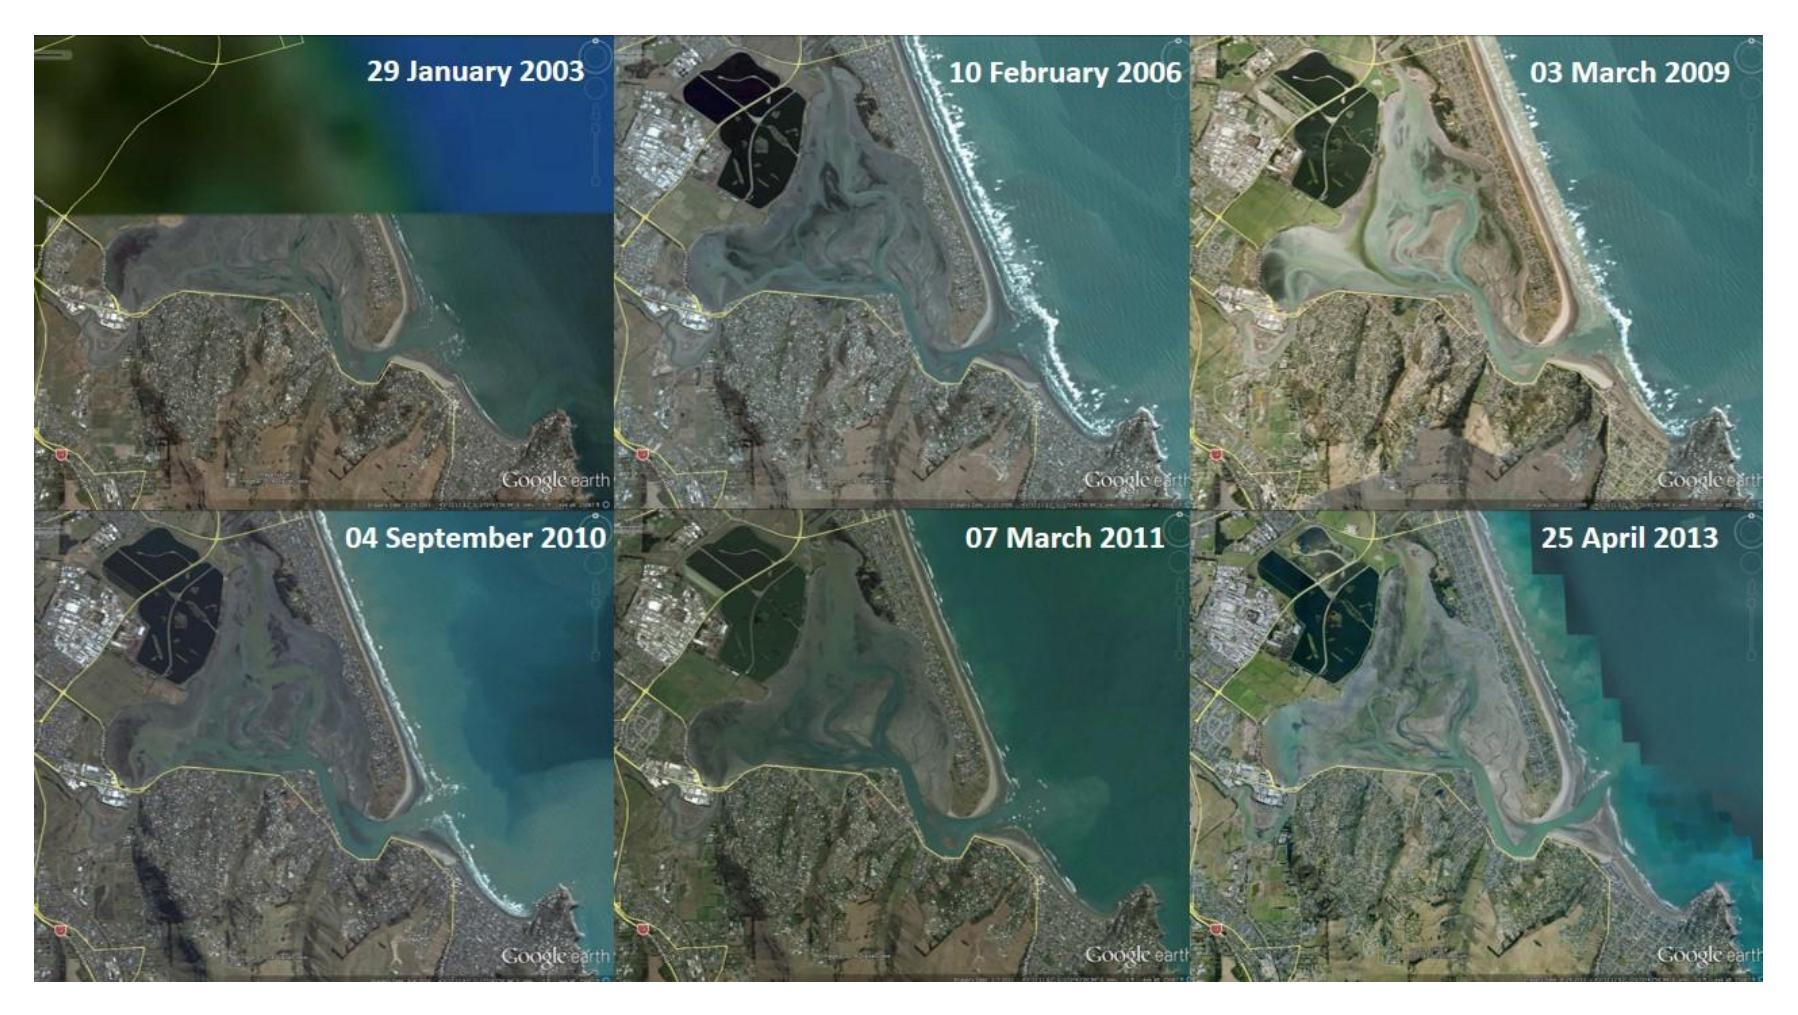
Figure 4-10 Time series of Google Earth images of the inlet (43° 33' 41.45"S, 172° 45' 14.44"E) and the estuary from 29 January 2003 to 25 April 2013. For direct comparison of the inlet and estuary morphology, it has to be considered that the images have not been referenced to the respective tidal phases yet.

To demonstrate the rapid changes from the earthquake sequence, a time series of Google Earth images from 2003 to 2013 is shown in Figure 4-10. The images indicate no significant changes of the inlet from 2003 to 2009. However, in the 2010, a distinct channel can be seen interrupting the line of breaking waves, likely corresponding to a sandbar-like feature as can often be observed at deltas and inlets. This behaviour can continuously be found in the following images. A generally limited wave action must also be considered an influencing factor. A major change in inlet morphology can then be seen in the image from 2013. The channel at the ocean side bends northward leading to a pointed flat at the southern side of the inlet. Entering the estuary, the channel bends southward, intensifying the meandering loop that seemed to have had less significance in the past, and creating a larger flat at the inner side of the end of the spit (Figure 4-10). It should be noted that the Google Earth images are not referenced to a particular tidal phase and state of wave action, introducing a degree of variation when comparing the images.
