GEOTECHNICAL & FLOODING RECONNAISSANCE OF THE 2014 MARCH FLOOD EVENT POST 2010-2011 CANTERBURY EARTHQUAKE SEQUENCE, NEW ZEALAND

Version 1: 19 June 2014

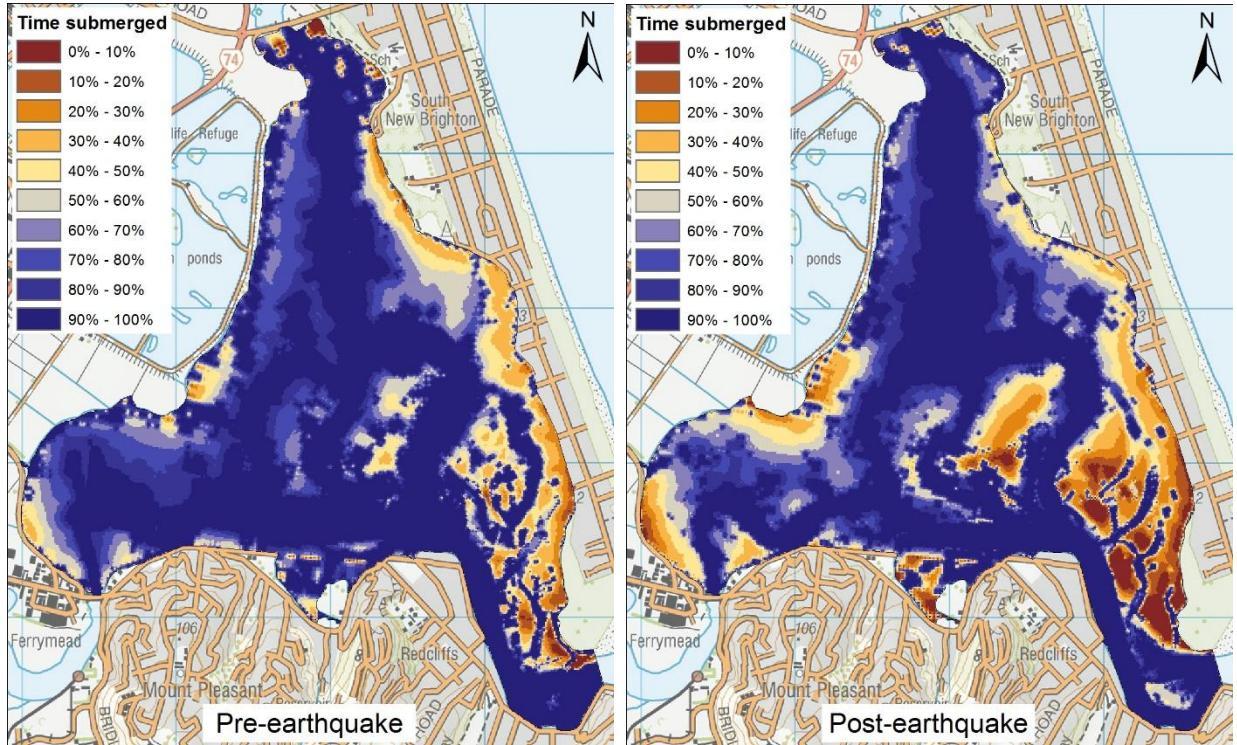
Figure 4-11: Proportion of time estuary bed is submerged pre and post-earthquake. Clear changes are visible in the southern and eastern parts of the estuary which are having significant effects on habitat and morphology. Figure reproduced from Measures (2013).

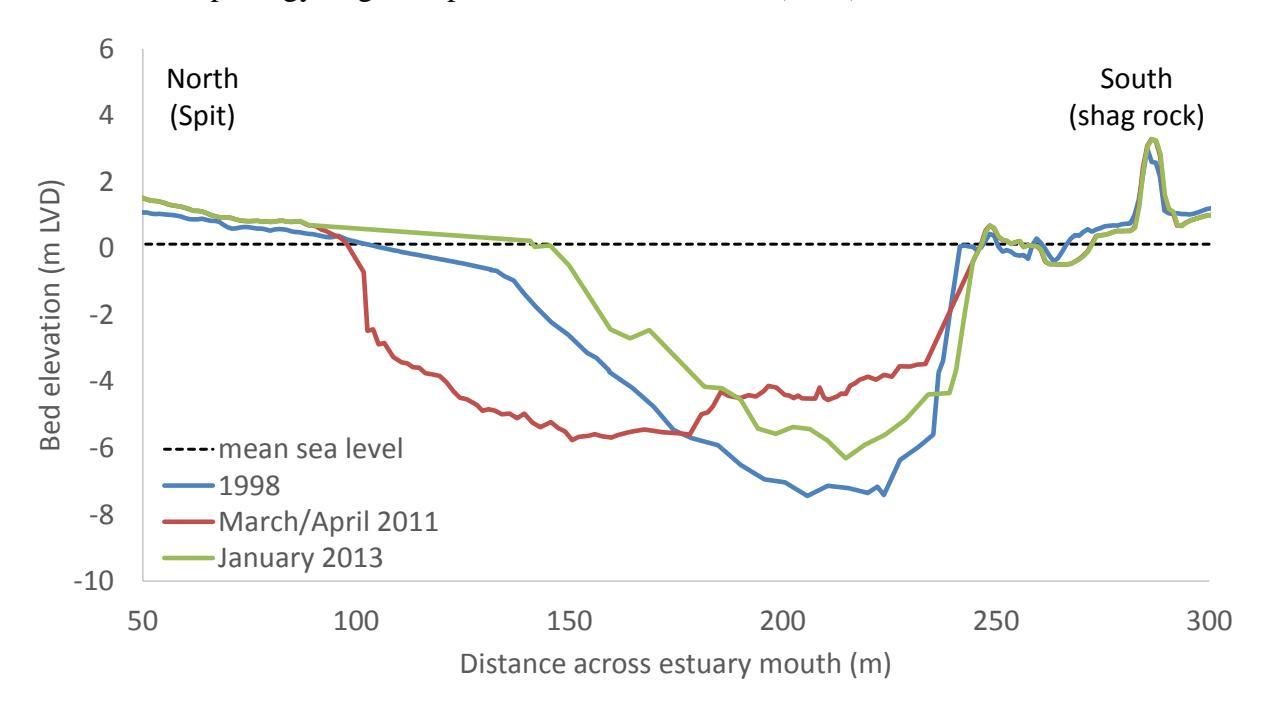
Figure 4-12 Changes in mouth cross-section pre-earthquake (1998), immediately post-earthquake (March/April 2011) and following morphological adjustment (January 2013). Cross-section extracted from echo-sounder surveys of the neck of the estuary. Figure reproduced from Measures (2014).

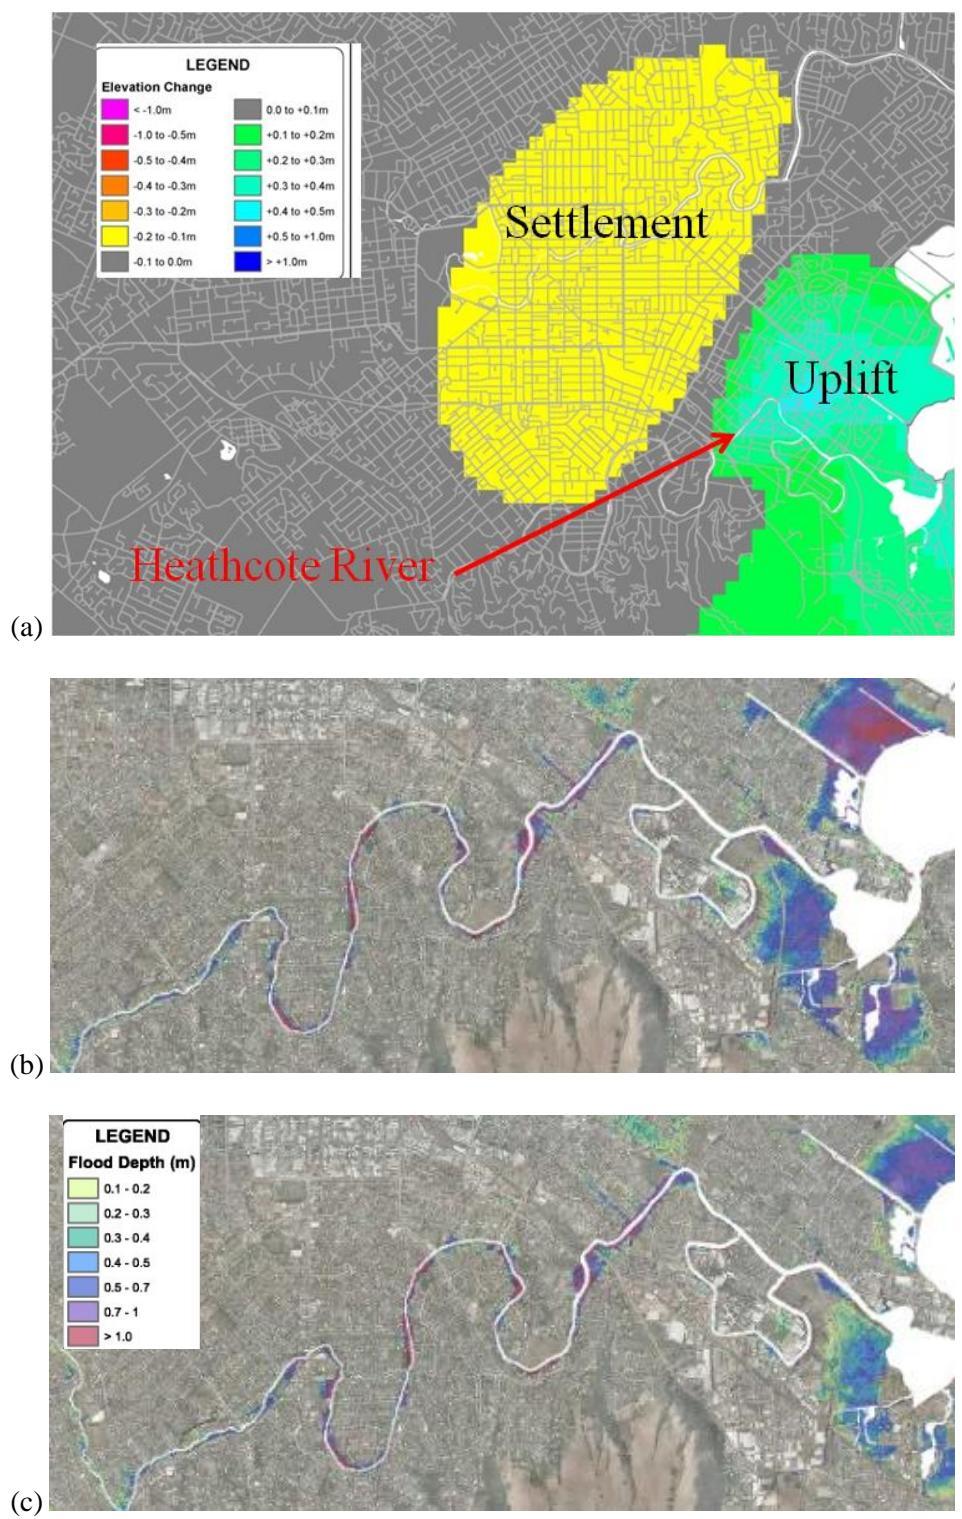
The Heathcote River lower section is tidally influenced and, as shown in Figure 5-1a, has risen by up to 400 mm, while the upstream portion of the river has settled by 100-300 mm. The mechanisms leading to this deformation pattern were described in Chapter 3. These elevation changes have resulted in a gentler hydraulic gradient, reducing the river's hydraulic capacity and leading to increased bed levels (CCC Task Force, 2014). As example of the settlement along the Heathcote River, stop-banks constructed in 1986 in the vicinity of Radley to Garlands Roads have settled by up to 0.5 m (River Level 10.9 m to 10.4 m). Since the 2010-2011 earthquake sequence the ecology of the Heathcote River has begun to adjust to this change in the river-scape, with the re-establishment of invertebrates in the lower section.

Overland flow modelling was carried out by T & T, using both the DHI MIKE software suite and TUFLOW packages (Chapter 4), and making reference to pre- and post-earthquake LiDAR data. Figures 5-1b and 5-1c present maps showing the qualitative comparison for pre- and post-earthquake conditions, respectively, in the Heathcote River lower section, where the tectonic uplift was observed. These figures highlight the reduction of expected overland flow area and a decrease in the expected flood depth: that is, maximum expected flood depth in the area is in the range of 0.7-1 m (Figure 5-1b) for the pre-earthquake conditions and in the range of 0.5-0.7 m (Figure 5-1c) for post-earthquake conditions. However, as previously noted the model does not include groundwater changes, storm surges and climate induced accelerated sea level change. Also, the pre-earthquake LiDAR data (2003) is considered of limited accuracy. Thus the uncertainty in results is not well constrained, but the trend is consistent with observed ground movement and expected changes in flow patterns.

Figure 5-1 Heathcote River area: (a) impacts of tectonic uplift (Tonkin & Taylor, 2013); (b) pre-100 year annual return interval (ARI) event flood depth; and (c) post 2010-2011 earthquake sequence ARI event flood depth excluding stop-banks and climate change (Tonkin & Taylor 2013).

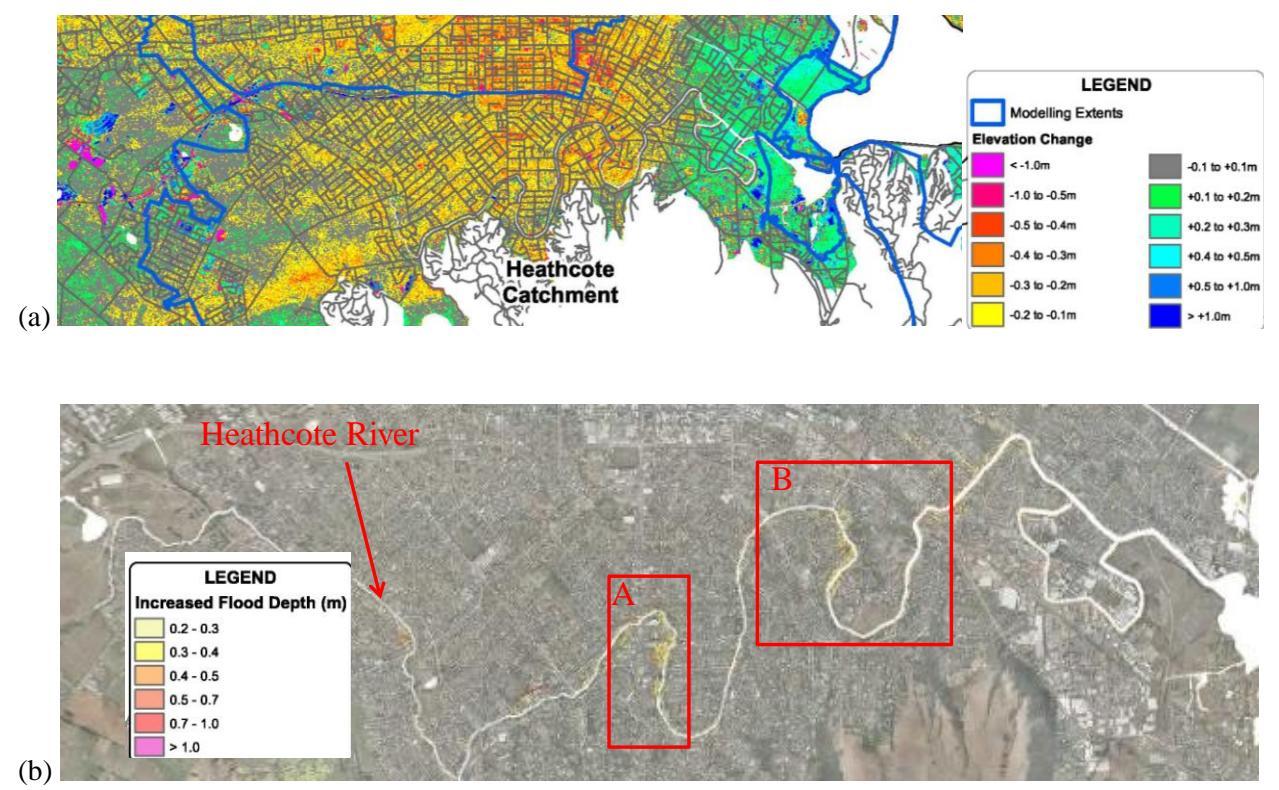
In the Heathcote catchment area Figure 5-2a shows both settlements and uplift of ≤ 0.3 m were experienced. Canterbury Geotechnical Database (CGD) data show that vertical and horizontal ground movements occurred in the upper Heathcote River area (i.e. the area from Halswell Road to Cashmere View Street on both sides of the Heathcote River), with the land generally settling between -0.1m to -0.3 m after the earthquake events.

Figure 5-2b shows the resulting cumulative changes in overland flow flood depths estimated by T & T, taking into account both pre- and post-earthquake land elevations, which included both liquefaction-induced settlement and tectonic uplift. Figure 5-2b shows liquefaction induced settlement in the middle reaches of the Heathcote River increased the flood depth by up to 0.5 m.

Figure 5-2 Heathcote River: (a) cumulative elevation change along the river pre-2010 to post June/December 2011 (Tonkin & Taylor Ltd, 2013, Figure A10); (b) overland flow increased flood depths post-December 2011 compared to pre-September 2010 (Tonkin & Taylor, 2013).

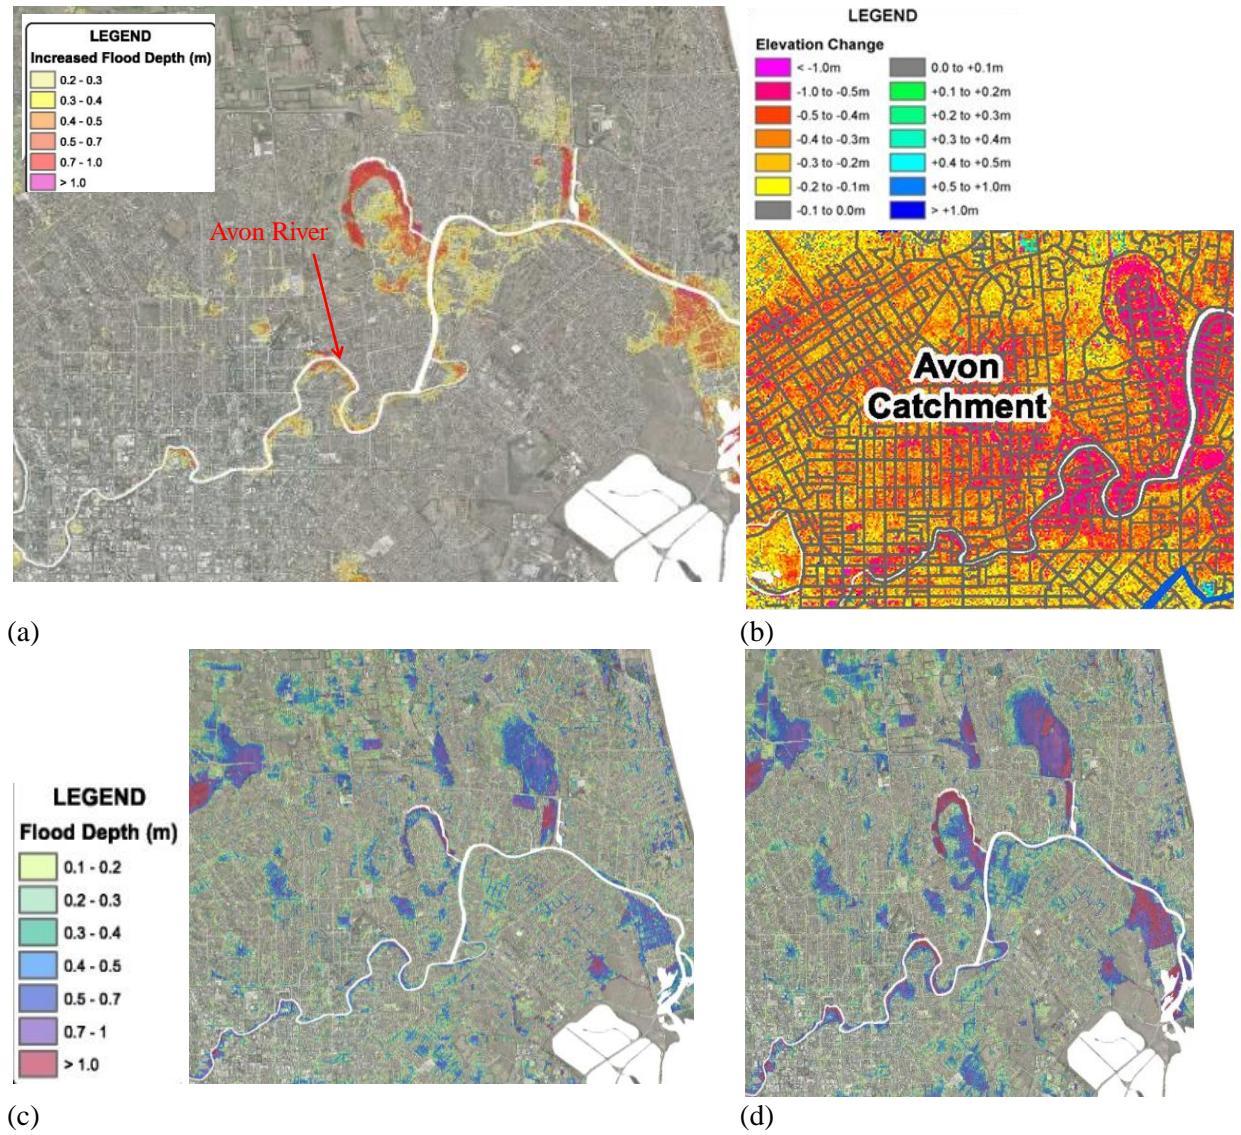
Figure 5-3a shows the estimated Avon River catchment area cumulative changes in overland flow flood depth, as assessed by T & T, taking into account both pre- and post-earthquake land elevations. These results indicate an increased flood depth up to 1 m in this area, resulting from the cumulative settlement shown in Figure 5-3b from the 2010-2011 earthquake sequence exceeding 1 m within the same area.

Figure 5-3 Avon River: (a) overland flow increased flood depth for the Avon River pre-September 2010 to post-December 2011; (b) cumulative elevation changes due to liquefaction; (c) increased overland flow flood depth from the overland flow model for the 100 year ARI excluding stop-banks and climate change for pre September 2010; and (d) post 2010-2011 earthquake sequence (Tonkin & Taylor, 2013).

Modelling of the overland flow was carried out by T & T, using both the DHI MIKE software suite and TUFLOW packages (Section 4), and making reference to pre- and post-earthquake LiDAR data. Figures 5-3c and 5.3d present maps showing the qualitative comparison of the pre- and post-earthquake conditions, respectively in the Avon River lower section. These results highlight an increase in the expected flood depth: that is, maximum expected flood depth in the area is in the range of 0.5-0.7 m (Figure 5-3c) for the pre-earthquake conditions, while expected to exceed 1 m in post-earthquake-conditions (Figure 5-3d).

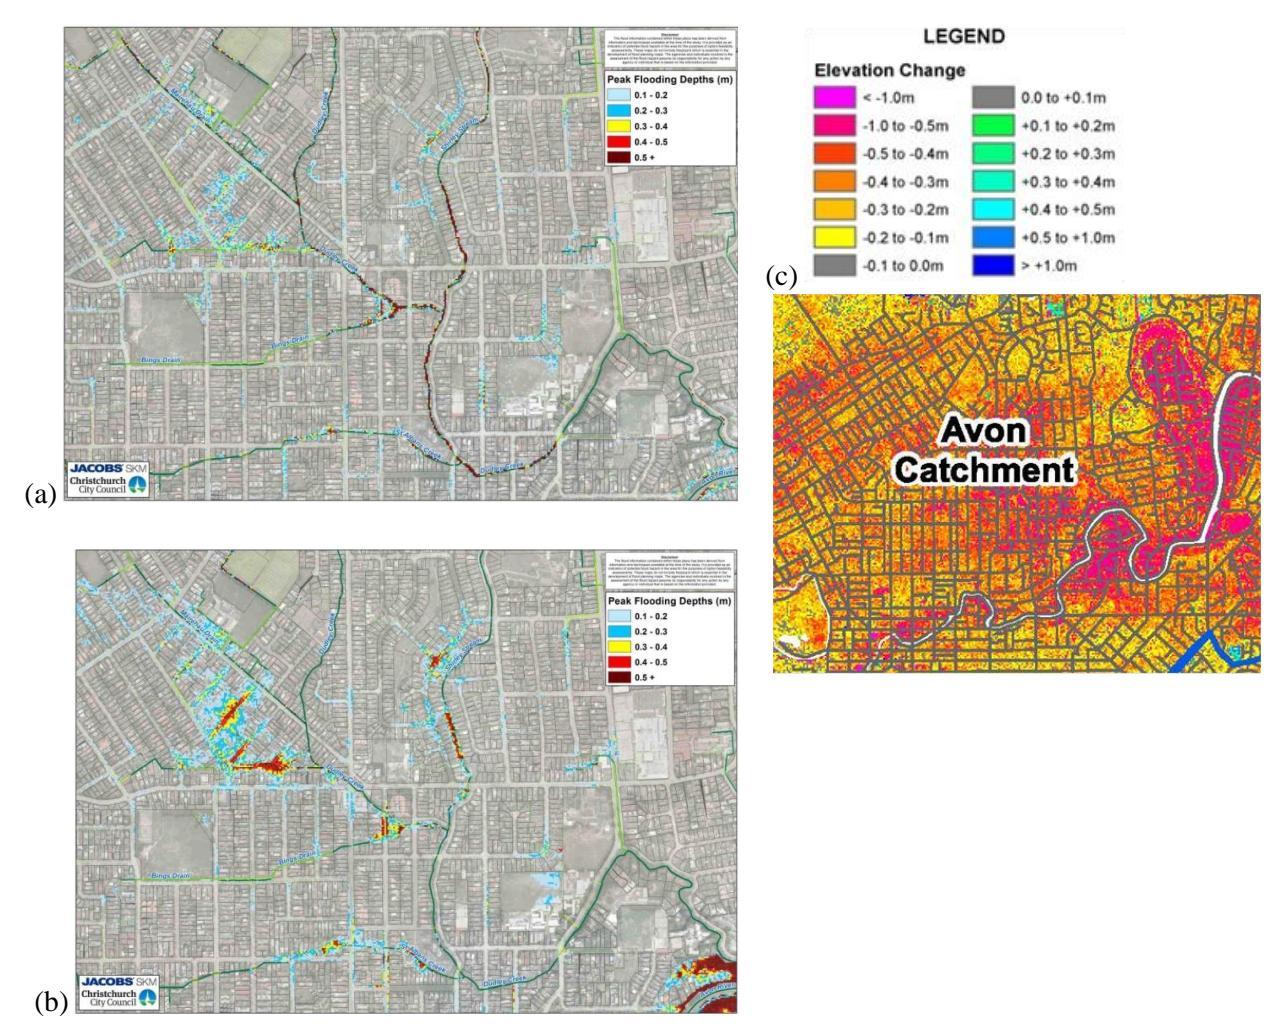
Jacobs Sinclair Knight Merz (JSKM), who conducted the Dudley Creek project under the Land Drainage Recovery Programme, have extensively studied the Dudley Creek catchment including the Flockton area. An increase up to 0.5 m in flood depth can currently be observed in the Flockton Basin when comparing the peak flooding depth expected for a 10-year return-period rainfall event pre-September 2010, resulting from the JSKM study and shown in Figure 5-4a, with the peak flooding depth expected for the same rainfall event in post-earthquake sequence condition shown in Figure 5-4b. This increased flooding depth is a result of subsidence across a large proportion of the Dudley Creek catchment. Subsidence of between 0.2 and 0.5 m is shown in Figure 5-4c, resulting from the 2010-2011 earthquake sequence. Bed heave has also occurred extensively along Dudley Creek and its tributaries, resulting in a subsequent loss in hydraulic capacity.

Figure 5-4 Dudley Creek catchment, including the Flockton area: (a) height of flood water for a 10-year return-period rainfall event pre-September 2010 (CCC, 2014); (b) increased height of flooding for same rainfall event post-earthquake sequence (CCC, 2014); (c) cumulative liquefaction induced settlement in the area as a result of the 2010-2011 earthquake sequence (Tonkin & Taylor, 2013).

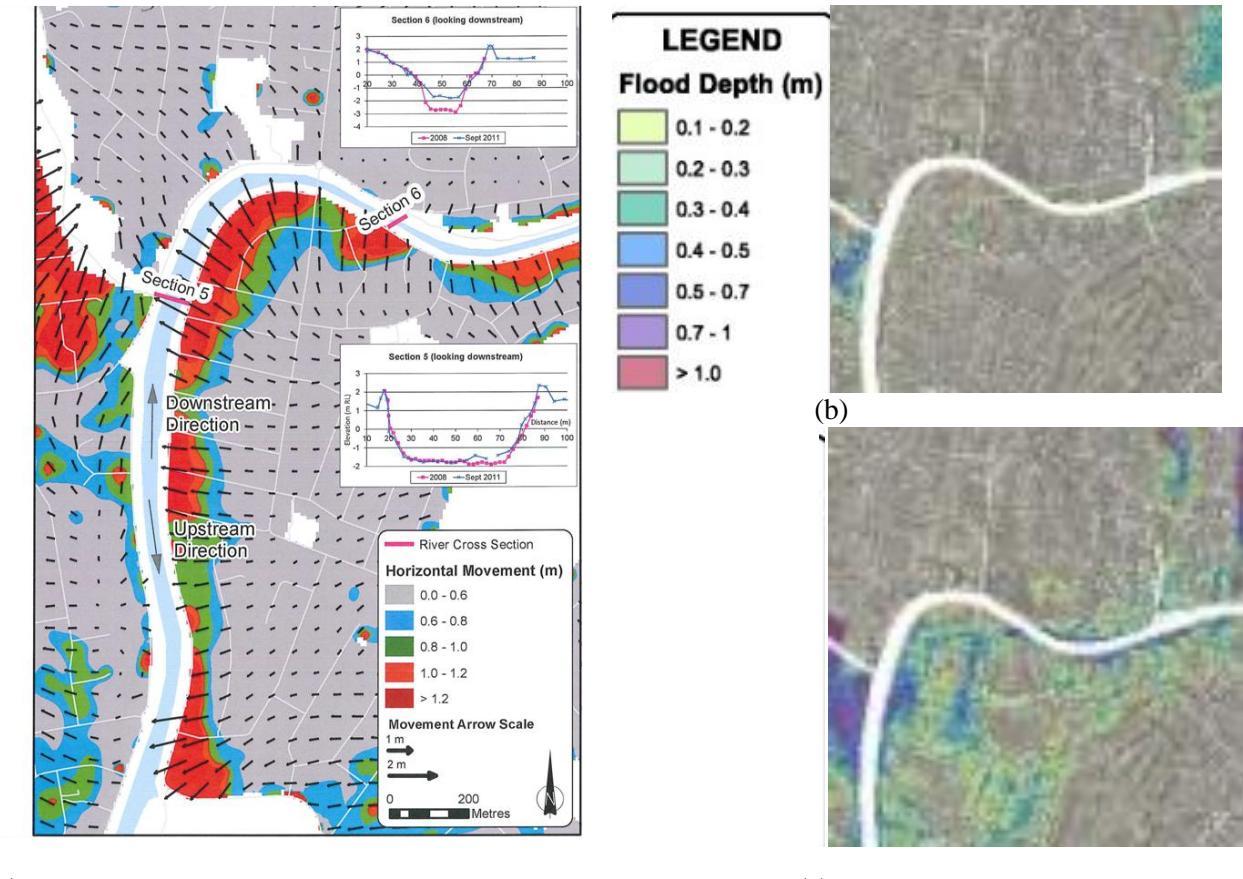
Figures 5-5a and 5-6a illustrate the moderate to severe lateral spreading that has occurred along the length of the Avon River, where major horizontal movements in excess of 1.2 m were observed as a result of th4e 2010-2011 earthquake sequence.

As previously described in Chapter 3 and shown in cross-section 6 in Figure 5-5a, the channel area between Avondale Bridge and Anzac Bridge was subject to significant infilling following the 2010-2011 earthquake events, resulting in a shallower water depth of ~1.8 m in 2011. The Avon River banks suffered significant slumping from liquefaction and lateral spreading. Figure

5-5a cross-section 6 clearly shows a shallower slope on submerged banks, especially on the northern bank.

Qualitative comparison of the T&T overland flow maps for pre (Figure 5-5b) and post (Figure 5-5c) earthquake conditions along the Avon River in the area from Avondale Bridge to Anzac Bridge highlights an extended overland flow and an increase in the expected flood depth of up to 0.7 m (Figure 5-5c).

Figure 5-5 Avon River from Avondale Bridge to Anzac Bridge: (a) post-earthquake sequence cross sections; (b) pre-earthquake sequence river flood depth modelling for the 100 year ARI, excluding stop-banks and climate change; and (c) post-earthquake sequence river flood depth modelling for the 100 year ARI, excluding stop-banks and climate change (Tonkin & Taylor, 2013).

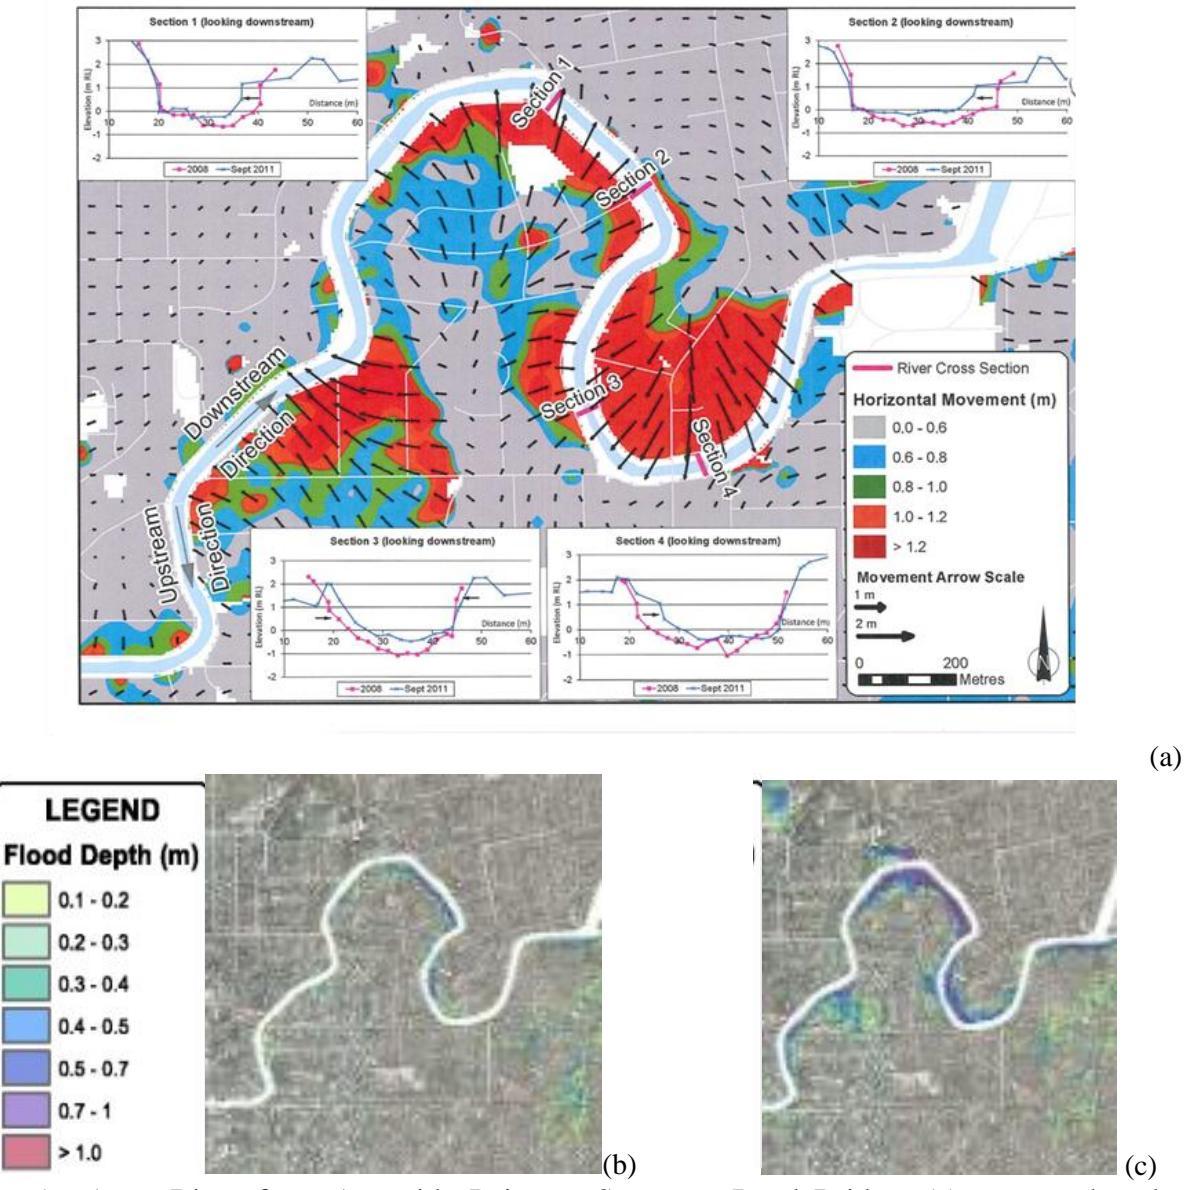
Figure 5.6 Avon River from Avonside Drive to Stanmore Road Bridge: (a) post earthquake sequence cross sections; (b) pre-earthquake sequence river flood depth modelling for the 100 year ARI, excluding stop-banks and climate change; and (c) post-earthquake sequence river flood depth modelling for the 100 year ARI, excluding stop-banks and climate change (Tonkin & Taylor, 2013).

Figure 5.6a presents the horizontal movements (up to 1.2m) observed along the Avon River section in the area from Avonside Drive and to Stanmore Road Bridge. In Section 4 of Figure 5.6a a shift of the northern bank narrowing the river to a width of around 20 m can be observed, along with a decrease of the river depth of around ~0.4 m. At cross-section 3 the river width was narrowed to around 16 m and the water depth was decreased from approximately 1 m to 0.4 m. For both cross-sections 2 and 1 the northern/north-eastern bank remained steady, while the

southern/south-western bank shifted laterally by around 5 m into the river and the water depth at the deeper part of the channel decreased by around 0.5m to between 0 and 0.3 m. Further details and comments on the earthquake-induced impacts and changes to river morphology can be found in Chapter 3 of this report.

The qualitative comparison of the T&T overland flow maps for pre (Figure 5-6b) and post (Figure 5-6c) earthquake conditions for the Avon River highlights, in the area from Avonside Dive to Stanmore Road Bridge, an extended overland flow and an increase in the expected flood depth that is expected to exceed 1 m (Figure 5-6c). It is worth noting that the overland flow model, while accounting for the earthquake-induced changes in the river morphology does not account for stop-banks and climate change. The performance of the Avon River stop-banks after the 2010-2011earthquake sequence is described in Chapter 6 of this report.

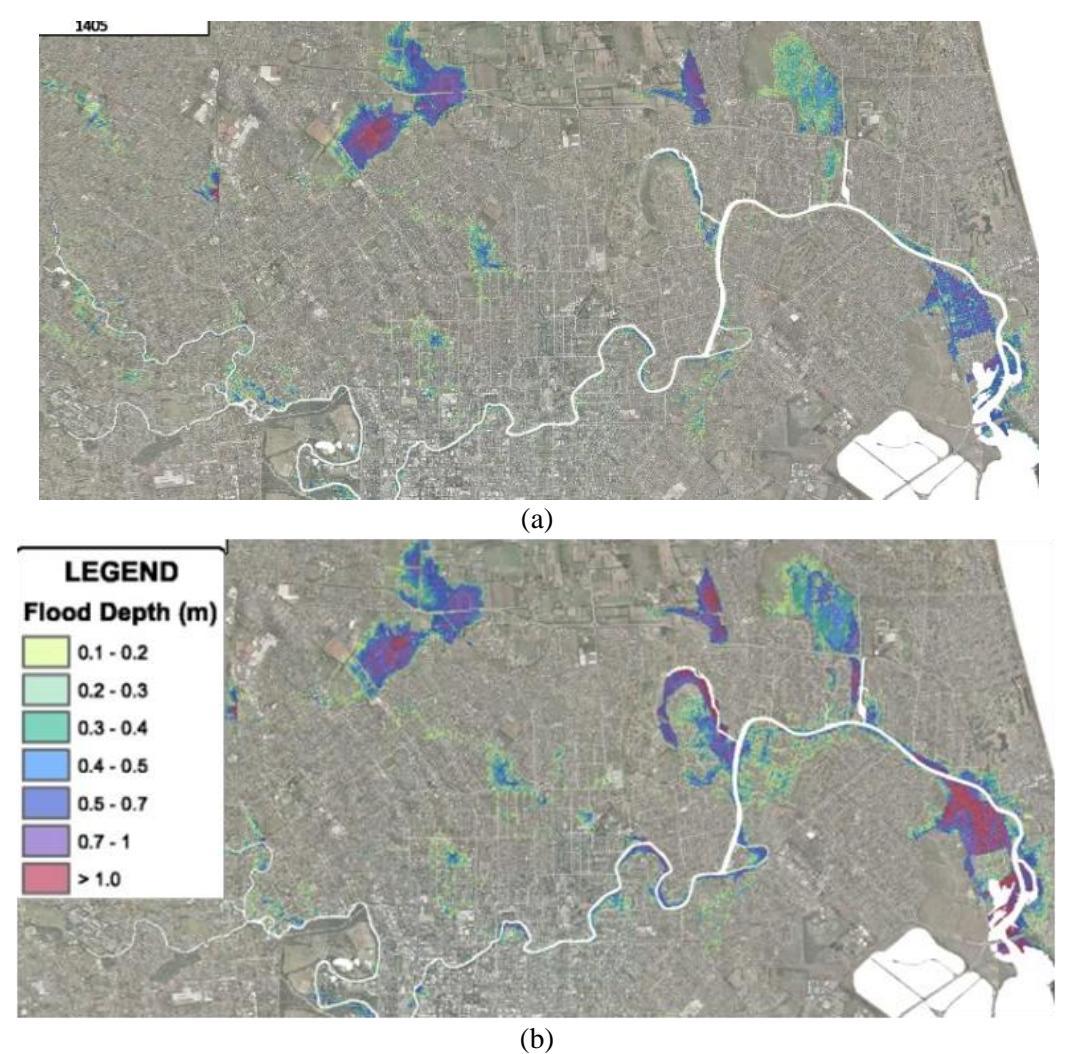
Figure 5-7 shows the pre- post-earthquake estimated Avon River flood depths (Tonkin and Taylor, 2014). A comparison of these figures identifies increased river flooding depths of over 1 m along portions of the Avon River and in the Avon-Heathcote Estuary Ihutai.

Figure 5-7 Increased river flood depths for the Avon River, excluding stop-banks and climate change for the 100 year ARI for (a) pre September 2010 and (b) post 2010-2011 earthquake sequence (Tonkin & Taylor, 2013)

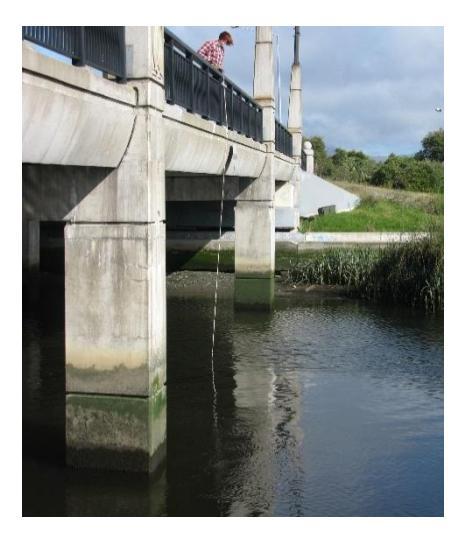
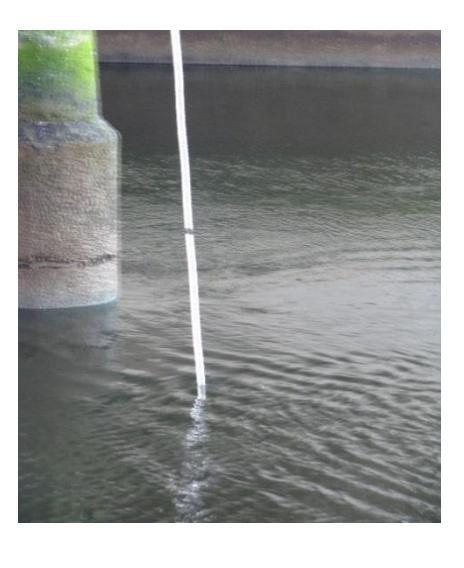
Figure 6-3 (a) Depth soundings at Anzac Drive Bridge and (b) depth reading using a marked rope.

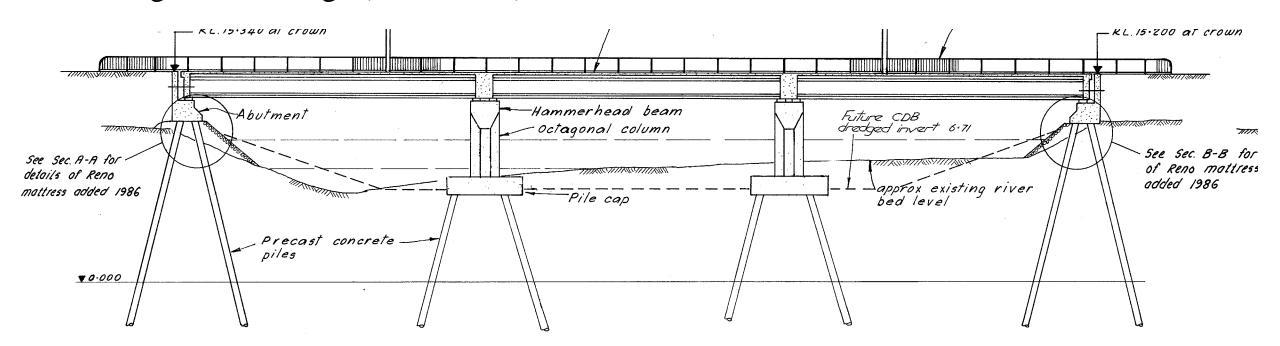
Figure 6-5 Profile view of South Brighton Bridge (CCC, 1978).

With the original river bed level (Figure 6-5), scour would correspond to the octagonal columns, probably reaching the pile caps and making them a scour protection. With full exposure of the pile caps, scour would be expected to develop in a different shape, in response to the sharp pile cap edges. However, destabilization of the bridge due to scour is very unlikely, because of the support provided by the concrete piles. Surveying was limited due to construction work (Figure 6-6, Figure 6-7, and Figure 6-8). Figure 6-8 shows the soundings generally indicating a deepening towards the east in the channel, and the downstream side was generally deeper by ~30-40 cm. An irregularity was found at a distance of 24-26 m from the western lightpost which served as datum. Due to the limited soundings, it cannot be determined if the shoaling or the deepening represents the irregularity, or if this might be related to a gravel bank deployed around the piers for a remediation of the pier pile caps. A more detailed investigation after the conclusion of the construction work would answer this question.

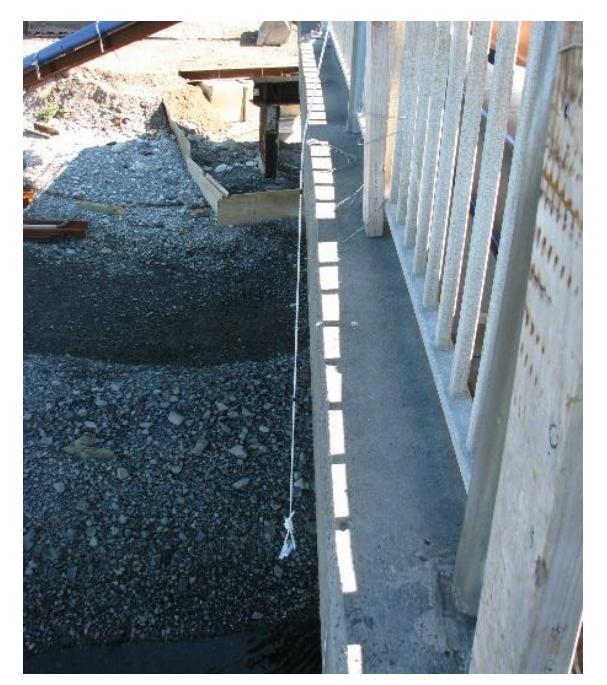
Figure 6-6 Sounding at South Brighton Bridge with construction work in the background on 19 March 2014.

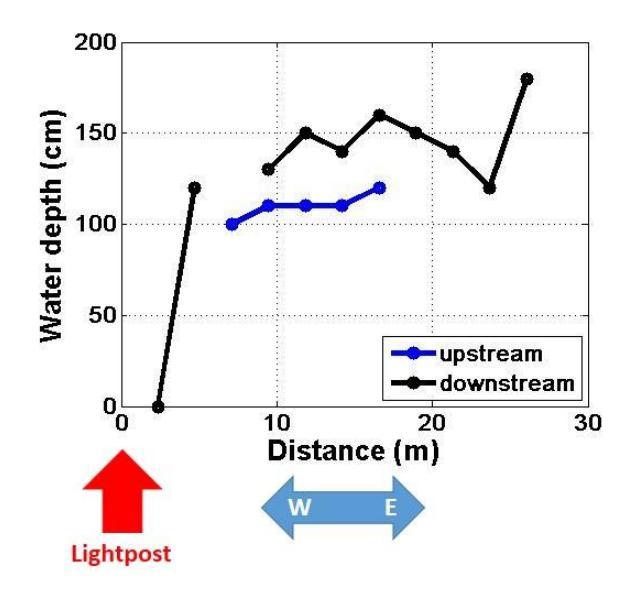
Figure 6-8 Soundings at the Avon's Bridge Street Bridge. Zero represents the western lightpost of the bridge. Construction work restricted the sounding particularly on the upstream side, and in close vicinity of the piers.

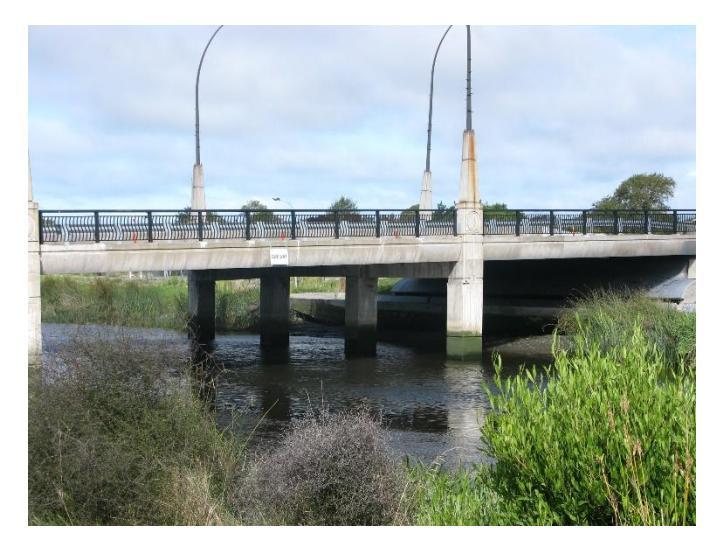
Figure 6-14 Anzac Drive Bridge on 19 April 2014.

The bridge sustained moderate to severe damage following the Christchurch earthquake due to liquefaction and lateral spreading, and this was further progressed in the subsequent events, mainly the 13 June 2011 earthquakes.

Following the Christchurch earthquake, both pier frames suffered extensive cracking of the concrete columns and beams as well as the beam-column joint regions of the pier cap. Spalling of the concrete cover appears to be primarily as a result of interaction between the transverse motion of the bridge and the rotation of the piers due to lateral spreading. There was no serious damage to the bridge superstructure.

No details of the repair and retrofit approach are available at this stage.

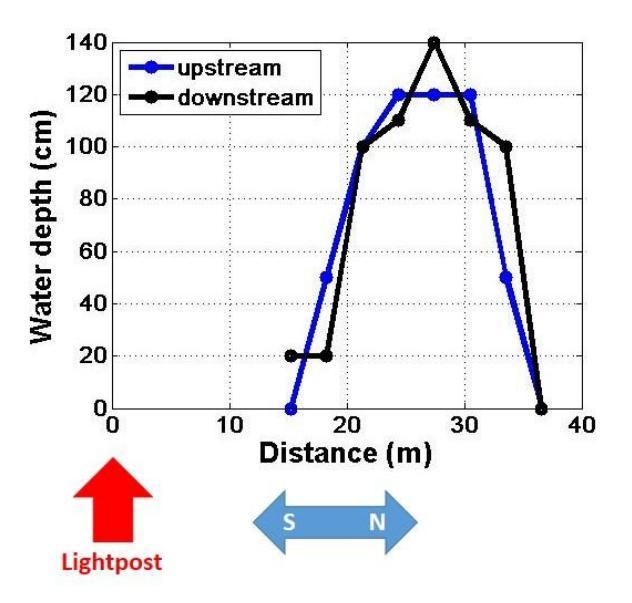
The soundings at Heathcote River Bridge are shown in Figure 6-19 and indicated that most of the flow is going between the two pile groups. No significant water depth variations were noted at the foundations, while downstream a slight deepening in the center of the channel by ~ 0.2 m was observed, likely eroded due to compression of streamlines between the piers.

Figure 6-19 Soundings at the Heathcote River Bridge.

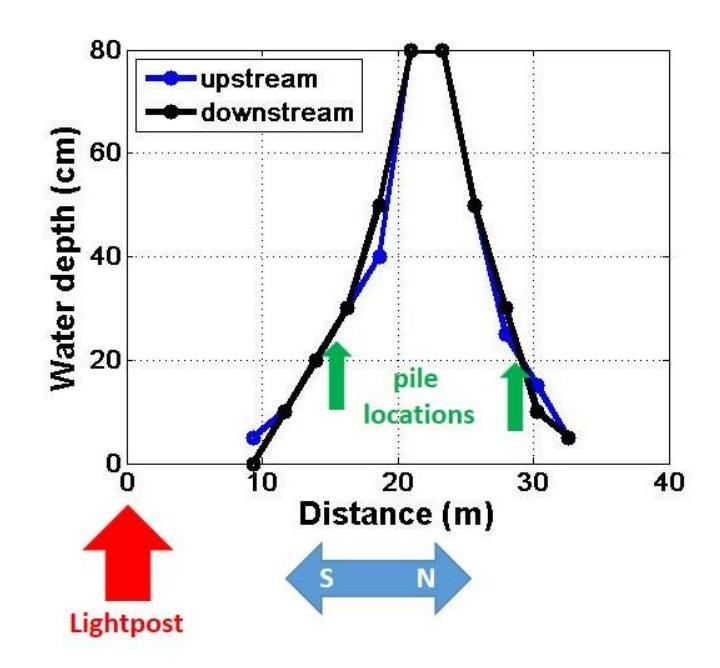
The soundings shown in Figure 6-21 highlighted that flow is funneled through the two pier structures, but no indicators for scour were observed.

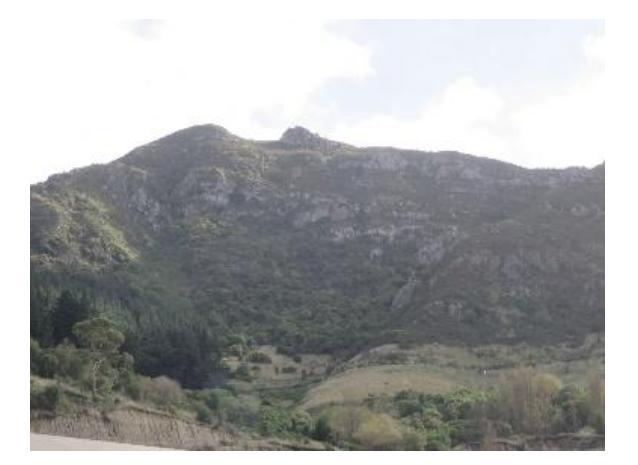
Concerns were expressed regarding the safety issue and current closure of (Old) Sumner Rd. These roads represented an alternative access route to Lyttelton and the port in the case of tunnel closure. Significant destabilization of the steep slopes along these roads as shown in Figure 6-28 made them a major safety issue and led to closure. An alternative trucking route to the port is highly desired as a backup to the tunnel. The tunnel entrances are subject to risk of closure due to landslides, which risk may even increase during heavy rain events. If it came to a flood in the tunnel at the same time, the port could theoretically become inaccessible. No such observations were made during the flood and heavy rainfalls in March 2014, but it was mentioned as a possible concern related to flood and heavy rainfall events.

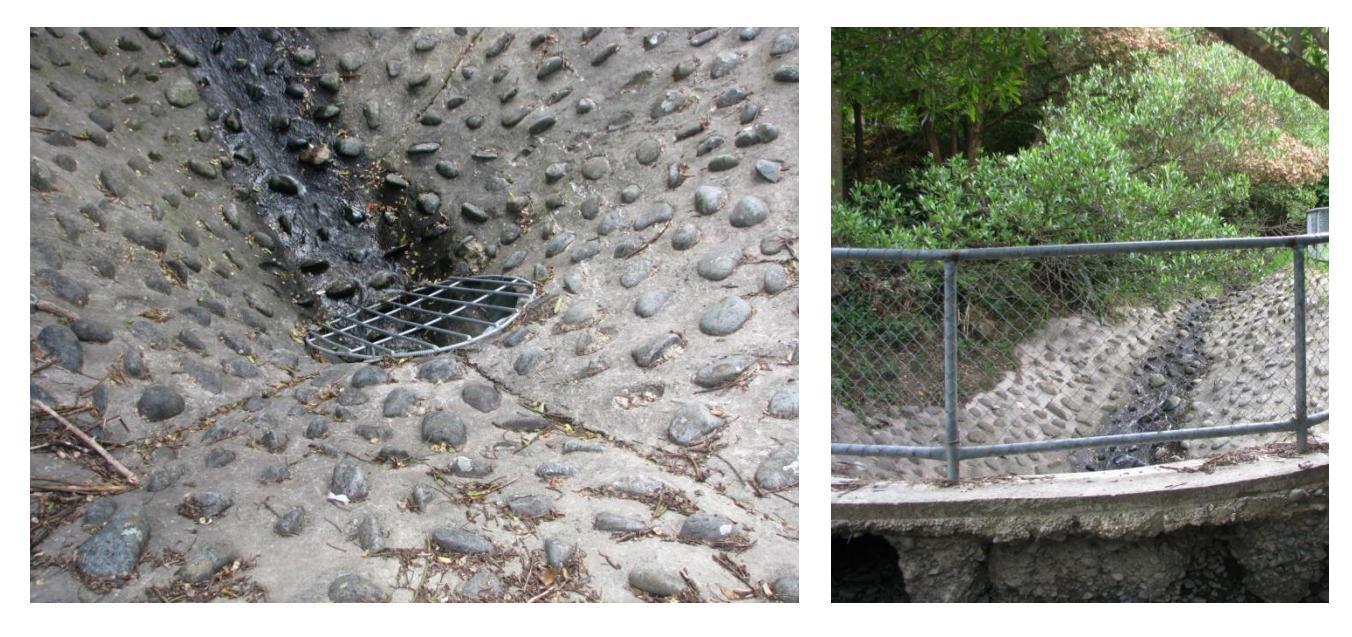
The over topping of the storm water inlet shown in Figure 6-29 at the top of Canterbury Street in Lyttelton led to progressive failures downstream during the March 5th flood event. This storm water inlet is at the top of the drainage system and collects water that flows off the top of the Port Hills in an undeveloped section above Lyttelton. The GEER team found the culvert unplugged and free flowing at the time of its field reconnaissance. Evidence was found that the inlet became plugged at some point during the storms leading to overtopping of the collection basin and undermining/erosion downstream of the inlet structure as shown in Figure 6-29b.

Figure 6-29 Storm water inlet at the top of Canterbury Street that was overtopped during the March 5th event (Canterbury Street: -43.596225°, 172.723001°).

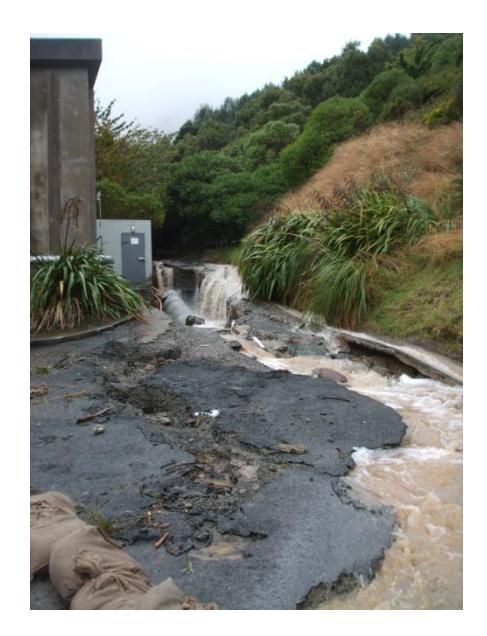
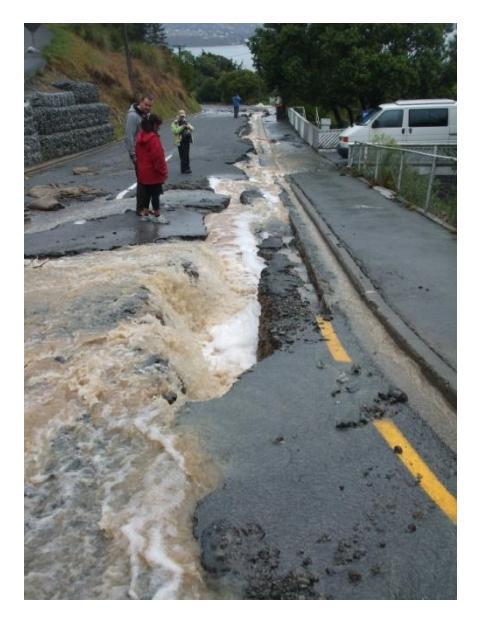
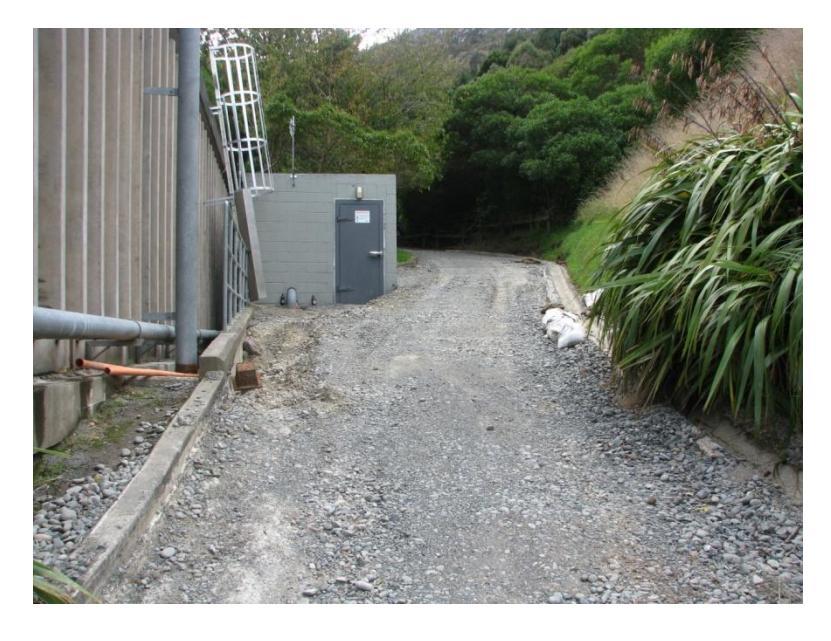
Water then eroded the pavement and base course exposing the storm water pipe as shown in Figure 6-30a. As shown in Figure 6-30b, the erosion of pavement and the base course continued down Canterbury Street. Repairs to the streets shown in Figure 6-30c had been made at the time of the GEER team's reconnaissance.

Figure 6-30 Erosion as a result of the storm water inlet in Figure 6-29 overtopping. (Photos (a) and (b) courtesy of Michael Hayes) (c) Canterbury Street restored to grade (93 Canterbury Street: -43.596590°, 172.722847°).

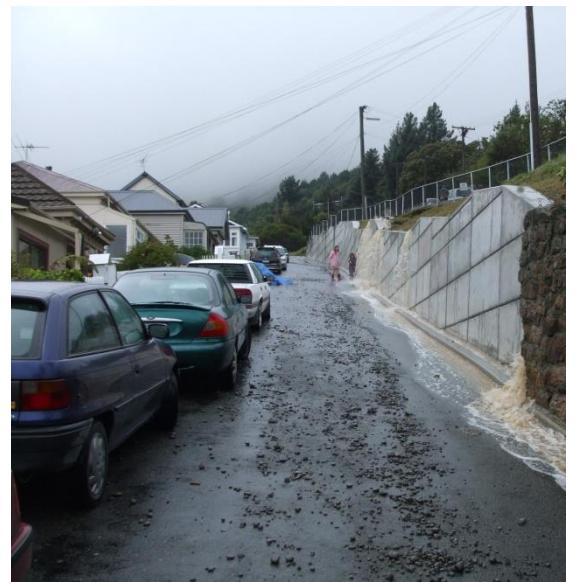
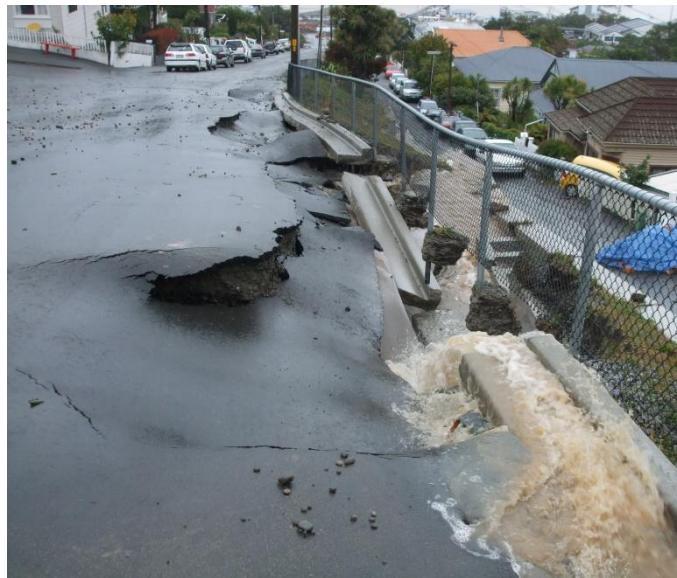
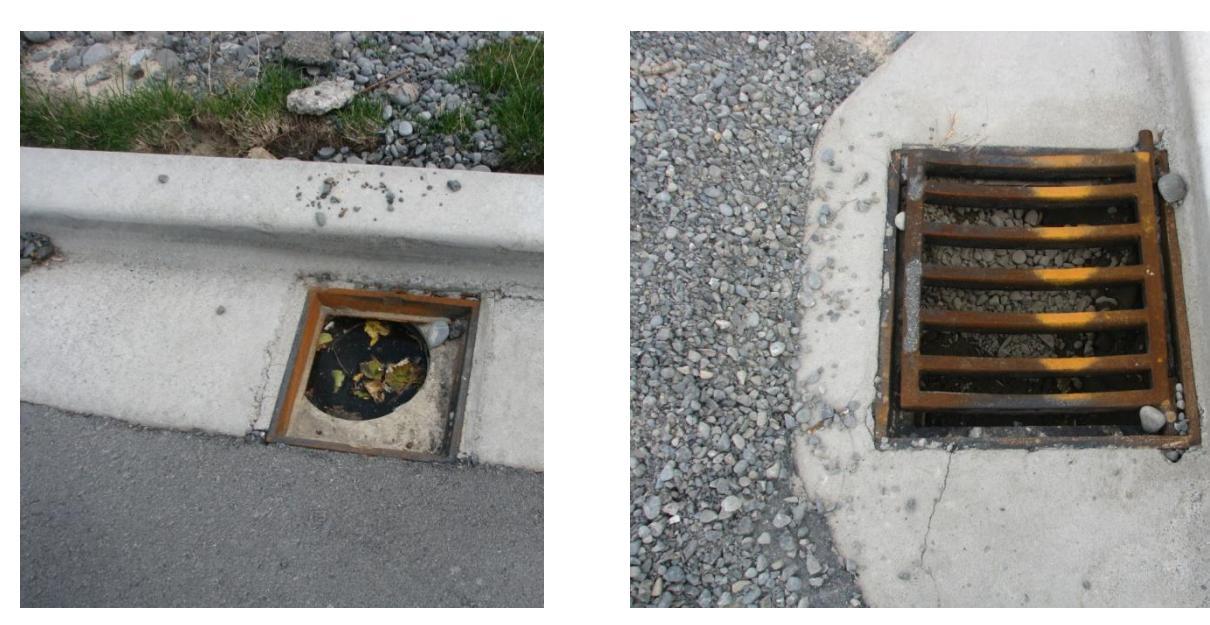
Further down Canterbury Street, water eroded the retained earth and street above a retaining wall shown in Figure 6-31, which had previously failed and been replaced in 2013 by SCIRT. The new retaining wall consists of a wet cast block. As shown in Figures 6-31c and 6-31d, the drainage system behind the wall was found to be plugged at the time of the GEER teams visit on March 22, 2014. SCIRT reported that the wall was found to be safe. GEER found no noticeable horizontal wall movement. SCIRT also reported damage to a new retaining wall being constructed on Sumner Road as a result of the flood event.

Figure 6-31 (a) Storm water flowing over the Canterbury Street retaining wall. (b) Erosion of Canterbury Street and retained earth above the wall. (c) and (d) plugged drains directly behind the wall as a result of upstream erosion seen in Figure 6-30 (a and b). Photos (a) and (b) courtesy of Michael Hayes (73 Canterbury Street: -43.599005°, 172.722243°).

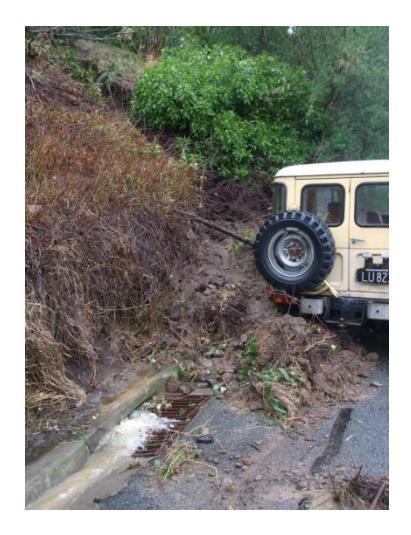
GEER found evidence of numerous plugged inlets to the storm water system such as that on Selwyn Street in Lyttelton, shown in Figure 6-32. In interviewing the local community GEER found that locals unearthed the plugged inlets to enable the runoff to enter the storm water system. The Selwyn Street example in Figure 6-32a and b shows a small slump that fell from above the drainage inlet and plugged it resulting in the flow being routed down Selwyn Street instead of into the storm water system.

It's plausible that had the culvert not been unplugged during the storm event that water pressure behind the walls in Figures Figure 6-32c and Figure 6-32d could have resulted in failure, or failure of another type further downstream. A previous landslide below the sheet pile wall in Figure 6-32c had occurred prior to the 2010-2011 Canterbury earthquake sequence resulting in damage to the home below which is no longer present.

Figure 6-32 Unplugged culvert on Selwyn Street above crib retaining wall, Photo courtesy of Michael Hayes (a). Post cleanup by CCC at the drain inlet (b). Previous slope failure and
