GEOTECHNICAL & FLOODING RECONNAISSANCE OF THE 2014 MARCH FLOOD EVENT POST 2010-2011 CANTERBURY EARTHQUAKE SEQUENCE, NEW ZEALAND

Version 1: 19 June 2014

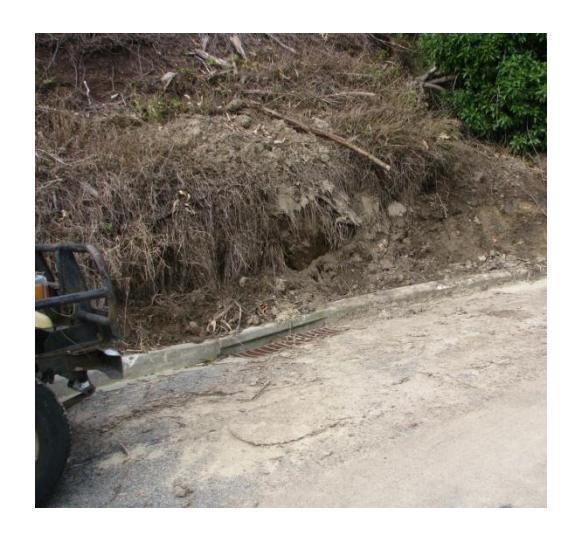
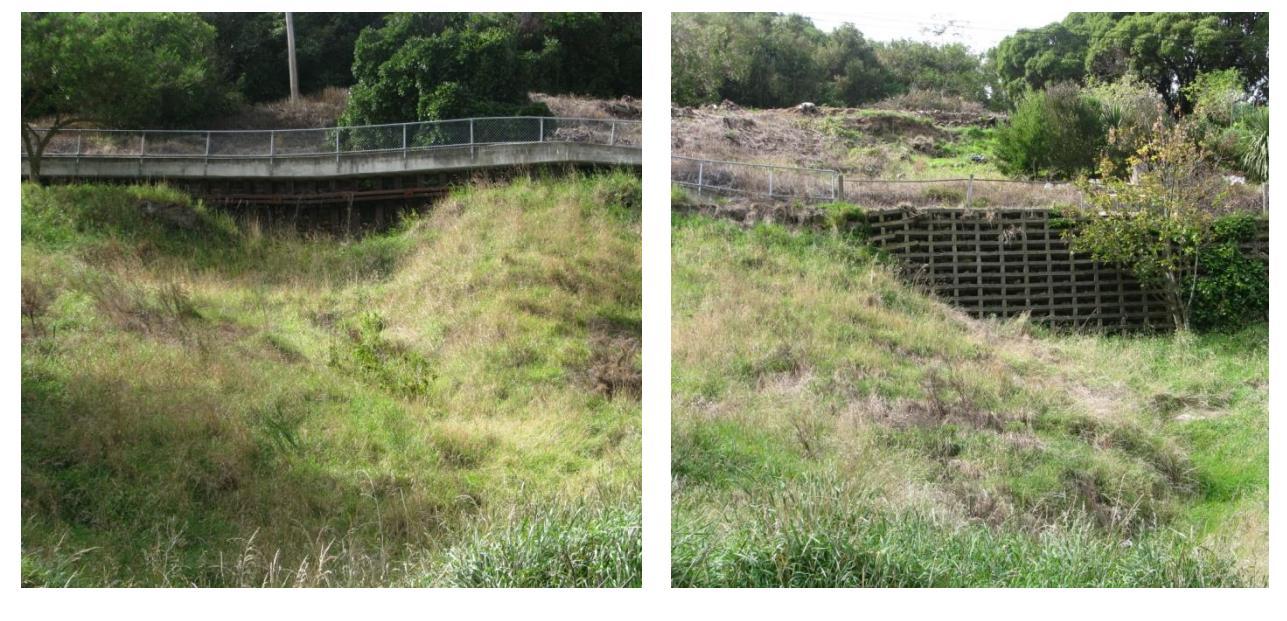
It's plausible that had the culvert not been unplugged during the storm event that water pressure behind the walls in Figures Figure 6-32c and Figure 6-32d could have resulted in failure, or failure of another type further downstream. A previous landslide below the sheet pile wall in Figure 6-32c had occurred prior to the 2010-2011 Canterbury earthquake sequence resulting in damage to the home below which is no longer present.

Figure 6-32 Unplugged culvert on Selwyn Street above crib retaining wall, Photo courtesy of Michael Hayes (a). Post cleanup by CCC at the drain inlet (b). Previous slope failure and

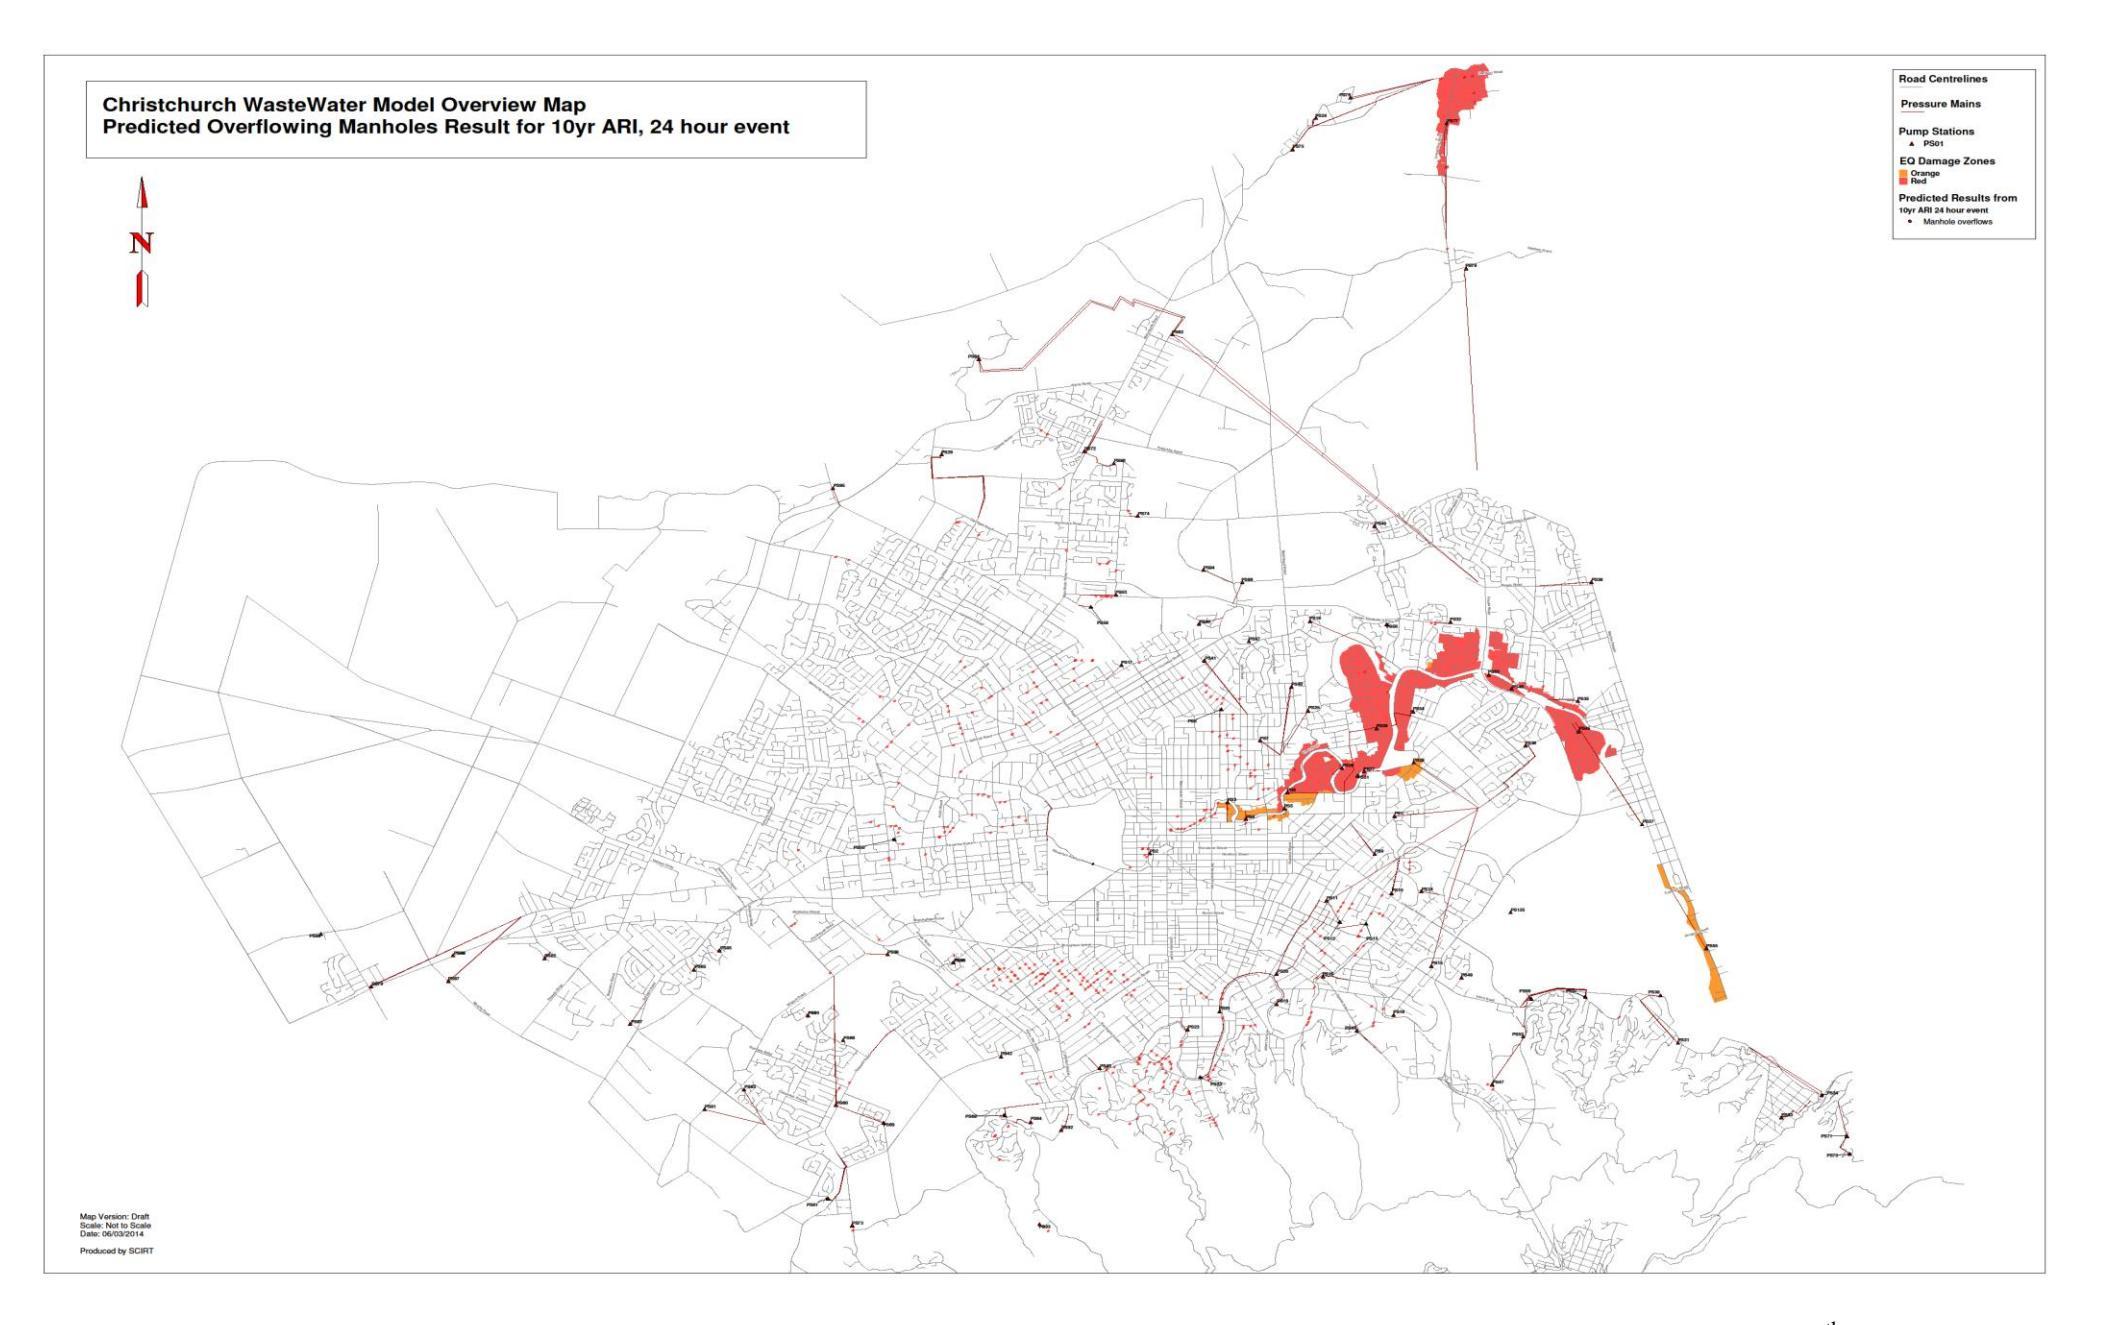
The CCC Asset Network & Planning team modelled the predicted surcharging from manholes, under urgency on 6th March, as seen in Figure 7-1. This model prediction was then used in the response as an indicator for where the WW maintenance crews should go to clean up the effects of surcharging WW and inspect/replace manhole covers. This prediction was used in conjunction with WW related geospatially located phone calls placed to CCC in the March 5th event as seen in Figure 7-2, noting that phone call data from a prior flood event in June 2013 was used as a comparison. Specific mention should be made of the Southwest area of Christchurch in Figure 7-1 which the model predicted to have surcharging but which experienced substantially less, most likely due to recent WW project completions.

Figure 7-1 Prediction modelling of a 1 in 10 year rain event effects on the wastewater system in Christchurch, used as a guide only for the 5th March event, source R. Meek (personal communication, 7th April 2014).

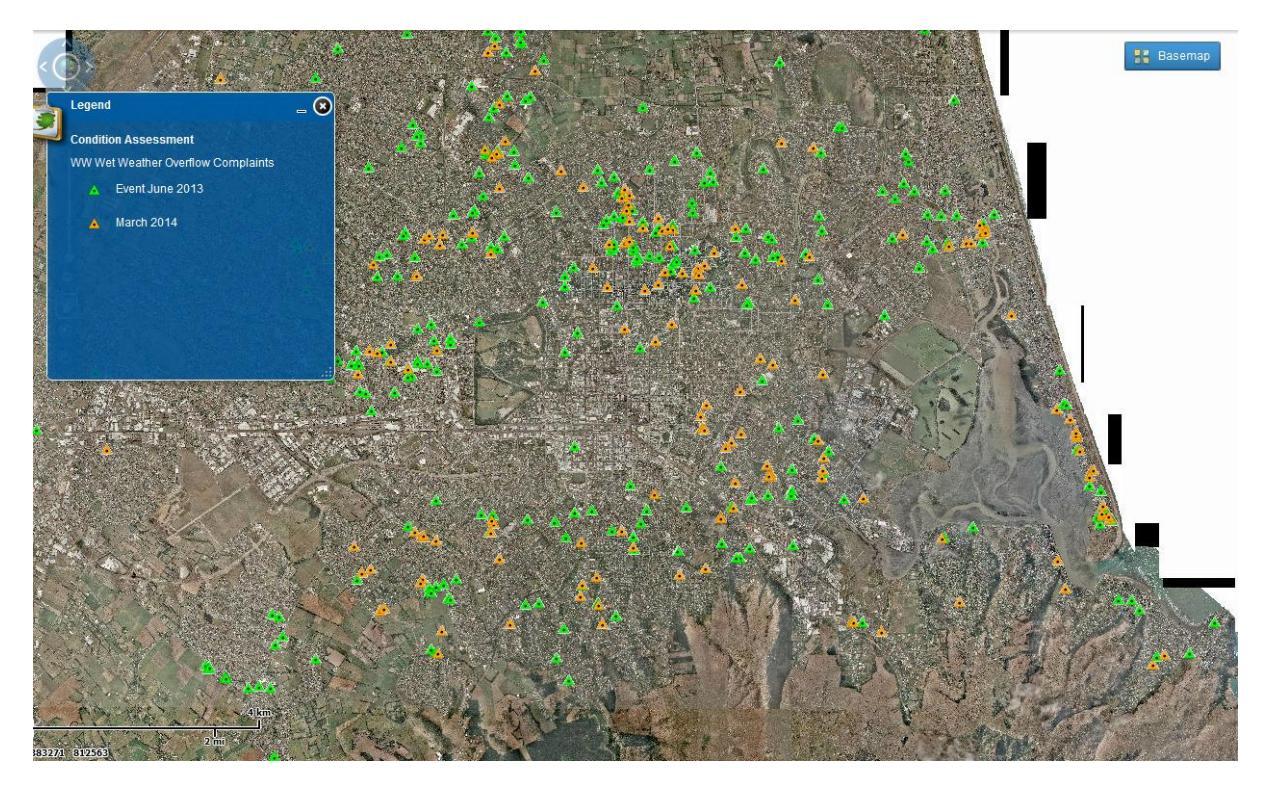
Figure 7-2 Location of WW related received calls taken by the CCC call centre during the event with calls from a previous large rainfall event in June 2013, R. Meek (personal communication, 7th April 2014).

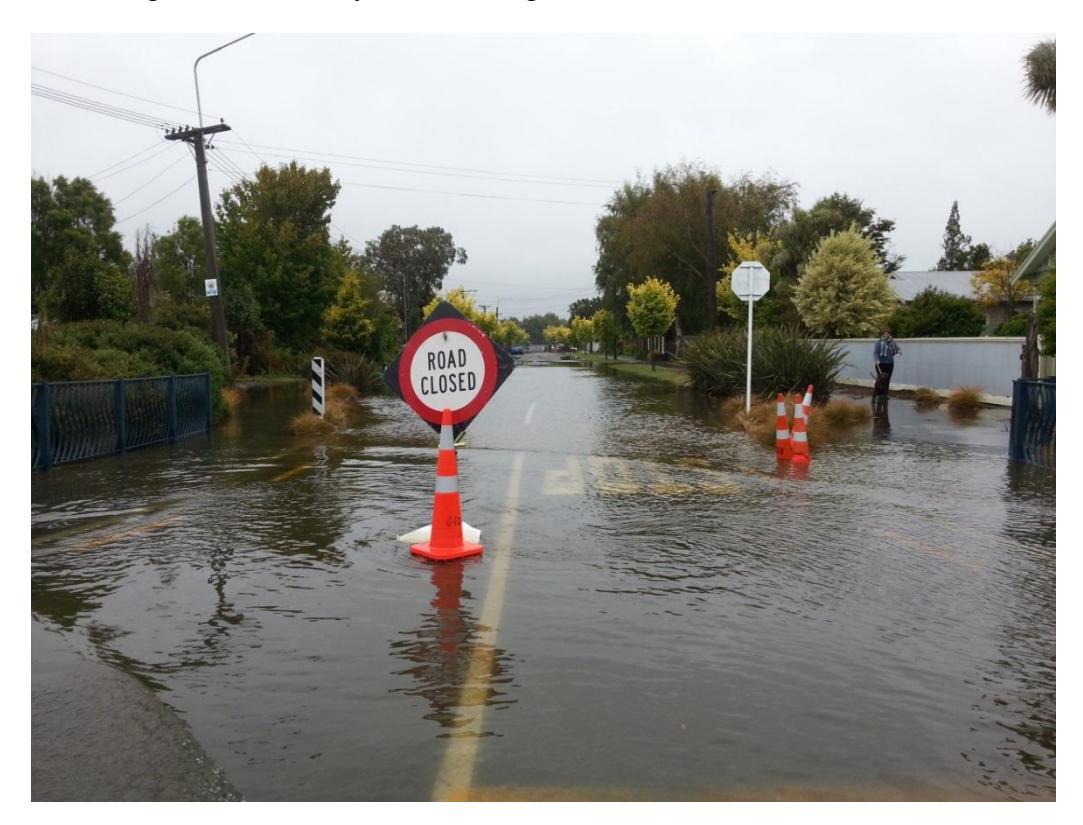
Figure 7-6 Road closure due to temporary traffic management – Geraldine Street (-43.515579°, 172.647506°), Edgeware, Christchurch. Photo courtesy of Su Young Ko.

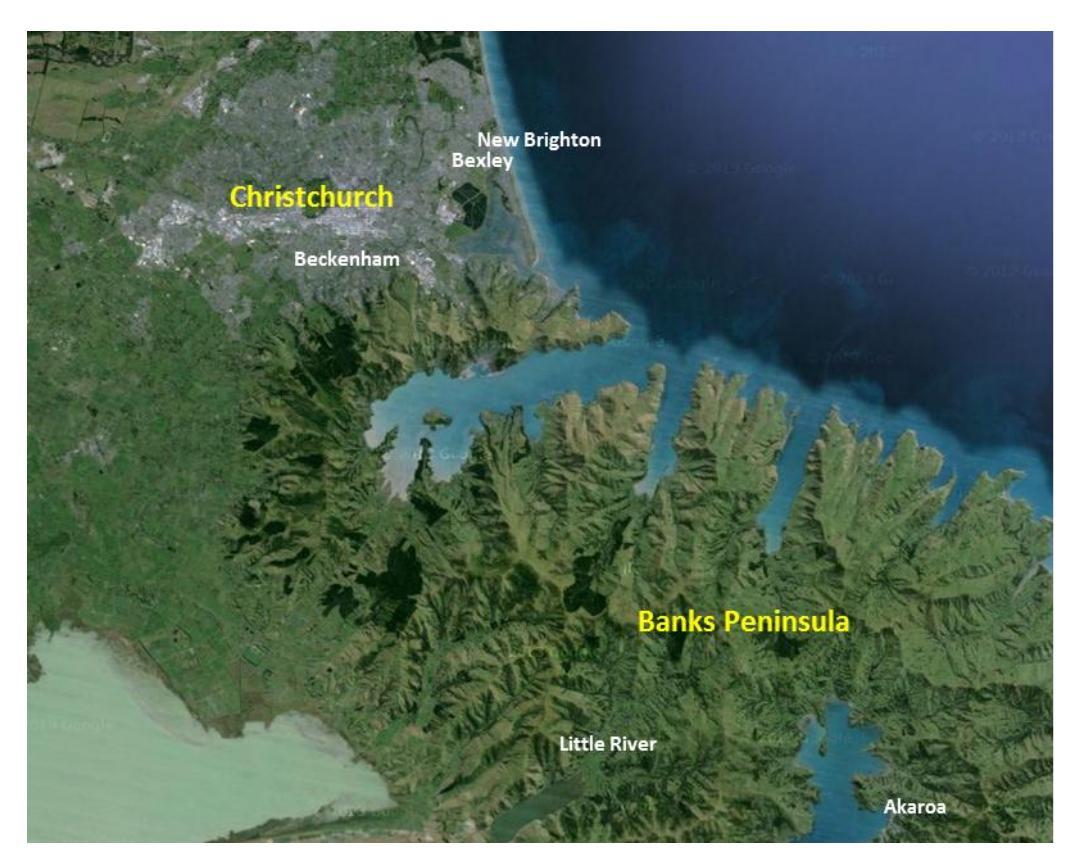
Figure 7-8 shows where the major cable fault locations occurred in Bexley, New Brighton and Beckenham as a result of the flooding. Access to some of the sites was not possible because large portions of these suburbs were inundated to depths of 1.5 m.
Approximately 600 customers lost service for about 3 to 4 days until the flood water receded and the access was gained for repair.

The failure of the electricity connection to Banks Peninsula (operated by Orion) for 2 to 3 days meant that an alternative power source had to be provided to the Little River exchange (

Figure 7-8). High flood waters blocked the streets; however, a large transporter was engaged to deliver the generator to the site and the service was regained. Both Akaroa and Mt Pearce exchanges ran on their own generators during the power outage. Visits were made to outlying radio stations and cabinets to replace the batteries or to apply portable generators.

Figure 7-8 Map showing the locations of major telecommunication cable faults in Christchurch and Banks Peninsula (Google, 2014).

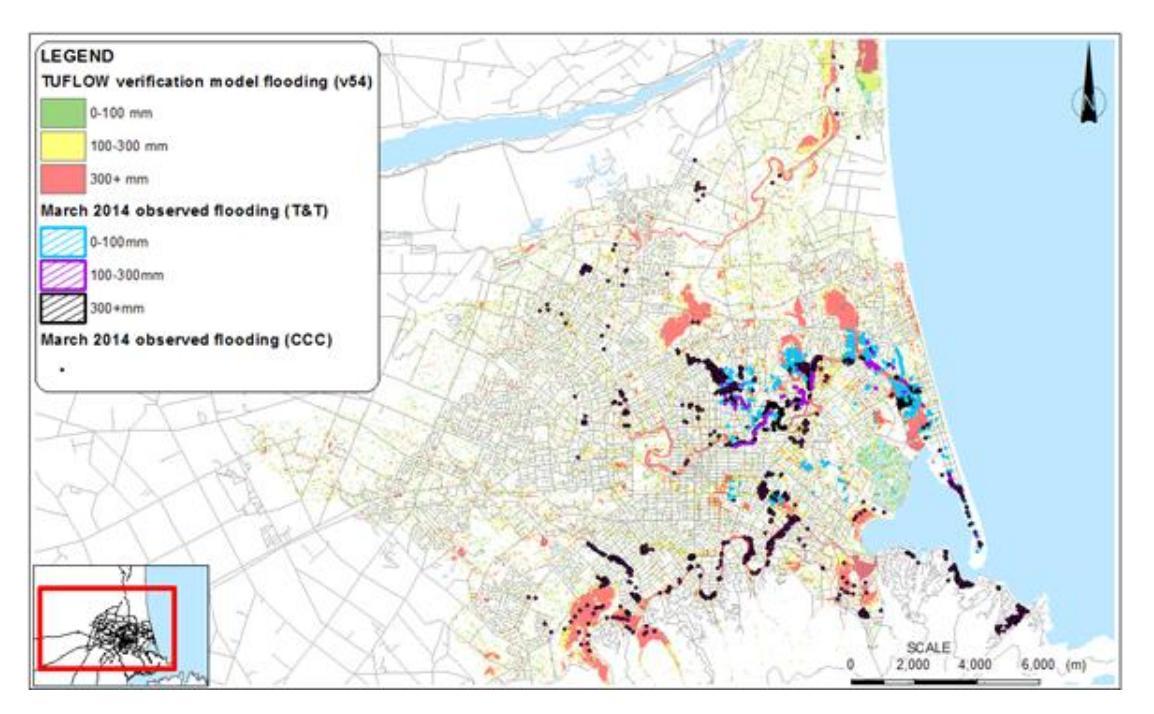
Figure 8-2 Observed Flooding in Christchurch March 2014 with hind cast model predictions (courtesy of Tonkin & Taylor, 2014).

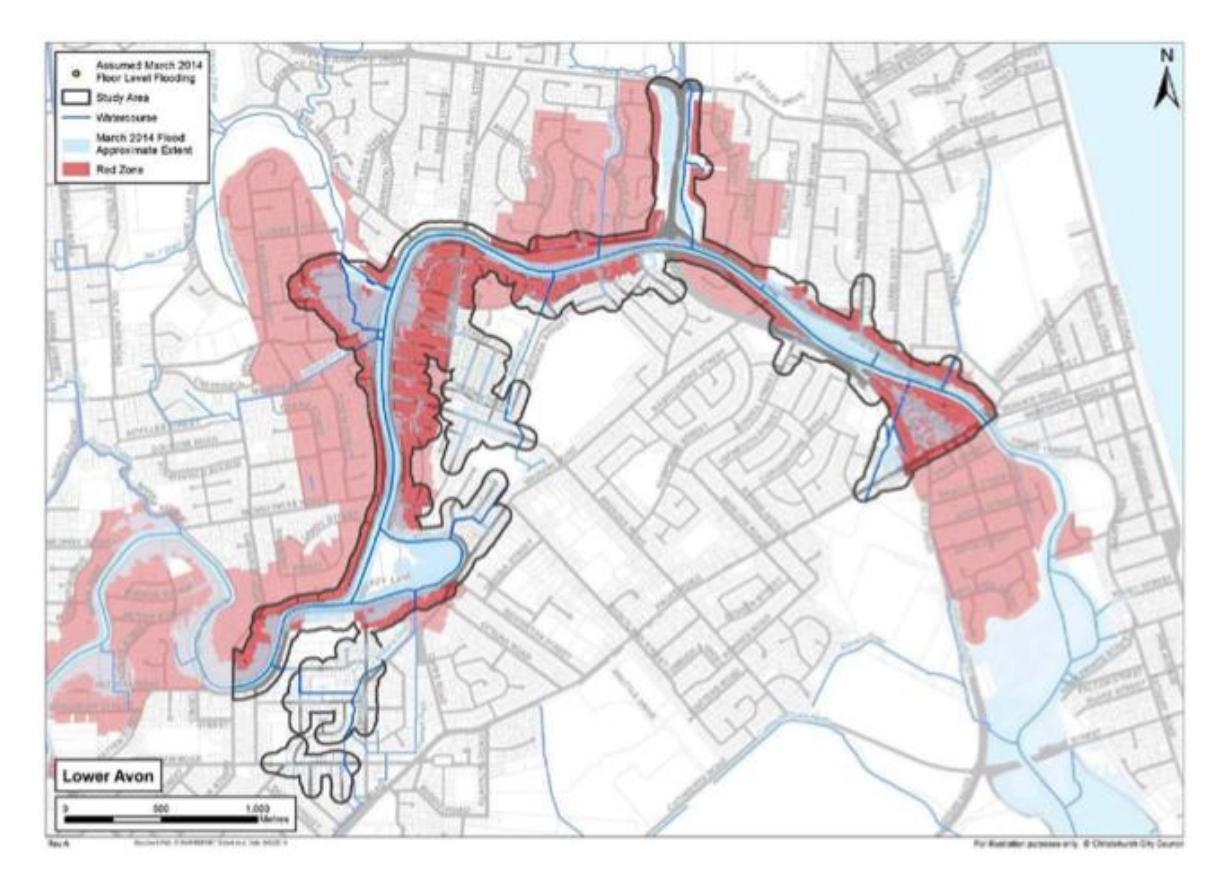
Figure 8-3 shows the Lower Avon River area that was declared Residential Red Zone (RRZ)2 area after the 2010-2011 earthquake sequence. This area suffered significant ground settlement as a result of the earthquakes and is now typically at river level (RL)10.0 – RL11m. Vertical and horizontal ground movements in the range of -0.1 m to -0.5 m have been observed along the Avon, with some localised movement of -0.5 m to - 1.0 m. As described in Chapter 3, moderate to significant liquefaction accompanied by moderate to severe lateral spread occurred along the length of the Lower Avon River and within the RRZ. The riverbed experienced heaving. Some parts of the RRZ area are now below annual high tide level and the river flood level for moderate to major storm events (CCC Task Force, 2014b).

Figure 8-3 Lower Avon River: boundary of the area analysed by the CCC Taskforce and extent of March 2014 flood (map from CCC Task Force 2014b).

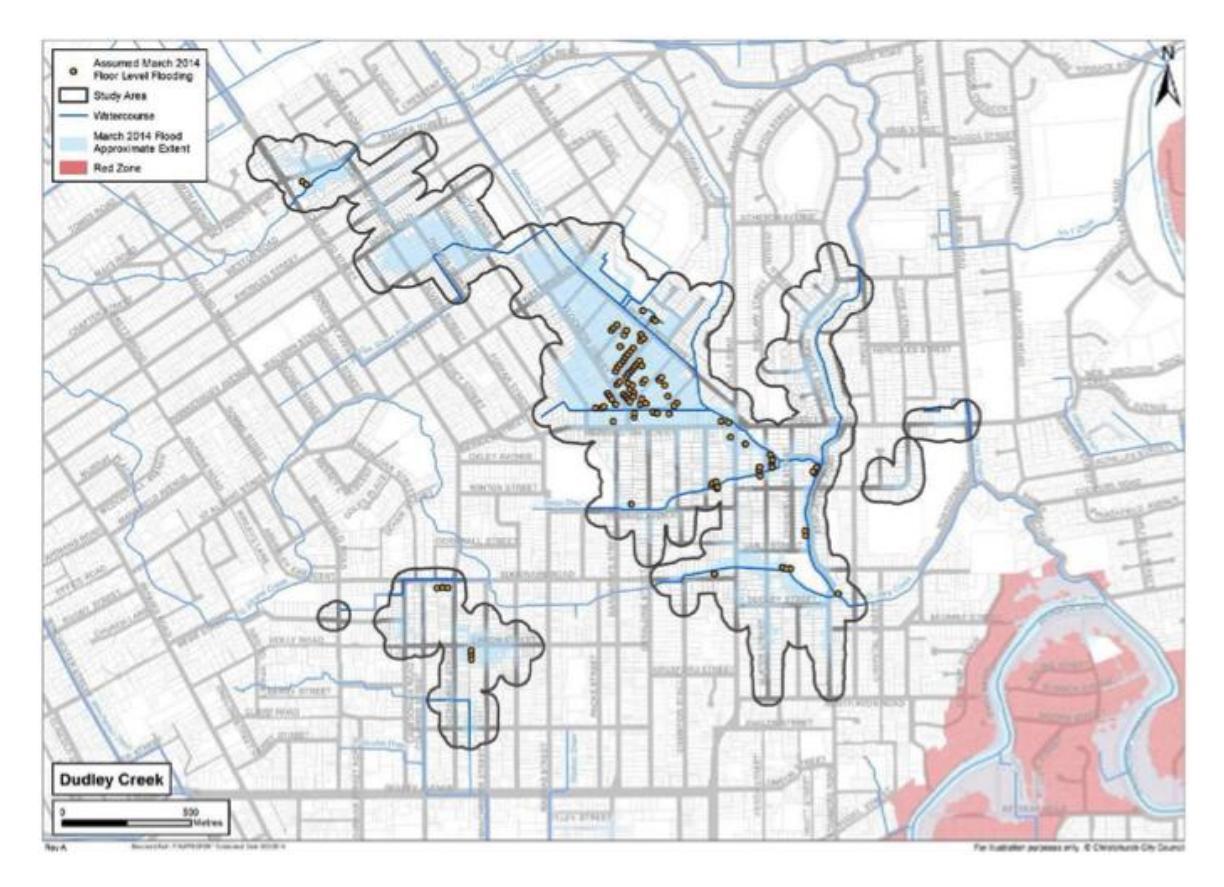
Figure 8-4 Dudley Creek location plan: boundary of the area analysed by the Taskforce; extent of March 2014 flood and location of flooded houses (map from Task Force, 2014b).

Figure 8-4 shows the extent of recorded pluvial floodwaters recorded from the March event, which exceeded 600mm in depth in some areas. Flooding in the Dudley Creek catchment resulted from the previously described under capacity waterways, which restrict flows causing water to back up in heavy rainfall. Additionally, flooding is enhanced from the significant seismic-induced ground settlement coupled with the waterways suffering from lateral spreading and bed heave. The inability of the waterways to convey flow has a direct impact on the ability of drainage infrastructure to function. Fluvial water backflows the associated piping and spills into the Flockton area exacerbating pluvial flooding issues.

The Flockton area flooding caused an estimated 97 properties to experience water intrusion above floor level at locations shown in Figure 8-4. This number of flooded properties was based on GIS data and the surveyed flood extent. For the wider area, the majority of properties experienced flooding across the section or under foundations.

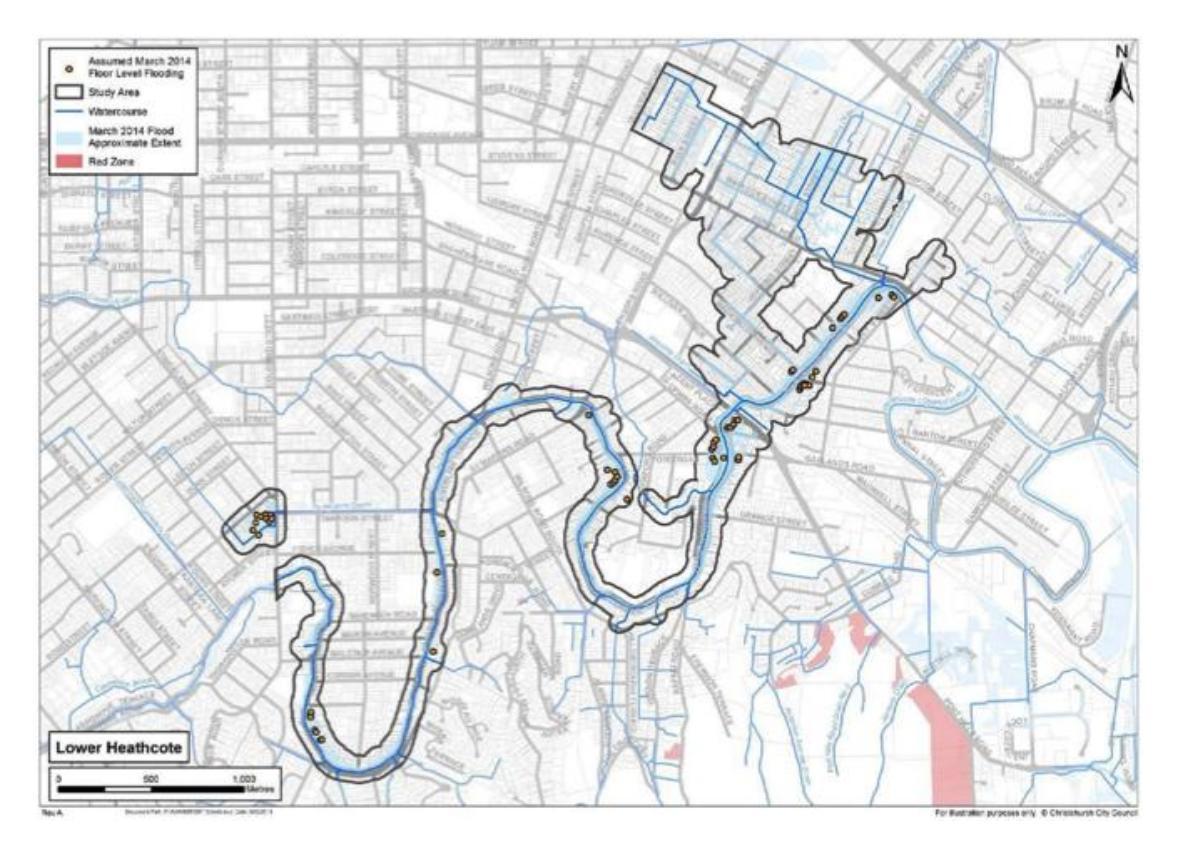
Although flooding had previously been experienced in the catchment, a number of residents in the area indicated that there had been no previous flooding on their properties prior to the earthquakes (CCC Task Force, 2014b). After the earthquake sequence, it is fairly common for riverside properties in this catchment to experience shallow flooding or have restricted access during large rainstorms. Three severe rain events from March 2014 to April 2014, have resulted in the recent floor level flooding in the area, along with widespread road, property, and ancillary buildings flooding. Figure 8-5 shows flooded areas from the March 2014 event.

Figure 8-5 Lower Heathcote: boundary of the area analysed by the CCC Taskforce; extent of March 2014 flood and location of flooded houses (map from CCC Task Force 2014b).
