GEOLOGIC, GEOMORPHIC, GEOTECHNICAL, AND DISPLACEMENT MAPS OF LAND AND BUILDINGS AT SELECTED SITES OF CHRISTCHURCH CITY COUNCIL OWNED REINFORCED CONCRETE STRUCTURES DAMAGED DURING THE 2010-2011 CANTERBURY EARTHQUAKES

MANCHESTER ST CARPARK STUDY

University of Canterbury Consultancy Report CN4600001360

November 2015

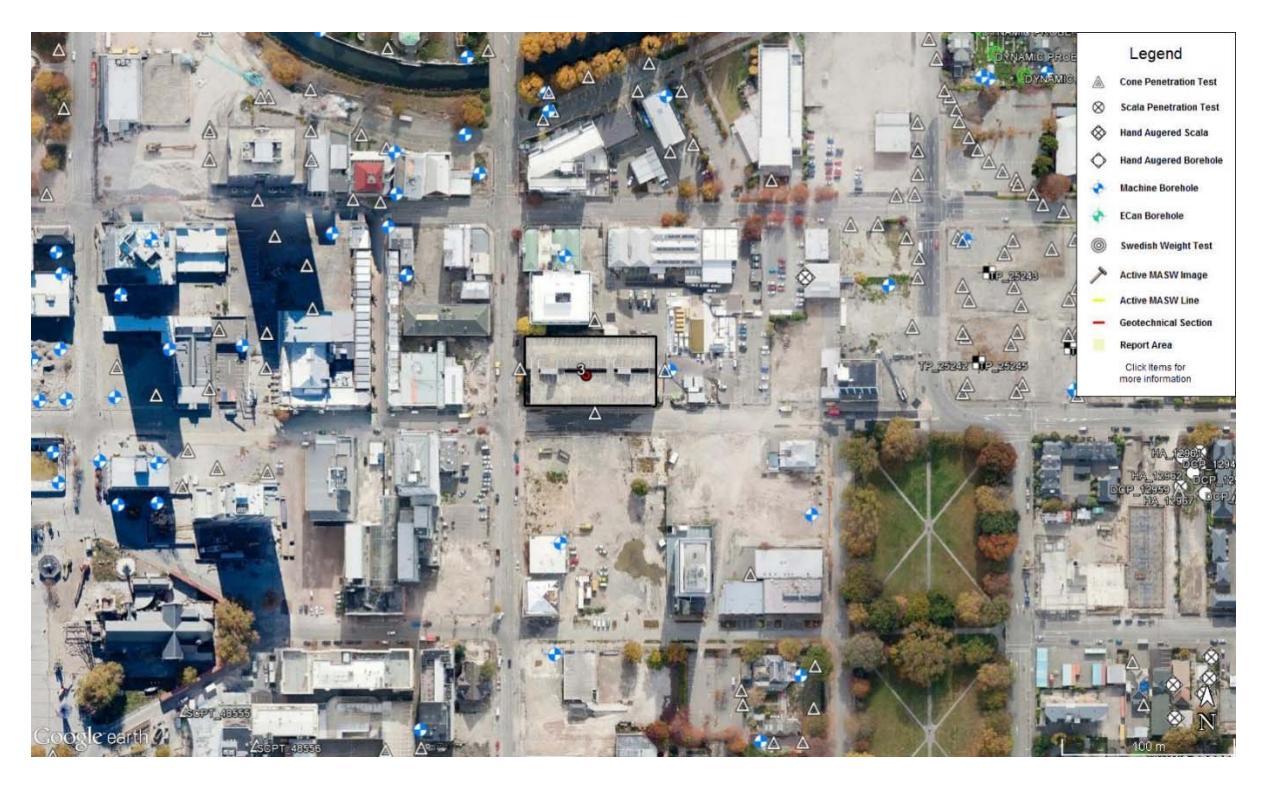
Figure 3: Location of CPT, borehole, and other geotechnical sampling sites in the vicinity of Manchester St Carpark. These data were variably used to construct geologic cross-sections (e.g., Fig. 9-11).

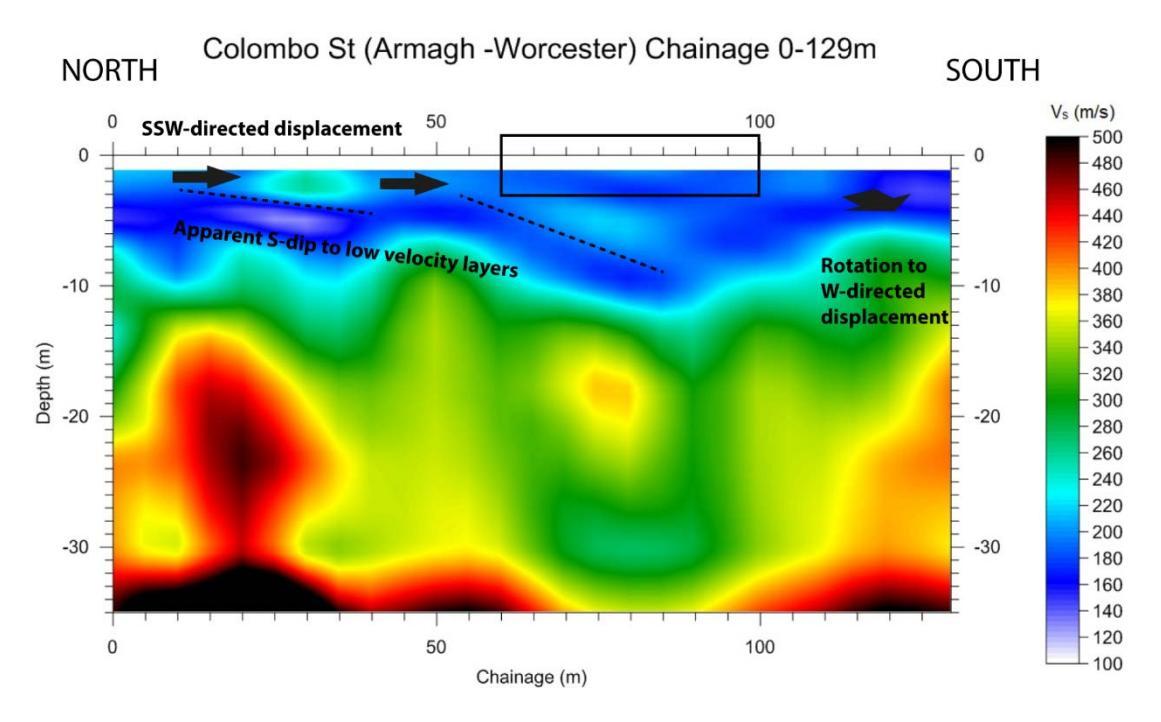
Figure 7: Interpreted MASW survey for Colombo St between Armagh St and Worcester St, immediately west of the Manchester St Carpark. See Fig. 4 for corresponding chainage.

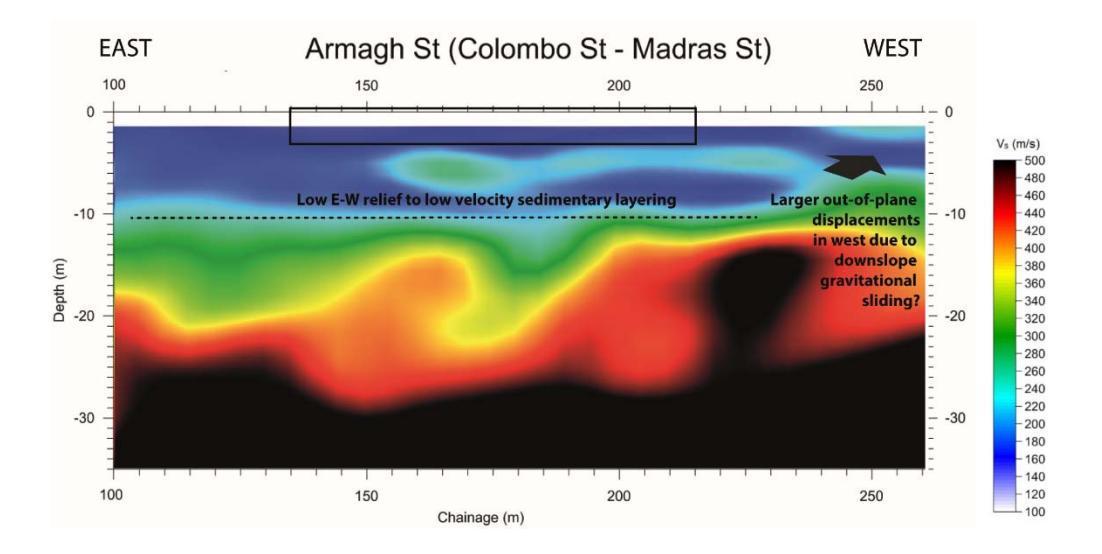
Figure 8: MASW survey for Armagh St, immediately north of the Manchester St Carpark (looking direction to the south). See Fig. 4 for corresponding chainage.

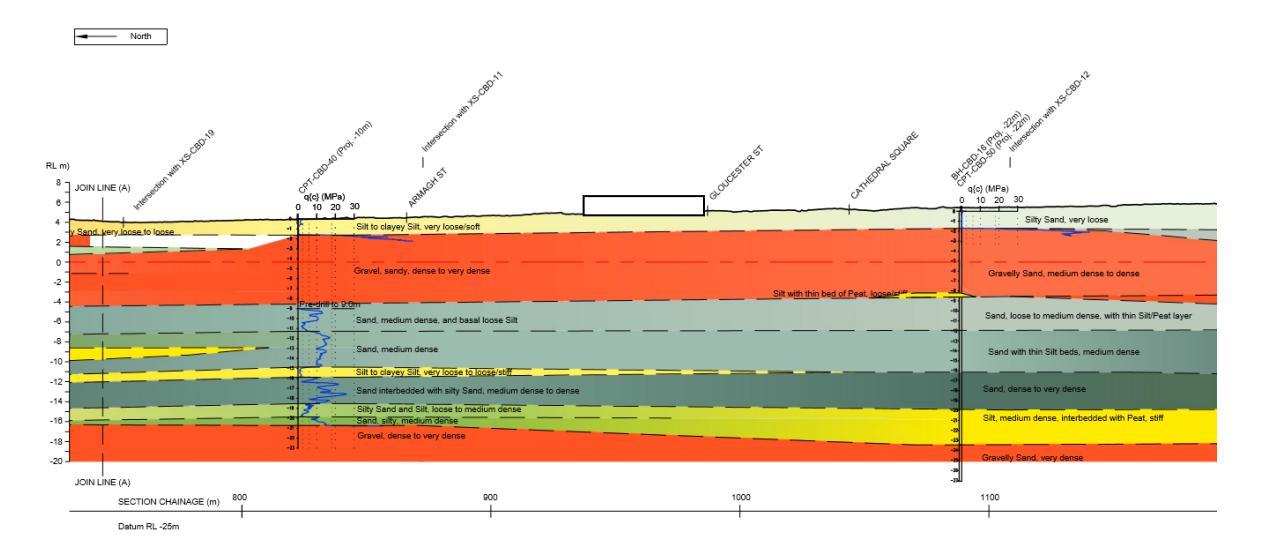
Figure 9: Geologic cross-section GXS-CBD-03 (Colombo St) showing projected position of Manchester Cark Park.

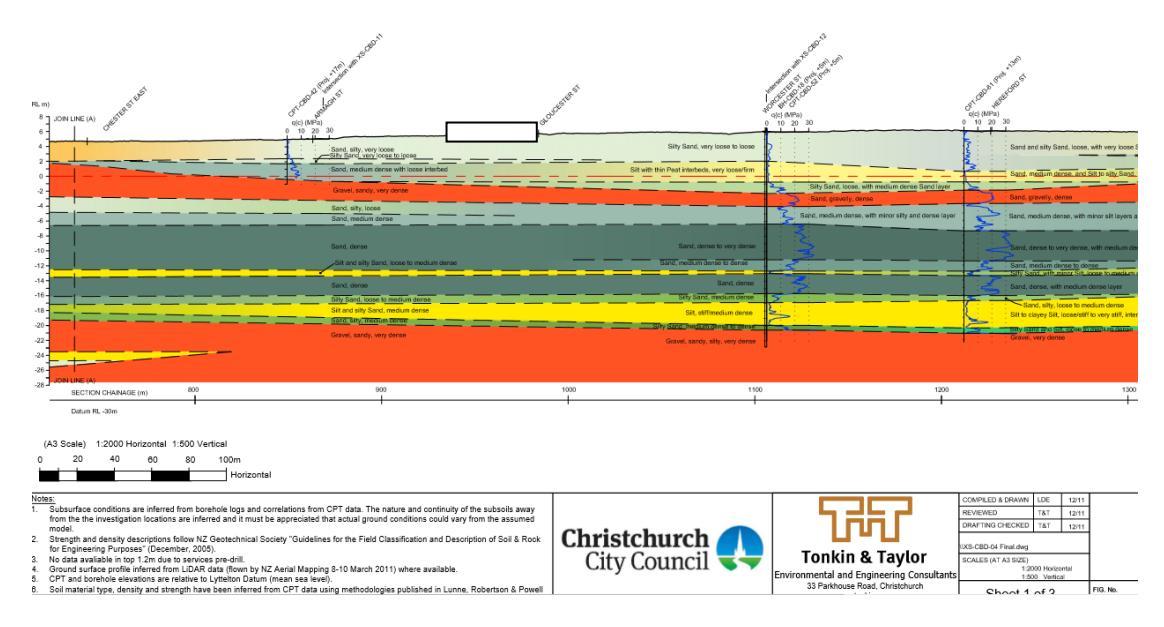
Figure 10: Geologic cross-section GXS-CBD-04 (Madras St) showing projected position of Manchester Cark Park.
