6<sup>th</sup> International Conference on Earthquake Geotechnical Engineering 1-4 November 2015 Christchurch, New Zealand

# Greendale Fault rupture of 2010 (Darfield Earthquake, New Zealand): an Example of Recurrence Interval and Groundsurface Displacement Characterisation for Land-use Planning and Engineering Design Purposes

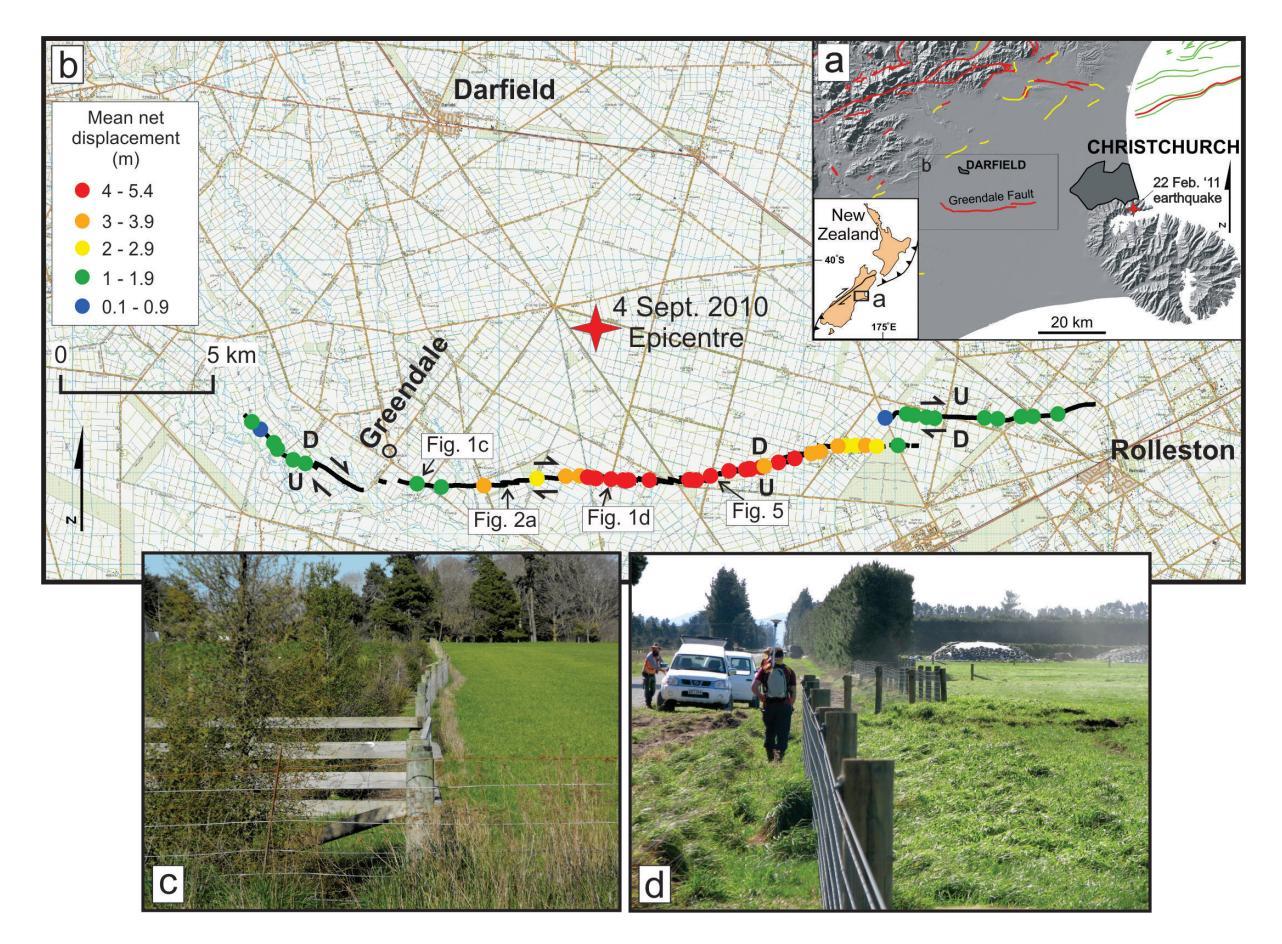
Figure 1. a) General location of the Greendale Fault and other tectonically active structures. Red lines are active faults, and yellow and green lines are, respectively, onland and offshore

active folds. b) Mapped surface trace of the Greendale Fault (black line) and measured surface rupture displacements (coloured dots). c) Fence line adjacent to Coaltrack Road right-laterally offset by ~1.7 m across an ~100 m wide surface rupture deformation zone. d) Fence line near Courtenay Road right-laterally offset by ~4.3 m across an ~35 m wide deformation zone.

The Greendale Fault surface rupture extended for ~30 km across a low-relief alluvial plain with pastoral farming land-use, and comprised a distinctive series of *en echelon*, east-west striking, left-stepping traces (Figs. 1 & 2a) (Quigley et al. 2012). Many fences, roads and crop-rows were displaced dextrally across the surface rupture deformation (Figs. 1 c & 1d) and provided ideal markers for measuring the amounts and patterns of deformation

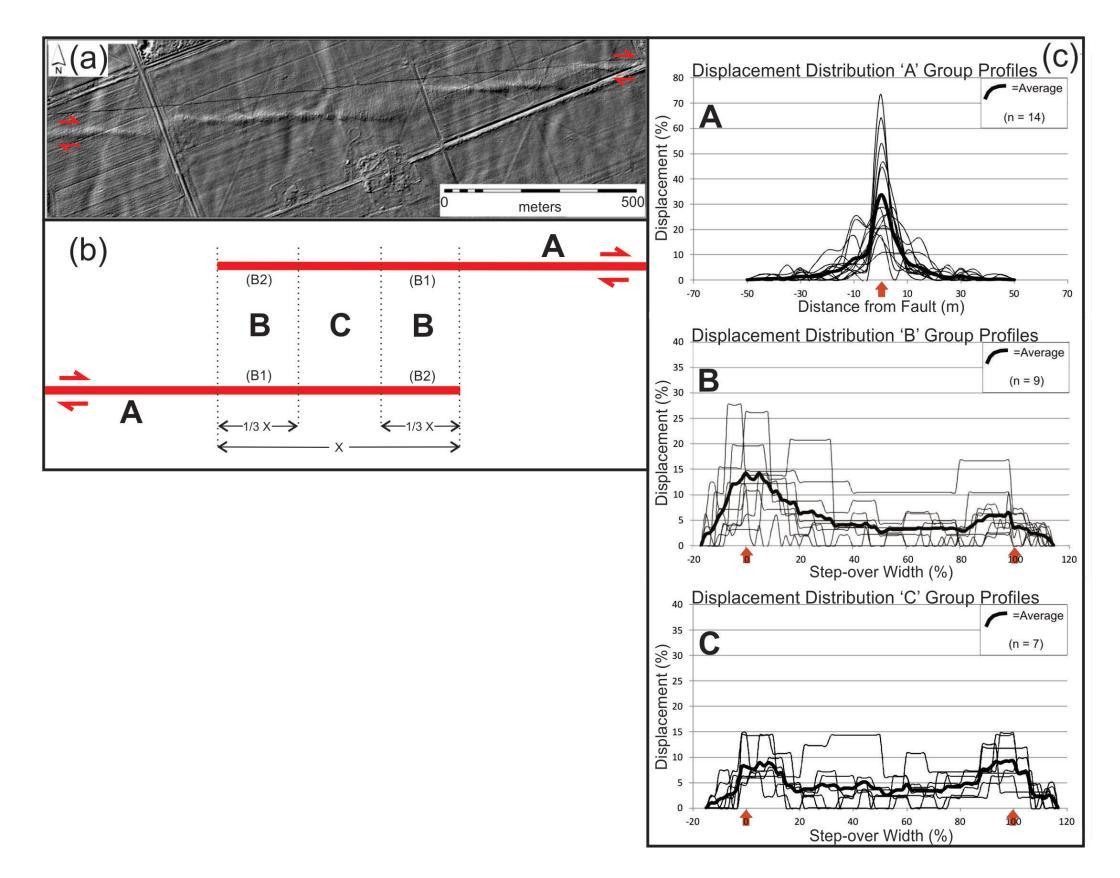
Figure 2: a) Lidar hillshade image showing distinctive pattern of side-stepping traces along a 1.5 km-long portion of the Greendale Fault. b) Conceptual structural positions on a fault step-over; A is where the fault comprises a single trace, B represents the start/end of a step-over, and C represents the middle of a step-over. c) Displacement distribution plots, and their averages, of dextral deformation profiles across the Greendale Fault grouped according to the fault trace structural positions, A, B & C, defined in Figure 2b.

We further characterised the variations in surface rupture deformation zone width by grouping, and plotting, the 30 deformation profiles that cross the entire fault zone according to their structural position on the fault trace (Fig. 2) (Van Dissen et al. 2013). In these plots, all deformation profiles are normalised to displacement, and for those profiles crossing a step-over, they are also normalized to step-over width. All three structural groupings (A, B & C of Fig. 2c) show that horizontal deformation was predominantly distributed, rather than concentrated solely on a small number of discrete shears. Even where the fault comprises a

single trace (group A of Fig. 2) significant distributed deformation occurs over a width of ~30 to 40 m. Across the central part of a step-over (group C), dextral deformation is distributed and equally shared across both sides of the step-over. At the beginnings/endings of a step-over (group B) deformation is, again, distributed, with the dominant side of the step-over (B1 of Fig. 2b) typically carrying about two to three times more displacement than the subordinate side (B2 of Fig. 2b).

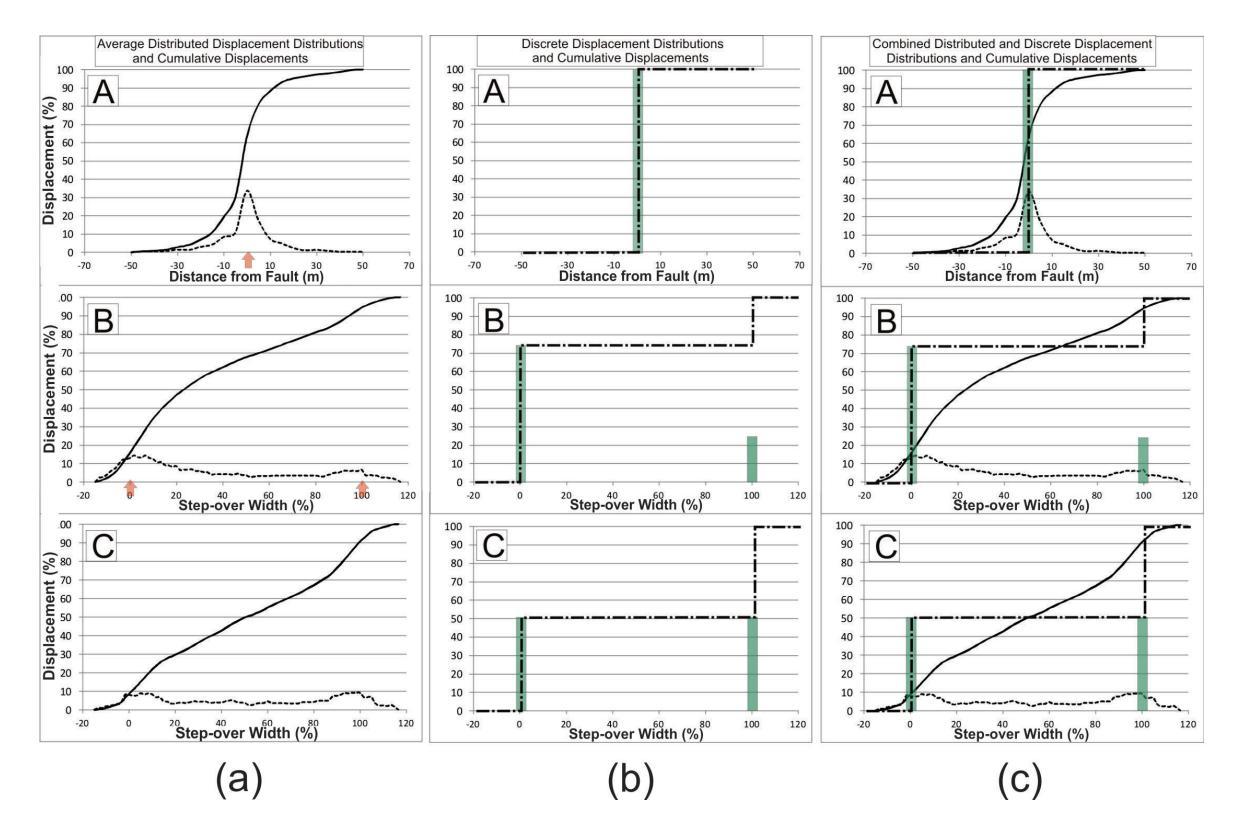
Figure 3: a) Average displacement distributions (dotted lines) and cumulative displacement curves (solid lines) for the Greendale Fault for the three fault trace structural groupings - A, B & C - defined in Figure 2. b) Displacement distributions (green shaded bars) and cumulative displacement curves (dot-dash lines) for a hypothetical case where strike-slip deformation is entirely discrete. c) Figures 3a & 3b combined, highlighting the differences in slip distribution between the hypothetical end-member discrete displacement example, and the near end-member distributed displacement (Greendale) example.

Figure 3a plots the Greendale Fault's average displacement distributions for the three structural groupings (A, B & C) defined in Figure 2, along with their corresponding cumulative displacement curves. Figure 3b shows analogous plots for a hypothetical strike-slip case where deformation is entirely discrete. Figure 3c combines these plots onto a single diagram. Comparable displacement plots are available for two sites along the 1906 rupture of the San Andreas Fault (Bray & Kelson 2006) and 11 sites along the 1999 ruptures of the North Anatolian Fault (Rockwell et al. 2002). Invariably, those strike-slip displacements were less distributed than the Greendale displacement, more distributed than the hypothetical discrete case, and would fall between the two "bounding" curves of Figure 3c. We suggest that Figure 3 has relevance as a first-approximation design curve to aid in engineering and land-use applications where it is desirable to characterise the manner in which strike-slip surface fault rupture deformation is distributed perpendicular to fault strike. See Van Dissen et al. (2013) for more detail, and Kelson et al. (2004) and Hitchcock et al. (2008) for related examples.

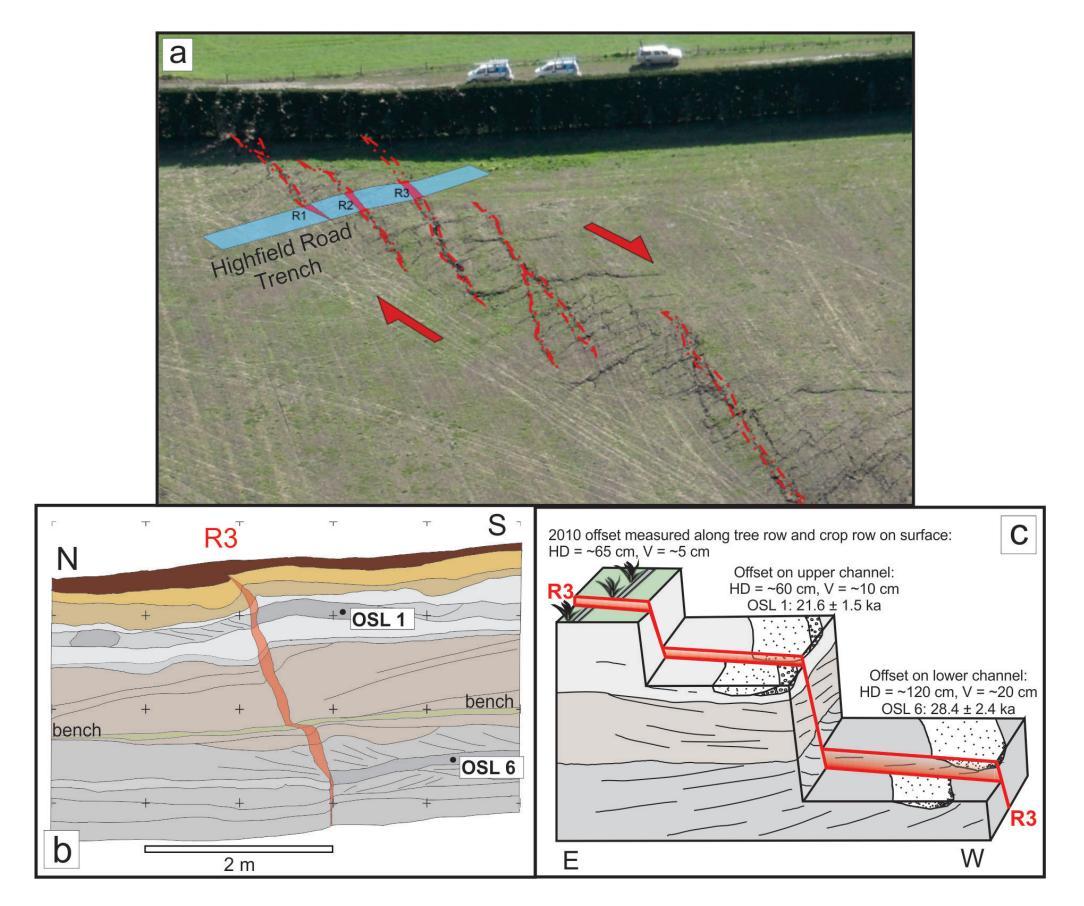
Figure 4: a) Oblique aerial view northwest across the Highfield Road trench site with distinct Riedel shears highlighted in red. b) Log of the east wall of the trench showing the R3 Riedel shear, and locations of OSL samples 1 & 6. Units exposed in trench were predominantly loose gravel-dominated alluvial deposits. c) Schematic diagram showing displaced paleo-channels across the R3 Riedel shear. HD and V denote horizontal and vertical displacement, respectively.

At the Highfield Road trench site (Fig. 4) discrete surface fracturing accommodated ~30% of the total ~4.8 m of right-lateral displacement; the remainder was accommodated by distributed deformation spread over ~175 m width. The trench itself was excavated across the maximum horizontal displacement gradient within the surface rupture deformation zone; it was ~30 m long by 3 m deep, and spanned ~65% of total horizontal deformation at the site. Most of the surface fractures exposed in the trench were undetectable in the gravel-dominated alluvial deposits at depths  $\geq 1$  m below the ground surface; however, large (>5 m long), discrete Riedel shears continue to depths exceeding 3 m (i.e., the base of the trench), and clearly displace interbedded gravels and thin sand-filled paleo-channels. One of the distinct Riedel shears at the Highfield site, R3 (Fig. 4), displaced linear surface features (e.g., fences, roads and plough lines) and a subsurface (0.6 m deep) paleo-channel by 60 cm right-laterally and 10 cm vertically, indicating that the paleo-channel has been displaced only in the Darfield earthquake.

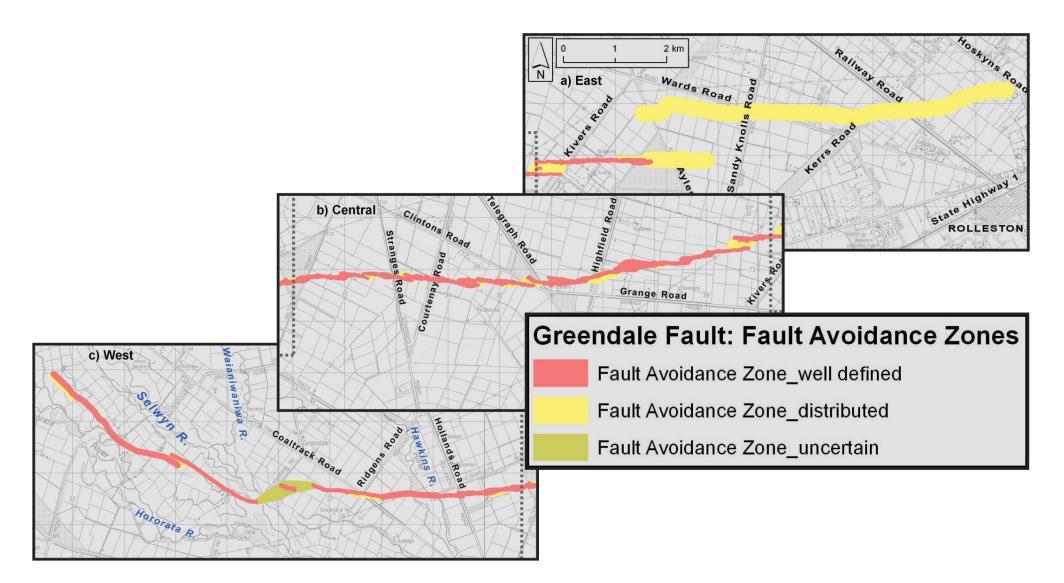
Figure 5: Fault Avoidance Zones for the Greendale Fault.

In the aftermath of the Darfield earthquake, and in response to re-build pressures in areas near the Greendale Fault, the Canterbury Regional Council commissioned an investigation to map and zone the Greendale Fault (Villamor et al. 2011, 2012) in accord with the New Zealand Ministry for the Environment's best-practice guidelines on planning for development of land on, or near, active faults (Kerr et al. 2003), hereafter referred to as the MfE Guidelines. In the MfE Guidelines, the surface rupture hazard of an active fault is characterised by two parameters: 1) the location/complexity of surface rupture of the fault (i.e. the mapping of Fault Avoidance Zones), and 2) the activity of the fault, as measured by its average recurrence interval of surface rupture (i.e. the characterisation of Recurrence Interval Class). Figure 5 presents examples of the Fault Avoidance Zone mapping of Villamor et al. (2011, 2012) for the Greendale Fault. The Fault Avoidance Zones are attributed as well defined, distributed, and uncertain, and range in width from about 70 m to greater than 300 m. The MfE Guidelines promulgate a risk-based approach to land-use planning, and recommend that more restrictive Resource Consent Categories be applied to well defined Fault Avoidance Zones, and more permissive Resource Consent Categories be applied to uncertain Fault Avoidance Zones.
