Anthropocene

Influence of anthropogenic landscape modifications and infrastructure on the geological characteristics of liquefaction

Keywords: Liquefaction Engineered structures Engineered sediment Canterbury earthquake sequence Ground penetrating radar (GPR) Christchurch

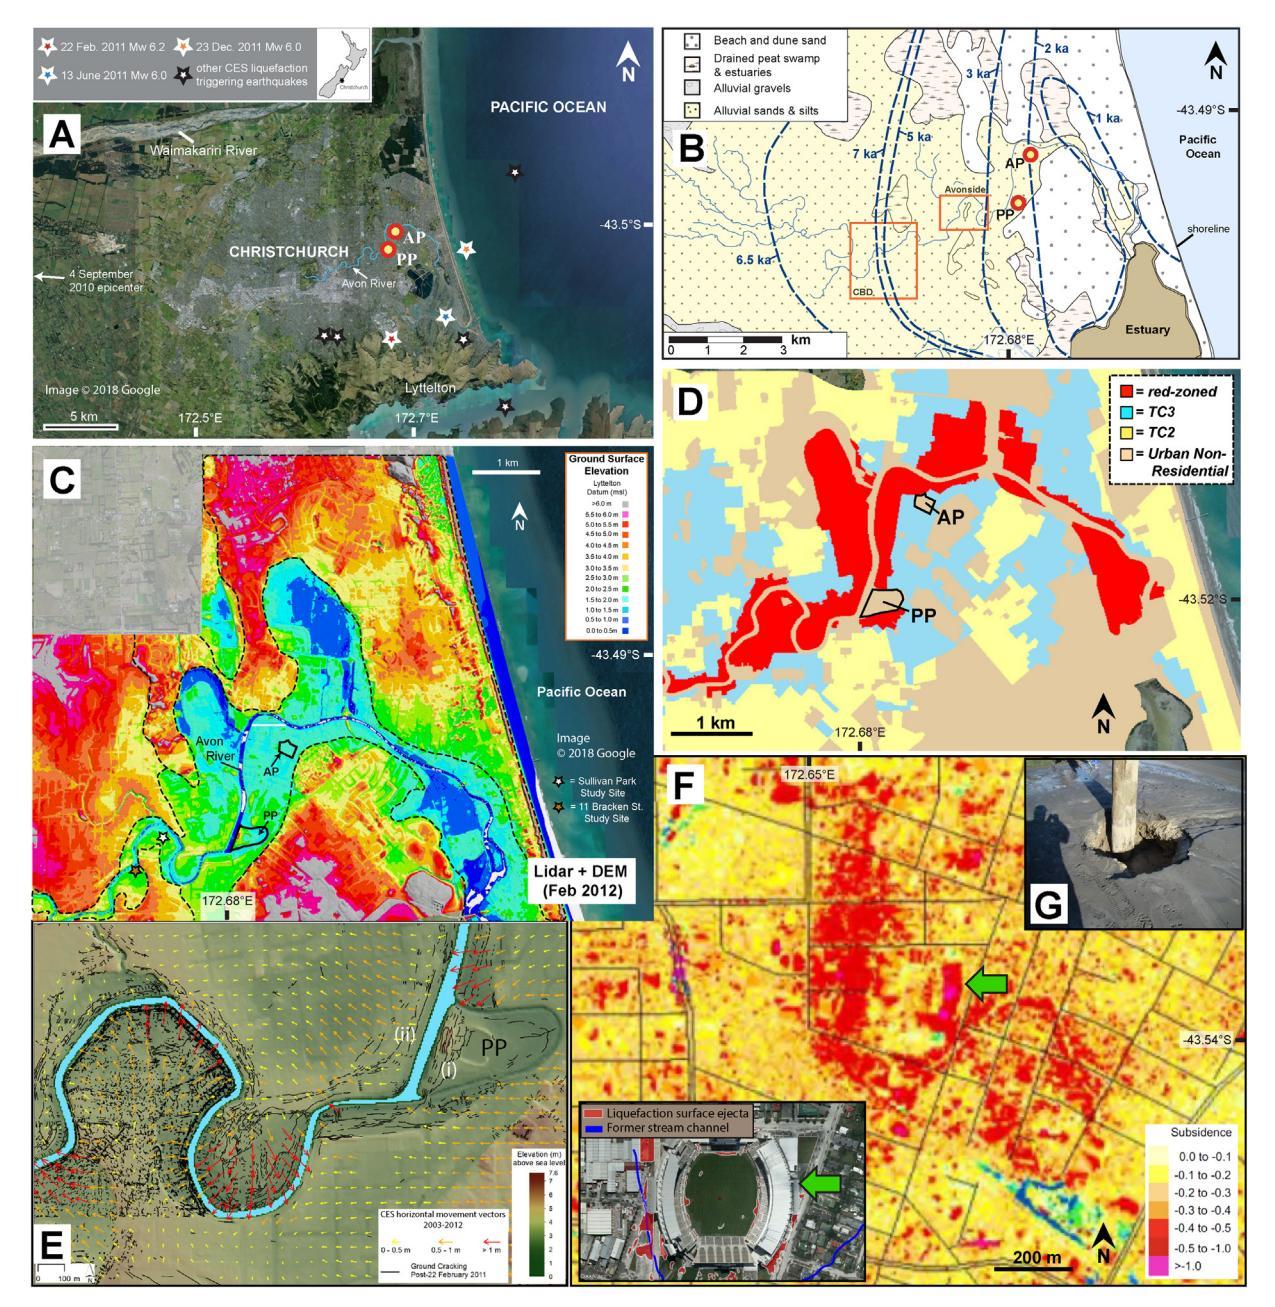
Fig. 1. (A) Site map showing the City of Christchurch and Avondale Park (AP) and Porritt Park (PP) study locations. **(B)** Simplified geological map of the Christchurch area (modified from Brown and Weeber, 1992). **(C)** Light detection and ranging (LiDAR) digital elevation model (DEM) for eastern Christchurch. **(D)** Liquefaction residential technical categories map for eastern Christchurch showing the extent of liquefaction damage resulting from the 4 September 2010, 22 February 2011, 13 June 2011, and 23 December 2011 earthquakes (modified from van Ballegooy et al., 2014). **(E)** Liquefaction-induced horizontal ground displacement vectors in Porritt Park area indicating the direction and magnitude of lateral spreading associated with the CES. **(F - inset)** Aerial photograph of Lancaster stadium Christchurch after the 22 February earthquake. **(F - main)** Differential lidar image including stadium area. [Further information on Fig.1 is provided in supplementary item ST.1, https://doi.org/10.5061/dryad.z612jm67z].

concentrators and vertical conduits for liquefaction ejecta to reach the surface (Fig. 1G).

The Avondale Park and Porritt Park study sites experienced large spatial variations in the severity of land damage during the CES (Fig. 1D; Fig. S.1, https://doi.org/10.5061/dryad.z612jm67z; Bradley and Hughes, 2012a, b; O'Rourke et al., 2012). Avondale Park experienced moderate land damage and was assigned as Technical Category 3 (TC3) land during government decision-making, defined as "where liquefaction damage is possible in future large earthquakes and individual engineering assessment is required to

map). Porritt Park experienced severe land damage and was designated by the government as 'red-zoned' land, where "rebuilding may not occur in the short-to-medium term" (see Quigley et al., 2019a; and references therein) (Fig. 1D). Avondale Park (area $\sim 38,000 \text{ m}^2$; average elevation = 4 m asl) is positioned within a distal inner meander bend of the Avon River (Figs. 1C and 2). Porritt Park (area $\sim 127,000 \text{ m}^2$; average elevation = 5.5 m as) is located on an old meander bend of the Avon River that was separated from the main Avon River channel sometime before ~ 1950 (Figs. 1C-E and 2). Porritt Park is currently surrounded by a lightly flowing stream sourced by an overflow pipe connected to

During the CES, lateral spreading was most severe in inner flood-plain meanders (see red arrows, Fig. 1E). However, at Porritt Park, diversion of the Avon River and filling of eastern bank with engineered material resulted in a high density of large lateral spreading cracks (see i, Fig. 1E) with an orientation and severity that would not have occurred if the river had not been diverted. To the west of the engineered stream channel (see ii, Fig. 1E), lateral spreading vectors point away (west) towards inherited (i.e. naturally-formed) topography, rather than towards the engineered reach of the proximal Avon River. This demonstrates the concept of 'landscape memory'; despite major anthropogenic landscape changes, the lateral spreading vectors are strongly influenced by pre-existing topography and geology. Subsidence of Lancaster stadium in Christchurch during the 22 February 2011 earthquake further highlights the concept of 'landscape memory'. Although localization of liquefaction ejecta around the edges of the stadium stands (red; Fig. 1F inset) and localized building subsidence (Fig. 1F) indicate anthropogenic effects on geological manifestations of liquefaction and subsidence, it is also clear that subsidence patterns in this highly engineered environment (red sinuous zone of subsidence) were strongly controlled by the presence of a prehistoric paleochannel that enhanced liquefaction and subsidence. We term these collective effects of prehistoric geology on liquefaction hazard characteristics in highly engineered environments as 'landscape memory' effects.

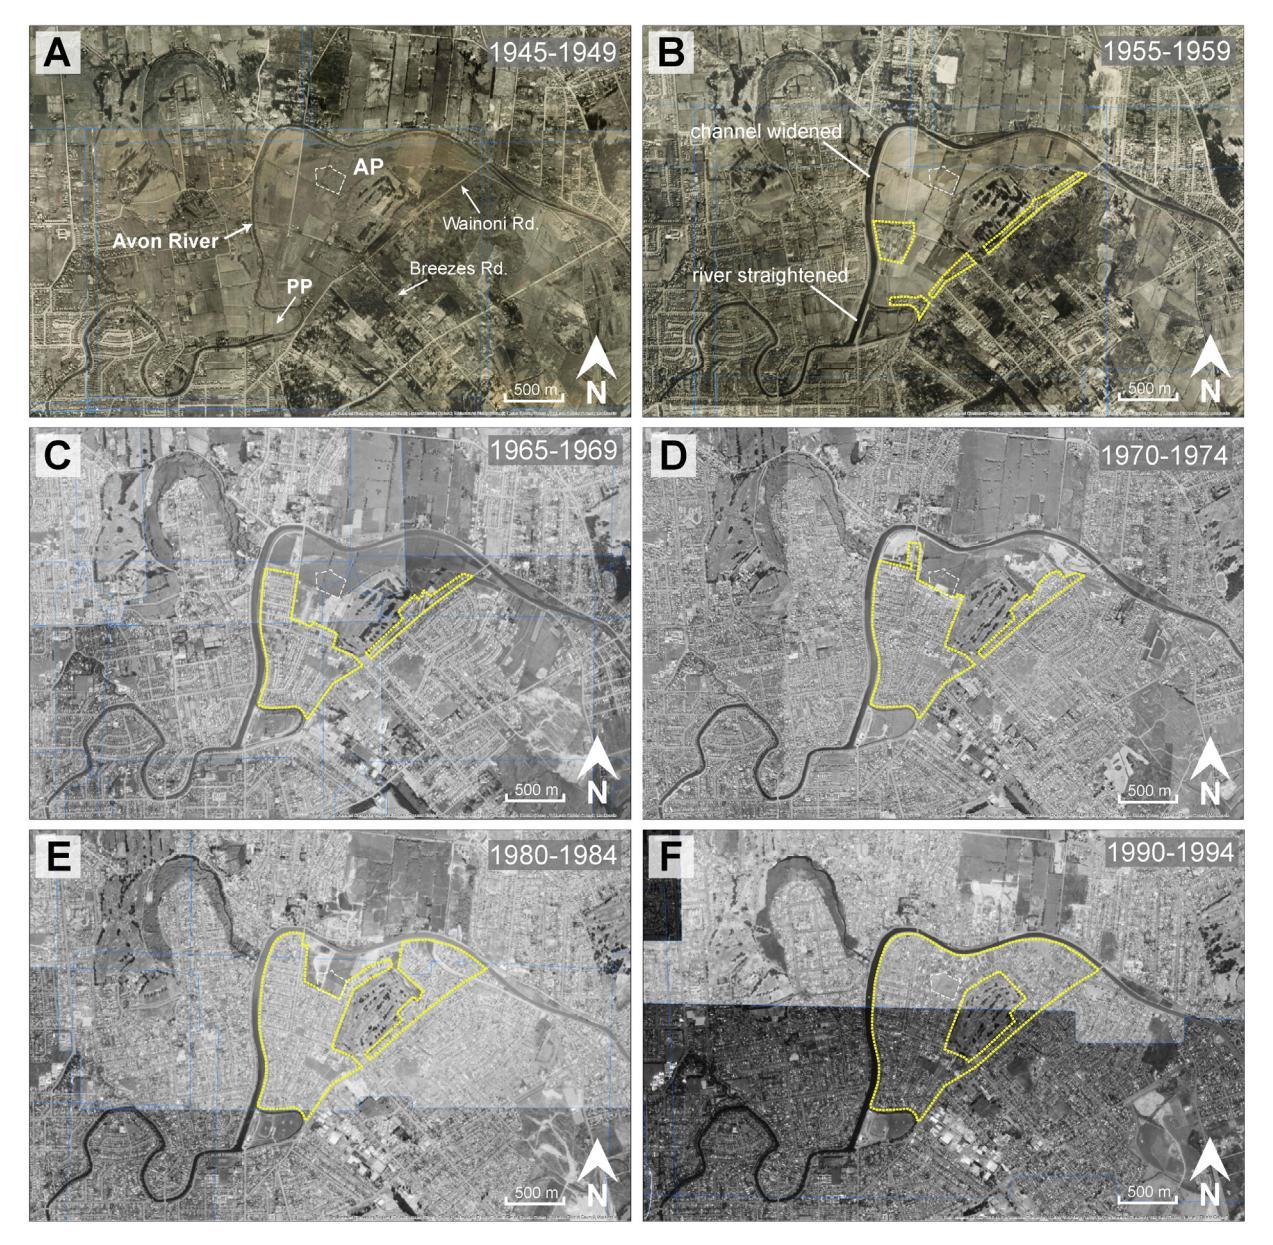
Fig. 2. Historical aerial photographs highlighting the sequence (A–F) of anthropogenic modifications near Avondale Park, Porritt Park, and surrounding residential areas. [Further information on Fig. 2 is provided in supplementary item ST.1, https://doi.org/10.5061/dryad.z612jm67z].

A review of historical aerial photography (1940–2011) indicates there have been significant anthropogenic modifications to both study areas (Fig. 2). The Avondale Park and Porritt Park sites and adjacent area between the Avon River and Wainoni Road remained undeveloped until at least 1949 (Fig. 2A). Changes to the Avon River and the initiation of residential development are evident between 1949 and ~1955-1959 (Fig. 2B), when the north-south oriented section of the Avon River was widened and a new southern extension adjacent to Porritt Park was created, effectively cutting off and isolating the Porritt Park meander bend (Fig. 2B). Between 1965 and 1969 the development of homes continued to the northnortheast (Fig. 2C), suggesting that the majority of anthropogenic fill was probably placed in the area prior to 1965. The 1970–1974

aerial photographs show the continued development and construction of homes in the area moving to the north and northwest (Fig. 2D). At this time, Avondale Park had not been established but homes were constructed to the present-day southern limit. Porritt Park was heavily modified in the 1970s, including the installation of an extensive E-W oriented subdrain system (Fig. 3A). Following the installation of the subdrain system, several playing fields and associated buildings were constructed circa 1974 (Fig. 3A). Aerial photographs indicate that the development of roads, homes, and all parks (as we observe them today) in the area were completed sometime between 1990 and 1994 (Figs. 2E,F). At Porritt Park, a series of solid irrigation pipes were installed in 2002, followed by the construction of several new sport courts in 2004 (Fig. 3B). As a result of damage during the 2010-2011 CES, the playing fields are no longer present and Porritt Park is not maintained, resulting in overgrown vegetation and swampy conditions. The Avondale Park sports field/park (Fig. 3C,D) was established in the late 1990's, with the first irrigation system constructed during this time. Ten centimetres of subsoil was placed beneath the field turf. From 2001-2002, a new field drainage and irrigation system was constructed at Avondale Park (Fig. 3D). Some minor alterations to the surface have been performed following the CES. No grading reports or records documenting fill placement at Avondale Park or Porritt Park were available at the Christchurch City Council.

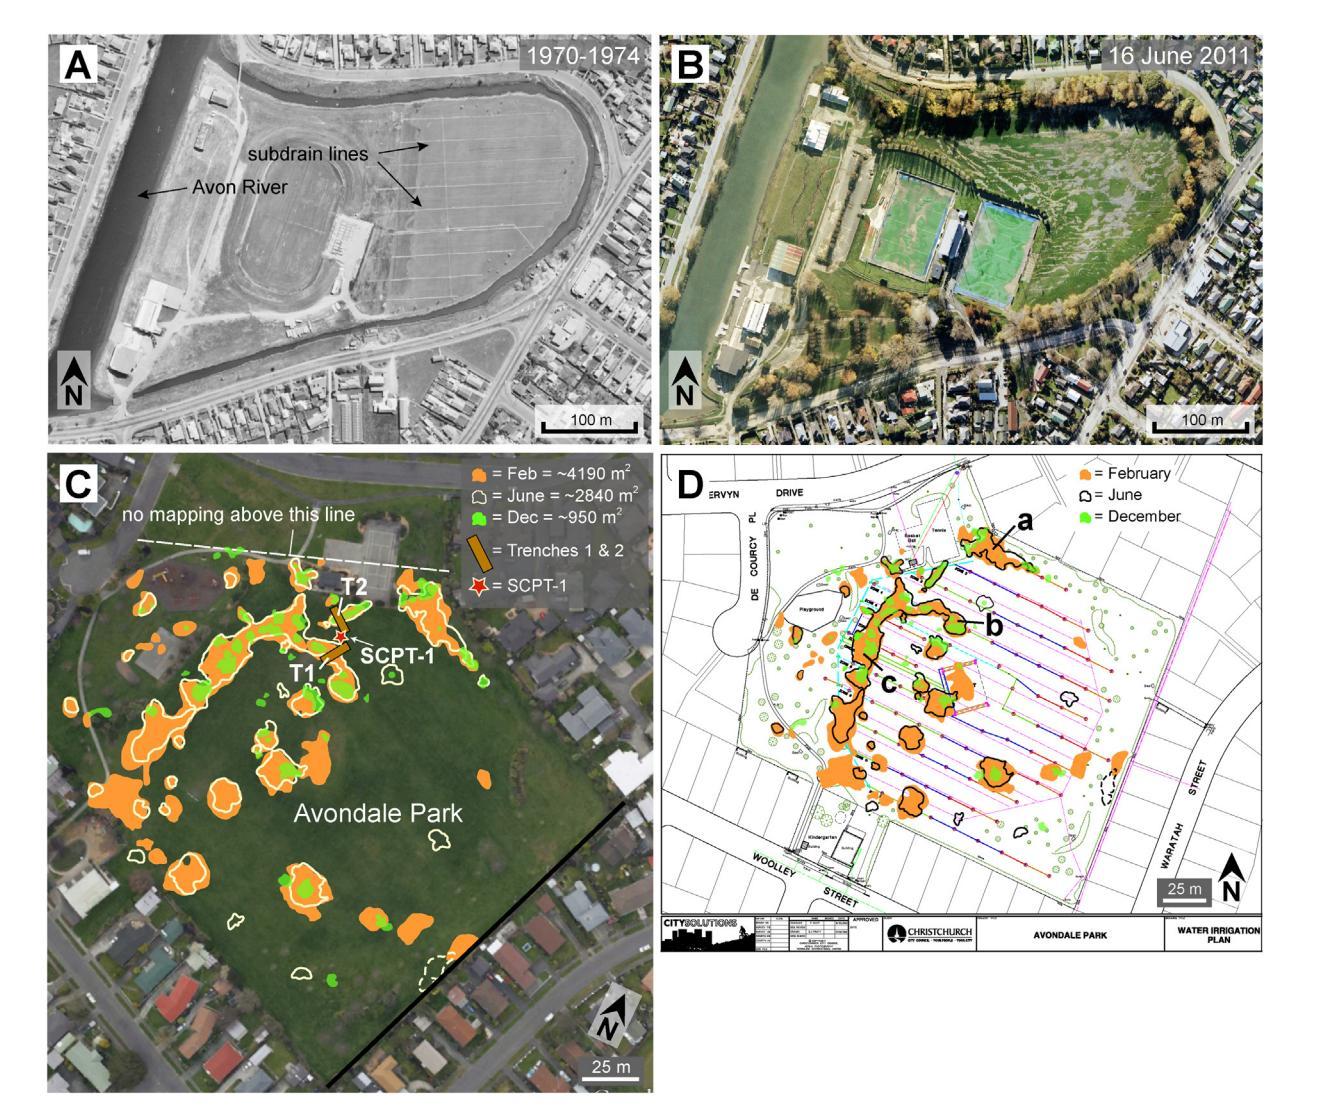
Fig. 3. (A) Porritt Park before CES: 1970–1974 historical aerial photographs showing East-West oriented subdrain system. (B) Porritt Park after CES: Aerial photograph taken on 16 June 2011, a few days after the 13 June 2011 earthquake. Note the locations for the pre-existing subdrain lines and distribution of liquefaction ejecta. (C) Liquefaction ejecta at Avondale Park study site in eastern Christchurch. (D) Surface liquefaction features superimposed on the Avondale Park water irrigation and drainage plan. [Further information on Fig. 3 is provided in supplementary item ST.1, https://doi.org/10.5061/dryad.z612jm67z].

(if present) liquefaction features (Fig. 3C). We used wellestablished criteria for identifying earthquake-induced liquefaction features, including analysis of aerial photography, trenching, and dating of subsurface deposits (e.g. Sims, 1975; Obermeier et al., 1991; Obermeier, 1996; Tuttle, 2001; Bastin et al., 2013, 2015; Villamor et al., 2016). The trenches were excavated perpendicular to aligned sand blow vents. The trench walls were cleaned using handheld scrapers and then photographed and logged at centimeter scale to document small-scale changes in the morphology of the liquefaction features and the surrounding stratigraphy. The trench bottoms were also photographed at several locations of interest to highlight key liquefaction and sedimentary features. The liquefaction features and the surrounding unmodified anthropogenic fill and underlying natural stratigraphy were described in terms of their grain size, sorting, colour (using Munsell hue, value, and chroma), and degree of sediment mottling. Hand-auger borings were performed in Trenches 1 and 2 (A1 and A2, respectively) to depths of 1.73 and 1.20 m (from trench bottom), respectively (Figs. 4–6). Below these depths, the sediment lacked cohesion and could not be retrieved. Radiocarbon dating was performed on a single charcoal sample from in situ silty clay sediment located at the bottom of Trench 2 (Fig. 6). Due to the swampy conditions (i.e. high groundwater), we were unable to trench at Porritt Park.

No surface liquefaction ejecta was identified at Avondale Park during field and photographic investigations immediately following the 4 September Darfield earthquake. The most extensive sand blow development occurred during the 22 February earthquake, followed by the 13 June and 23 December earthquakes (Fig. 3C). The total area of surface ejecta at the Avondale Park study site was ~4190 m² for 22 February, ~2839 m² for 13 June, and ~946 m² for 23 December earthquakes, with June and December surface ejecta comprising ~68 % and ~23 % of the February surface ejecta area, respectively (Fig. 3C). Mapping of surface liquefaction features

(e.g. sand blows) at Avondale Park indicates recurrent liquefaction occurred at the site. At the Trench 1 location, surface sand blow features were evident only after the February and June earthquakes, while at Trench 2 surface liquefaction features were generated during each of the 2011 earthquakes (Fig. 3C).

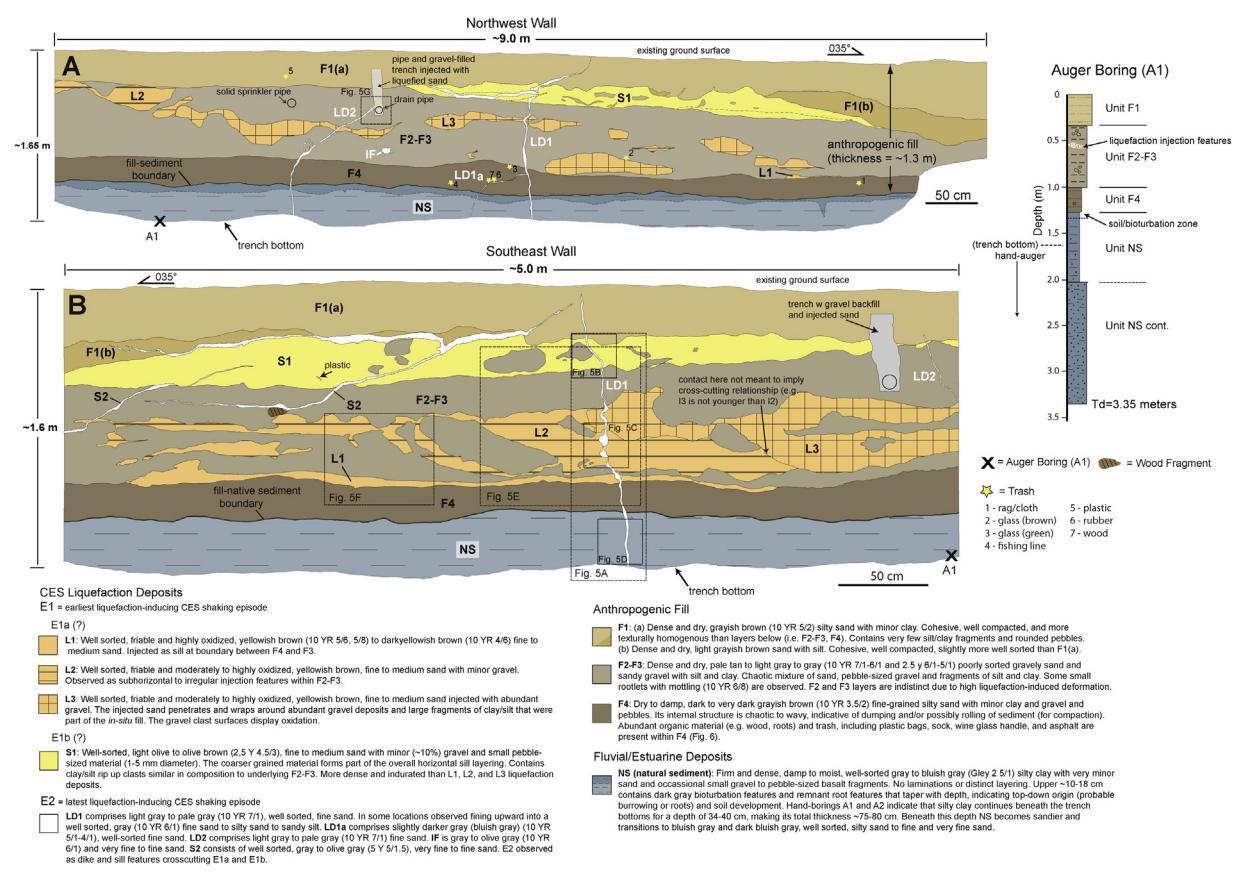
Fig. 4. Trench logs for Northeast (A) and Southeast (B) walls of T1. [Further information on Fig. 4 is provided in supplementary item ST.1, https://doi.org/10.5061/dryad. z612jm67z].

1 walls (see S2 in Fig. 4B). A unique assemblage of horizontal to subhorizontal, elongate to irregularly shaped liquefaction injection features (Figs. 4, 5) are contained within F2-F3. Three primary 'types' of liquefaction injection features are distinguished within F2-F3 (i.e. L1, L2, L3). Sedimentary characteristics of L1-L3 are described in the Fig. 4 legend.

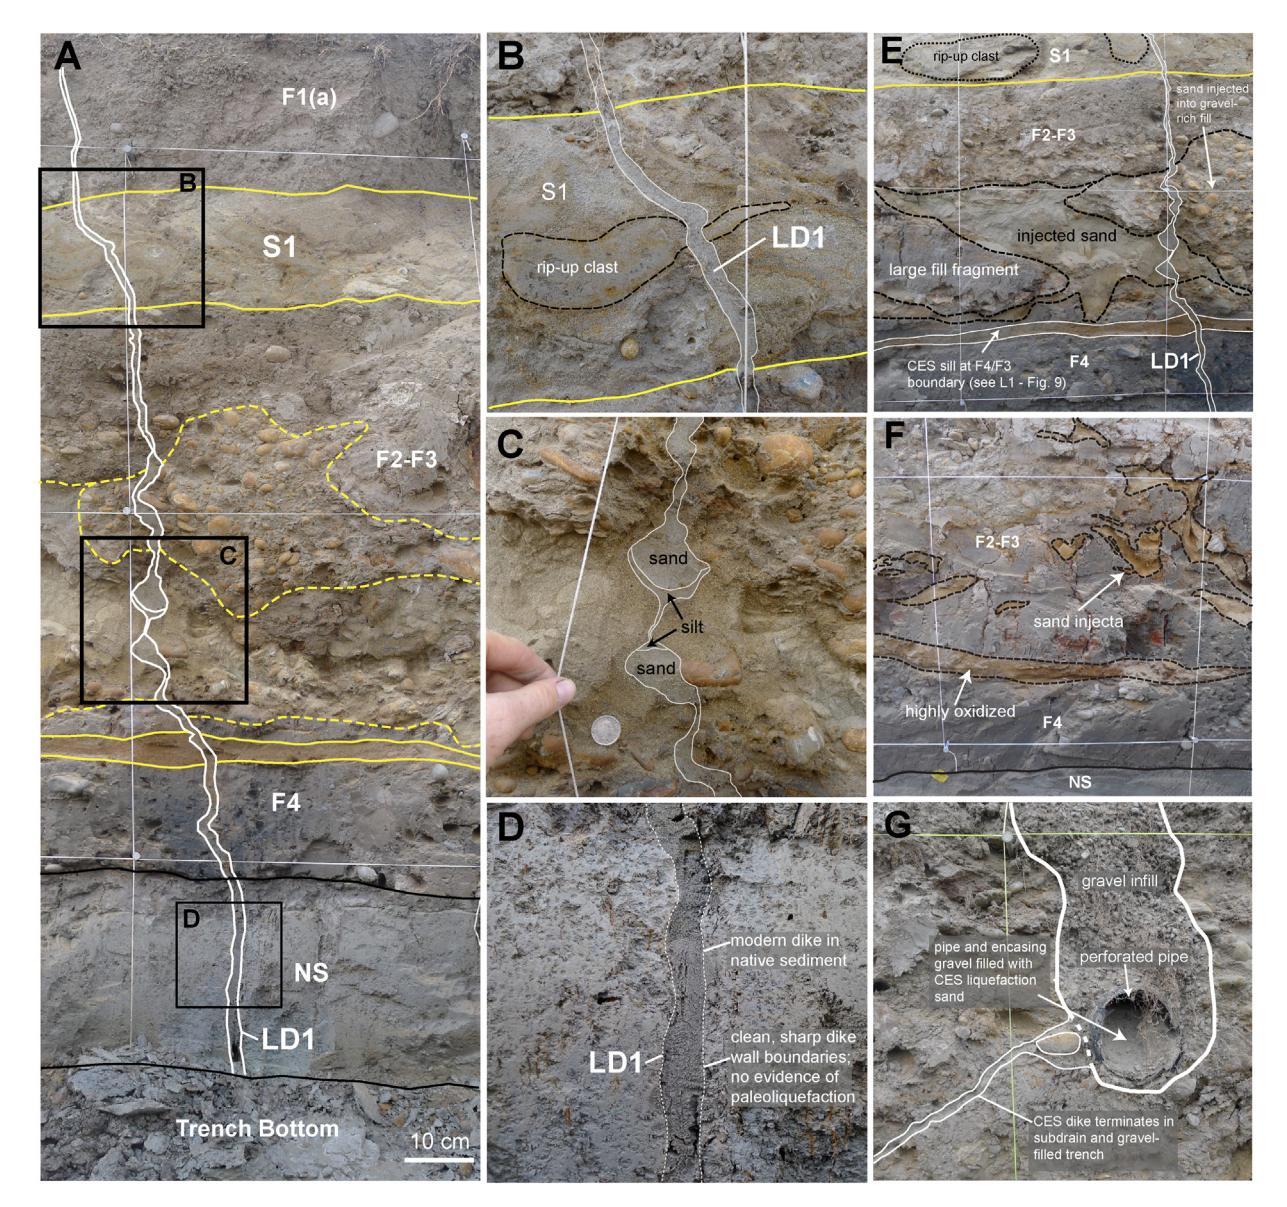
Fig. 5. Photos of CES liquefaction features in T1. (A) At least two distinct episodes of CES-induced liquefaction are evident in the southwestern wall of Trench 1. (B) LD1 crosscuts the large sill (S1) present at the bottom of F1a. (C) The orientation of CES liquefaction dikes is typically irregular through the gravel-rich fill layers F2 and F3 and preexisting liquefaction features. (D) CES liquefaction dike crosscutting natural sediment (NS). (E) Liquefied sand injecta in F2-F3. (F) Liquefaction injecta within F2-F3, primarily within the silty-clay host fill sediment. (G) Termination of CES liquefaction dike into existing perforated subdrain pipe. [Further information on Fig. 5 is provided in supplementary item ST.1, https://doi.org/10.5061/dryad.z612jm67z].

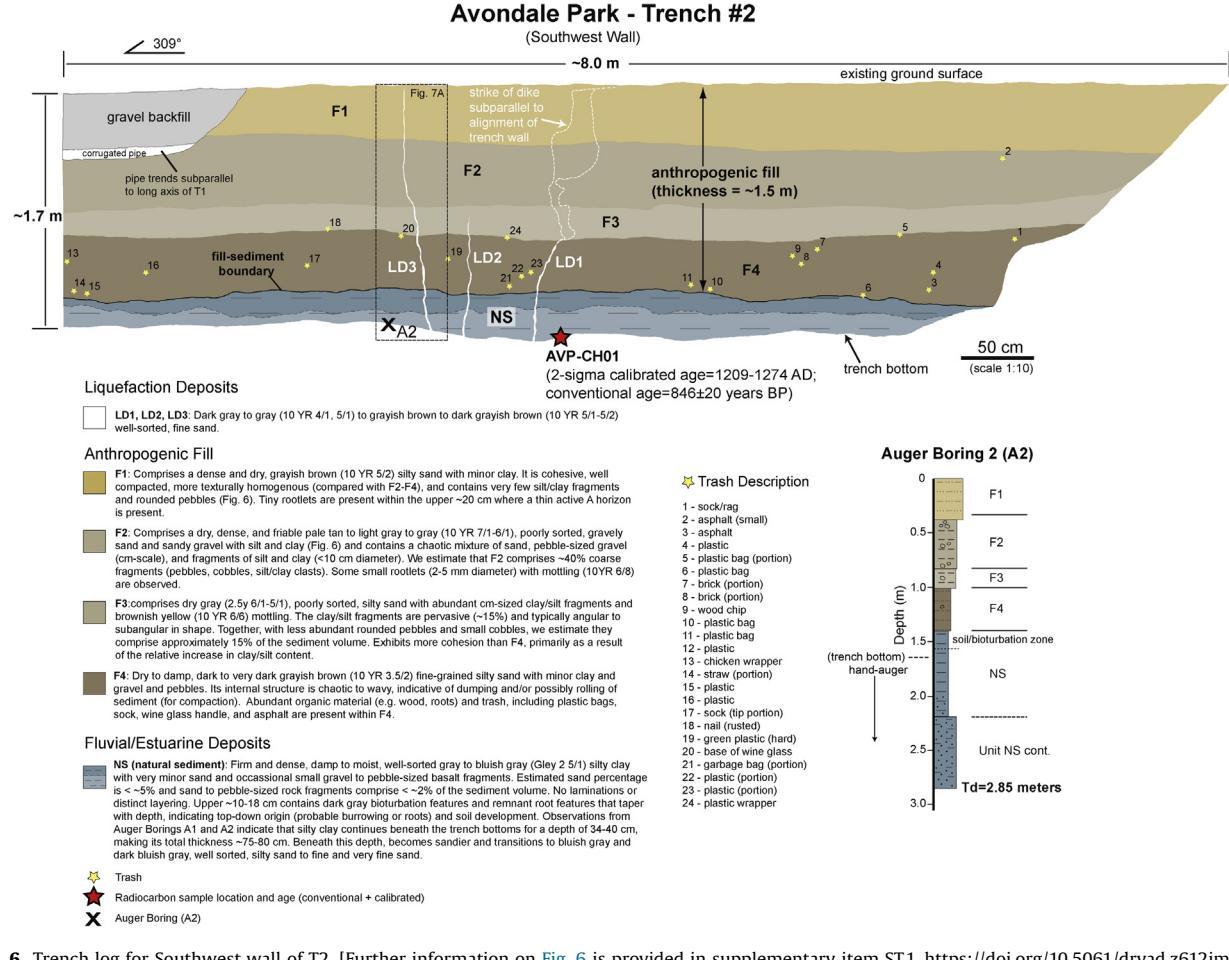
Fig. 6. Trench log for Southwest wall of T2. [Further information on Fig. 6 is provided in supplementary item ST.1, https://doi.org/10.5061/dryad.z612jm67z].

The anthropogenic fill sequence in Trench 2 is only weakly deformed by the CES and therefore provides a stratigraphically intact sequence of fill stratigraphy (Figs. 6, 7). Four separate fill layers (F1-F4) are delineated within Trench 2 based upon a comparison of sediment colour, composition, and texture (including grain sorting) (Fig. 6). Within Trench 1, the central fill layers (i.e. F2 and F3) have been sufficiently deformed to a level where distinguishing between the two layers is difficult (Figs. 4, 5). Consequently, we collectively refer to these layers as F2-F3 when describing Trench 1 observations (Figs. 4, 5). Natural and anthropogenic fill stratigraphy is described in detail in Figs. 4 and 6. The ^{14}C age of 846 \pm 20 yr B.P. (Table S.3 and Fig. S.5, https:// doi.org/10.5061/dryad.z612jm67z) from Avondale Park represents the youngest age for *in situ* natural sediment (NS) identified at this trench site and provides a minimum age estimate for the last occurrence of liquefaction at the study site. Bastin et al. (2016) identified multiple paleo-liquefaction events since 800 B.P. at other sites in the CES area; it is likely that the Avondale Park area may have different site characteristics or geological history relative to these apparently more liquefaction-susceptible sites.

The modern liquefaction dikes (Fig. 6 - see LD1, LD2, LD3) in Trench 2 are oriented vertical to subvertical, have a maximum thickness of \sim 1.5 cm, and thin upwards to \sim 2–5 mm near the surface. Very thin (< 0.5 mm) silt linings were observed along the dike sidewalls. The absence of multiple crosscutting silt linings within the modern dikes makes it impossible to determine if reactivation occurred during successive CES shaking events. The modern dike walls range from distinct to highly oxidized depending on the surrounding sediment/fill and elevation relative to the water table. No significant mottling is observed along any of the dike walls. The highest degree of oxidation is observed within F4, where the dike boundaries are difficult to identify (Fig. 7C). The oxidation of liquefaction features is consistently highest within F4 in both trenches and less pronounced within the natural sediment (NS)(although minor oxidation is observable) and generally absent to minimal within F1, F2, and F3. Vertical dike orientation is most irregular (particularly for LD1) within F2 and F3 (Fig. 6), highlighting the influence that heterogeneities in anthropogenic fill (i.e. gravel and cm-scale sediment fragments) have on dike propagation and orientation. In some instances, the dike boundaries within the gravel-rich F2 and F3 layers were difficult to follow and became diffuse (Fig. 7A, B), as the higher porosity gravels allowed for local dissipation of high fluid pressures. The liquefaction dikes splay off a larger feeder dike observable at the trench bottom (Fig. 7D, E).

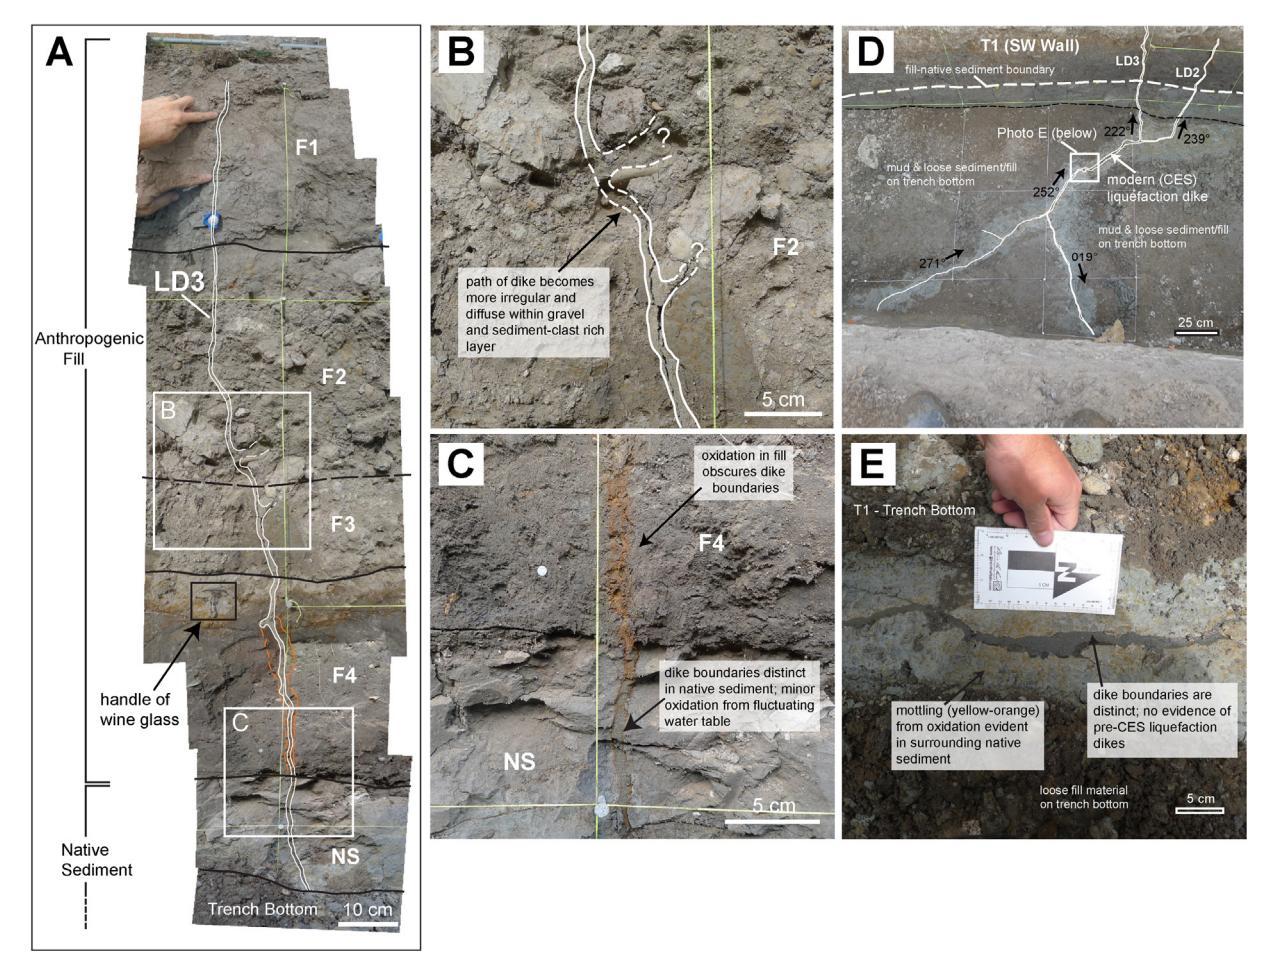
Fig. 7. Photos of CES liquefaction features in T2. **(A)** CES liquefaction dike crosscuts natural sediment and anthropogenic fill layers. **(B)** Dike boundaries become more diffusive within fill layers F2 and F3 where gravel and randomly placed fragments of silt/clay are abundant. **(C)** Mottling from oxidation is greatest within F4. **(D)** Photo of CES liquefaction dike at trench bottom. **(E)** CES dike boundaries are distinct. [Further information on Fig. 7 is provided in supplementary item ST.1, https://doi.org/10.5061/dryad. z612jm67z].

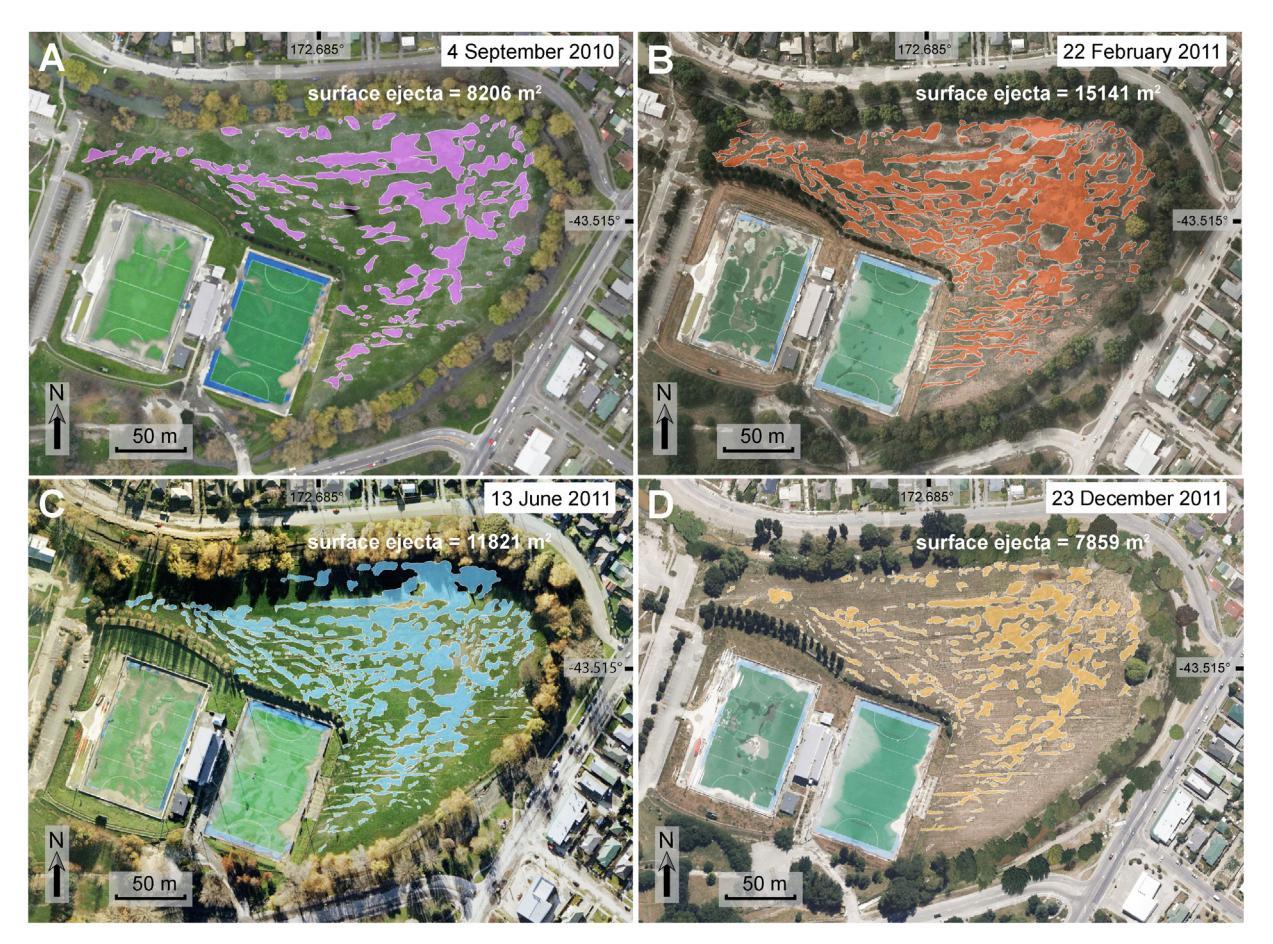
Fig. 8. Surface ejecta during each of the primary CES earthquakes - (A) 4 September 2010 and (B) 22 February, (C) 13 June, (D) 23 December 2011. [Further information on Fig. 8 is provided in supplementary item ST.1, https://doi.org/10.5061/dryad.z612jm67z].

The amount of surface ejecta by percent area at Porritt Park was highest during the February and June 2011 earthquakes (Fig. 8B,C). During the February earthquake, surface ejecta covered \sim 41 % of Porritt Park. The surface patterns reveal the underlying influence of the 1970 subdrain system and meander scroll bars (Fig. 8A-D).

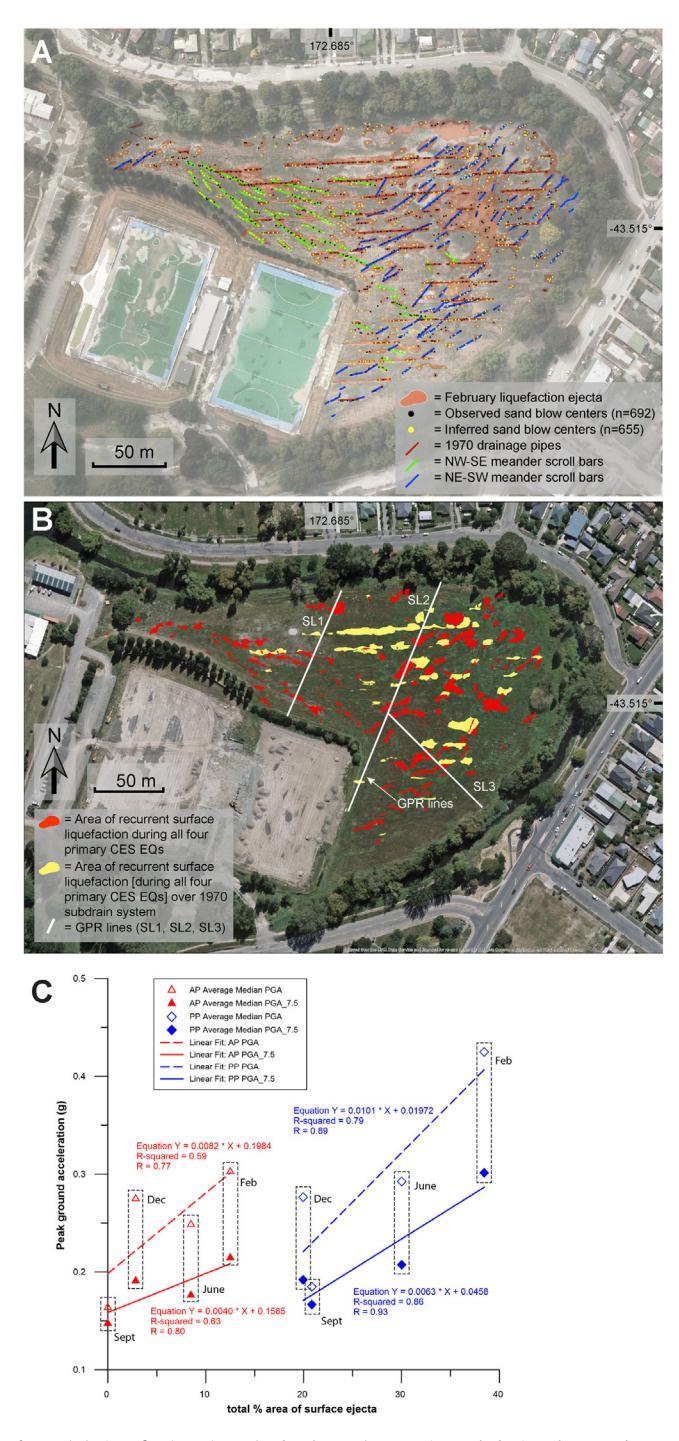
Fig. 9. (**A**) Liquefaction ejecta (red polygons) at Porritt Park during the 22 February 2011 earthquake. (**B**) Areas of recurrent liquefaction ejecta at Porritt Park. Red polygons show the areas where liquefaction ejecta occurred at the surface during each of the primary CES earthquakes (September 2010, February, June, December 2011). [Further information on Fig. 9 is provided in supplementary item ST.1, https://doi.org/10.5061/dryad.z612jm67z].

Three survey lines (i.e. SL1, SL2, SL3) were conducted at Porritt Park (Fig. 9B) using a Sensors and Software pulse EKKO Pro GPR system that utilizes multiple antennae frequencies. The survey lines were positioned to cross three distinct sand blow array patterns identified during desktop mapping. Two different frequency antennae, 100 MHz and 200 MHz, were used for each survey line. Lower frequencies provide greater depth of penetration but lower resolution, while higher frequencies provide higher resolution but lower penetration depth (Jol and Bristow, 2003). The 100 MHz survey lines recorded radar readings every 0.25 m with the antennae 1.00 m apart, while 200 MHz survey lines recorded readings every 0.10 m with the antennae 0.50 m apart.

We mapped 1347 individual sand blow centres (692 observed, 655 inferred) for the 22 February 2011 earthquake (Fig. 9A). Locations of the 1970 subdrain lines are superimposed on the liquefaction polygons and mapped sand blow centres (Fig. 9A). Three distinct linear trends are established from the geometry/ orientation of ejecta polygons and the alignment of linear sand blow arrays (see red, green, and blue lines - Fig. 9A). Linear sand blow arrays trending E–W are attributed to the influence of the underlying 1970 subdrain lines while the sand blows trending NW-SE and SW-NE are attributed to the influence of underlying river meander scroll bars.

The red polygons show the areas where liquefaction ejecta occurred at the surface during each of the primary CES earthquakes (Fig. 9B). The total area of recurrent liquefaction was 4115 m^2 and

represented ~11 % of the Porritt Park area. The yellow polygons depict areas of recurrent liquefaction occurring above the 1970 subdrain system. The total area of recurrent liquefaction overlying the 1970s subdrain lines was 1533 m² and comprised ~37 % of the total recurrent liquefaction area (~4 % or Porritt Park area), demonstrating the strong influence of the old subdrain lines on the surface distribution and expression of liquefaction ejecta at Porritt Park, particularly in the northern section of the site.

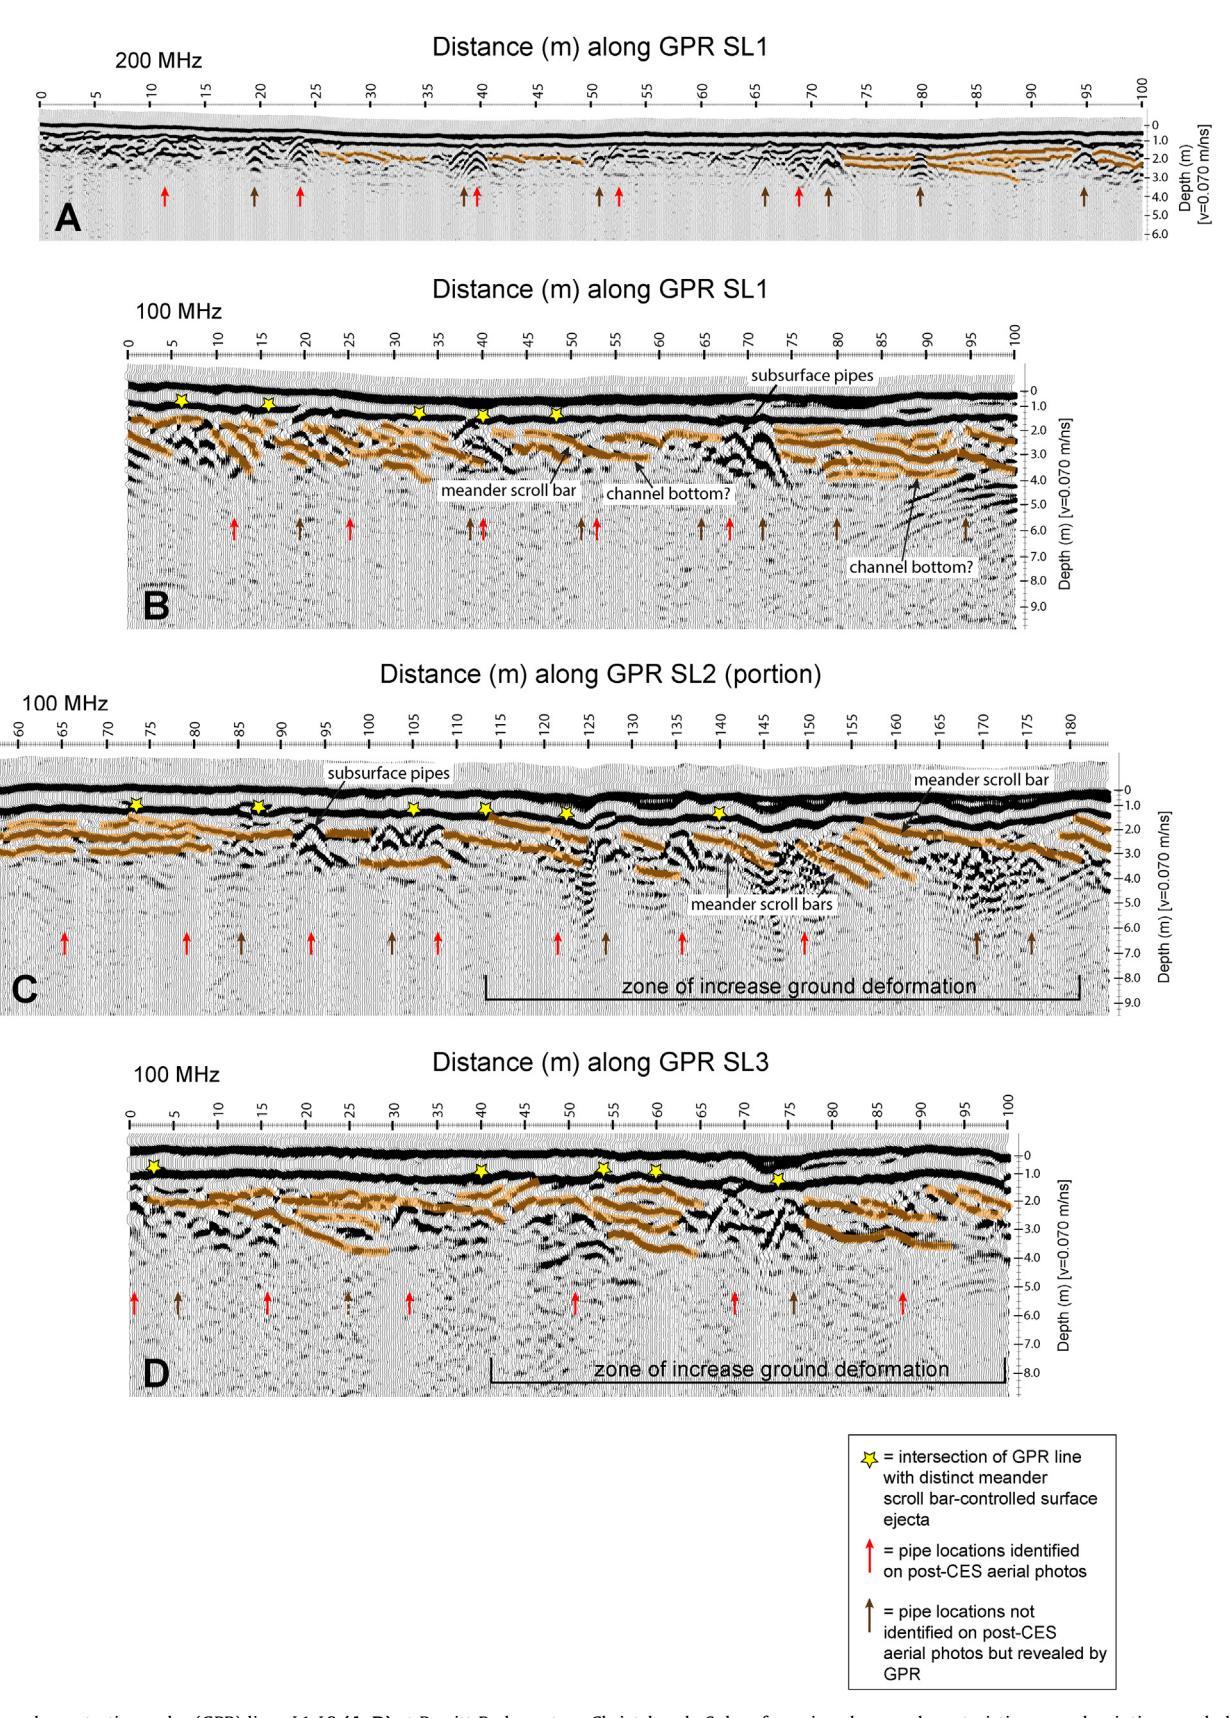
Fig. 10. Ground penetrating radar (GPR) lines L1-L3 **(A–D)** at Porritt Park, eastern Christchurch. Subsurface pipes have a characteristic upward pointing parabola shape. Meander scroll bar accretions are evident and dip to the North and East. Yellow stars depict locations where surface liquefaction ejecta are influenced by scroll bars; note the intersection of several bar reflections with the observed ejecta sites. [Further information on Fig. 10 is provided in supplementary item ST.1, https://doi.org/10.5061/dryad. z612jm67z].

The GPR effectively captures the locations for subdrain pipes (Fig. 10 – black and red vertical arrows) and resolves meander scroll bar and channel bottom features (Fig. 10). The 200 MHz resolution reveals subsurface pipes not apparent in the post-CES aerial photographs (see Fig. 10A, black vertical arrows). Meander scroll bar accretionary layers are evident and dip to the northeast in L1 and L2, and southeast in L3 (see Fig. 10B,C,D). Ground deformation is most severe in areas where subsurface drainpipes and distinct scroll bar reflections interact (see Fig. 10C,D), although the observed ground deformation could be partially influenced by lateral spreading closest to the Porritt Park meander boundaries. The location of mapped surface liquefaction ejecta sourced from meander scroll bars is marked on L1, L2, and L3 (see yellow stars -Fig. 10). We note the intersection of several point bar reflections with observed surface ejecta sites, suggesting that the boundaries of point bar accretionary layers (in addition to the 1970 subdrain system) act as potential conduits for liquified sediments.

The GPR at Porritt Park is successful in imaging anthropogenic and natural depositional features in the shallow subsurface. The 200 MHz frequency is most effective in imaging the location of drainpipes and reveals several drainpipe locations that are difficult to resolve with the 100 MHz frequency (Fig. 10). However, the 100 MHz frequency is more successful in capturing natural depositional features including meander scroll bar features and potential channel boundaries. The GPR suggests that minimal to no fill was placed beneath the area studied at Porritt Park, as several of the scroll bar horizons can be observed intersecting the ground surface (Fig. 10C). This implies that the subdrain system was excavated directly into the natural ground surface and is consistent with liquefaction ejecta strongly mimicking the meaner scroll bars at the surface. If anthropogenic fill of sufficient thickness (similar to Avondale Park) was placed on the site, we wouldn't expect the pattern of the underlying accretion bars to be so clearly expressed at the surface. In some locations, the scroll bar boundaries intersect at the surface with linear sand blow arrays (see Fig. 10C - yellow stars), suggesting that liquefied sediment is migrating upward along the boundaries between individuals point bars or being directly sourced by the point bar deposits. Giona Bucci et al. (2018a, b) describe the guiding of fluidized sand along inclined sediment body boundaries (e.g. within point bar deposits and buried channel margins) to the ground surface and present a conceptual framework for evaluating the implications of this process on transporting fluidized sediment and influencing surface liquefaction patterns. Our GPR analysis supports this model and provides the first subsurface imaging of these potential ejecta pathways. Importantly, the results indicate that, in some cases, GPR can be used to predict where liquified sediment (as sourced from natural depositional features) will erupt at the surface. We note that the zones of most severe ground damage and liquefaction ejecta coincide with areas containing multiple subdrain lines and meander scroll bars (Fig. 10). This highlights the complex interplay between the 1970 subdrain lines and the scroll bar features in delivering liquefaction ejecta to the surface, and in this case, increasing the amount of surface deformation.
